# Regal Home Inspections, LLC

## Property Inspection Report

Client(s): **Sample Report**  
Property address: **New Jersey**  
Inspection date: **Saturday, April 04, 2015**

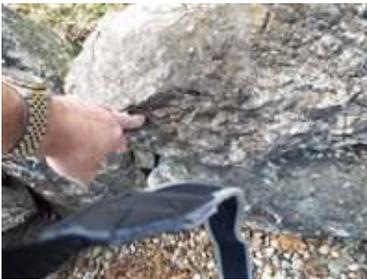
**Photo 4-1**

**4) Safety, Repair/Maintain** - There are numerous, loose stones on the retaining wall by the pool. In some sections of the walls in the yard the stones are secured in place with mortar. In areas such as the ones seen below, the stones are loose and secured only by gravity and friction/placement. As a result they are a safety hazard as they can fall and injure adults and children alike.

Stone is loose.

Recommend that a qualified hardscape or masonry contractor secure all stones.

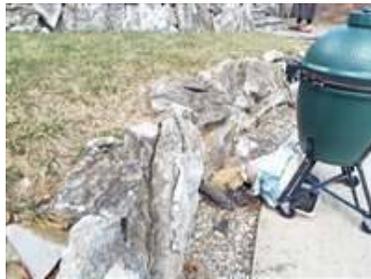
**Photo 4-2**

Some of these stones are loose as well.

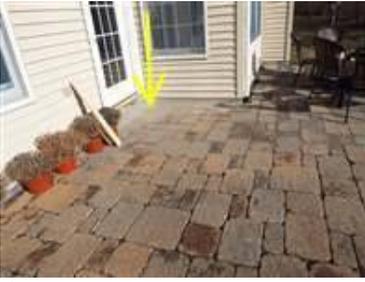
Photo 5-1

**5) Repair/Replace** - Patio/pavers are improperly installed because they are sloped toward the house. A 6' level was used to demonstrate to the clients that the slope is incorrect. The low point is in the corner as indicated by the arrow in the associated photo. All surfaces around the house, soil, sidewalks, decks, patios, etc. must be sloped so that water drains away from the structure. In this instance the pavers will facilitate water flowing toward the house, its foundation and structure. Combined with the damaged flashing and poorly attached siding (numerous holes & missing starter strip of "J" channel both noted in the Exterior Section) the current condition will be an issue and should be corrected prior to closing. The implications are that with the high potential for chronic water/moisture in this area a condition conducive to fungal rot to the wood and water leaking into the basement exists by its current design.

Recommend that a licensed, hardscape/landscape contractor remove the pavers, back fill with appropriate sub surface aggregate, properly compact the sub surface materials to retard further compaction of the patio base and, of course, pitched in a manner that facilitates water to flow away from the house. This should be combined with repairing the damaged flashing to proper building standards.

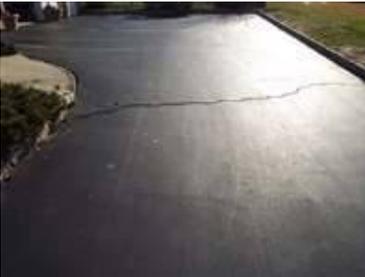
Photo 6-1

**6) Repair/Maintain, Comment** - Minor deterioration (e.g. cracks) was found in the driveway, but no trip hazards were found. Recommend having repairs made by sealing the cracks with water proof sealant. If left unsealed, the crack will allow water penetration, softening of the ground beneath and further deterioration.

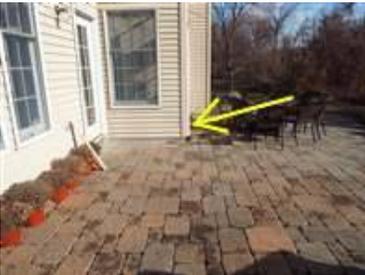
Photo 7-1

**7) Repair/Replace** - Sections of siding and/or trim were loose. Recommend that a qualified person repair, replace or install siding or trim as necessary.

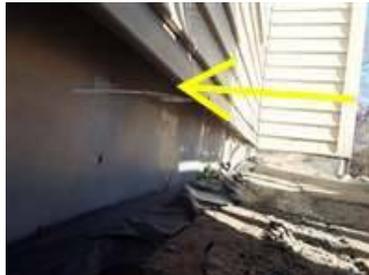
Photo 7-2

Missing starter strip or "J" channel to secure siding. Siding is loose.

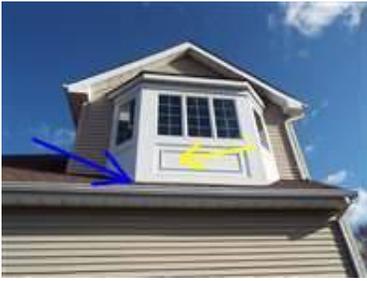
**8) Repair/Replace** - Fungal rot and soft, wet wood was found at one or more sections of siding or trim. Conducive conditions for rot should be corrected. Recommend that a qualified person repair as necessary by removing all wet, rotted wood and replacing with new. All rotten wood should be replaced. A small area (bubble) of plywood delamination seen as indicated by the yellow arrow below in photo 8-1. Plywood delamination was not pervasive but was evident.

**Photo 8-1**  
Some plywood delamination noted in the area of the yellow arrow. The next two photos are in the area indicated by the blue arrow.

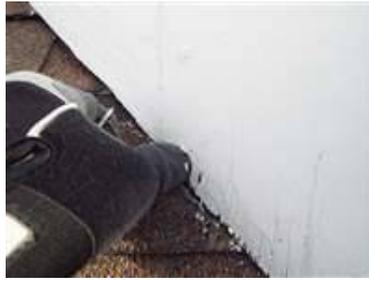
**Photo 8-2**  
Soft wood and water emerges from the wood when pressed with thumb. Here and Photo 8-3.

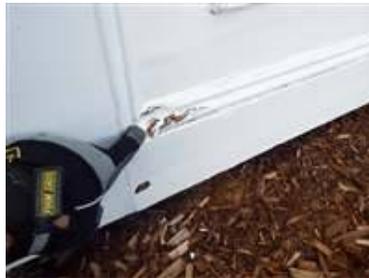
**Photo 8-4**  
This wood/trim rot is to the right of the front entry door. Here and next photo.

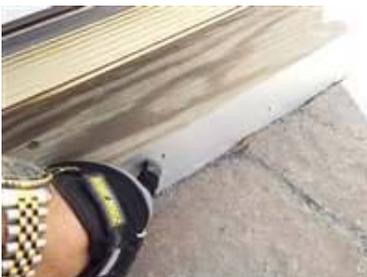
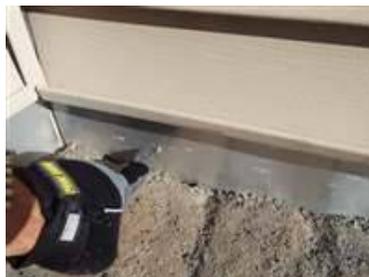
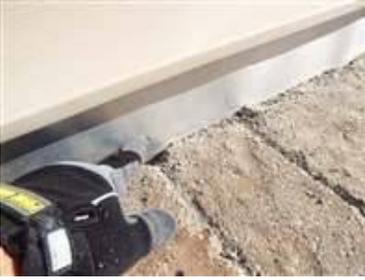
**9) Repair/Replace** - Flashing at one or more locations was damaged. Flashing in the back by the pavers that were re-set has numerous holes. Flashing should be an impervious membrane. Leaks can occur as a result of the holes and additional holes may exist below the pavers. Recommend that a qualified person repair, replace or install flashing as necessary, and per standard building practices along with the recommended (Grounds Section) repair of the paver slope/grading.

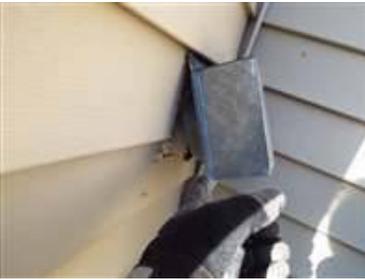
Photo 10-1

**10) Repair/Replace** - One or more exhaust duct end caps were damaged. Their purpose is to prevent unconditioned air from entering the building, and keep out birds, rodents and bugs. Blocked ducts can cause fan motors and/or clothes dryers to overheat and can pose a fire hazard. Recommend that a qualified person repair or replace caps as necessary.

Fireplace vent.

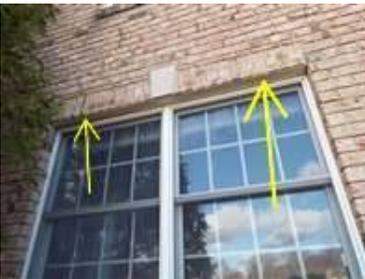
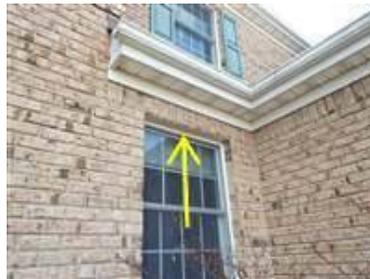
**11) Maintain, Monitor** - Window and some door openings on brick veneer walls, like the front of the house, have lintels that span over the window and support the bricks above. Lintels are iron support brackets and carry the weight of the bricks over the windows. Since they are iron over time they may rust and should be maintained with rust inhibiting paints. Additionally, the lintels themselves are supported by the brick on either side of the window opening. If they are not maintained and rust, the rust can cause cracks in the brick surface. There were no cracks seen here.

Lintels are located for example, here in this and in the next photo.

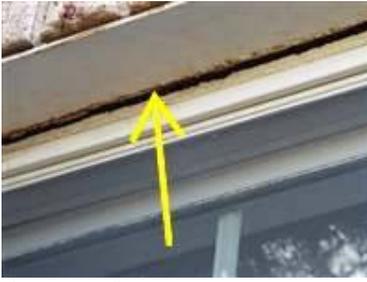
**Photo 11-3**

Below the iron lintel is the window and a weather proof seal should be maintained. There appears to be a gap between the lintel and the windows that should be sealed with a flexible sealant such as an exterior rated silicone.

Close inspection indicates the need for sealing the obvious gaps. Here and in next photo.

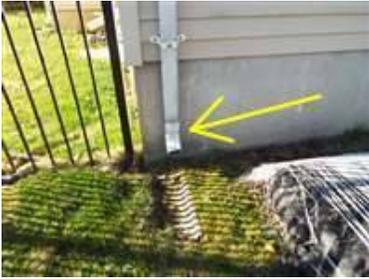
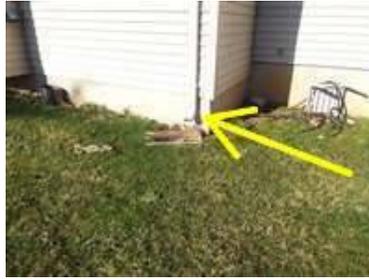
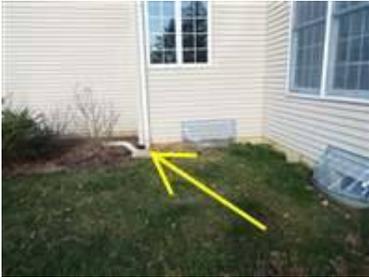
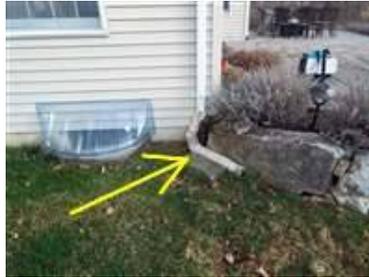
**13) Repair/Maintain** - Extensions such as splash blocks or drain pipes for one or more downspouts were missing. Water can accumulate around the building foundation or inside crawl spaces or basements as a result. Recommend that a qualified person install, replace or repair extensions as necessary so rainwater drains away from the structure.

Downspout extensions should route the water at least 6 feet away from the building.

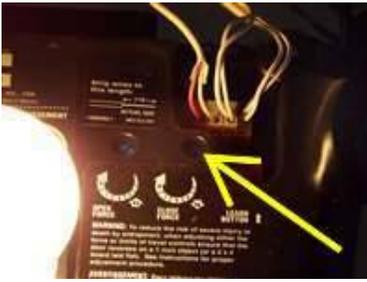
**16) Safety, Repair/Maintain, Evaluate** - The auto-reverse mechanism on one or more automatic openers for garage vehicle doors . This is a potential safety hazard. A qualified contractor should evaluate and repair as necessary.

**Photo 16-1**  
"Down Force" setting needs  
adjusting by a garage door  
professional.

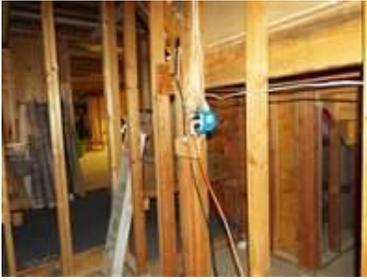
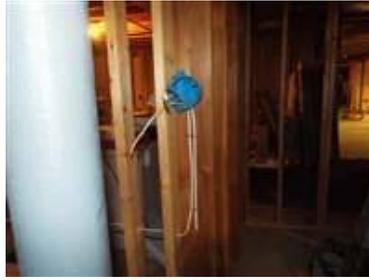
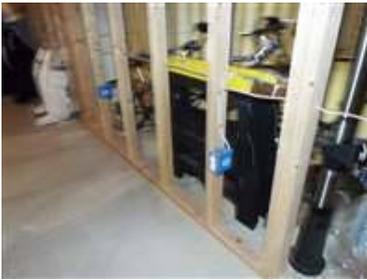
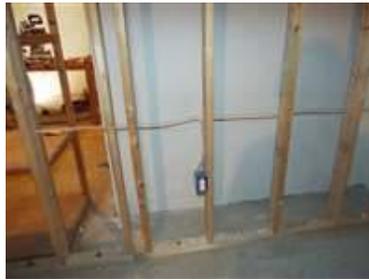
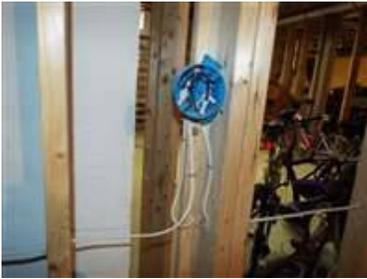
**18) Safety, Repair/Replace, Evaluate** - Substandard wiring was found at the basement. For example, exposed wiring, unterminated wires, exposed splices, missing cover plates and partially completed wiring job. This is a safety hazard. Recommend that a qualified electrician evaluate and repair as necessary and per standard building practices.

Highly recommend inquiring with the seller and the town building department about the permitting of this work. It appeared to be partially completed. Some sections were checked with a voltage detector but no indications that the wiring was energized. This work was, obviously, never inspected by the Holmdel municipal inspector.

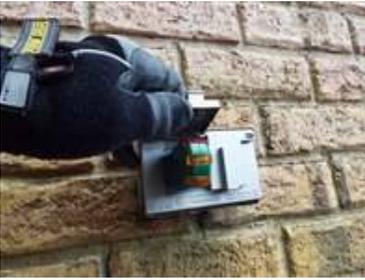
**Photo 19-1**

**19) Safety, Repair/Replace, Evaluate** - One or more electric receptacles (outlets) at the exterior had no visible ground fault circuit interrupter (GFCI) protection. If not GFCI-protected, receptacles in wet areas pose a shock hazard. Recommend that a qualified electrician evaluate and install GFCI protection if necessary and per standard building practices. General guidelines for GFCI-protected receptacles include the following locations:

Outlet to right of front door was energized but did not trip with a GFCI test device. Other outlets, inside for example, did properly trip with the same test device.

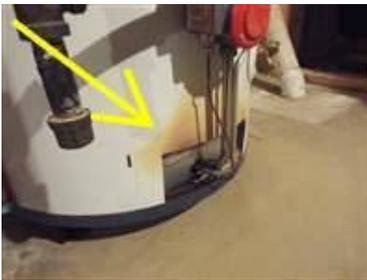
**Photo 23-1**

**23) Safety, Repair/Replace, Evaluate** - The water heater burner flames "rolled out" of the combustion chamber. This is a fire hazard due to the possibility of excessive heat damaging heating components, controls and wiring. Recommend that a qualified contractor evaluate and repair as necessary.

Brown area indicative of flame roll out.

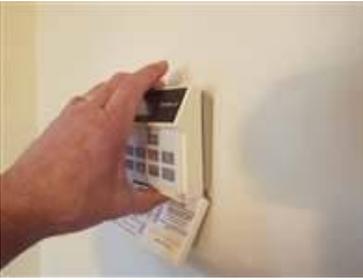
Photo 27-1

**27) Maintain** - The thermostat was loose. Recommend that a qualified person evaluate and repair or replace as necessary.

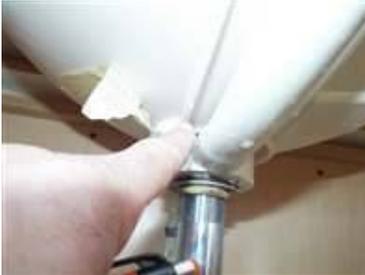
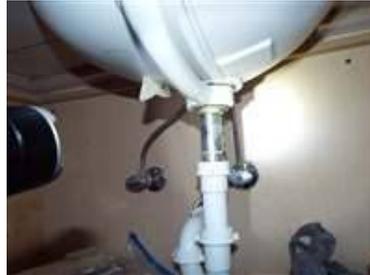
**35) Repair/Replace** - The sink at location(s) #E was damaged or significantly deteriorated. Recommend that a qualified contractor replace the sink.

The basin's overflow plumbing was broken and leaked. Repairs with black tape attempted but ineffective. This is to the right sink in the master bath.

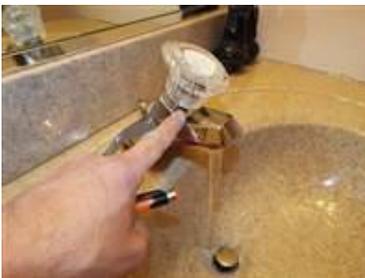
Photo 36-1

**36) Repair/Maintain** - The sink faucet valve handle at location(s) #C was leaking. Recommend that a qualified person repair as necessary.

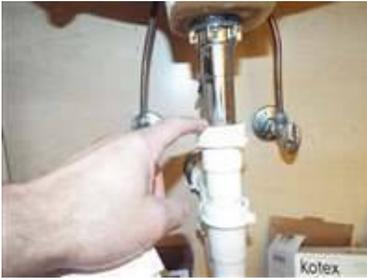
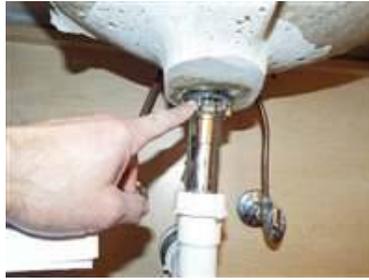
**37) Repair/Maintain** - One or more sink drains were leaking at location(s) #C. A qualified person should repair as necessary.

Right sink in Jack & Jill bathroom.

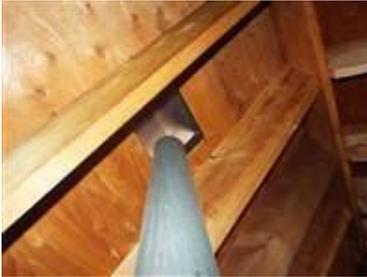
Photo 38-1

**38) Repair/Maintain** - One bathroom vent in the attic was not properly connected to the exhaust hood. It is a substandard installation and one which can allow the moist air from the bath to stay in the attic. Moist air in the attic can create a condition that is conducive to mold growth and roof sheathing (plywood) deterioration. Recommend that a qualified contractor properly attach the duct to the hood using proper construction standards.

The duct terminates in close proximity to the exhaust hood vs. being directly connected with proper unions and couplings to ensure that all vented air goes to the exterior.

Vent is close, but not properly connected, to the exhaust hood.

Recommend that the qualified contractor also inspect the other exhaust fan's (to the right when ascending the attic steps) connection to the hood to ensure proper attachment.

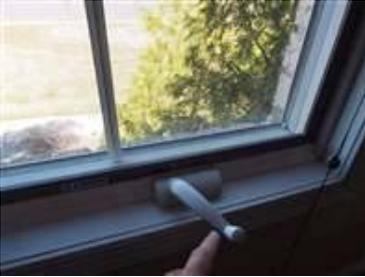
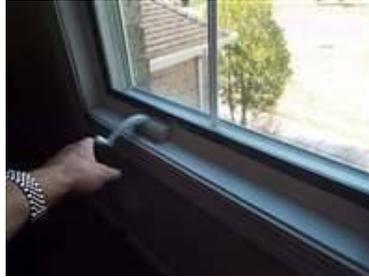
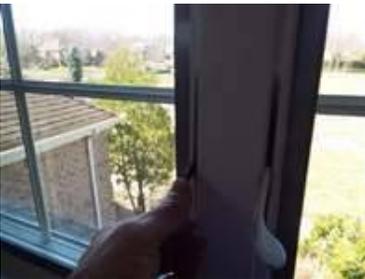
**40) Repair/Replace** - Crank handles at the windows in the Master sitting area were inoperable. Recommend that a qualified person replace handles or make repairs as necessary.

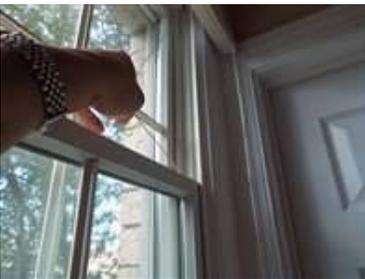
Photo 41-1

**41) Repair/Maintain** - Window retention string does not properly support the window and becomes slack. 1st floor, bath/laundry area. Recommend having the window repaired by an Andersen window specialist.
