Regal Home Inspections, LLC

SAMPLE Property Inspection Report

Property address: **New Jersey**

Inspection date: **Thursday, September 10, 2015**

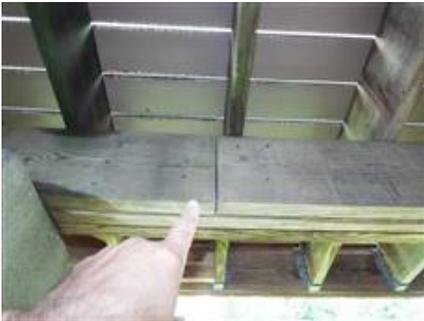
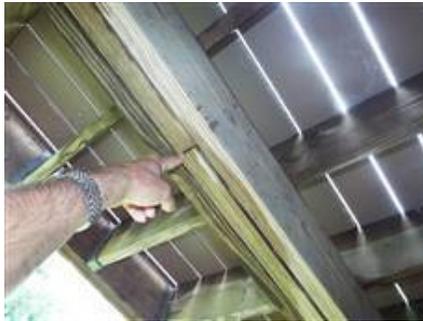
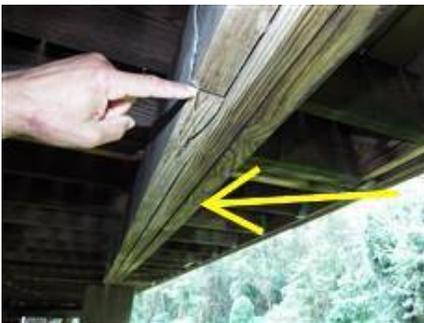
4) Repair/Replace, Evaluate - The deck beams, (built up, 3 timber beams), had beam splices (butt ends) that were not over a vertical support column. All points where two beam members are butted together must be over a vertical support. There are a number of spans with at least one beam splice and at least one where there are two or more.

If you compare the built up beam in the house with the one under the deck, wherever there is a beam splice, that splice is above a vertical support column in the basement. That IS NOT the case under the deck.

This span has two splices. One identified with my hand. The other is highlighted by the arrow. For this span, there is only one continuous timber rather than three.

Highly recommend that a professional engineer inspect this and evaluate. Resource options include:

Modifications should be made as the professional engineer deems necessary or he will certify the construction as it is.

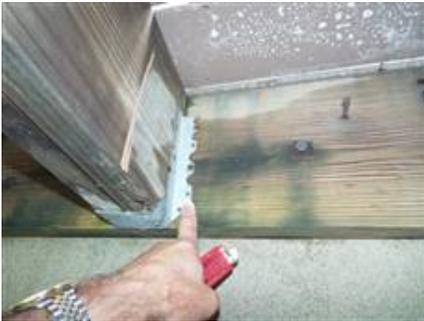
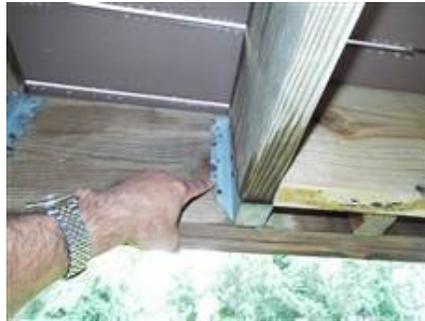
5) Repair/Replace - Fasteners for joist hangers at decks or porches were missing. All nail holes for such hardware should be filled with approved fasteners such as "Teco" nails. Recommend that a qualified person install approved fasteners where missing.

Additionally, one bracket was broken. Joist may not be structurally supported.

Photo 5-1
Numerous brackets are missing nails. Every nail hole should have the correct sized nail installed. Here and next photo are but two examples.

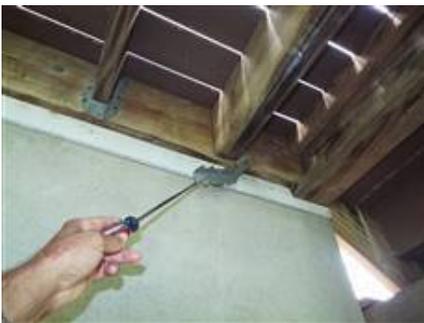
Photo 5-3
This bracket is broken.

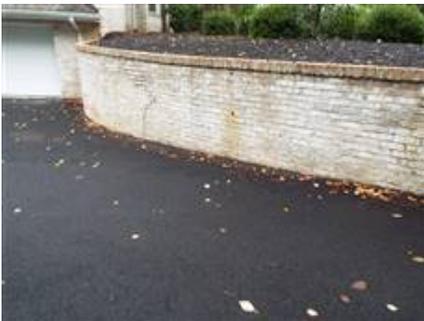
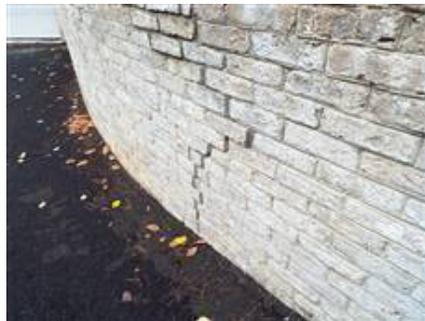
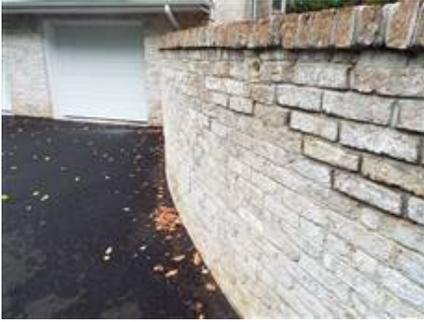
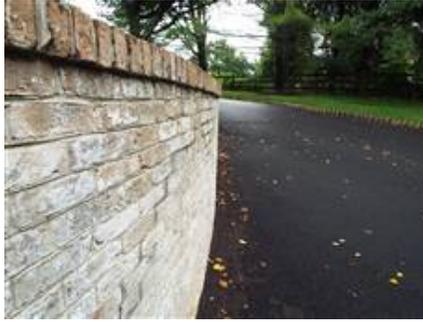
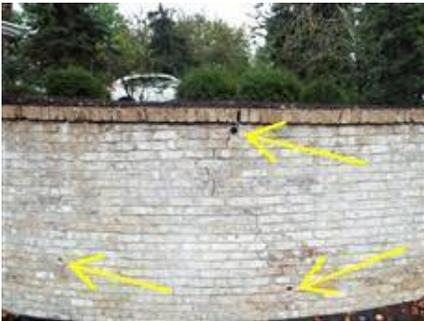
6) Repair/Maintain, Evaluate - The brick retaining wall is cracked next to the driveway. The inspector was not able to inspect the structural components of the wall behind the brick veneer. There should be a solid concrete or concrete block wall and the bricks are merely a finished surface.

Drain holes are high and low.

At a minimum the wall should be repaired and all cracks sealed. If the client retains the recommended services of the professional engineer for evaluation of the deck items noted in this section, I suggest that the P.E. look at this as well and advise the client accordingly.

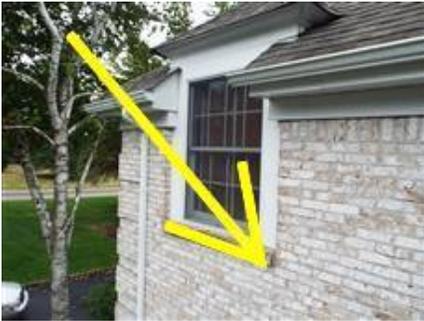
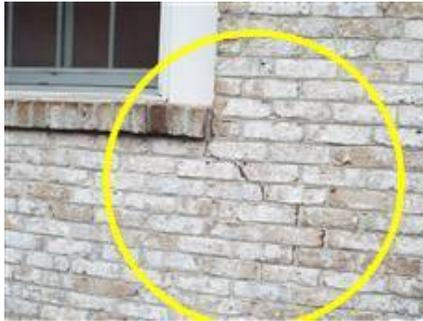
7) Repair/Maintain - The masonry, brick veneer was cracked or damaged in some areas. Where cracks or openings are exposed, water can enter the wall structure causing mold, fungal growth and structural damage. This is a conducive condition for wood-destroying organisms. Two areas noted. One is above the guest quarter on the right side of the house. The other is the chimney as seen from the

Photo 7-1
Area as viewed from the roof on the right side.

Photo 7-2
Close ups in next two photos.

Recommend that a qualified contractor repair as necessary. For example, by repointing mortar or replacing broken or missing masonry.

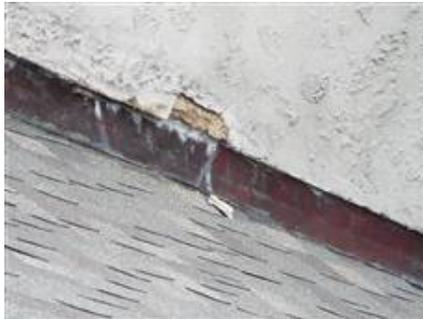
Photo 7-6
Top coat damage could allow water to penetrate behind the flashing.

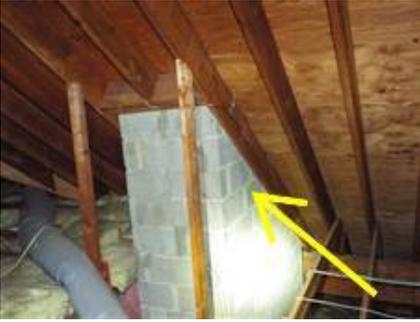
**Photo 7-7**

This is the area immediately below the previous photo. No ill effects can be seen however the exterior should be repaired.

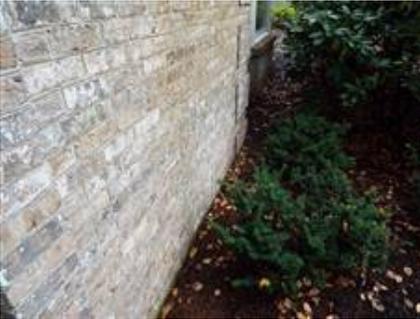
**Photo 8-1**

8) Maintain - Soil was in contact with or less than 4 inches from brick, stone or faux stone veneer. For most residential installations of this type of veneer, this is a conducive condition for wood-destroying organisms. Weep holes may be covered. Condensed water behind the veneer may not be able to escape, and moisture can accumulate in the wood structure behind. Recommend grading and/or removing soil as necessary to maintain a 4-inch clearance if possible.

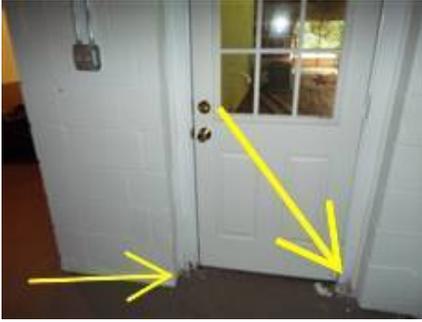
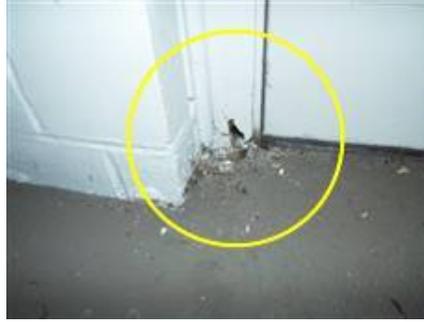
9) Repair/Replace - Fungal rot was found at one or more exterior door jambs. Recommend that a qualified person repair as necessary. All rotten wood should be replaced. Please note that the termite inspector did not find any wood destroying insects and that it was likely fungal rot (chronic moisture) that caused the door jamb damage.

Photo 9-1
Areas of close up in next photos.

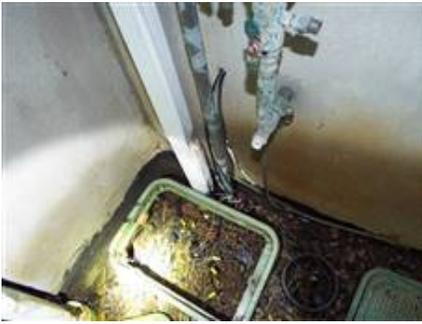
Photo 10-1

10) Repair/Replace - Extensions such as splash blocks or drain pipes for one or more downspouts were missing. Water can accumulate around the building foundation or inside crawl spaces or basements as a result. Recommend that a qualified person install, replace or repair extensions as necessary so rainwater drains away from the structure.

Under the deck the leader deposits all the water next to the foundation wall.

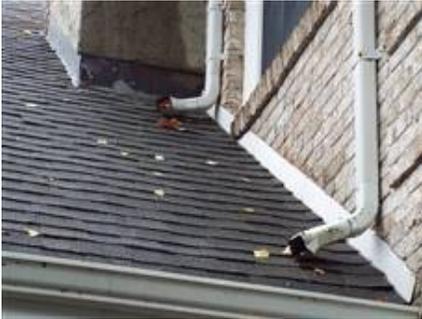
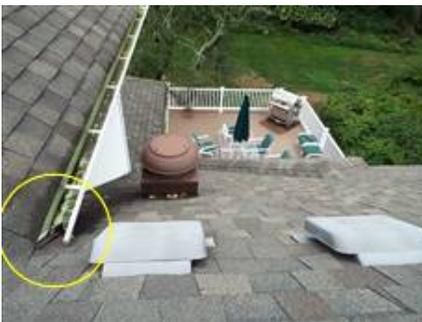
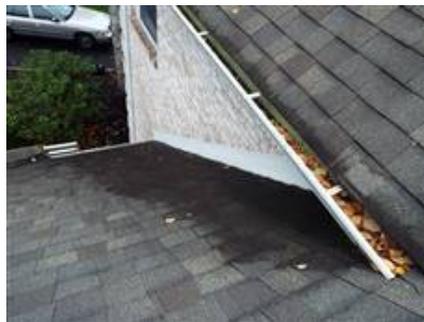
11) Repair/Replace - While a very common practice, it is not advisable to have gutters or downspouts end and then rely on the roof surface to channel the rain water to a gutter at a lower level. This can force water under the shingles. It is a better practice to use leaders that lay on the roof surface and channel the rain water to the gutter at a lower level.

There are also gutters with the back ends open. This too can have the same result where rain water exits the gutter in an upstream manner increasing the potential for water to get under the shingles.

Recommend that a gutter specialist repair the gutters so that unnecessary rain water is not put on the roof.

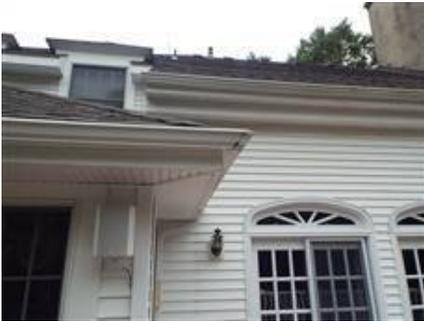
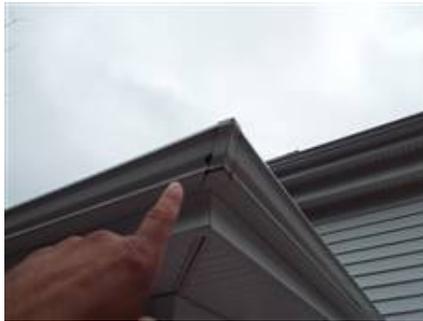
12) Repair/Maintain - The gutter over the deck is leaking at the corner. Recommend that a gutter specialist seal all corners and/or seams.

Photo 12-1
This area is highlighted in the next photo.

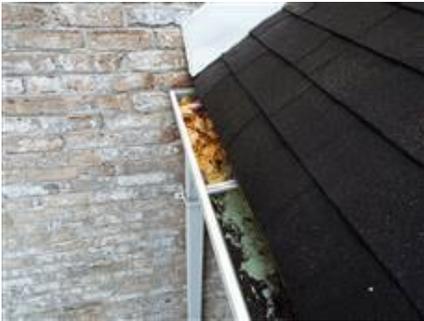
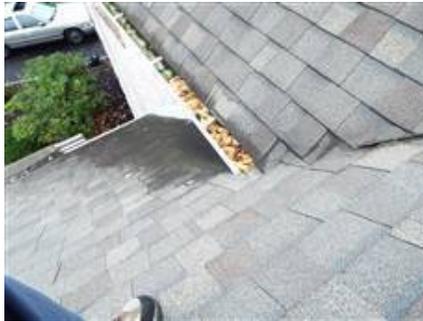
13) *Maintain* - Typical tree debris has accumulated in one or more gutters or downspouts. Gutters can overflow and cause water to come in contact with the building exterior, or water can accumulate around the foundation. This is a conducive condition for wood-destroying organisms. Recommend cleaning gutters and downspouts now and as necessary in the future.

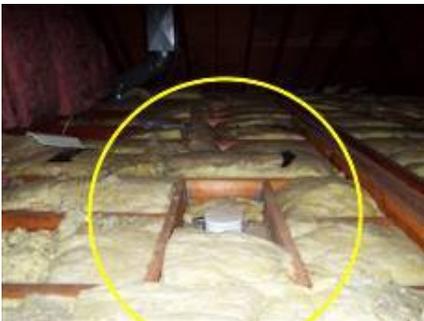
Photo 16-1

16) Repair/Maintain - Some areas of the attic were not insulated. These were very limited and most were due to recessed lights. Recessed lights can act like chimneys and allow warm air from the living space to rise into the attic. Recommend that an insulation specialist insulate over the recessed lights. The lights MUST first be identified as "IC" or "Non IC". Recessed light fixtures that are rated, "IC" can have insulation in direct contact. Those that are "Non IC" rated cannot have insulation in direct contact.

This is a recessed light above the laundry room area. Note exposed recessed light.

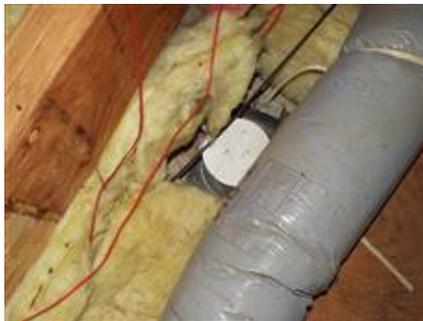
Photo 16-2

This is in the attic above the second floor.

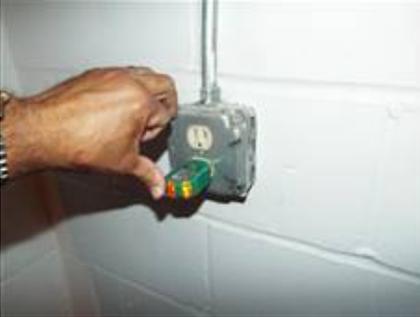
Photo 18-1

18) Safety, Repair/Replace, Evaluate - One or more electric receptacles (outlets) at the basement had no visible ground fault circuit interrupter (GFCI) protection. If not GFCI-protected, receptacles in wet areas pose a shock hazard. Recommend that a qualified

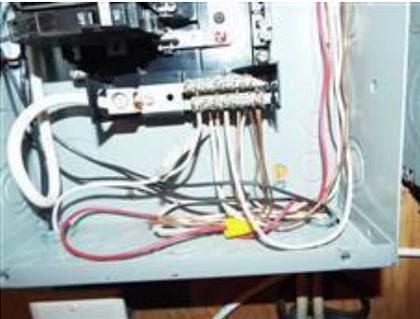
Photo 19-1

19) Safety, Repair/Replace - Neutral and equipment ground wires were bonded (connected) at sub-panel(s) C. This should only occur in the main service panel, not sub-panels, and is a shock hazard. Neutral wires should be attached to a "floating" neutral bar not bonded to the panel, and grounding wires should be attached to a separate grounding bar bonded to the sub-panel. Recommend that a qualified electrician repair per standard building practices.

Neutrals (white wires) and ground (uninsulated wires) are terminated on the same bar in the Panel C. Therefore they are not isolated as required. They are bonded in the sub panel.

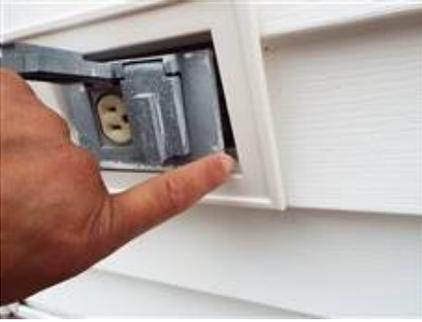
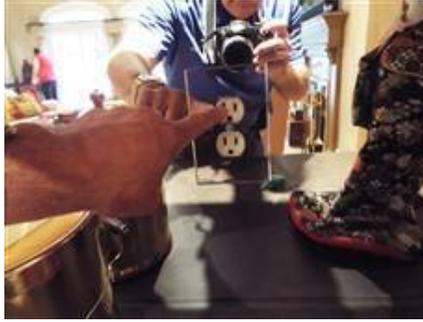
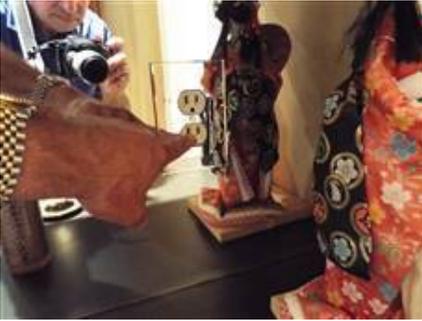
20) Safety, Repair/Replace - Both exterior and interior outlet(s) were loose. For the outside fixture, rain water can get into the electrical box. For all loose outlets, over time the movement can damage the wiring or cause connections to loosen. Recommend that a qualified electrician repair per standard building practices.

This outdoor outlet is loose as are the two outlets at the bar sink (next two photos).

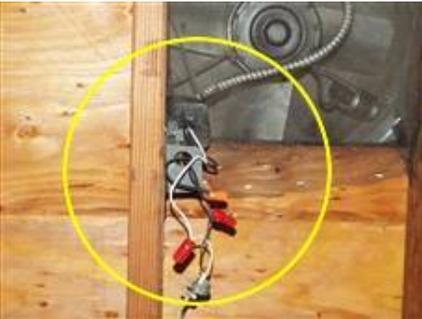
**Photo 21-1**

21) Safety, Repair/Replace - Wire splices were exposed and were not contained in a covered junction box. This is a potential shock or fire hazard. Recommend that a qualified electrician repair per standard building practices. For example, by installing permanently mounted junction boxes with cover plates where needed to contain wiring splices.

Walk in attic area.

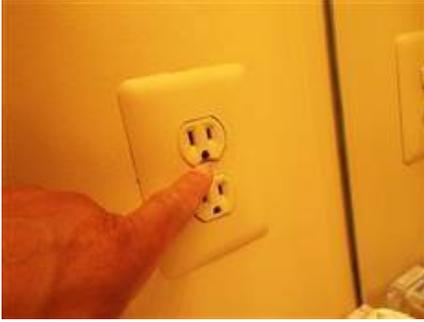
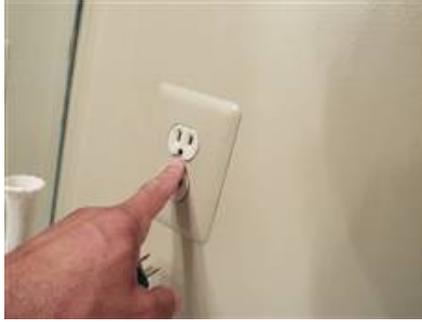
22) Safety, Repair/Replace - One or more receptacles (outlets) were broken or damaged. This is a potential shock or fire hazard. Recommend that a qualified electrician replace such receptacles as necessary.

Photo 22-1
Bath C (here) and Bath D (next photo).

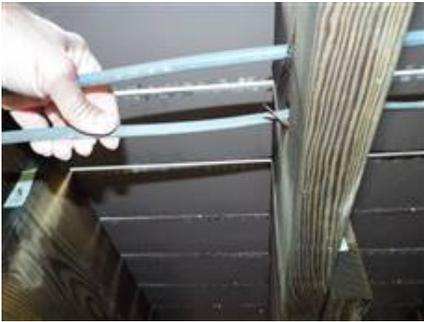
Photo 23-1

23) Safety, Repair/Replace - One or more sections of outdoor wiring were exposed and may not be rated for exterior use. This is a potential shock hazard. Recommend that a qualified electrician evaluate and repair per standard building practices as necessary. For example, by installing conduit, re-routing wires or replacing wiring.

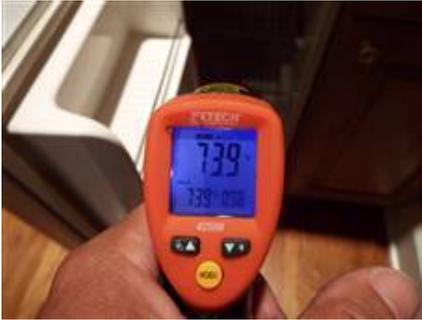
Photo 37-1

37) Repair/Replace, Evaluate - The bar sink refrigerator was inoperable. Please evaluate. The inspector is not allowed to pull appliances out from where they stand. The refrigerator may simply be unplugged or it may need repair or replacing. If it's inoperable, recommend that a qualified person repair or replace as necessary.

Inside temperature of the bar sink refrigerator when tested. 73.9 degrees.

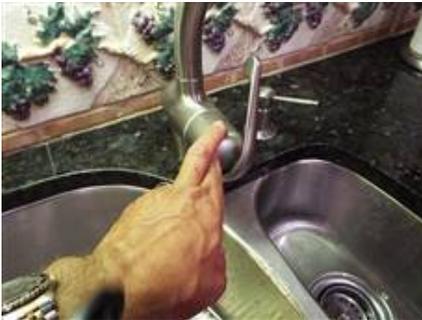
Photo 38-1

38) Repair/Maintain - The hot and cold water supplies appeared to be reversed at the sink. Typically, for mixing faucets, cold is typically supplied with the handle to the right and hot when the handle is to the left, or as indicated by the faucet's markings. At a minimum this is an inconvenience, but can result in accidental scalding. Recommend that a qualified plumber repair as the client deems necessary.

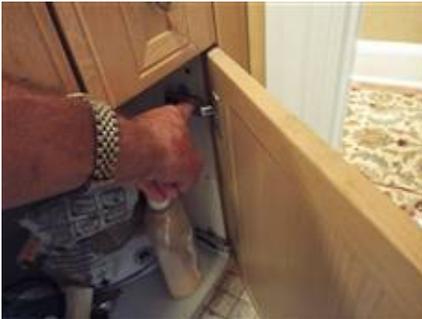
Photo 40-1

40) Repair/Maintain - Cabinet hardware such as hinges, latches, closers, magnets or pulls at location(s) A were loose, missing or damaged at one or more cabinet drawers, doors or turntables. Recommend that a qualified person repair as necessary.

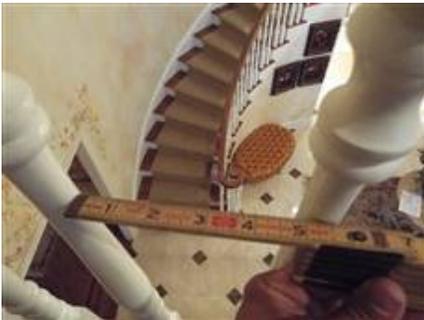
Photo 43-1

43) Safety, Repair/Replace - Guardrails at one or more locations with drop-offs higher than 30 inches had gaps that were too large. This poses a safety hazard for children (e.g. falling, getting stuck in railing). Guardrails should not have gaps or voids that allow passage of a sphere equal to or greater than 4 inches in diameter, or 6 inches in diameter at triangular spaces between stair edges and guardrails. Recommend that a qualified contractor repair or replace guardrails per standard building practices.

Ruler indicates the gap between spindles on the second floor are greater than 4 inches. Here and next photo.

4.25 inches.

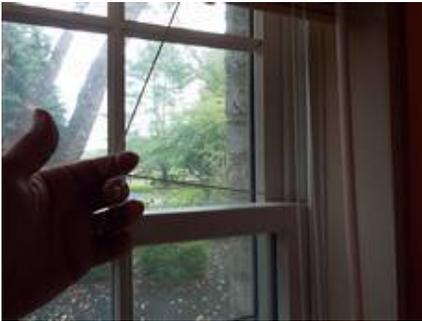
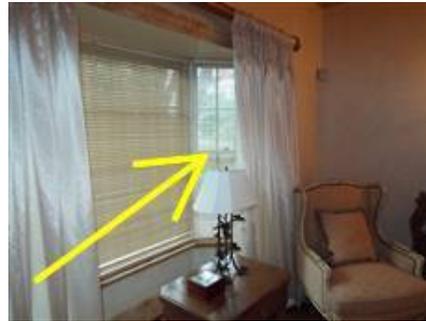
44) Safety, Repair/Maintain - The right window's retention string/spring/weight in the living room did not work. The retention string went slack when the window was opened. Recommend that a qualified Anderson window technician repair the retention mechanism.

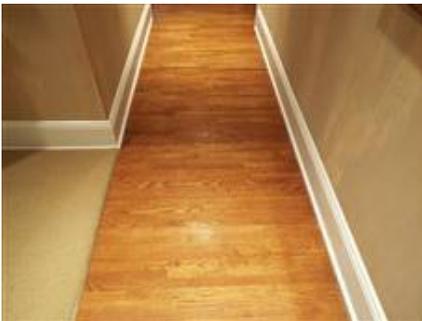
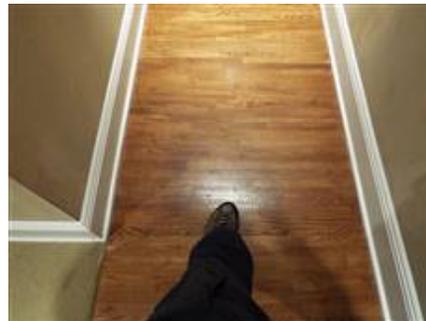
45) Repair/Replace, Evaluate - Squeaking or creaking noises occur when walking on one or more sections of flooring (Most notably in the first floor hall). This is usually caused by substandard construction practices where the sub-floor decking is not adequately fastened to the framing below. For example, not enough glue was used and/or nails were used rather than screws. In most cases, this is only an annoyance rather than a structural problem. Repairs to eliminate the squeaks or creaks may be more or less difficult depending on the floor covering and the access to the underside of the sub-floor. Recommend that a qualified contractor evaluate and repair as the client deems necessary.

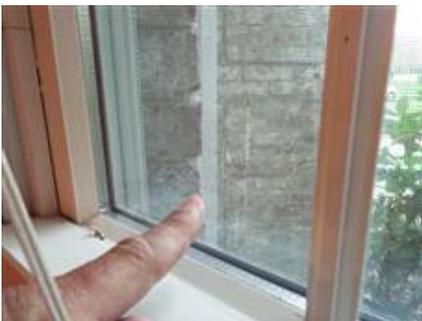
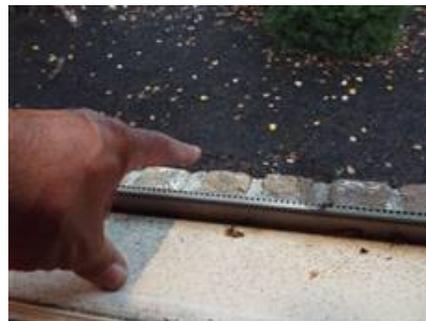
46) Repair/Replace - Some screens were damaged. Recommend replacing the damaged screens.

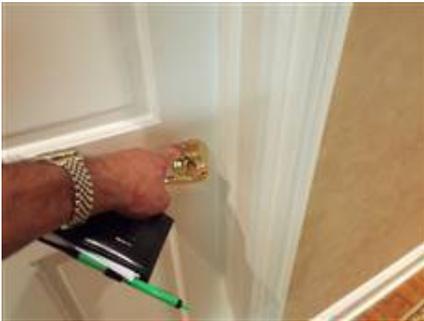
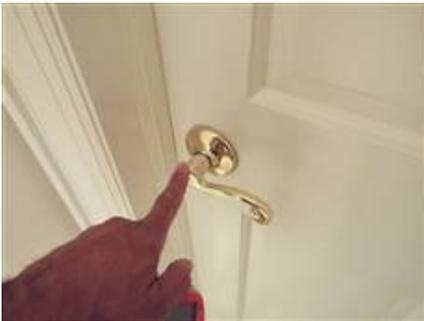
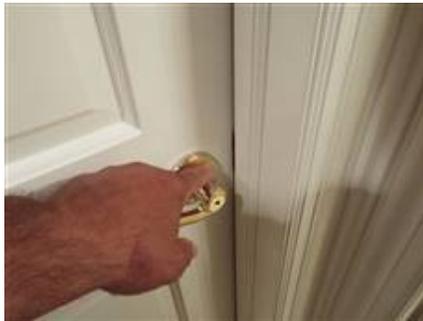
47) Repair/Maintain - One or more interior doors wouldn't latch or were difficult to latch. Recommend that a qualified person repair as necessary. For example, by adjusting latch plates or locksets.

Photo 47-1
1st floor guest room.

Photo 47-3
Nursery.

Photo 47-4
White bedroom.
