Regal Home Inspections, LLC

SAMPLE Property Inspection Report

Property address: **Buccaneer Way**

Inspection date: **Wednesday, May 22, 2024**

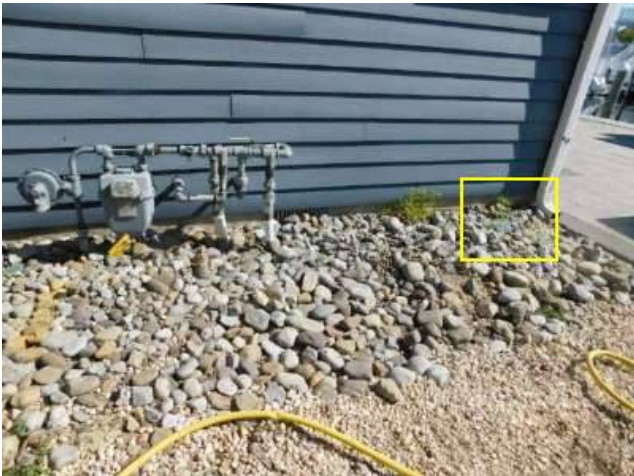
Photo 2-1 The green capped bait stations can be seen around the property such as the 2 seen in this corner of the property.

Highly recommend that the Termite Report, NPMA-33 provided be read, understood and acted upon with regard to any treatments, repairs or areas that may require attention (such as eliminating conditions conducive to insect activity).

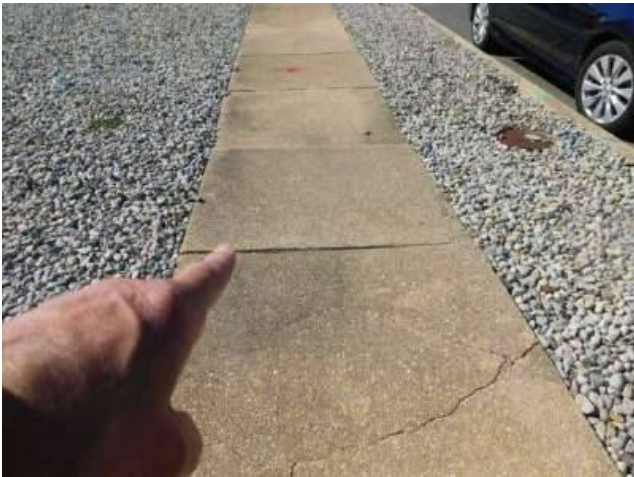
Photo 10-1

10) Material Defect/Safety, Repair/Maintain/Service - Cracks, holes, settlement, heaving and/or deterioration resulting in trip hazards were found in the sidewalks or patios. For safety reasons, required that a qualified contractor repair as necessary to eliminate trip hazards. Check with the Brick Township (Building Department or Code Enforcement Officer) to see if the homeowner is responsible for maintenance of the sidewalk at the curb in front of your house. If the homeowner is responsible and liable, Regal Home Inspections, LLC requires that all sidewalk repairs be made prior to taking ownership of the house.

Please note: A trip hazard is a 3/4 of an inch surface differential where one is not expecting a change in the surface elevation for paved areas like sidewalks and patios.

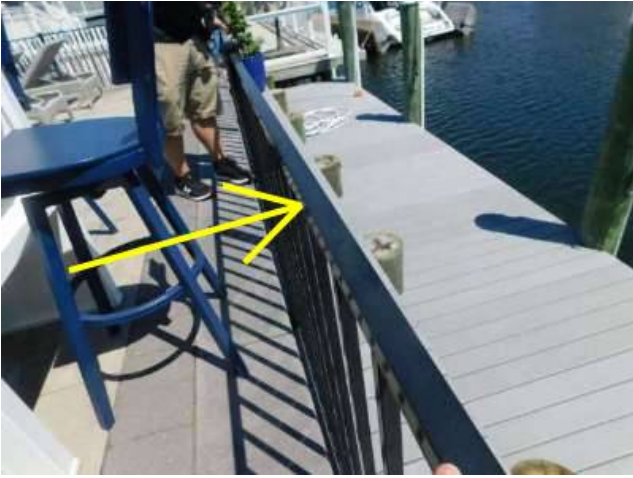
Photo 11-1

11) Material Defect/Safety, Repair/Maintain/Service - Guardrails at one or more locations were loose or wobbly and pose a fall hazard. Required that a qualified person repair guardrails as necessary.

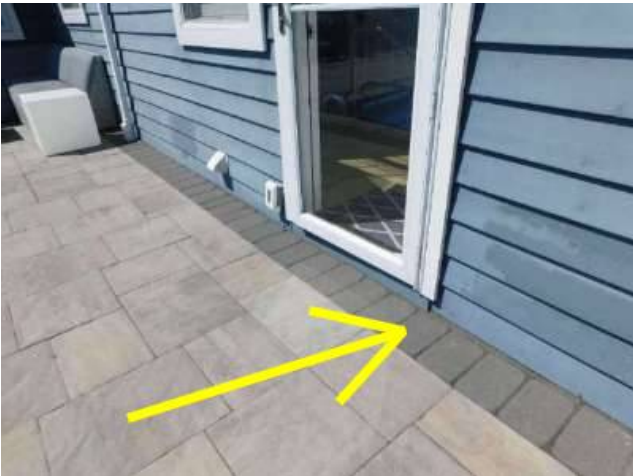
Photo 12-1

12) Repair/Maintain/Service, Evaluate - Pavement sloped down towards building perimeters in one or more areas. This can result in water accumulating around building foundations or underneath buildings. Monitor these areas in the future, especially during and after periods of rain. If significant amounts of water are found to accumulate, then it's required that a qualified contractor evaluate and repair as necessary. For example, by installing drain(s) or removing old pavement and installing new.

Please refer to the Crawl Space section. There were high levels of moisture seen in the crawl space in the area shown below. Additionally, there was some sub-floor wood rot that may be related to the staining seen at the back door (Seen in this photo) at the right side door jamb.

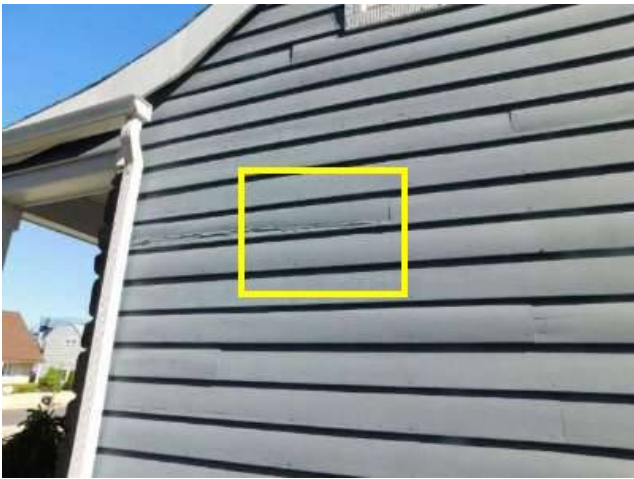
14) Replace - Fungal rot was found at one or more sections of siding or trim. Conducive conditions for rot should be corrected (e.g. wood-soil contact, reverse perimeter slope). Required that a qualified siding or window contractor repair as necessary. All rotten wood must be replaced.

Photo 14-1 Close up of this area in the next photo.

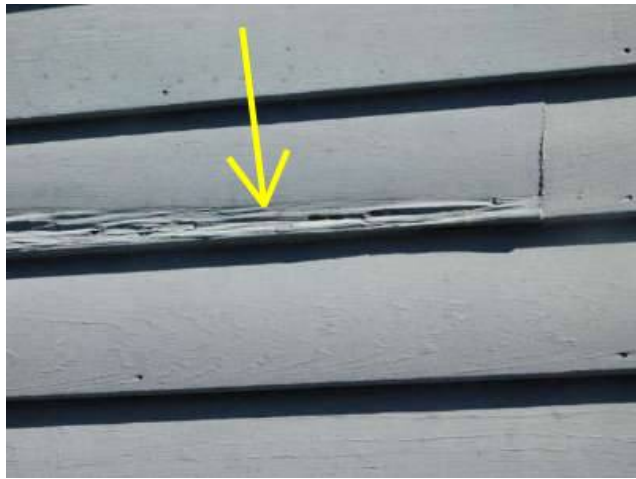
Photo 14-2 Soft wood.

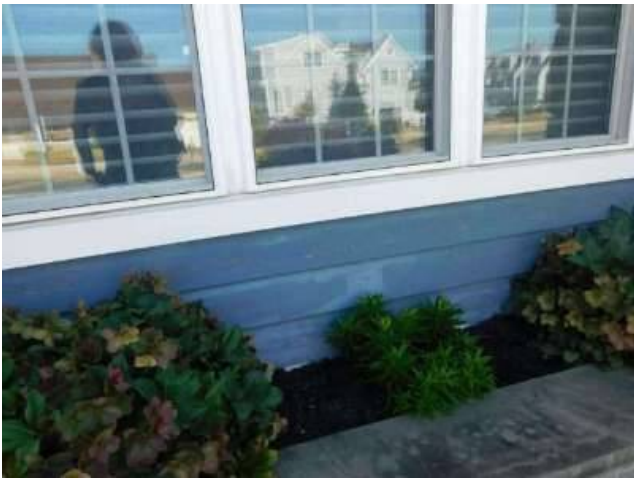
15) Repair/Maintain/Service, Maintain - The paint or stain finish in some areas was failing (e.g. peeling, faded, worn, thinning). Window frames or trim with a failing finish can be damaged by moisture. Required that a qualified contractor prep (e.g. clean, scrape, sand, prime, caulk) and repaint or re-stain the building exterior where necessary and per standard building practices. Any repairs needed to the siding or trim should be made prior to this.

Photo 15-1 Close up of this area in the next 2 photos.

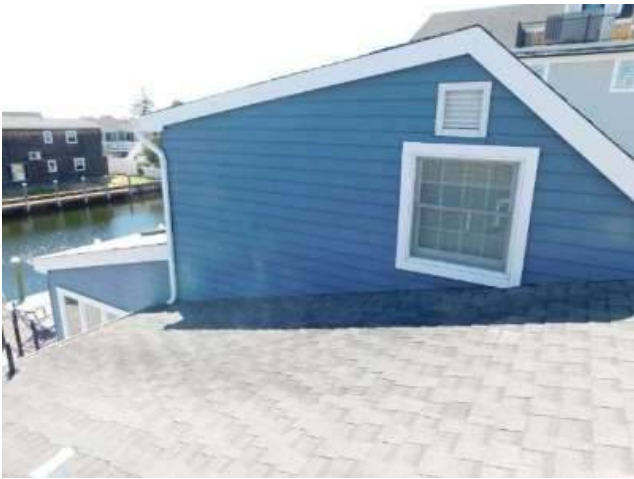
16) Repair/Maintain/Service, Evaluate - Areas of siding goes all the way to the roof surface material. As diagram I at the following link shows, there should be a 2 inch gap with proper flashing below. This 2 inch gap will prevent fungal rot of the siding material over time. Although the link is for a specific siding manufacturer, the gap recommended is a recommended best practice. <https://www.jameshardie.com/d2w/best-practices/quick-start-hz5-us-en.pdf>

Photo 16-1 Close up of this area in the next 2 photos.

Requires repair by a siding contractor.

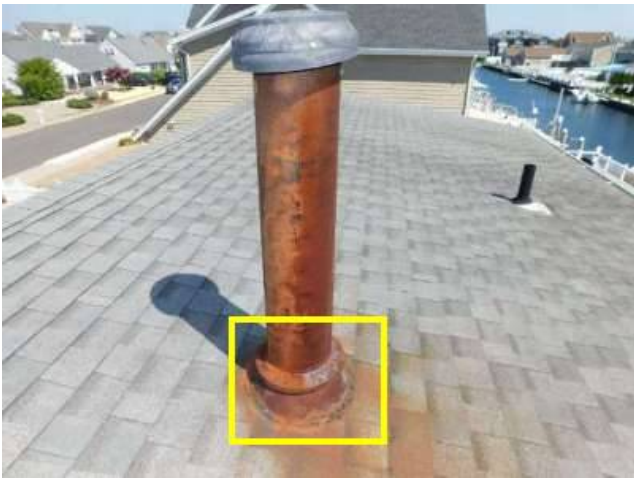
19) Replace - The metal collar for an apparently unused metal flue is rusted. Leaks can occur as a result. This is a conducive condition for wood-destroying organisms such as fungal rot. The inspector was unable to determine where this was exactly from the inside as it's apparently no longer in use. Requires that a qualified roofing contractor remove the unused flue and patch/repair as necessary.

Photo 19-1 Close up of this area in the next photo.

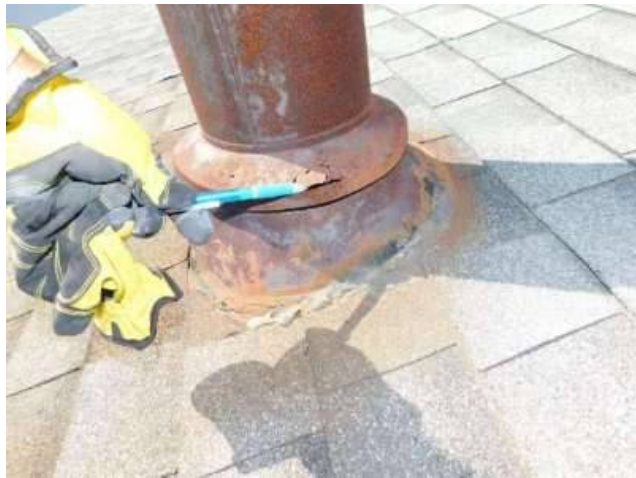
Photo 19-2 There are gaps or holes in the rusted metal.

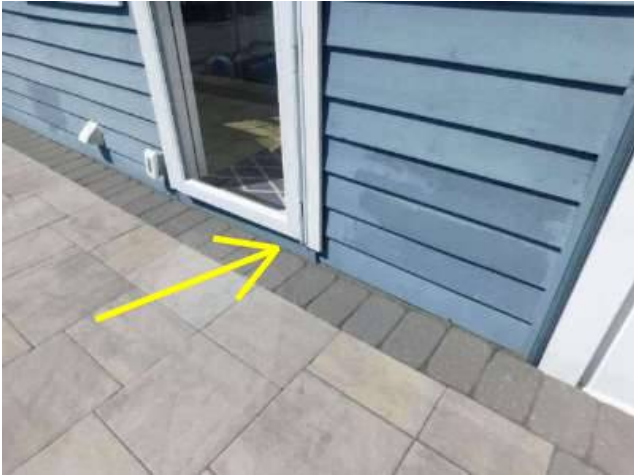
25) Material Defect/Major, Replace, Evaluate - Fungal rot was found at one or more sections of floor sheathing. Required that a qualified contractor evaluate and repair as necessary. All rotten wood should be replaced.

Photo 25-1 Close up of the inside of this general area in the next photo.

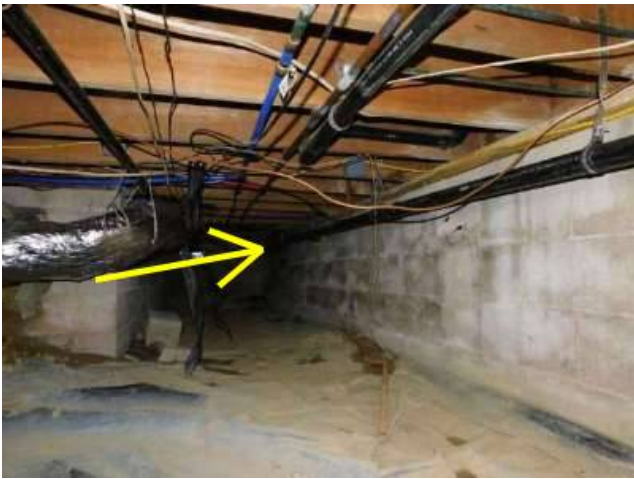
Photo 26-1 If one goes straight back from the crawl space hatch they will enter this area. The following photos were taken back there (Arrow).

Options include Hale Built Group www.halebuilt.com
www.quality1stbasementsystems.com

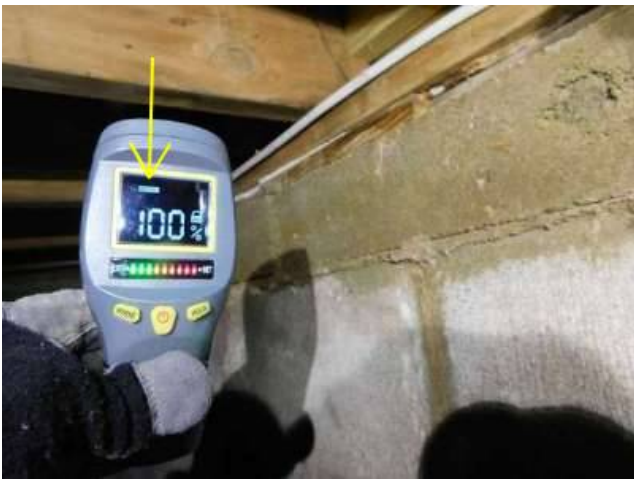
Photo 26-3 With the moisture meter set to, "Masonry" as indicated by the yellow arrow. The concrete block is holding 100% moisture. Notice the light-bar too: Green to yellow to red lights.

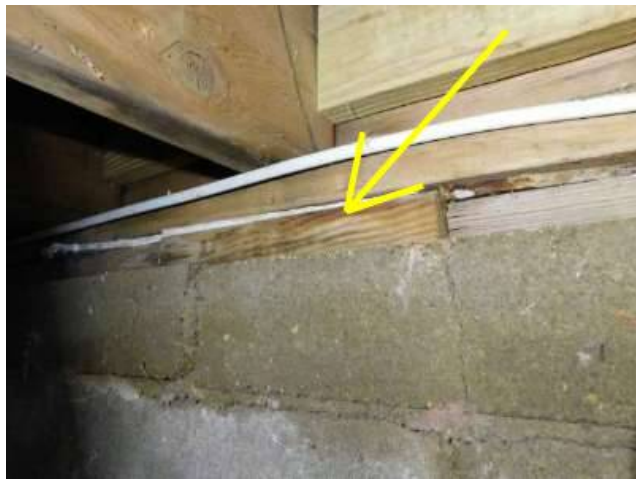
Photo 26-4 The wood sill plate was also measured. It's in contact with the concrete block below so it will absorb the moisture in the block.

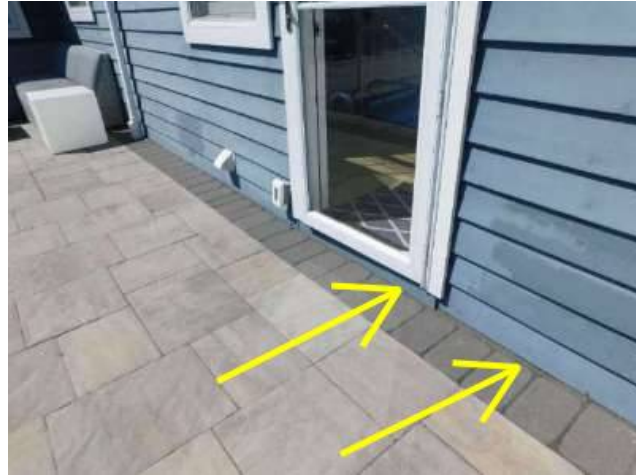
Photo 26-6 The previous photos are inside this general area.

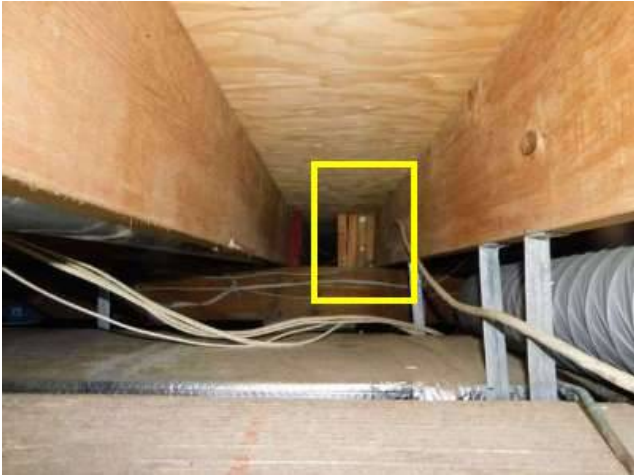
Photo 27-1 Here and the next photo are the left side of the span, when standing inside the house, and viewed from the canal side of the main beam.

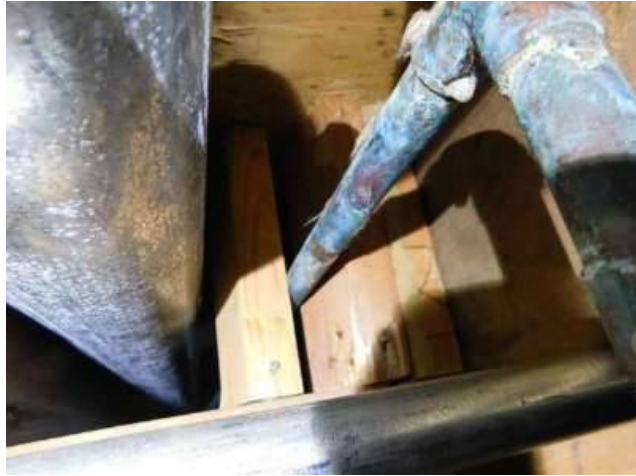
Photo 27-6 However, the inconvenience of the pipe and duct resulted in the structural construction to be changed. This may not be how it was intended. There are three added wood blocks vs. 4 on the other side (First few photos).

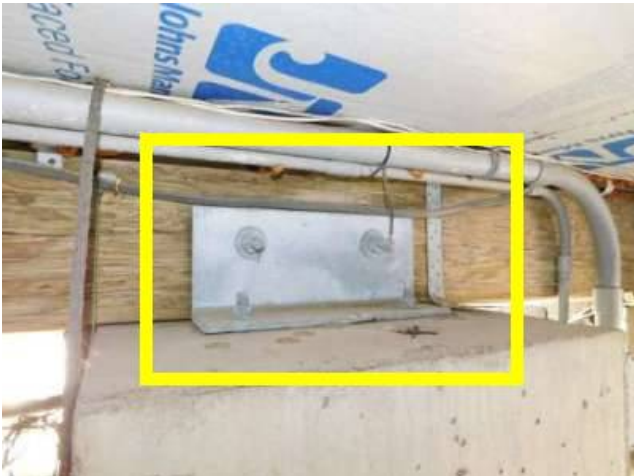
28) Material Defect/Major, Repair/Maintain/Service - One or more support posts were not positively secured to the beam above. While this is common in older homes, current standards require positive connections between support posts and beams above for reinforcement. Required that a qualified contractor repair per standard building practices. For example, by installing metal plates, plywood gussets or dimensional lumber connecting posts and beams.

Photo 28-1 This is an example of a post and beam tie seen on another Jersey Shore home.

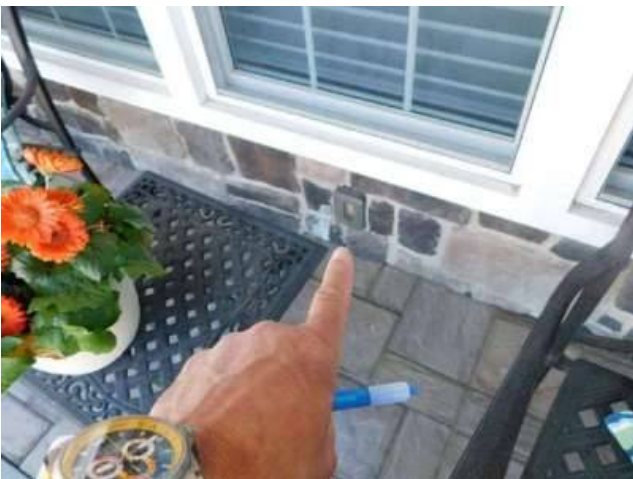
Photo 38-1

38) Material Defect/Safety, Replace, Evaluate - One or more ground fault circuit interrupter (GFCI) receptacles (outlets) wouldn't reset and had no power upon arrival at the exterior. This is a potential shock hazard. Required that a licensed electrician evaluate and repair as necessary.

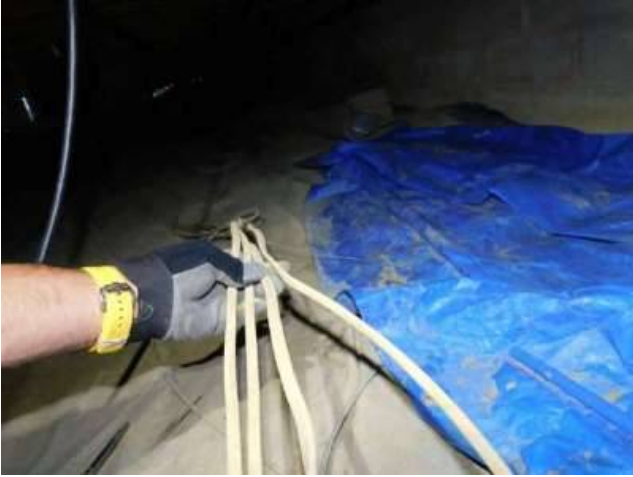
supported at one or more locations. Such wiring should be trimmed to length if necessary and attached to runners or to solid backing with fasteners at intervals of 4 1/2 feet or less. Fasteners should be installed within 12 inches of all enclosures. Required that a licensed electrician repair per standard building practices.

Photo 39-1 Crawl space here and the next 2 photos.

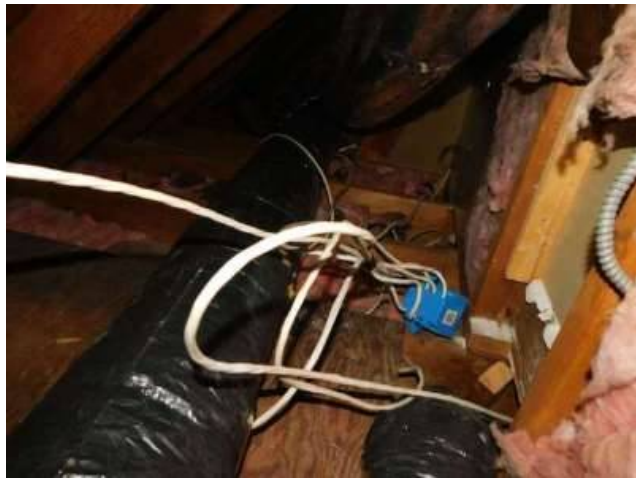
Photo 39-4 Knee wall attic space.

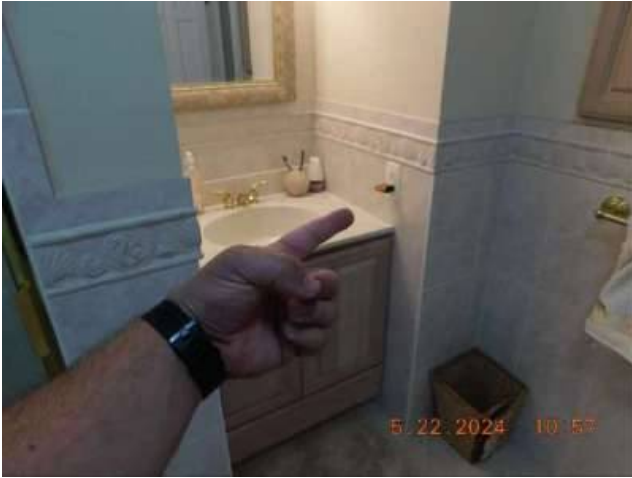
Photo 40-1

40) Material Defect/Safety, Replace - One or more ground fault circuit interrupter (GFCI) receptacles (outlets) wouldn't trip instantly and sputters before it cuts power at the exterior. This is a potential shock hazard. Required that a licensed electrician evaluate and repair as necessary. GFCI outlets should trip within 1/40th of a second. This sputters for a much longer fraction of a second before it trips.

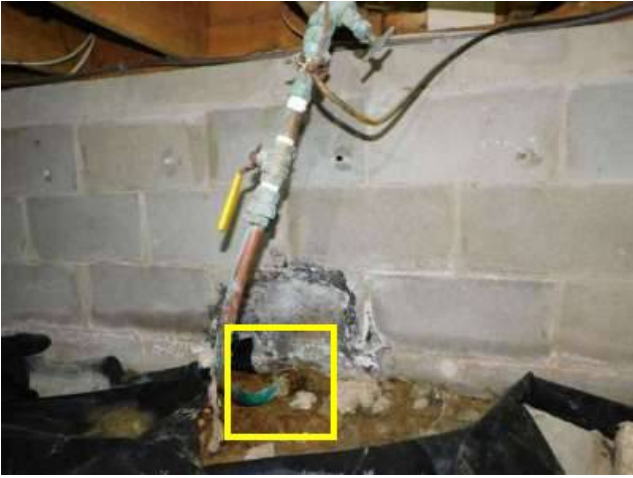
46) Repair/Maintain/Service - The copper water service pipe was embedded in concrete or masonry where it was routed through the foundation, and no protection from damage due to thermal expansion was visible. Copper pipes embedded in concrete or masonry should be wrapped with an approved tape or installed through a sleeve for abrasion protection. Required that a licensed plumber evaluate and repair per standard building practices as that professional deems necessary.

Photo 46-1 Close up of this area in the next photo.

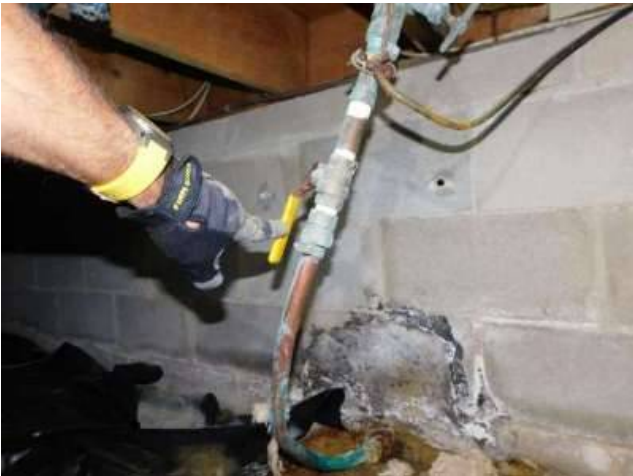
47) Repair/Maintain/Service - What appeared to be the main water shut-off valve was located in the crawlspace. This is an inconvenient location at best, and may prevent the water from being turned off in a timely manner in the event of a plumbing emergency. Required that a licensed plumber relocate the shut-off valve to a more convenient location, such as in a closet or a cabinet under a sink.

Photo 47-1 Main, water shut off valve.

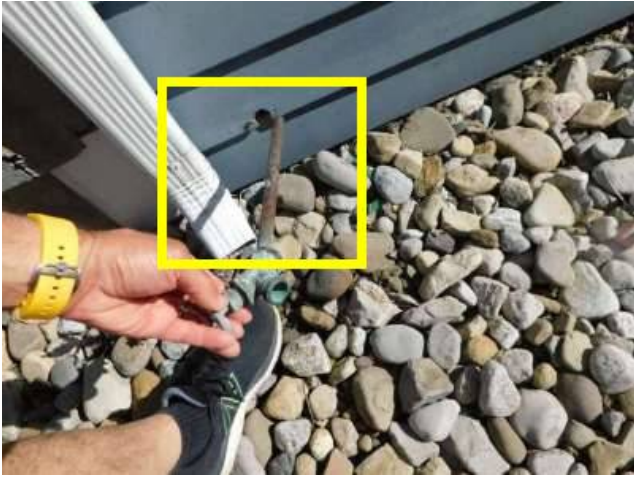
48) Repair/Maintain/Service - The hose bib on the right side of the house is not connected to anything. It's there to deceive one into thinking it's functional. As seen in the photo, it's not. A licensed plumber should repair to the client's satisfaction.

Photo 48-1 Close up of this area in the next photo.

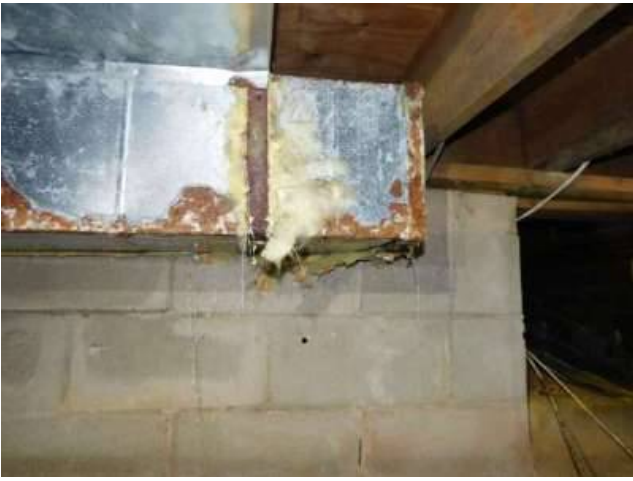
Photo 56-1

56) Replace, Repair/Maintain/Service - Some heating or cooling ducts had significant amounts of corrosion or rust. Holes may develop and result in reduced energy efficiency or return air being drawn in from locations other than intended. Required that a licensed and qualified HVAC contractor repair as necessary. For example, by repairing or replacing ducts or sections of ducts.

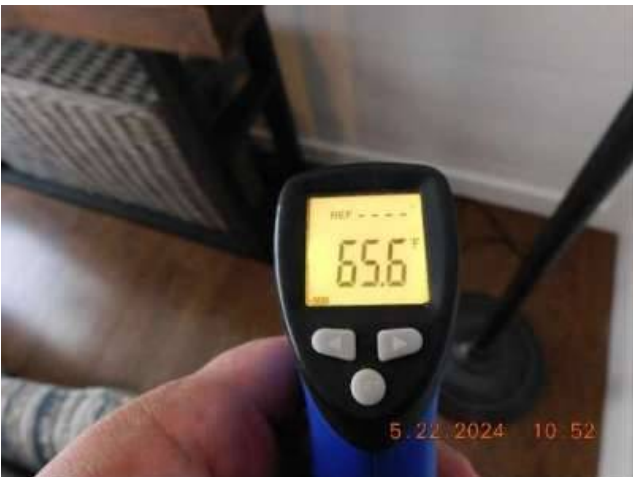
Photo 58-1

58) Repair/Maintain/Service, Evaluate - One or more heating or cooling air supply registers had a weak air flow, or no apparent flow. This may result in an inadequate air supply. Recommend asking the property owner about this. Adjustable damper(s) in ducts may exist and be reducing the flow. If dampers exist, then they should be opened to attempt to improve the air flow. If the property owner is unaware of such dampers, or if adjusting dampers does not improve the air flow, then required that a licensed and qualified HVAC contractor evaluate and repair or make modifications as necessary.

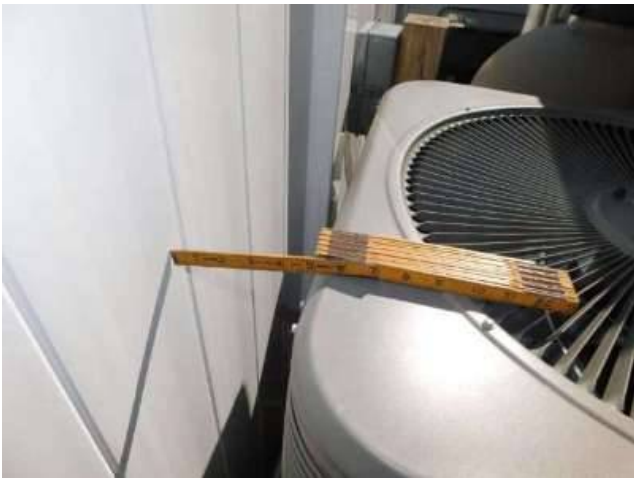
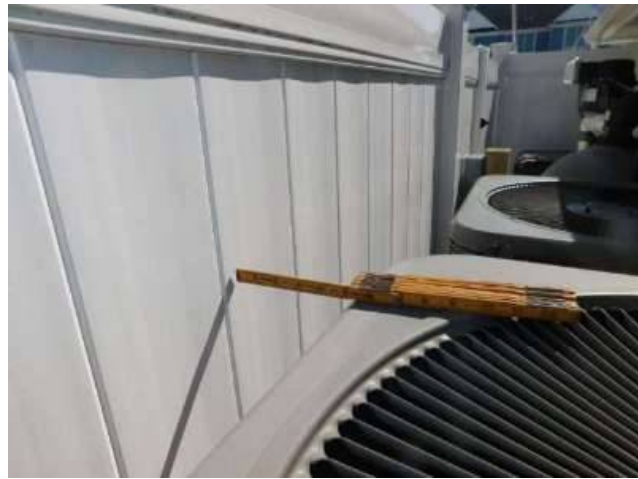
Photo 60-1

60) Repair/Maintain/Service - Permanent structures were too close to the air conditioning condensing unit. There should be at least 12 inches of clearance on all sides and at least 4-6 feet above. Inadequate clearances around and above can result in reduced efficiency, increased energy costs and/or damage to equipment. Requires making repairs or modifications as necessary to maintain these clearances, by a qualified, HVAC contractor as necessary.

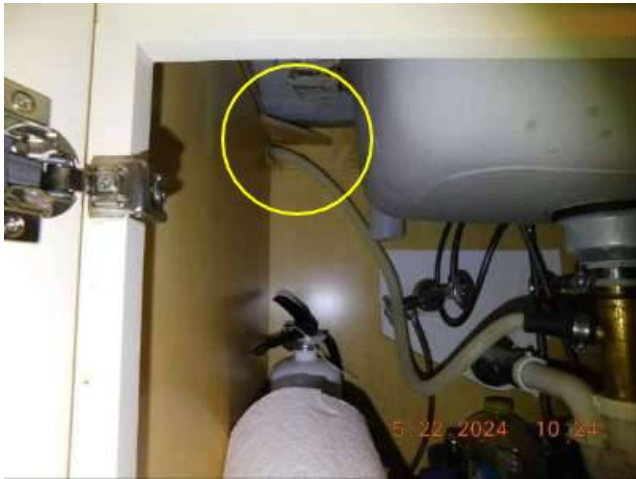
67) Repair/Maintain/Service, Evaluate - The high loop for the dishwasher drain could be slightly higher. A high loop is created by routing the drain line up to the bottom surface of the countertop above and securely fastening it to that surface. An air gap is a device that makes the drain line non-continuous. Both of these prevent waste-water backflow from entering the dishwasher, and possibly flooding out of the dishwasher if/when a siphon occurs. Some newer dishwashers have these devices built in. The client should try to determine if these devices are built into this brand and model of dishwasher (e.g., review installation instructions). If not, or if this cannot be determined, then required that a qualified contractor install a high loop and air gap per standard building practices.

Photo 67-1 Close up of this area in the following photo.

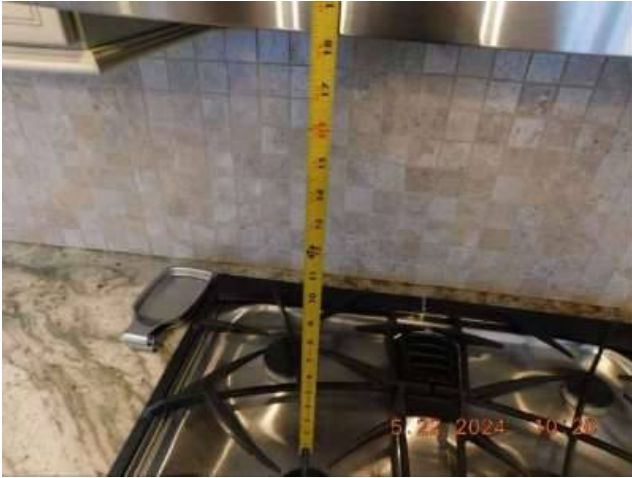
Photo 68-1

68) Repair/Maintain/Service - The clearance between the stove top and the base of the exhaust hood above was too low. While the recommended height varies per the hood manufacturer, standards usually call for a minimum of 24 inches of clearance. A low hood height can restrict visibility of the stove top. Required that a qualified contractor repair per standard building practices.

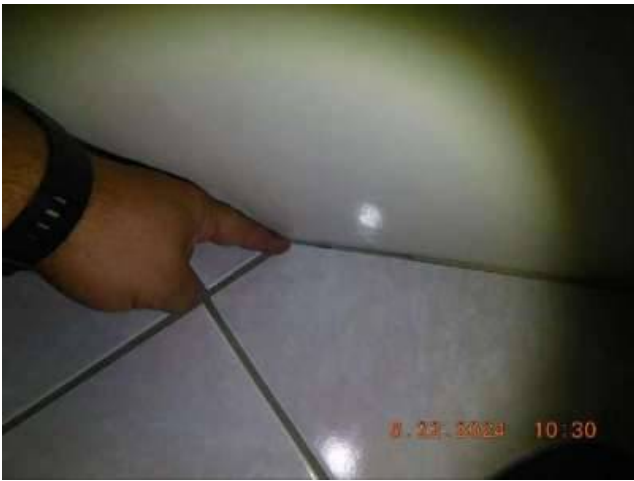
Photo 73-1

73) Repair/Maintain/Service - Gaps, no caulk, or substandard caulking were found between the bathtub and the floor at location(s) A. Water may penetrate these areas and cause damage. Recommend that a qualified person re-caulk or install caulking as necessary.

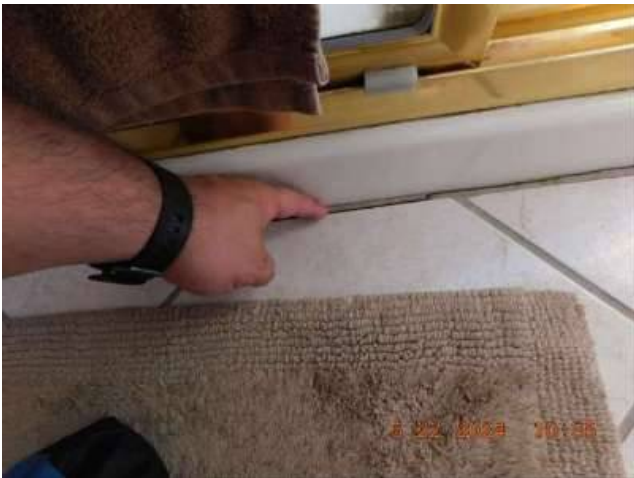
Photo 74-1

74) Repair/Maintain/Service - Gaps, no caulk, or substandard caulking were found between the shower enclosure and the floor at location(s) B. Water can penetrate these areas and cause damage. Recommend that a qualified person re-caulk or install caulking as necessary.

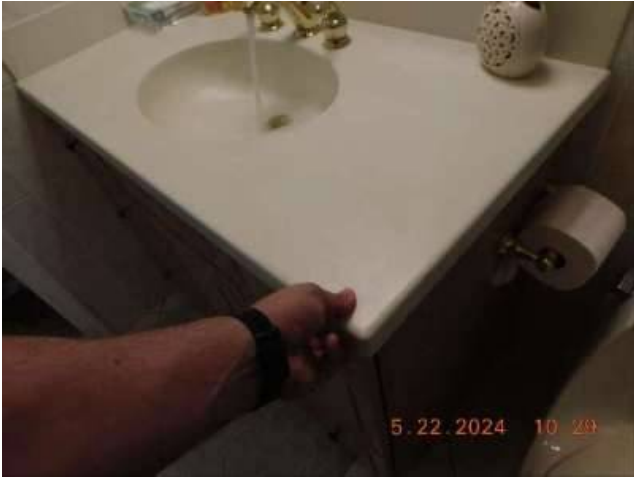
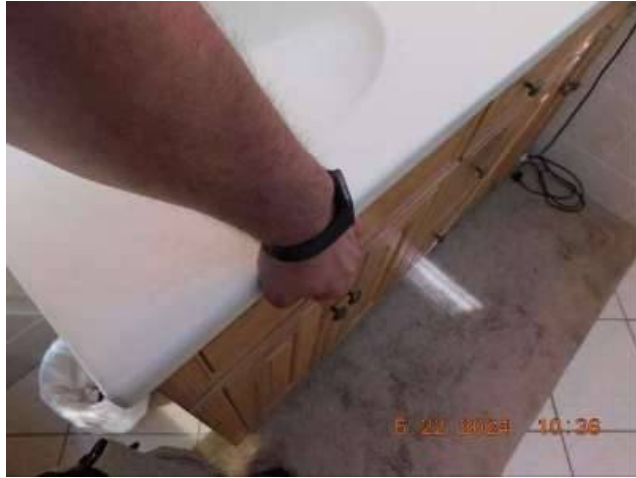
Photo 77-1

77) Repair/Maintain/Service - The countertop at locations A & B is loose. Required it be secured or fastened by a qualified contractor.

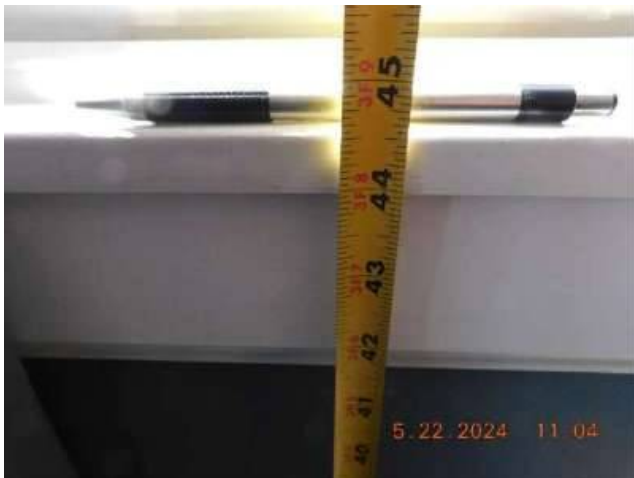
Photo 80-1

80) Material Defect/Safety, Replace - One or more bedrooms had windows that were too high off the floor. At least one window requires adequate egress in the event of a fire or emergency to allow escape or to allow access by emergency personnel. Such windows should have a maximum sill height of 44 inches off the floor. At a minimum, keep a chair or something that serves as a ladder below the window at all times. Required to have a qualified contractor repair or make modifications per standard building practices.

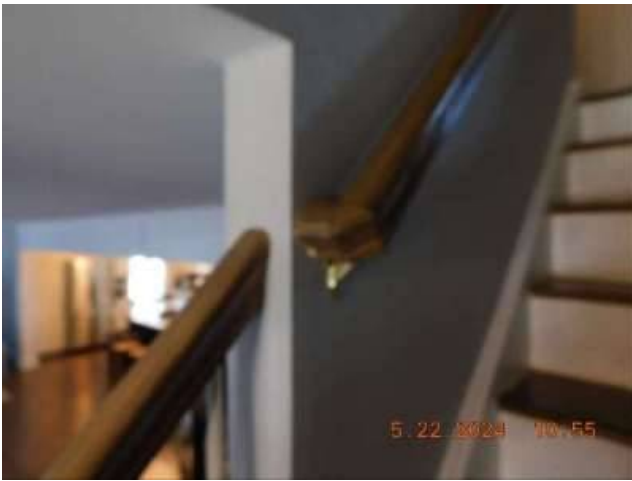
Photo 81-1

81) Material Defect/Safety, Replace - Handrails at one or more flights of stairs were not continuous or did not extend the full length of the stairs. This is a potential fall hazard. Handrails should be continuous for the entire length of the stairs. Required that a qualified contractor replace or repair handrails per standard building practices.

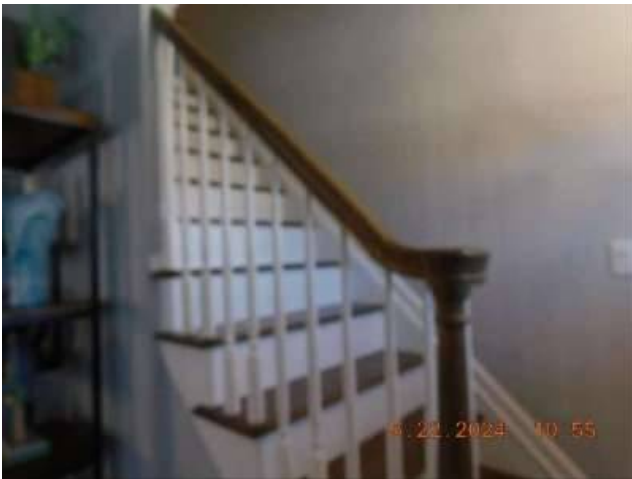
Photo 82-1

82) Material Defect/Safety, Repair/Maintain/Service - Handrails at one or more flights of stairs were wobbly. This is a safety hazard. Required that a qualified person repair as necessary.
