Regal Home Inspections, LLC

SAMPLE Property Inspection Report

Property address: **Locust Ln.**

Inspection date: **Monday, December 9, 2024**

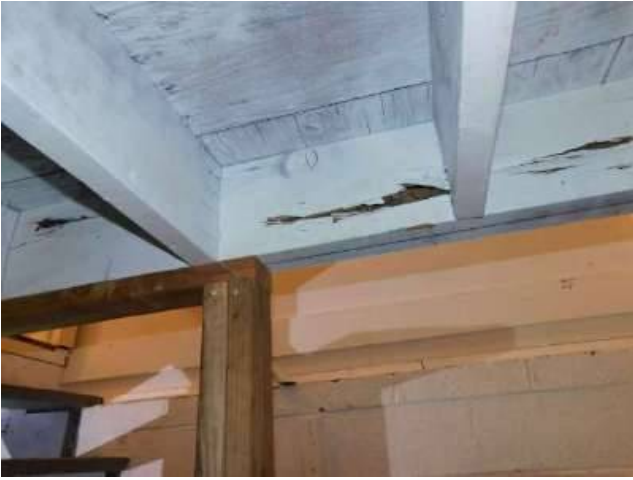
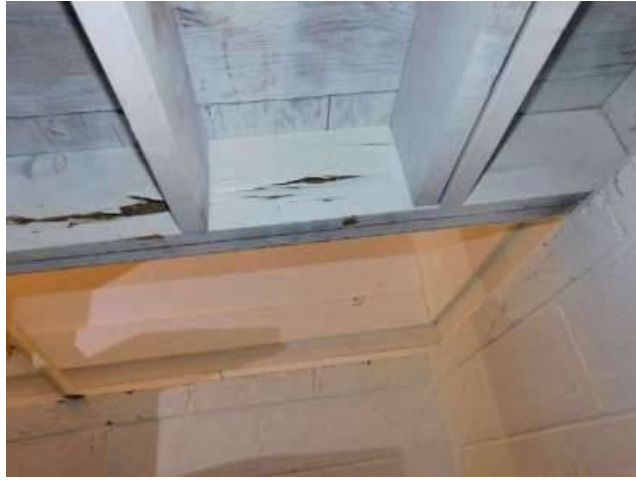
Termite damage was identified in joists in the basement. It's very important that the extent of the termite damage be determined so a repair cost can be estimated. A qualified contractor, one that's expert in exposing and gauging the extent of termite damage and can provide a cost to repair, and perform the needed repairs is required. Exposure of the affected areas is critical in determining the extent of the damage. One option is Terminite. They are qualified, licensed contractors that are expert in repairing termite damage. They charge approximately \$125 to evaluate the damage and provide a recommendation and quote for any repairs that may be required. Their number is 908 964 9900. All damaged wood must be replaced. Please also refer to the Basement section for other damage (NOT caused by termites) that must be replaced/repared as well. See Item 33 in the Basement section. Terminite can provide you with a cost to repair that (Item 33 findings) as well.

Highly recommend that the Termite Report, NPMA-33 provided be read, understood and acted upon with regard to any treatments, repairs or areas that may require attention (such as eliminating conditions conducive to insect activity).

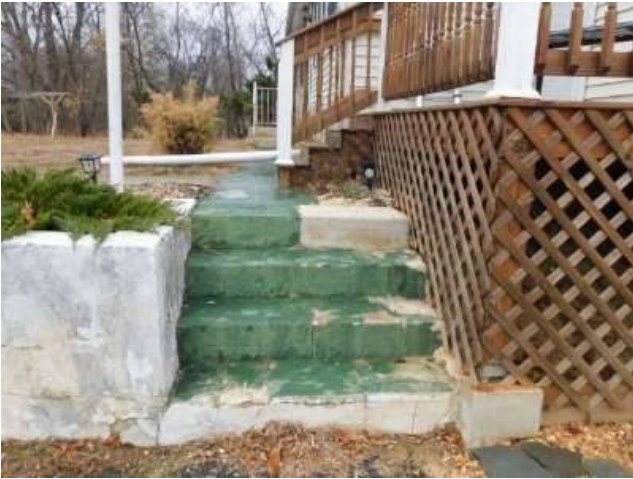
Photo 8-1

8) Material Defect/Safety, Replace - Handrails at one or more flights of stairs were missing. This is a potential fall hazard. Handrails should be installed at stairs with four or more risers or where stairs are greater than 30 inches high. Required that a qualified contractor install handrails where missing and per standard building practices.

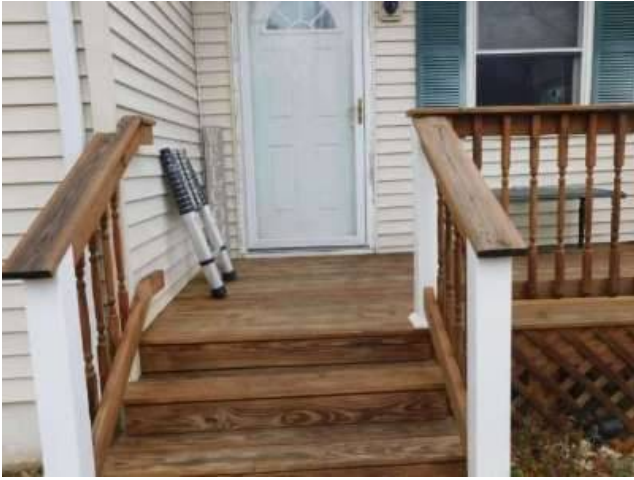
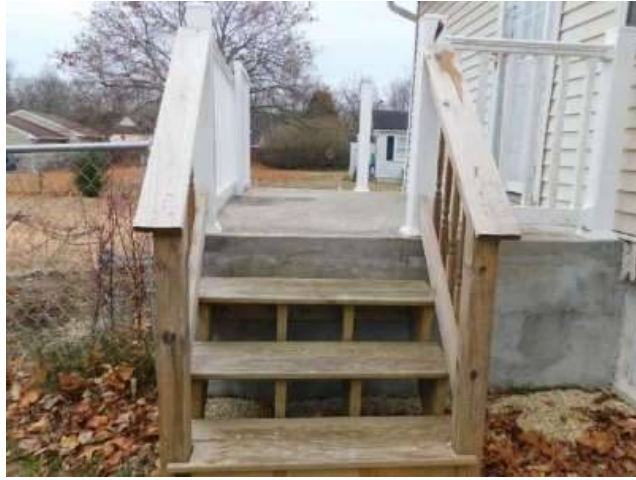
9) Material Defect/Safety, Replace - Handrails at one or more flights of stairs were not graspable and posed a fall hazard. Handrails should be 1 1/4 - 2 inches in diameter if round, or 2 5/8 inches or less in width if flat with recesses for fingers. Required that a qualified person install graspable handrails or modify existing handrails per standard building practices.

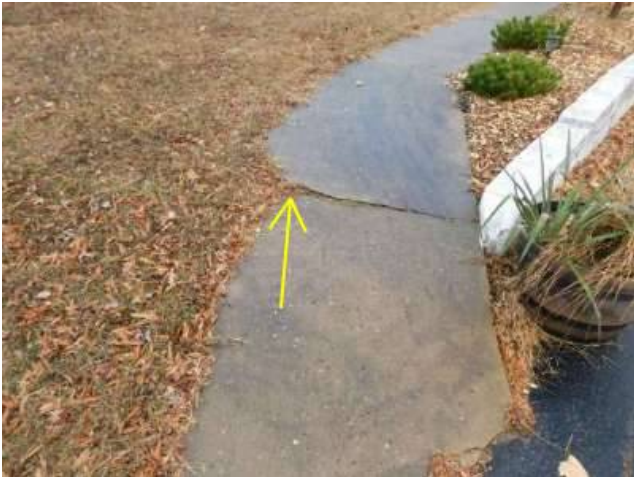
Photo 10-1

10) Material Defect/Safety, Repair/Maintain/Service - Cracks, holes, settlement, heaving and/or deterioration resulting in trip hazards were found in the sidewalks or patios. For safety reasons, required that a qualified contractor repair as necessary to eliminate trip hazards. Regal Home Inspections, LLC requires that all sidewalk repairs be made prior to taking ownership of the house.

Please note: Protocols for the home inspection define a trip hazard as a 3/4 of an inch surface differential where one is not expecting a change in the surface elevation for paved areas like sidewalks and patios. Other authorities, like the Americans with Disabilities Act, ADA have stricter definitions of a trip hazard.

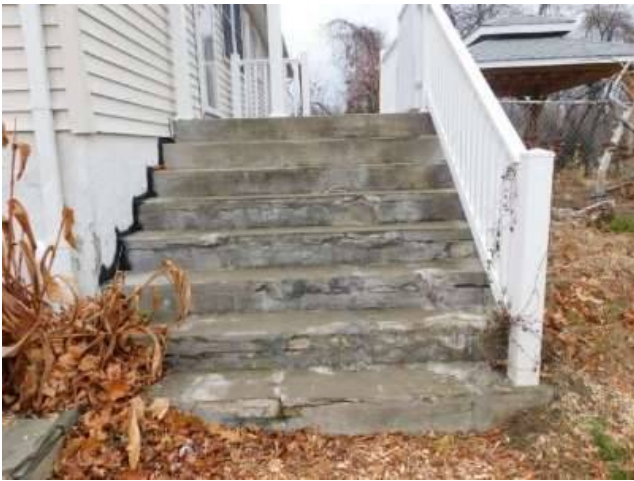
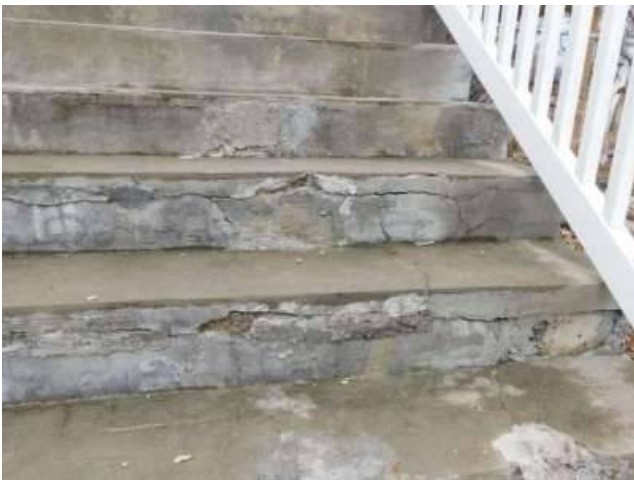
11) Material Defect/Safety, Repair/Maintain/Service - The concrete steps are deteriorated and present a fall hazard. Gaps and cracks allow water to penetrate the step/porch structure. Sections of the concrete are breaking away. In the freeze/thaw cycles of winter the ice will cause additional deterioration. Required that a qualified masonry contractor evaluate all and repair as that professional deems necessary.

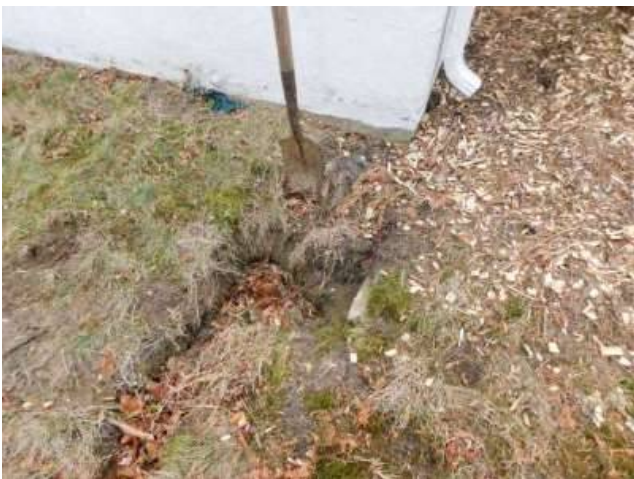
Photo 12-1

12) Repair/Maintain/Service, Maintain - The soil is eroding creating ruts. This can result in water accumulating around building foundations or underneath buildings and could be a fall hazard for any pedestrians. Required: Grade soil so it slopes down and away from buildings with the use of downspout extensions to distribute the water and not have it concentrated in one spot where erosion can occur.

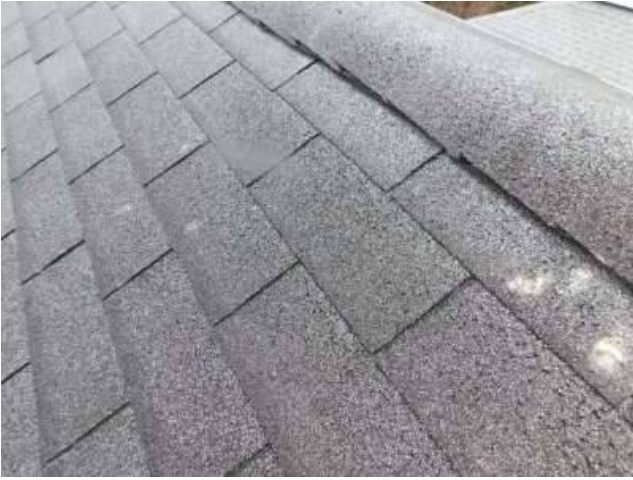
**Photo 15-5**

15) Material Defect/Major, Replace, Evaluate - The roof surface was significantly deteriorated and appeared to be at or beyond its service life. It needs replacing now. This is a conducive condition for wood-destroying organisms. Required that you consult with a qualified roofing contractor to determine replacement options. Note that some structural repairs are often needed after old roof surfaces are removed and the structure becomes fully visible. Related roofing components such as flashings and vents should be replaced or installed as needed and per standard building practices.

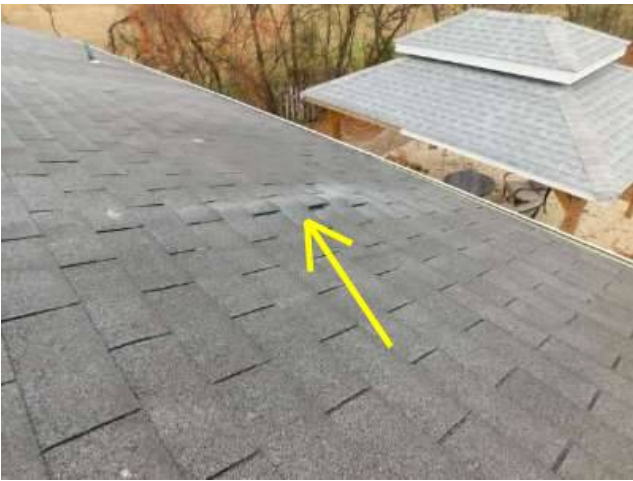
16) Material Defect/Major, Replace, Evaluate - A section of the roof structure is substandard. Shingles are lifting and/or shifting. Leaks will occur. Requires repair when the roof is replaced. Requires evaluation by a reputable, qualified roofing contractor and repair. This is a factor in the inspector's conclusion that the roof surface is at or beyond its service life.

While the inspector does not diagnose the specific cause, based on experience this appears to be related to deteriorated roof sheathing (Plywood). Often it's delamination of the plywood that causes conditions like this.

Photo 16-1 Close up of this area in the next photo.

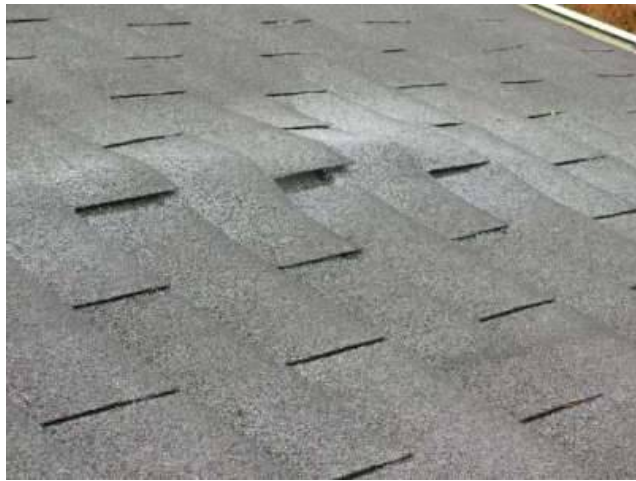
Photo 16-2 There is a distinct deformity in the roof surface. Requires repair by a qualified roofing contractor.

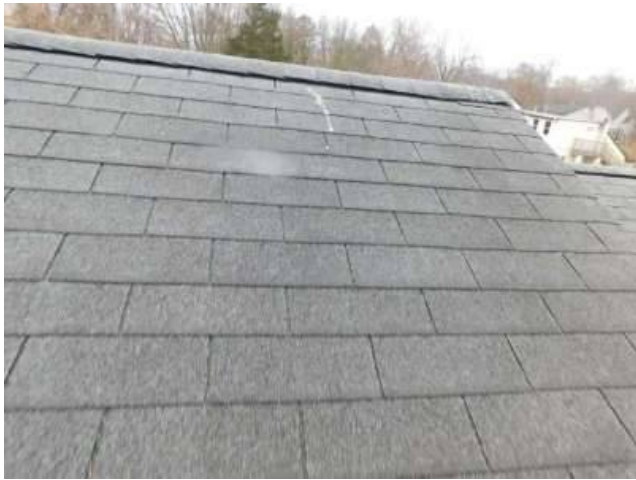
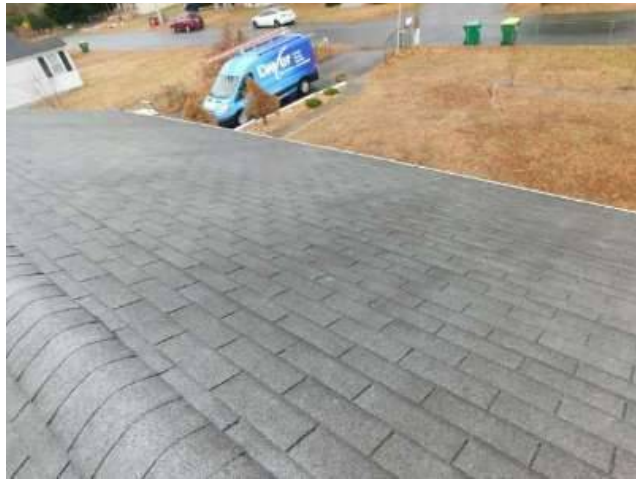
17) Material Defect/Major, Replace - This home's roof has shingles called, "3 tab shingles". These are often the least expensive and therefore, the shortest service life as compared to architectural shingles. Although a trademarked name, "Timberline" (R) shingles are often used to describe all architectural style shingles although it's one, specific brand.

The shingles on this roof showed significant wear and based on the age of the home and the general appearance of the shingle it's estimated that the roof surface is beyond its service life. Below are 2 links to different roofing websites that provide some additional information.

This is a factor in the inspector's conclusion that the roof surface is at or beyond its service life.

The client must be aware that this roof will need replacing in the near term. A more precise time beyond that is not possible nor within the scope of the NJ home inspection standards of practice. The client must consult with a reputable roofing contractor during your home purchase inspection period so that you, the home inspection client, are well aware of the replacement cost and can budget accordingly.

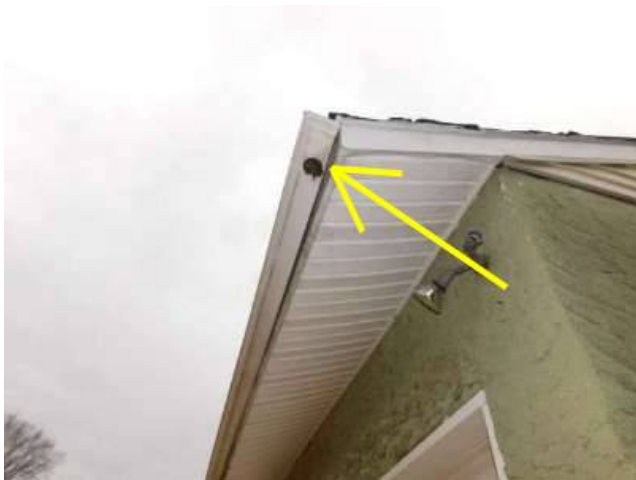
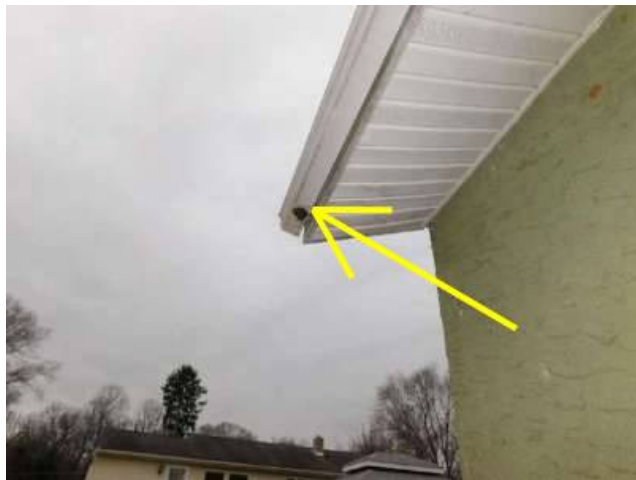
18) Replace, Repair/Maintain/Service - One or more downspouts were missing and/or at the garage. Rainwater can come in contact with the building exterior or accumulate around the building foundation as a result. This is a conducive condition for wood-destroying organisms. Required that a qualified roofing or gutter contractor repair or replace as necessary.

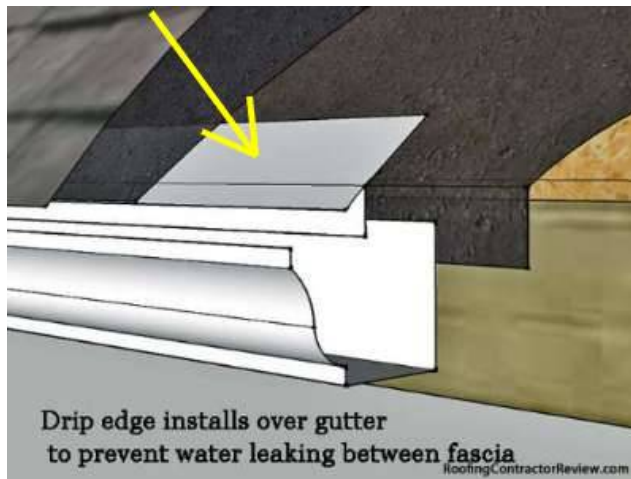
20) Repair/Maintain/Service - There is no drip edge flashing. Drip edge flashing is intended to protect the edge of the plywood roof sheathing where the shingles end and help ensure that all rain water goes into the gutter. It's often not installed by roofers so they can save money but is a good practice to ensure a more water repellent roof. Properly installed drip edge flashing should be installed around the entire perimeter of the roof. One edge should go between the plywood sheathing and the roof surface (shingles, etc.) and then bend downward into the back of the gutter or along the outside of the rake board. In this installation, when the shingles are lifted, bare plywood is exposed.

Photo 20-2 The drip edge flashing highlighted here is missing from under the shingles.

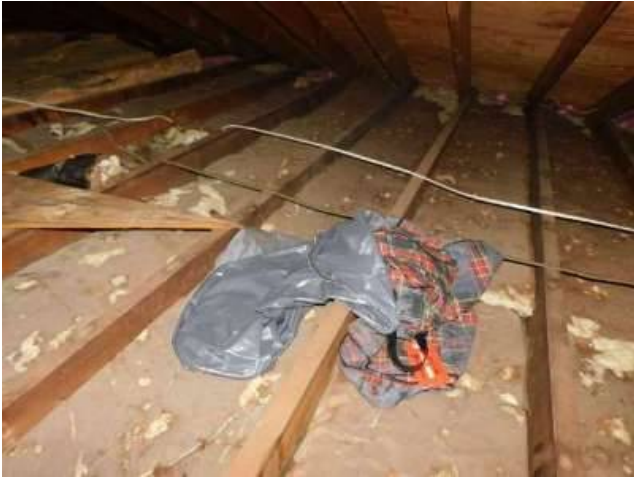
Photo 24-1 Here and the next 3 photos are probably original insulation. Quite compressed, thin and ineffective as an insulating barrier.

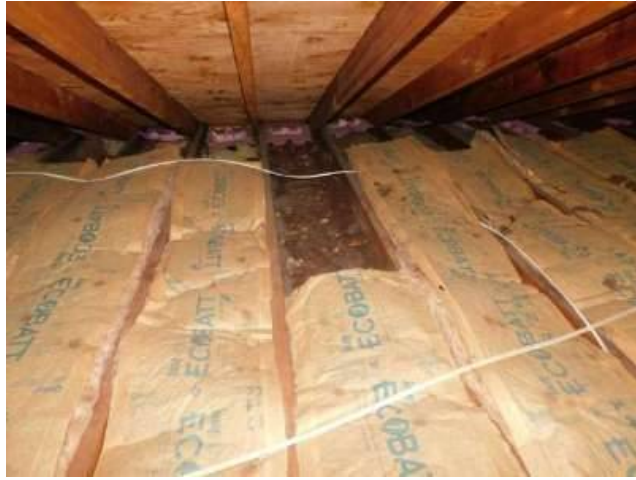
**Photo 24-10** Some insulation has been added but sections are missing.

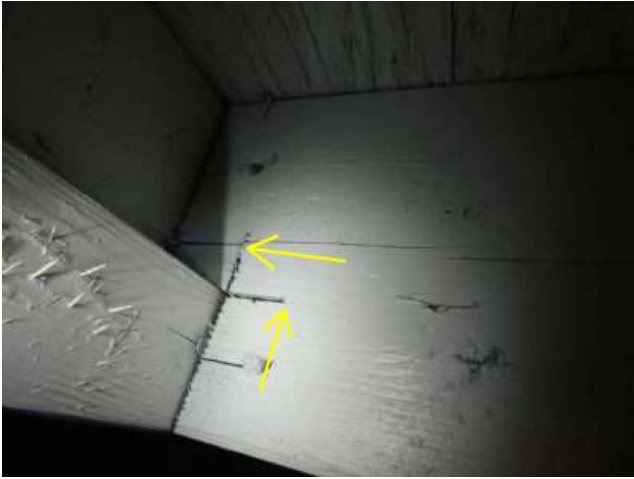
Photo 34-1 Numerous joists have been cut to create the needed notches to hang from the ledger board. The cuts made are significantly longer than need be. This weakens the joists. Another item in this section shows a number of split joists. The split almost always starts at these poor cuts.

Required that a qualified contractor evaluate and repair as necessary, and per standard building practices.

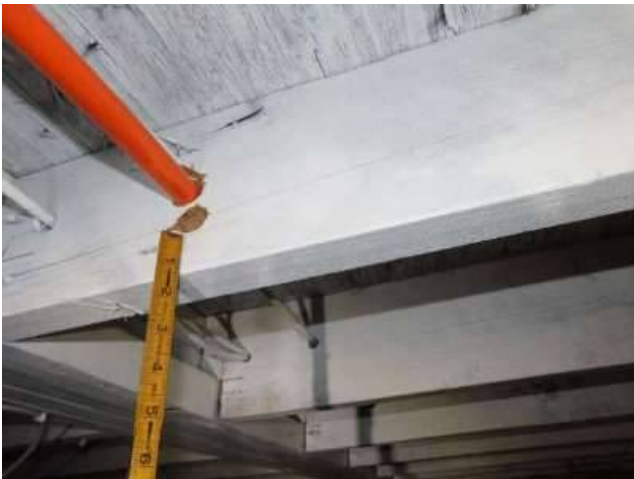
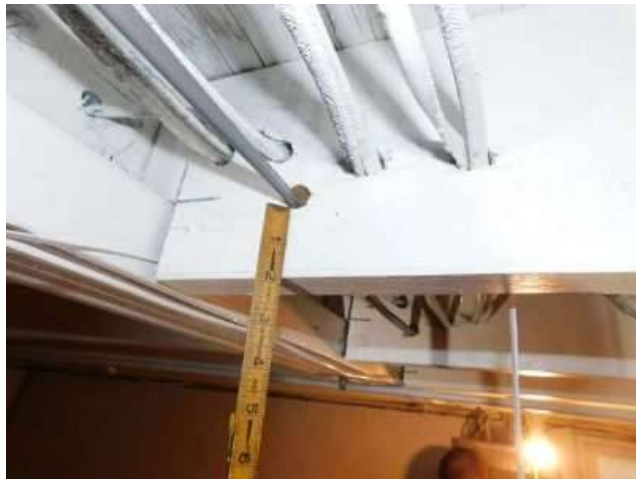
Photo 34-3 Holes must be 2 inches or more from the joist's edge as noted in one of the bullet points above. Here and the next 2 photos are examples of holes that are less than 2 inches from the bottom edge of the joist.

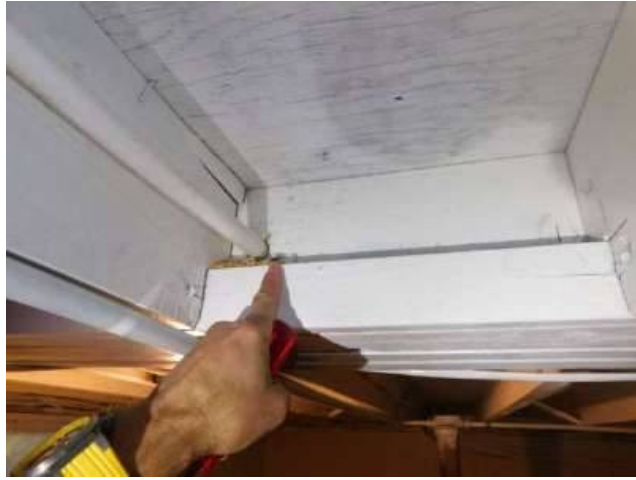
Photo 34-6 In this case, a beam is drilled. While joists can be drilled within reason, beams should never be modified, drilled or notched.

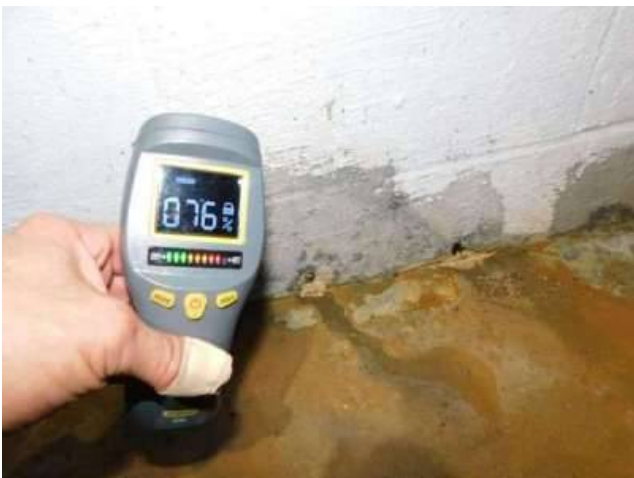
Photo 36-3 While it's obvious that there's moisture, the moisture meter confirms that.

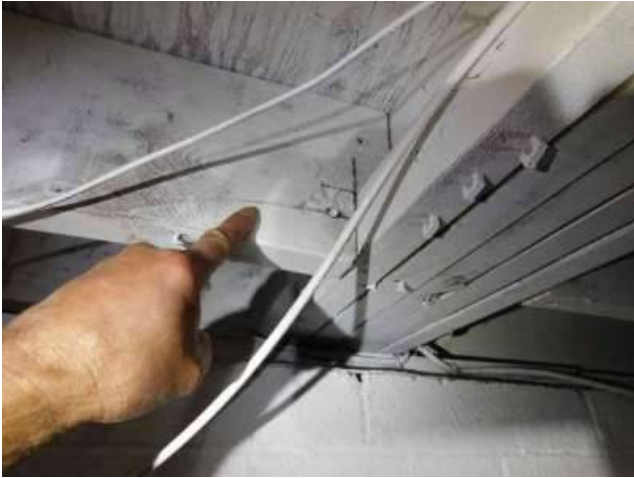
37) Material Defect/Major, Repair/Maintain/Service, Evaluate - One or more floor joists were split. This can reduce the floor's strength and cause sagging or spongy floors. Requires evaluation by a contractor familiar with framing and structures and have this and any other split or damaged joists repaired.

Photo 37-1 Some of these splits appear to be associated with the large cuts that were made to create the notches as noted above in this section.

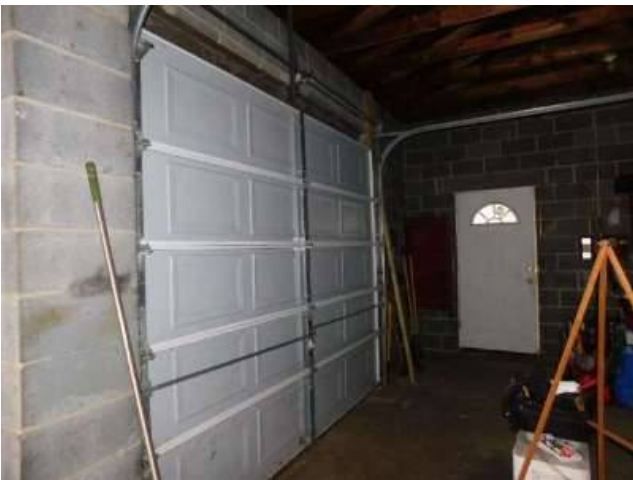
Photo 38-1

38) Material Defect/Safety, Repair/Maintain/Service - One or more garage vehicle doors weren't balanced. The door wouldn't stay in place when opened half-way, and fell to the ground instead. This is a potential safety hazard since the door(s) can fall when open and cause injury. A qualified contractor must repair as necessary. This applies to the door on the right facing out.

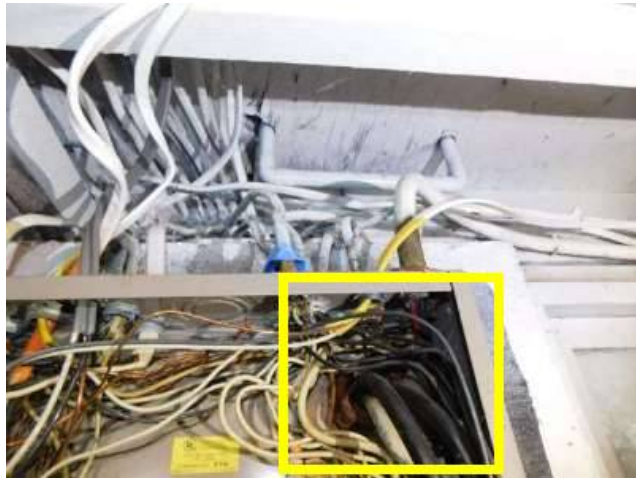
Photo 42-4 Rusted components inside Panel A. Findings will likely show that water is using the main electrical cable as a conduit to enter, and damage, Panel A.

- 1) Add a service mast to raise the service drop above the roof.
- 2) The service drop must have a drip loop and a weather-head.
- 3) It appears that the service cable, from the splice near the ridge of the roof to the meter is worn and requires replacement.
- 4) Water is entering the electrical panel, Panel A, and the items listed above are the cause or significant contributors. Water inside the electrical panel is a fire and safety hazard. Therefore, the electrical panel must be replaced.

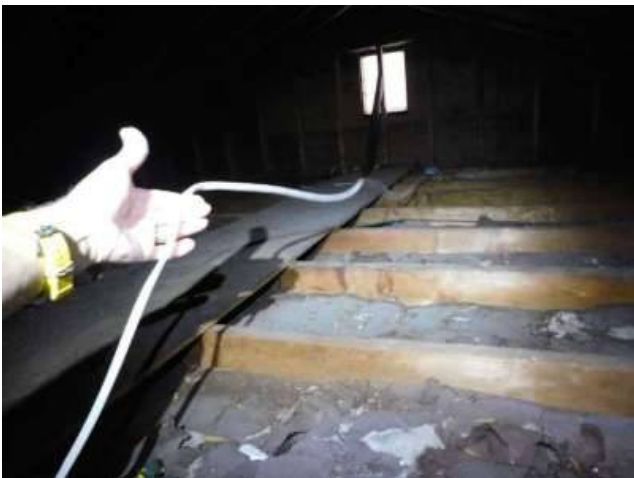
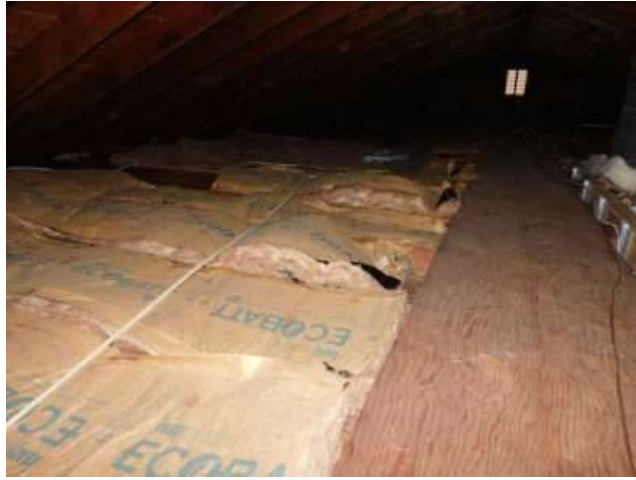
44) Material Defect/Safety, Replace, Repair/Maintain/Service - Non-metallic sheathed wiring was loose, unsupported, or inadequately supported at one or more locations. For example, at numerous locations inside the attic and over Panel A. Such wiring should be trimmed to length if necessary and attached to runners or to solid backing with fasteners at intervals of 4 1/2 feet or less. Fasteners should be installed within 12 inches of all enclosures such as Panel A. Required that a licensed electrician repair per standard building practices.

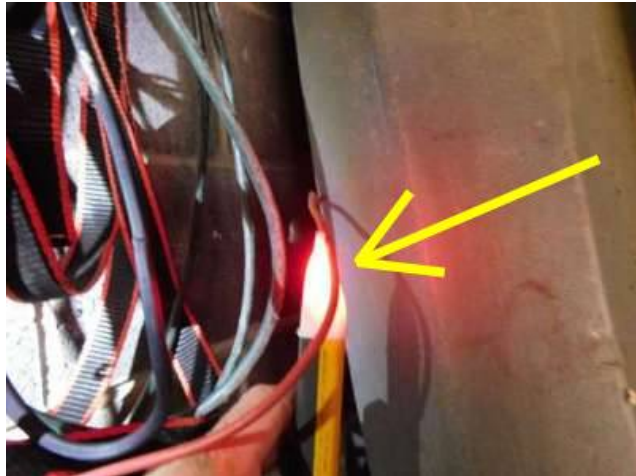
Photo 45-2 Exposed, insulated conductors. The voltage detector confirms that the exposed wires are energized.

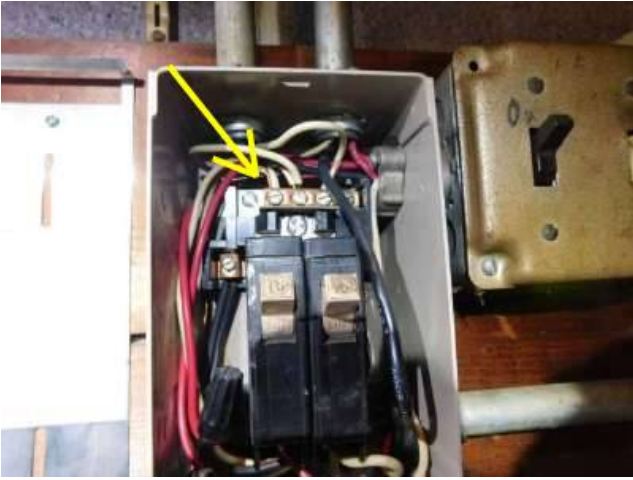
Photo 48-1

48) Material Defect/Safety, Replace - Neutral and equipment ground wires were bonded (connected) at sub-panel(s) B. This should only occur in the main service panel, not sub-panels, and is a shock hazard. Neutral wires should be attached to a "floating" neutral bar not bonded to the panel, and grounding wires should be attached to a separate grounding bar bonded to the sub-panel. Required that a licensed electrician repair per standard building practices.

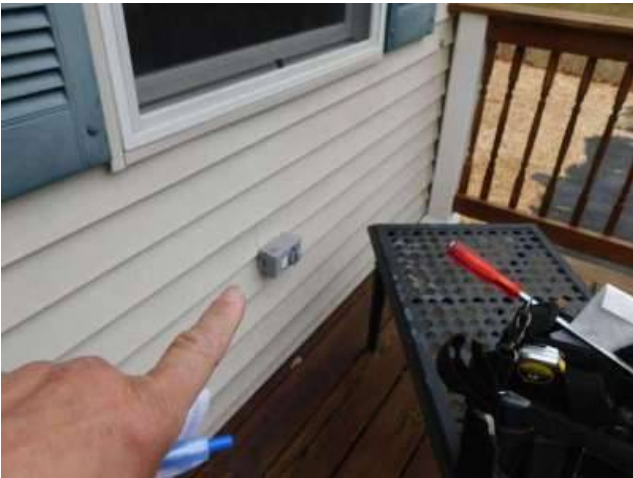
Photo 49-1

49) Material Defect/Safety, Replace - One or more electric receptacles (outlets) had an open ground. The ground prong is not connected to a ground wire and therefore, the appliance plugged into the outlet will not be properly grounded. Such receptacles may appear to be grounded when they aren't. This is a shock hazard, and can damage equipment plugged into such receptacles. Required that a licensed electrician repair as necessary.

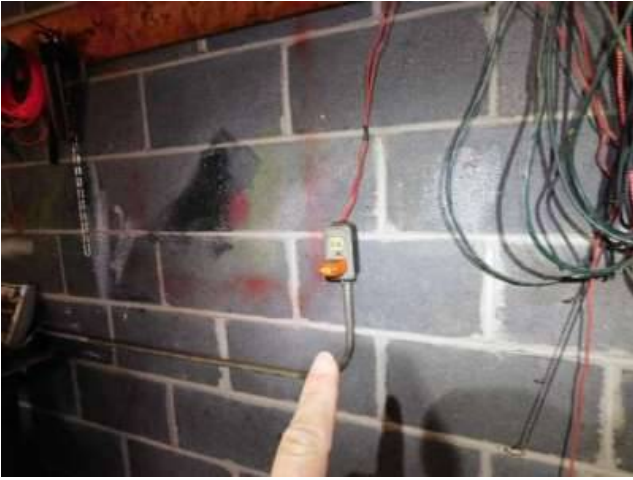
Photo 50-1

50) Material Defect/Safety, Replace - One or more electric receptacles (outlets) had reverse-polarity wiring, where the hot and neutral wires were reversed. This is a shock hazard. Required that a licensed electrician repair as necessary.

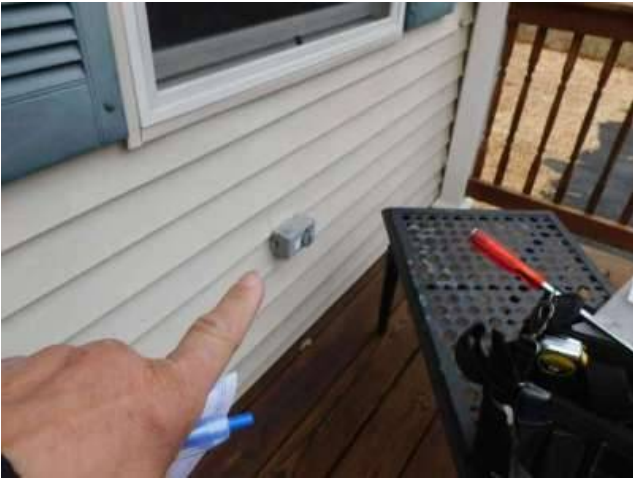
Photo 51-1

51) Material Defect/Safety, Replace - One or more cover plates installed outside were damaged. This is a potential shock and/or fire hazard. Required that a licensed electrician repair as necessary.

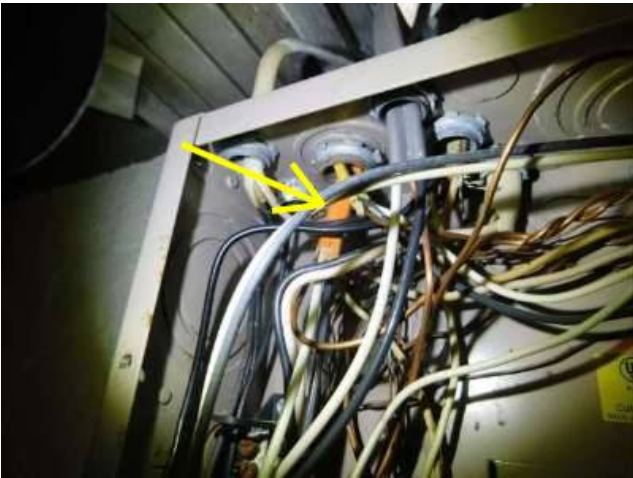
Photo 52-3 This orange wire feeds the breaker in question. A quick google search suggests that an orange wire is a 10 gauge wire for a thirty amp breaker.

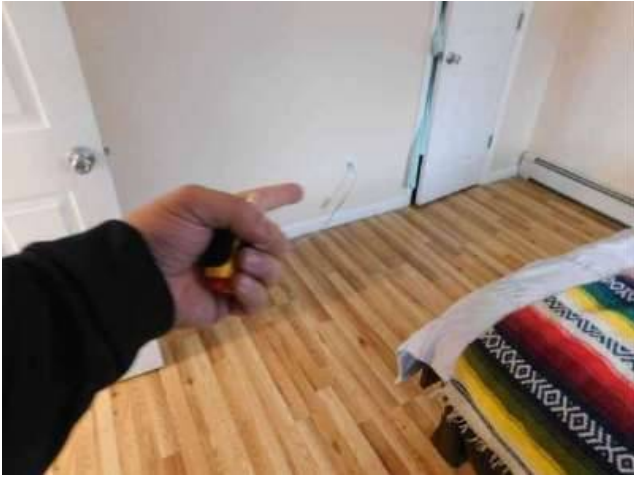
Photo 53-1

53) Material Defect/Safety, Replace - One or more electric receptacles (outlets) and/or the boxes in which they were installed were loose and/or not securely anchored. Wire conductors can be damaged due to repeated movement and/or tension on wires, or insulation can be damaged. This is a shock and fire hazard. Required that a licensed electrician repair as necessary.

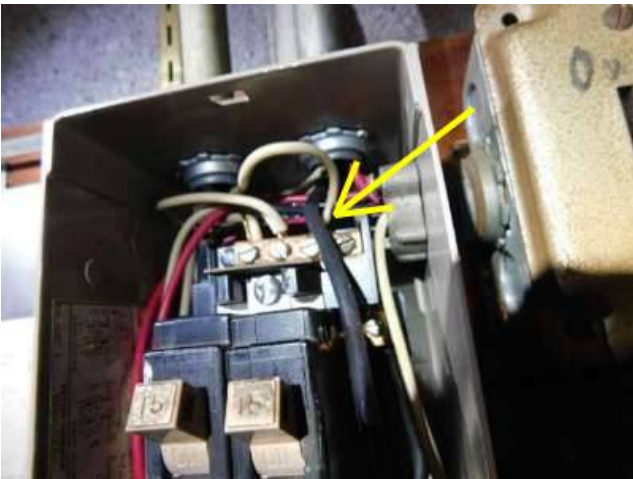
Photo 55-1

55) Material Defect/Safety, Repair/Maintain/Service, Evaluate - One of the neutral branch wires in Panel B was burnt.

It's very important that a licensed electrician evaluate and repair. This is a fire hazard.

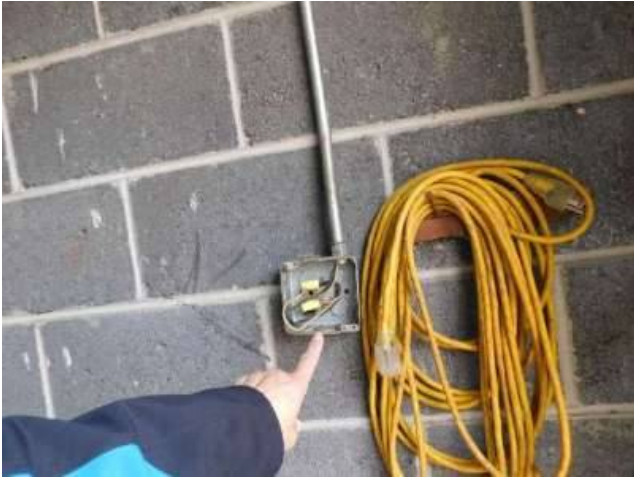
Photo 56-1

56) Material Defect/Safety, Repair/Maintain/Service - Numerous cover plates for switches, receptacles (outlets) or junction boxes were missing or broken. Examples are shown. Potentially other exist but were obscured on this day. These plates are intended to contain fire and prevent electric shock from occurring due to exposed wires. Required that a licensed electrician install cover plates where necessary.

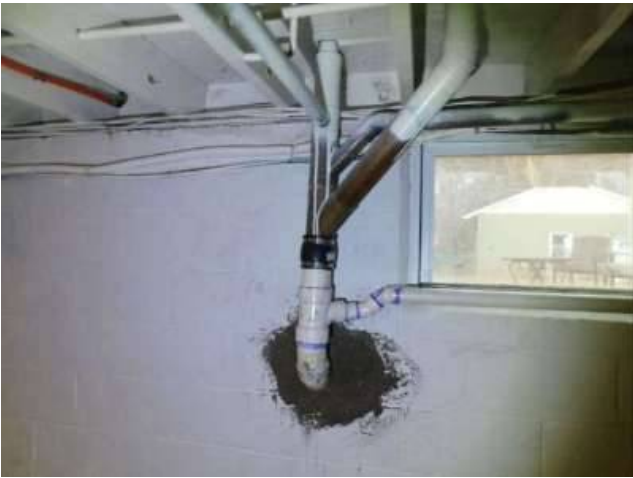
Photo 67-1

67) Evaluate - The plumbing system includes a copper drain line that transitions into a plastic drain line. The weight of the copper pipe may exceed what the plastic drain line is designed to support. This could lead to stress at the connection point, potentially causing leaks, joint failures, or damage over time. Required that you have a licensed plumber evaluate this configuration to address any potential issues. Proper bracing or an alternative transition method may be necessary to ensure long-term reliability and safety.

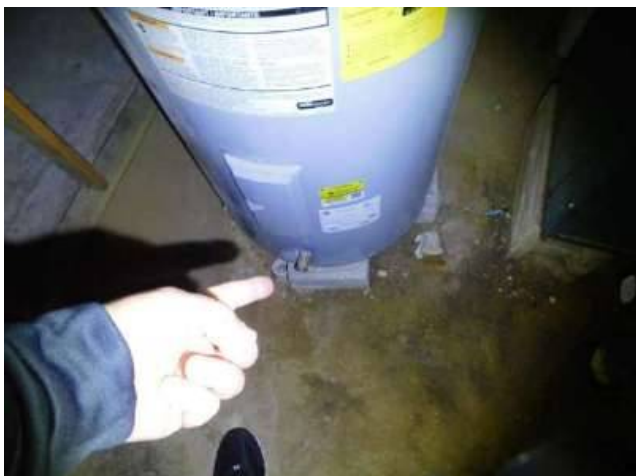
Photo 71-1

71) Repair/Maintain/Service - The water heater was installed in an unheated space on a concrete floor and was not resting on an insulated pad. The bottom of the casing is likely to rust, and energy efficiency may be reduced. Required installing an insulated pad under the water heater or as required by local plumbing standards. This work must be done by a licensed plumber.

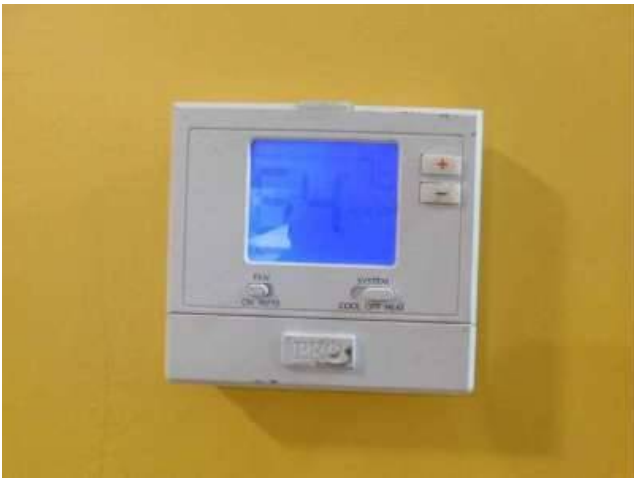
74) Material Defect/Safety, Replace, Evaluate - The boiler did not respond to normal controls (thermostat). It appeared to be inoperable. The inspector was only able to perform a limited evaluation. If possible, consult with the property owner and/or review documentation on this system. Required that a licensed and qualified HVAC contractor evaluate and repair as necessary.

Photo 74-1 Upon arrival the thermostat was calling for heat but the boiler was not running.

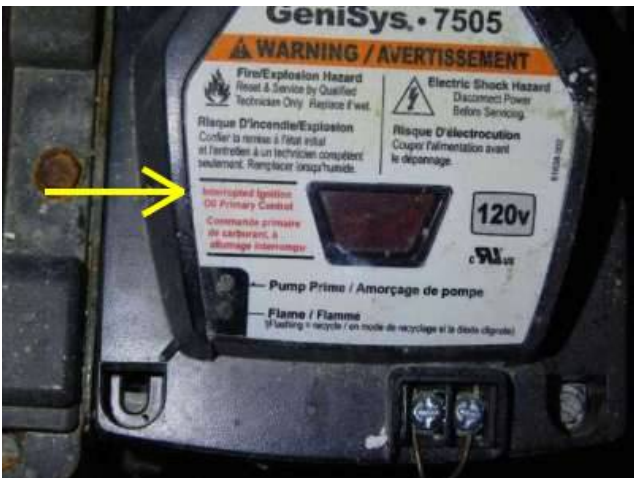
Photo 74-3 "Interrupted ignition oil primary control"

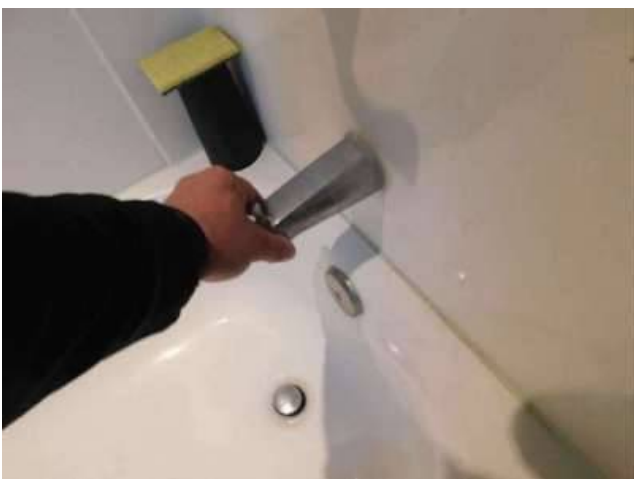
Photo 91-1

91) Repair/Maintain/Service - The pipes in the wall for the tub spout at bathroom A are loose. Leaks can occur and if they do, they are inside the wall where unknown damage can occur such as wood rot and potentially mold. A licensed and qualified plumber must repair so that the pipes are well secured in the wall.

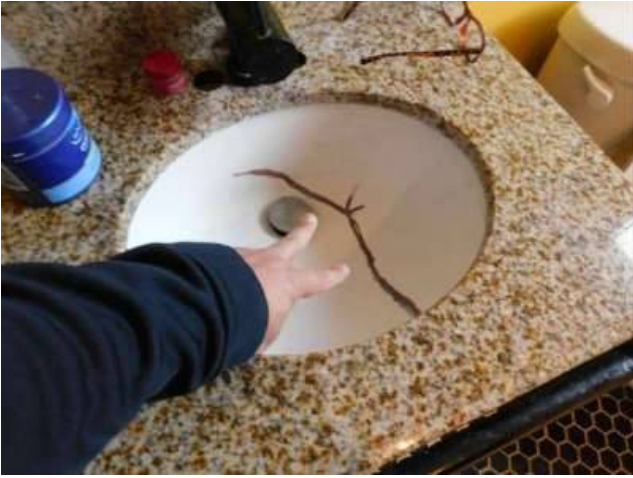
Photo 95-1

95) Comment/FYI - The sink at location(s) A was worn, blemished or deteriorated.

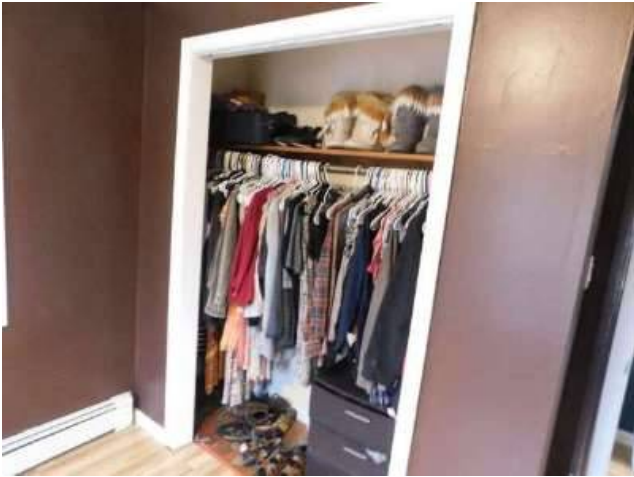
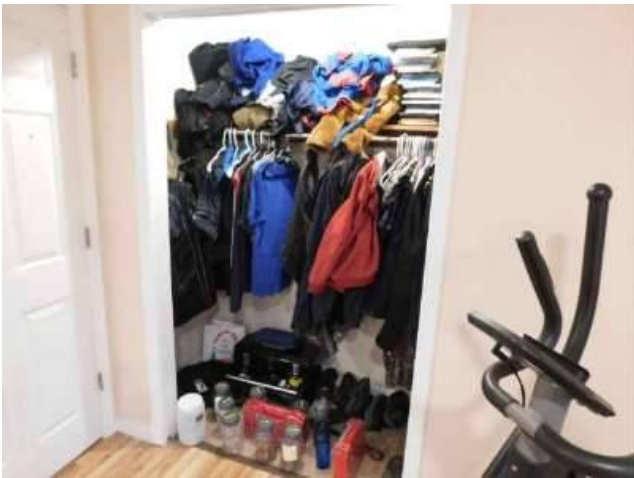
97) Replace - One or more interior doors were missing. Required that a qualified person replace or repair doors as necessary.

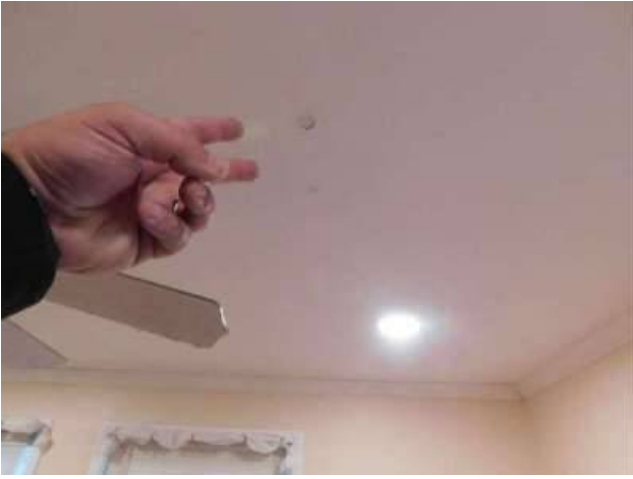
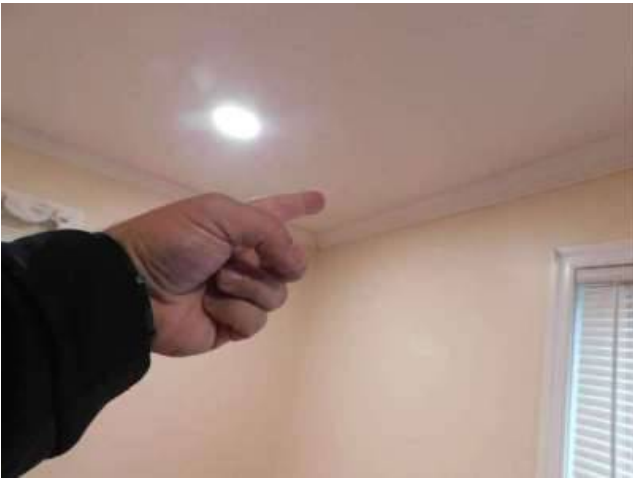
99) Repair/Maintain/Service - Cracks, nail pops and/or blemishes were found in walls and/or ceilings in one or more areas. Cracks and nail pops are common, are often caused by lumber shrinkage or minor settlement, and can be more or less noticeable depending on changes in humidity. Required that the client have a qualified contractor, such as a painting contractor, repair for aesthetic reasons.

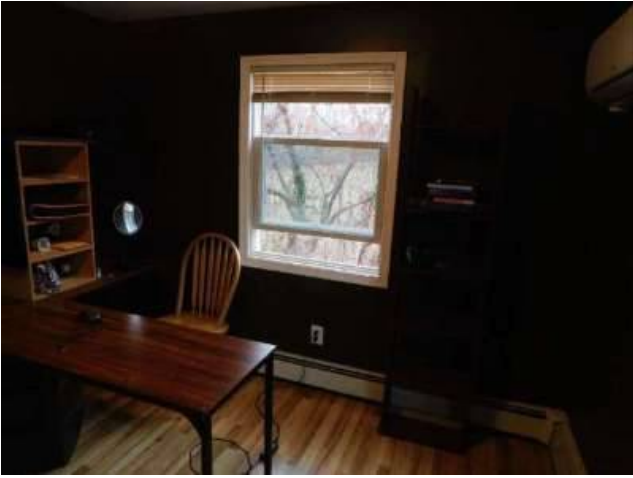
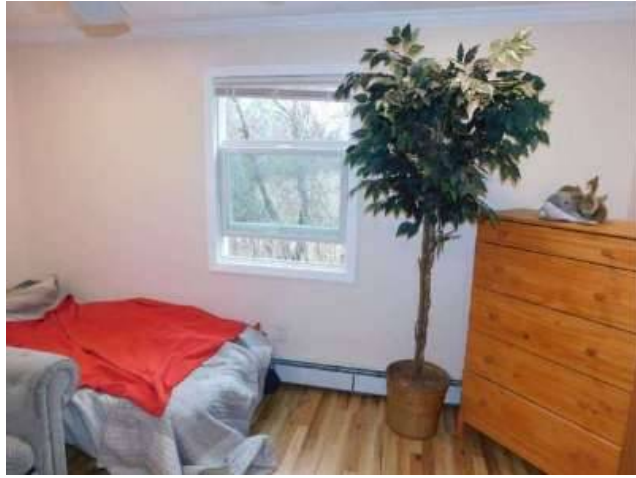
100) Comment/FYI - Screens were missing from some windows. These windows may not provide ventilation during months when insects are active.
