Regal Home Inspections, LLC

Property Inspection Report

Property address: **Holmdel, NJ 07733**

Inspection date: **Friday, November 16, 2018**

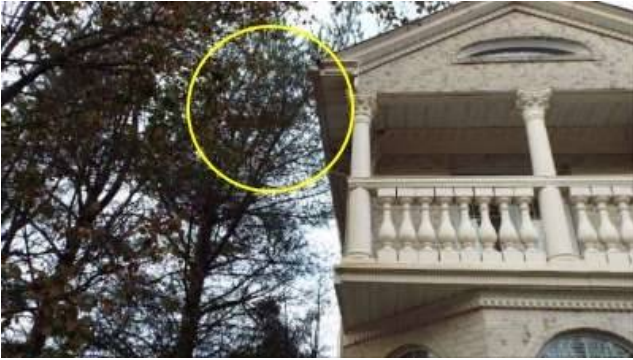
1) Repair/Replace - Evidence of rodent infestation was found in the form of traps and dead rodents (Mouse and squirrel) in the attic. Consult with the property owner about this. A qualified person should make repairs to seal openings in the structure, set traps, and clean rodent waste as necessary. Also see the Attic and Roof Structure section.

A squirrel was seen jumping from the pine tree to the roof and then entering the roof. See photos below.

Photo 1-1 A squirrel was seen jumping from the pine tree onto the roof.

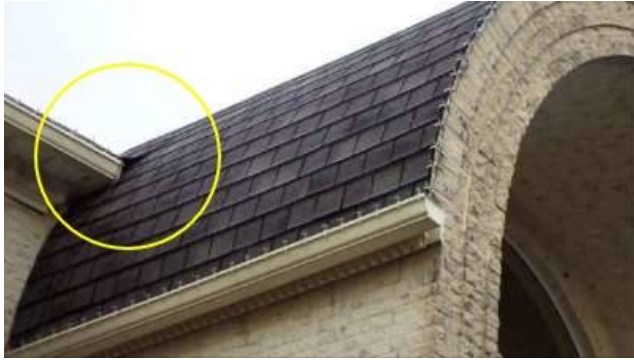
Photo 1-2 It emerged at this location...

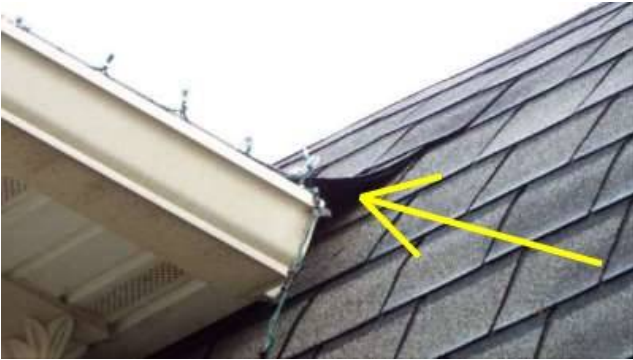
Photo 1-3 ...and climbed right into this opening.

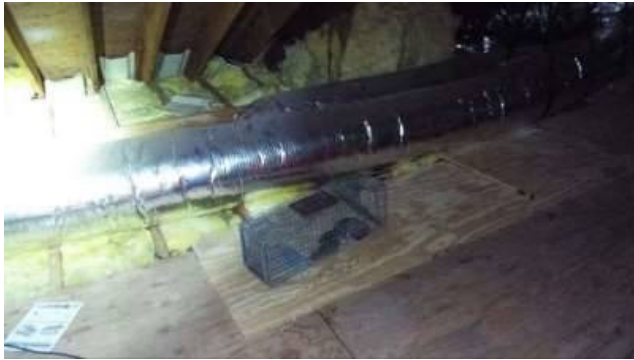
Photo 1-4 There's a dead squirrel in the trap...

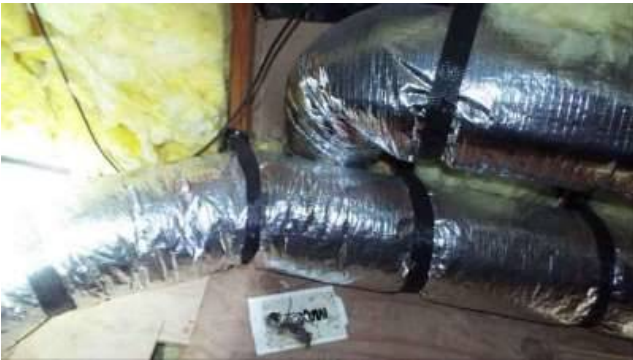
Photo 1-5 ...and a dead mouse.

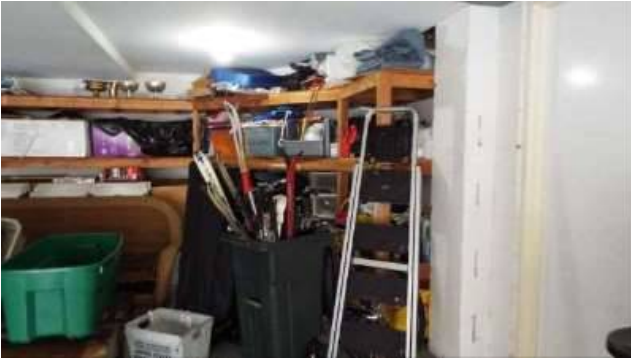
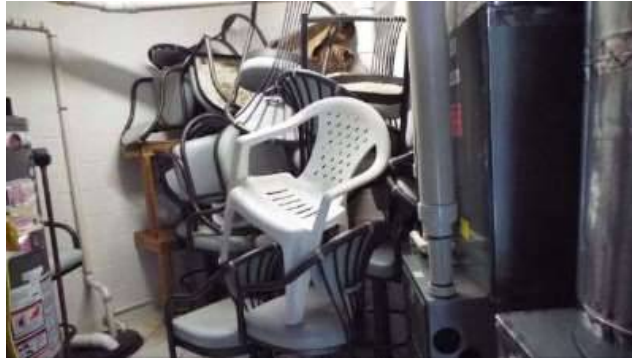
2) Comment/FYI - Numerous areas and items at this property were obscured by stored items and other things. This often includes but is not limited to walls, floors, windows, inside and under cabinets, under sinks, on counter tops, in closets, behind window coverings, under rugs or carpets, and under or behind furniture. Areas around the exterior, under the structure, in the garage and in the attic may also be obscured by stored items. Storage and utility areas in the basement were packed with stored items. The inspector in general does not move personal belongings, furnishings, carpets or appliances. When furnishings, stored items or debris are present, all areas or items that are obscured, concealed or not readily accessible are excluded from the inspection. The client should be aware that when furnishings, stored items or debris are eventually moved, damage or problems that were not noted during the inspection may be found.

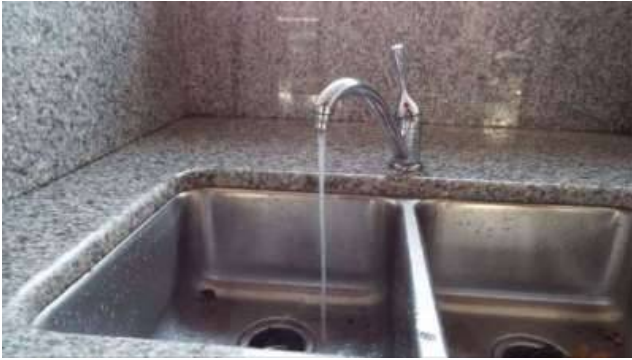
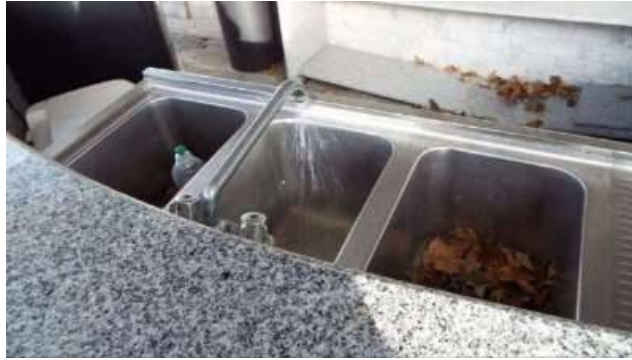
5) Comment/FYI - Please note that sinks outside at the cabana did not appear to be winterized. Highly recommend that the sellers be asked to ensure that everything outside is winterized as soon as possible. This includes the cabana as well as the pool house. The bathroom in the pool house appears to have been winterized but there's a water heater in the pool house and a small one in the cabana that should be winterized or confirmed that it was. The sinks at the cabana have not been.

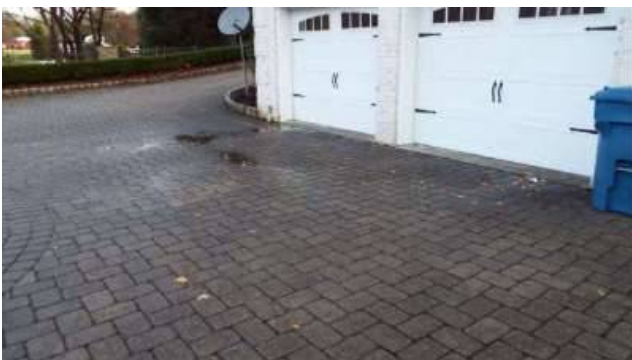
Photo 6-1

6) Evaluate - Pavement appears to slope down towards building perimeters in one or more areas such as by the garage. This can result in water accumulating around building foundations or underneath buildings. Monitor these areas in the future, especially during and after periods of rain. If significant amounts of water are found to accumulate, then recommend that a qualified contractor evaluate and repair as necessary. For example, by installing drain(s) or removing old pavement and installing new.

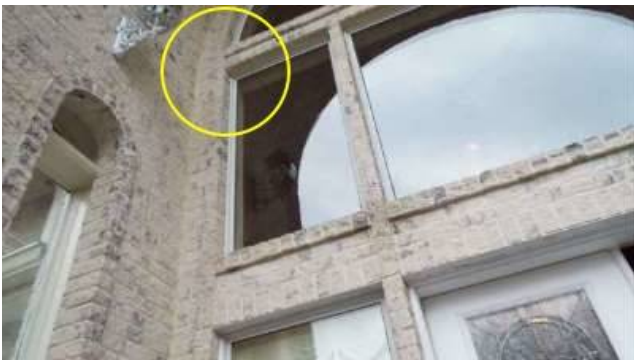
9) Material Defect/Major, Evaluate - Lintels are structural elements that support the weight of the brick over openings like windows and doors. Lintels are made of iron and often rust. Lintels are also embedded approximately 6 inches past the openings on either side to anchor them structurally. Over time lintels will rust. The rust can increase the size of the lintel and often applies upward force to the bricks causing cracks. Some cracks were seen here. Recommend that a qualified masonry contractor evaluate and repair. All gaps should be sealed. The lintels should also be maintaining by using a rust inhibiting paint and maintaining seals at the seams between the lintels and the brick.

Photo 9-1 Area of close up in the next photo.

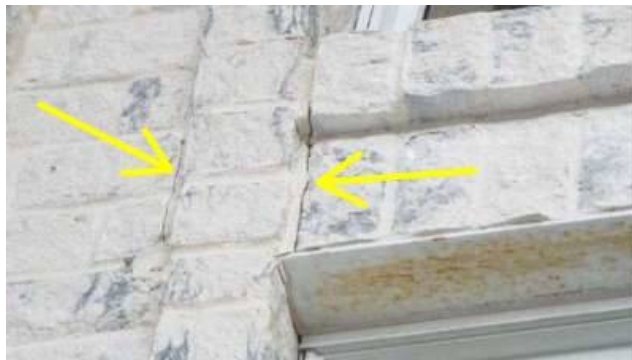
Photo 9-2 Some cracks above the lintel are seen.

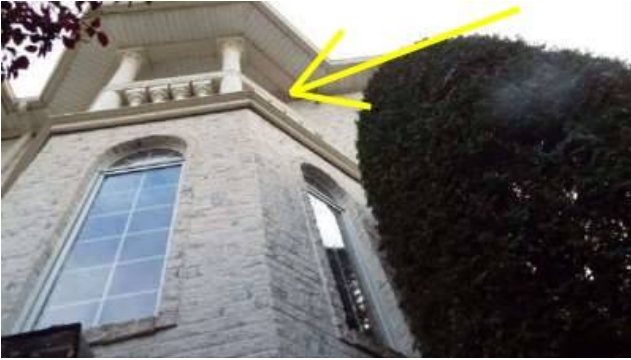
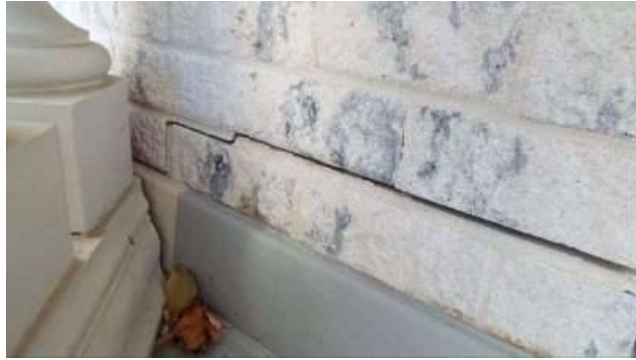
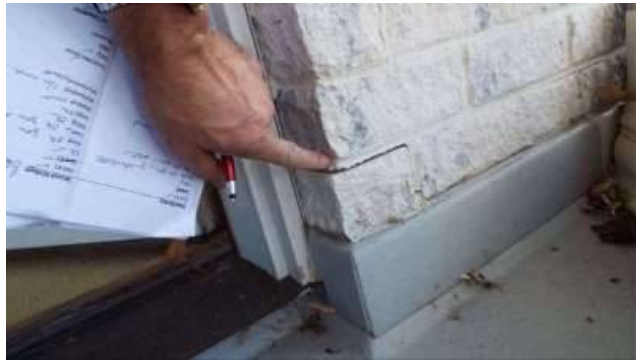
The cracks seen at the balcony (Photos 9 - 4, 5, & 6) could indicate that the structural elements (header) spanning the opening may be sagging. This specific area is the reason for the "Material Defect" classification. Recommend evaluation by a structural engineer and repair as that professional deems necessary.

Photo 9-3 The next photos are on the balcony for the room with the exercise equipment. I believe it's this location.

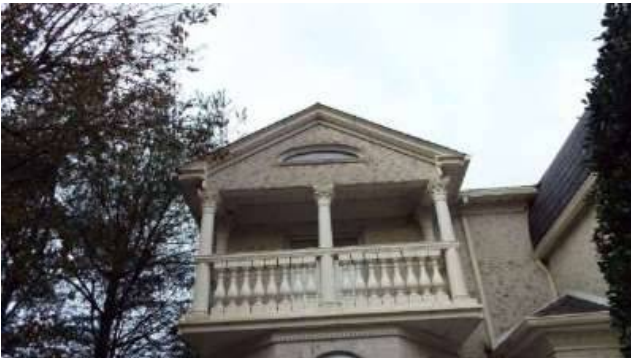
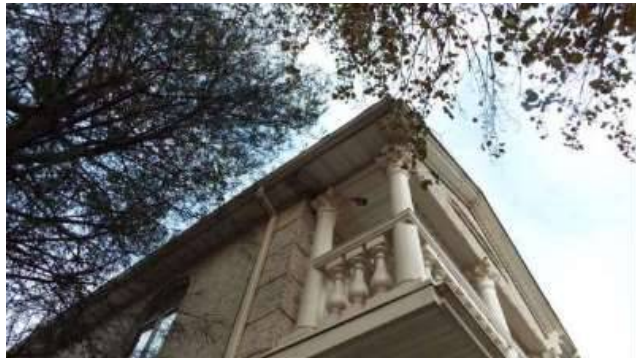
10) Maintain - Trees were in contact with or were close to the building at one or more locations. Damage to the building can occur, especially during high winds, or may have already occurred (see other comments in this report). Recommend that a qualified tree service contractor or certified arborist remove trees as necessary to prevent damage to the building exterior. A squirrel was seen jumping from the pine tree onto the roof then entering into the attic.

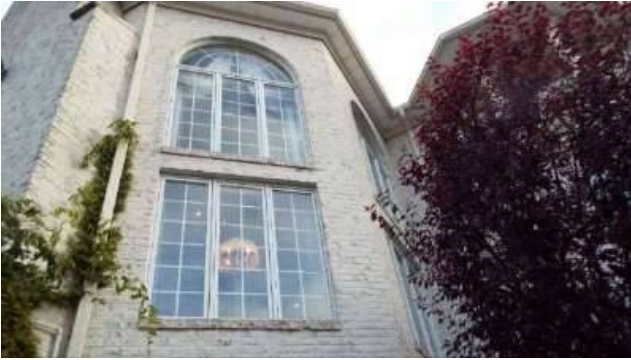
**Photo 11-1**

11) Maintain - Shrubs and vines were in contact with or close to the building exterior. Vegetation can serve as a pathway for wood-destroying insects and can retain moisture against the exterior after it rains. This is a conducive condition for wood-destroying organisms. Recommend pruning, moving or removing vegetation as necessary to maintain at least 6 inches of space between it and the building exterior. A 1-foot clearance is better.

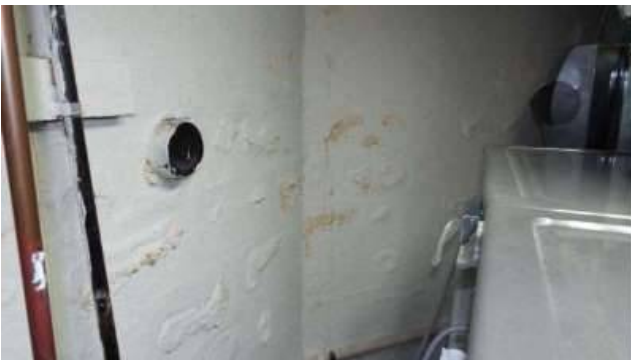
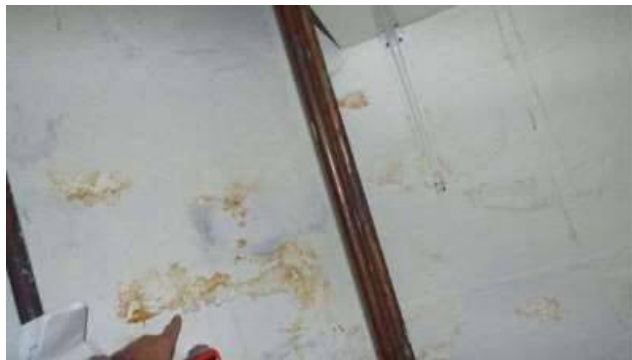
12) Comment/FYI - Efflorescence was found on the basement wall. Efflorescence are minerals that are drawn from the concrete materials. When there is excessive moisture outside the basement wall, the moisture naturally moves toward areas of lower humidity (on the inside of the basement wall). As the moisture moves through the masonry materials it draws the minerals, calcium and salts, from the masonry materials. As the moisture evaporates on the inside, it leaves behind the calcium and salts.

This is not necessarily a problem but rather a symptom of too much moisture on the outside. This can be due to poor drainage, slope or grading of the soil so that rain water flows toward the house, not away from it. It could be because downspouts and downspout extensions are not routing the rain water far enough from the foundation wall.

Recommend ensuring that the grading slopes water away from the house. Internal foundation wall sealants do not stop efflorescence. In fact the minerals will continue to accumulate below any finished coatings. Controlling the water outside is the best solution.

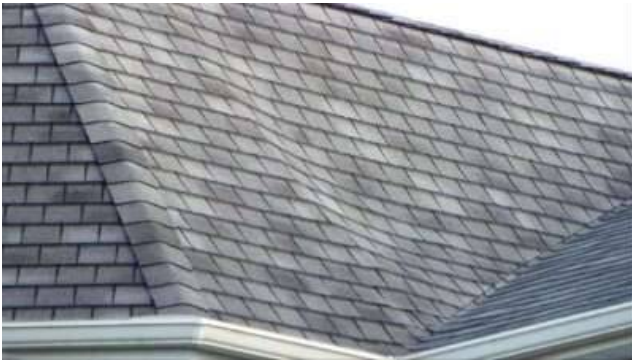
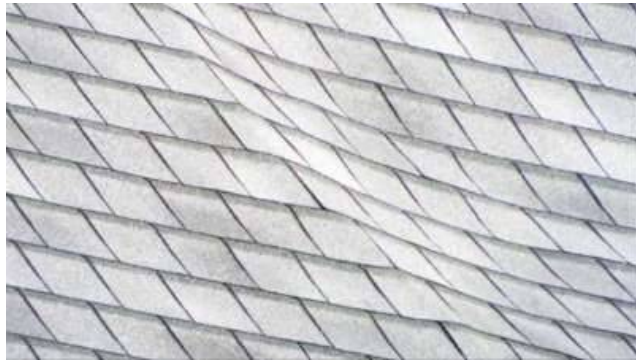
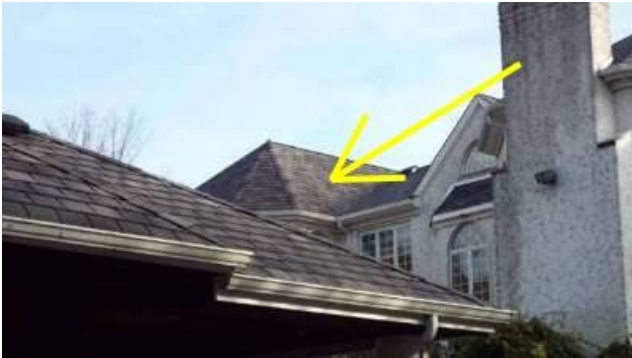
15) Repair/Maintain/Service, Evaluate - There was some visible deformity to an area of the roof. It was not located for viewing from inside the attic. Recommend that a qualified roofing contractor evaluate and repair as necessary.

Photo 15-3 Area of close up in the previous 2 photos.

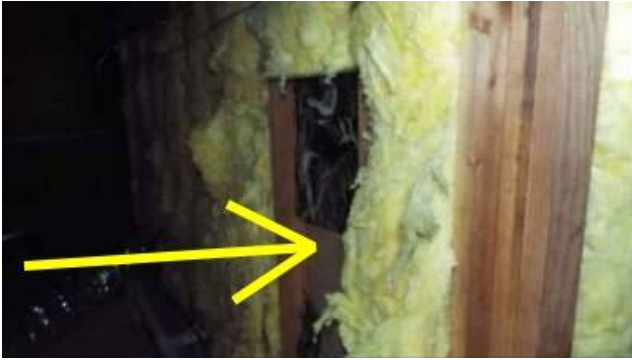
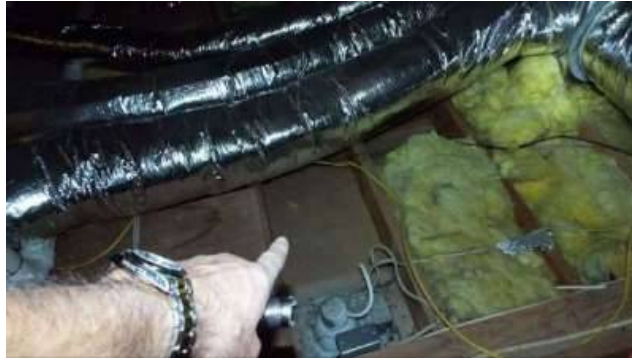
18) Repair/Maintain/Service - Attic insulation at one or more ceiling areas, skylight chases or attic walls has fallen down or was missing. Heating and cooling costs will likely be higher due to reduced energy efficiency. Recommend that a qualified person repair, replace or install insulation as necessary and per standard building practices.

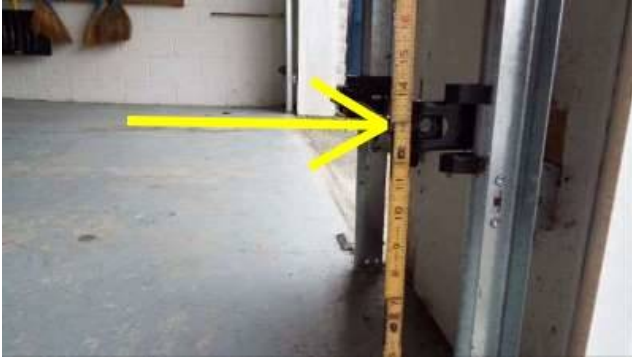
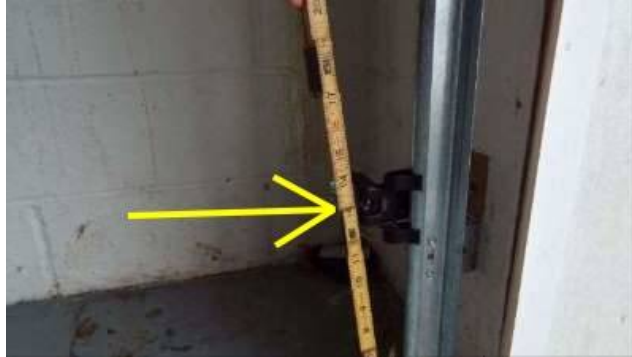
21) Material Defect/Safety, Repair/Maintain/Service - The photoelectric sensors that trigger the auto-reverse feature on one or more garage vehicle doors' automatic openers were located higher than 4-6 inches from the floor. This is a potential safety hazard. A qualified person should relocate sensors so they are 4-6 inches from the floor per standard building practices.

Photo 21-1 The ruler confirms (here and the next photo) that both sets of sensors are too high.

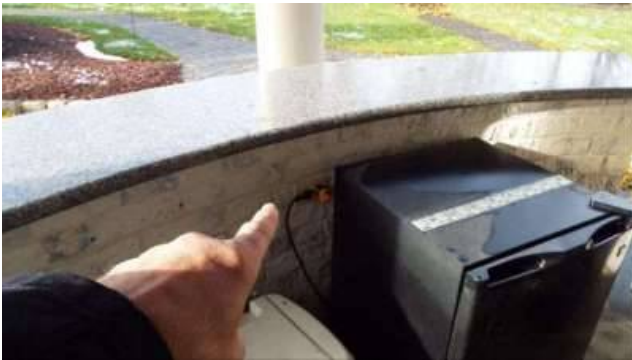
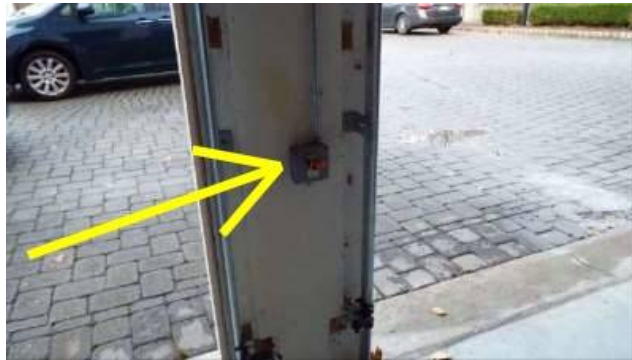
24) Material Defect/Safety, Repair/Replace, Evaluate - One or more ground fault circuit interrupter (GFCI) receptacles (outlets) wouldn't trip and/or wouldn't trip with a test instrument at the garage and/or exterior. This is a potential shock hazard. Recommend that a qualified electrician evaluate and repair as necessary.

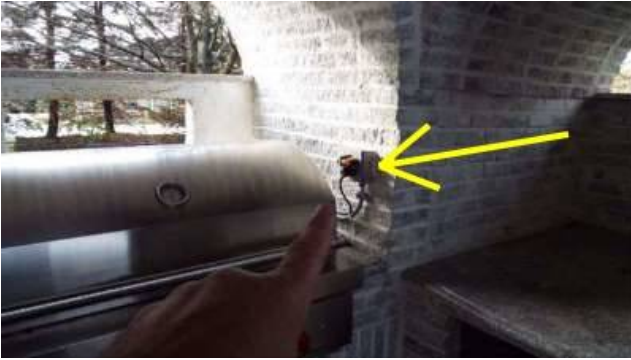
Photo 25-1

25) Material Defect/Safety, Repair/Replace, Evaluate - One or more electric receptacles (outlets) at the exterior (at the pool house) had no visible ground fault circuit interrupter (GFCI) protection. If not GFCI-protected, receptacles in wet areas pose a shock hazard. Recommend that a qualified electrician evaluate and install GFCI protection if necessary and per standard building practices. General guidelines for GFCI-protected receptacles include the following locations:

The age of the structure may predate all or portions of these requirements. The inspector recommends having a licensed electrician install GFCI protection as an upgrade to any circuits where there is a higher potential for electrical shock and GFCI protection does not currently exist. National electrical standards currently require that all outlets that serve the kitchen countertop surfaces be GFCI protected regardless of their proximity to a sink. Lack of GFCI protection where currently required is a safety issue for the occupant.

Recommend all outlets around the pool house be re-evaluated. It's possible that others are also not GFCI but were inaccessible or obscured on this day.

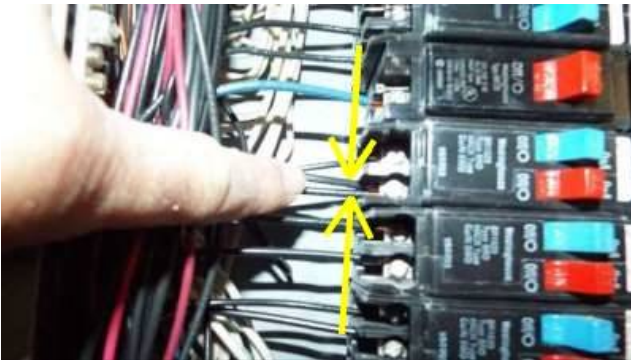
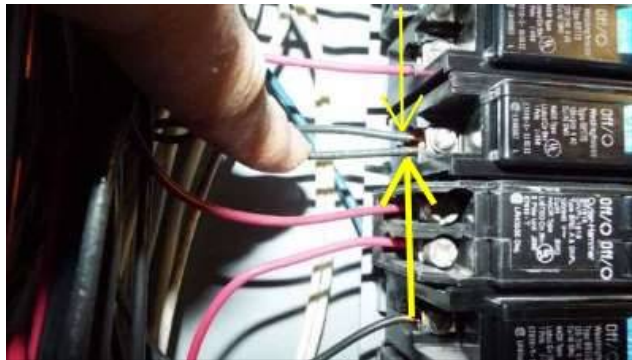
26) Material Defect/Safety, Repair/Replace - One or more circuit breakers in panel(s) B were "double tapped," where two or more wires were installed in the breaker's lug. Most breakers are designed for only one wire to be connected. This is a safety hazard since the lug bolt can tighten securely against one wire but leave other(s) loose. Arcing, sparks and fires can result. Recommend that a qualified electrician repair as necessary. Please note that the circuit breakers in Panel A appear to be manufactured to accept 2 wires however the circuit breakers in Panel B are different and appear to be able to have only 1 wire inserted into the lug.

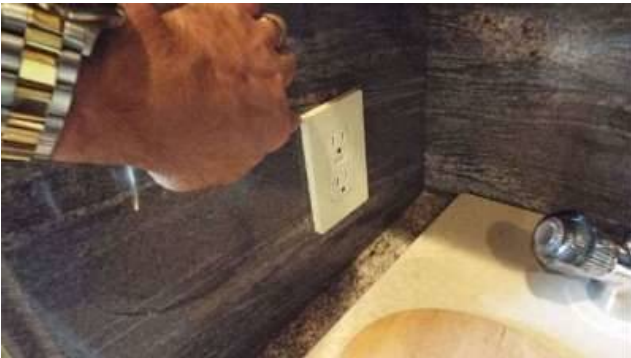
27) Material Defect/Safety, Repair/Replace - One or more electric receptacles (outlets) and/or the boxes in which they were installed were loose and/or not securely anchored. Wire conductors can be damaged due to repeated movement and/or tension on wires, or insulation can be damaged. This is a shock and fire hazard. Recommend that a qualified electrician re-evaluate all and repair as necessary.

Photo 27-1 Dining room bar sink.

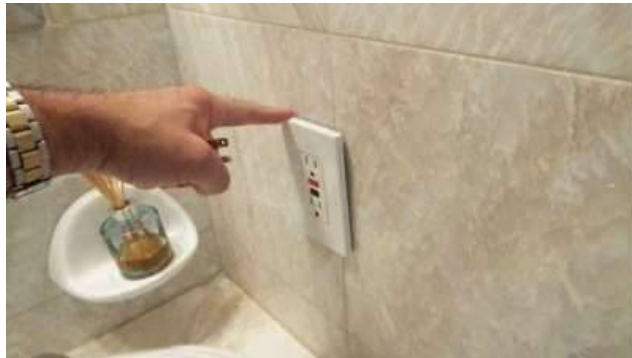
Photo 27-2 Bath F.

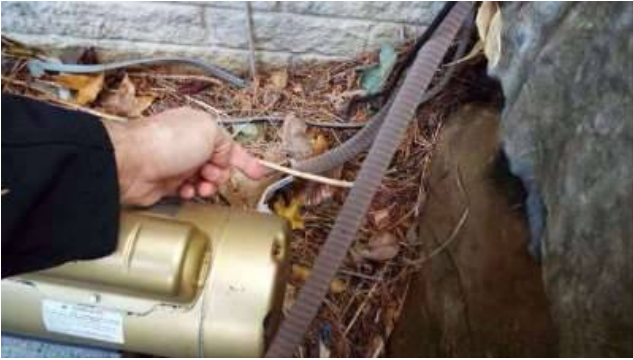
**Photo 28-1**

28) Material Defect/Safety, Repair/Replace - One or more conduits or conduit fittings installed outside were loose and the insulated conductors are exposed at the water pump for the water feature on the side of the house. This is a potential shock and/or fire hazard. Recommend that a qualified electrician repair as necessary. At the equipment for the waterfall, water feature.

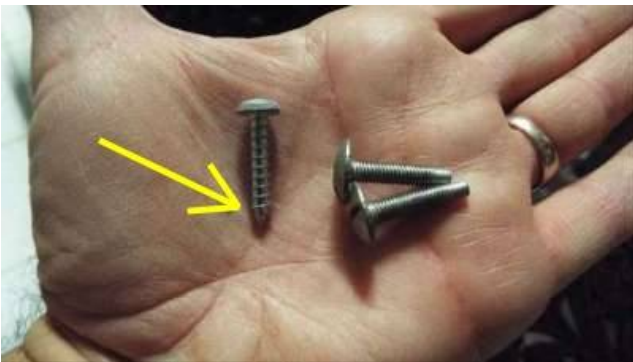
**Photo 30-1**

30) Repair/Maintain/Service - The electrical panel did not use the correct, panel cover screws. Screws that hold a circuit breaker panel cover on the panel box are very specific. They have flat tips to reduce the potential of the screw piercing wires inside the box and causing short circuits. The screws used in a panel are incorrect. Additionally, each panel was missing some screws. Recommend that an electrician replaces the screws with the proper ones.

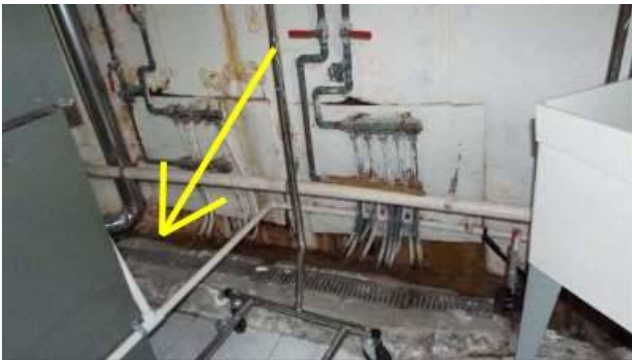
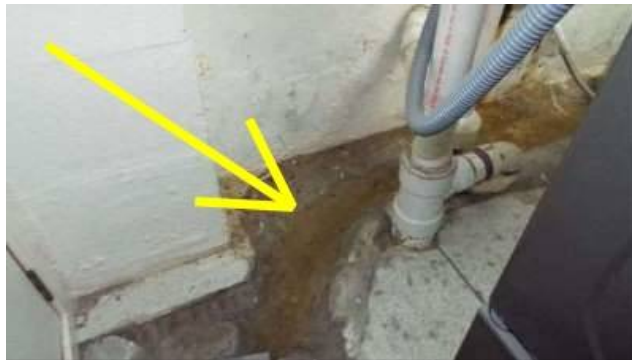
37) Repair/Replace, Evaluate - There is an open drain in the utility/laundry area in the basement. Recommend evaluation by a licensed plumber. Chronic exposed water as seen here will cause high moisture conditions creating conducive conditions for mold. Evaluation and upgrading (for whatever drainage need it's there to serve) should be considered.

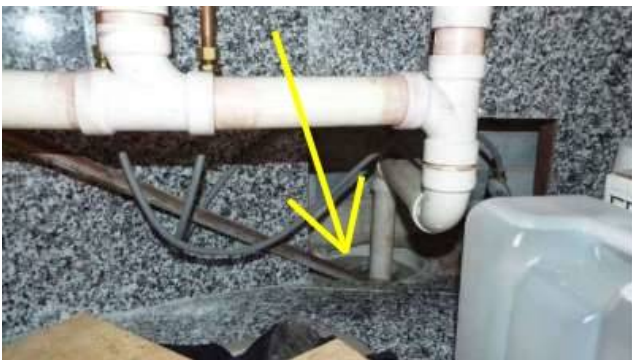
Photo 38-1

38) Repair/Replace, Evaluate - There is an open drain pit below the sink in the island bar in the basement. As the sink was operated for a few minutes, the water accumulated in this open pit and there's the potential that the pit could overflow onto the basement floor. Recommend evaluation by a licensed plumber. Ideally drains should be enclosed and include a water trap to prevent sewage gasses from backing up into the living space. No foul odors were detected but the design and drainage end point for this open drain could not be seen.

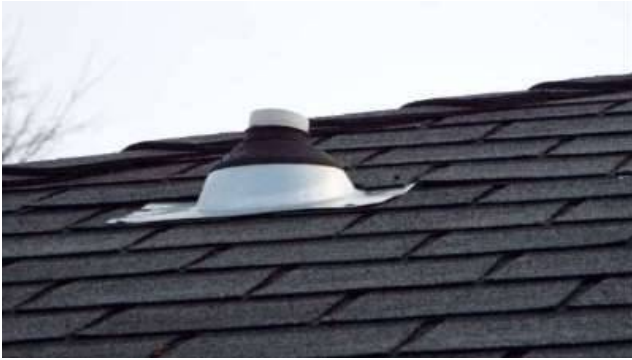
Photo 39-1

spaces. Recommend that a qualified person repair per standard building practices. For example, by extending pipe(s) to terminate at least 6 inches above the roof surface. As seen at the back roof of the pool house.

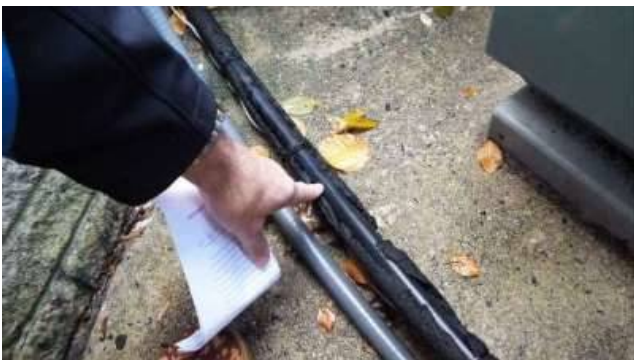
49) Repair/Maintain/Service - Insulation on the air conditioning condensing unit's refrigerant lines was deteriorated or missing in some areas. This may result in reduced efficiency and increased energy costs. Recommend that a qualified person evaluate all and replace or install insulation as necessary.

Photo 49-1 Seen here for the Unit 6 AC compressor.

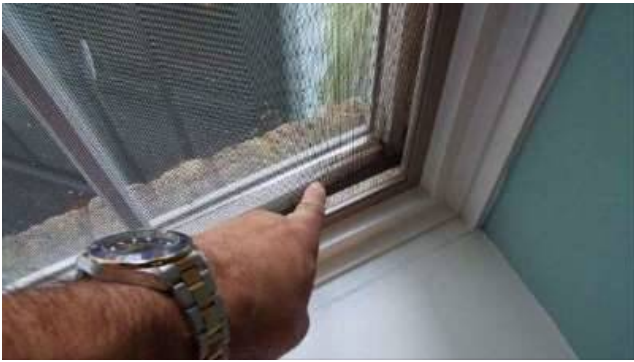
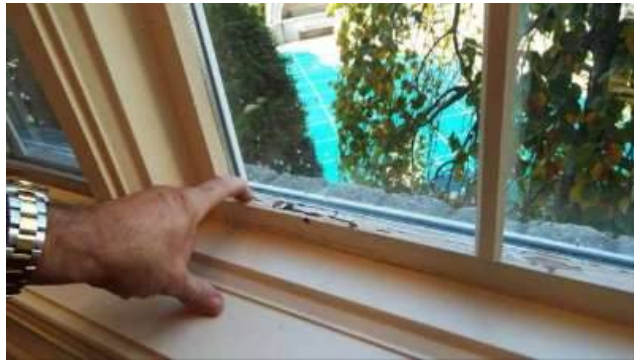
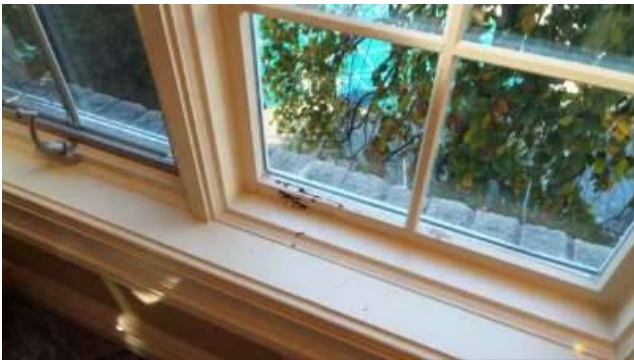
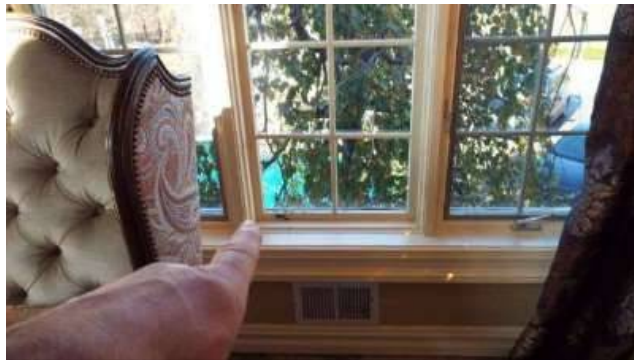
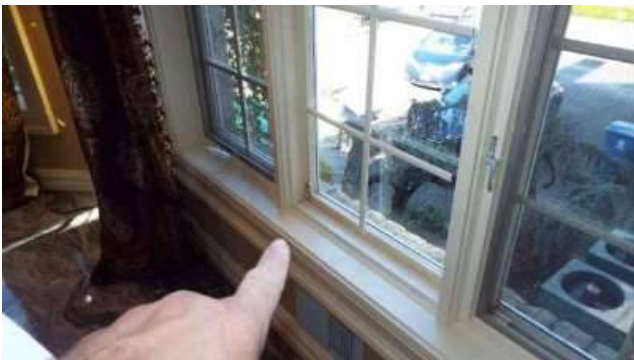
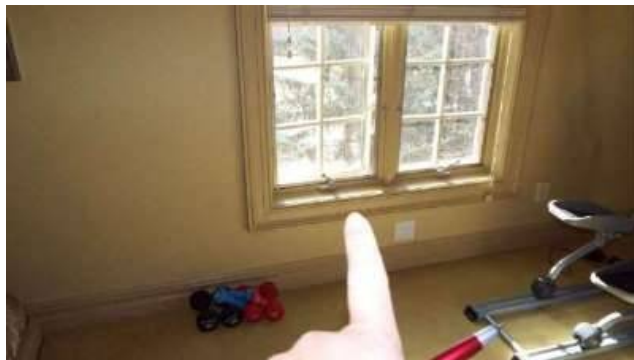
69) Repair/Replace, Evaluate - Numerous window frames had fungal rot. Literally, moisture could be pressed (using one's finger) from the wood on some windows. Recommend that all that are shown here be repaired. Also that all the windows be re-evaluated. Some windows were inaccessible due to furniture, for example. Following the NJ home inspection standards of practice, furniture is not moved. However, a window repair contractor, retained by the seller should have the seller's permission to do so. Please note that small sections may not be able to be repaired and full window panes may have to be replaced.

Photo 69-1 Windows seen here are from the basement level, 1st and 2nd levels.

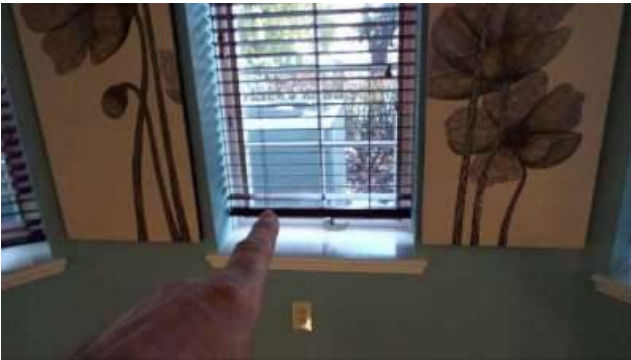
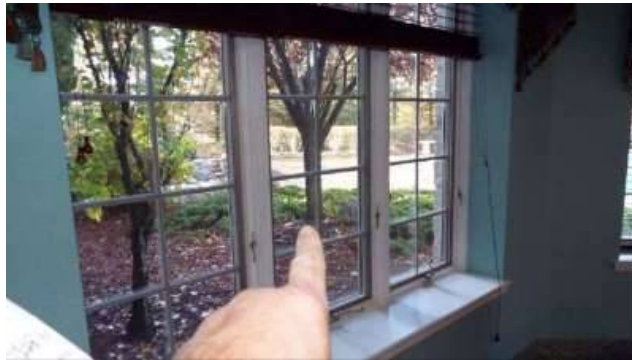
71) Repair/Maintain/Service - One or more windows that were designed to open and close were stuck shut and/or difficult to open and close. Recommend that a qualified person repair windows as necessary so they open and close easily. Both at the basement level.

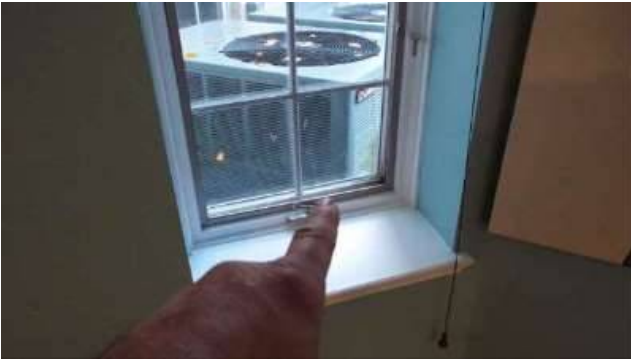
Photo 72-1

72) Repair/Maintain/Service - Crank handles at few windows were broken. Recommend that a qualified person replace handles or make repairs as necessary.
