Regal Home Inspections, LLC

Find of the Week 2/23/2019

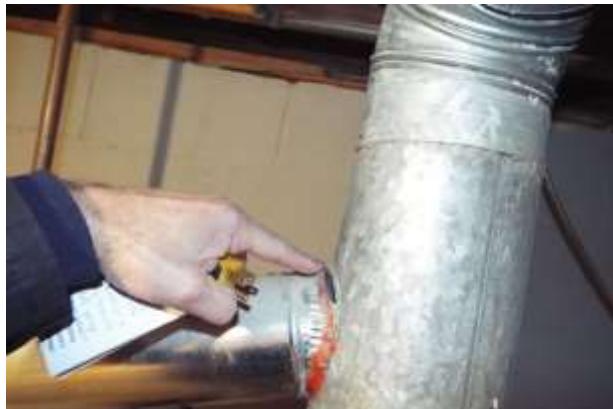
In this case, there was a large gap in the exhaust. That's problem #1. Problem #2 was that the vent pipe was pitched DOWN! Hot air, and exhaust, rises. It does not go down. By design, the exhaust flue must be sloped upward. Doesn't everyone know that? Doesn't everyone know that hot air rises? That's a fact of life. If you have an exhaust flue that's pitched down, the warm air will not travel down. Remembering an old TV favorite, "Hill Street Blues", there was an episode where a character said (in regard to a cow on a high floor in an apartment), "The cow don't have any down genes" meaning the cow doesn't know how to walk down steps. Hot air, don't have any down genes either. It only goes UP. So the exhaust has to be designed to work in a way that accommodates the genes of the hot air/exhaust.

Anyway, the problem was identified. It was classified as a material defect in accordance with NJ home inspection standards of practice. To the definition of a, "Material defect", this effected the "safety" of the occupants.

Figure 1 - There's a large gap where exhaust will leak into the living space.

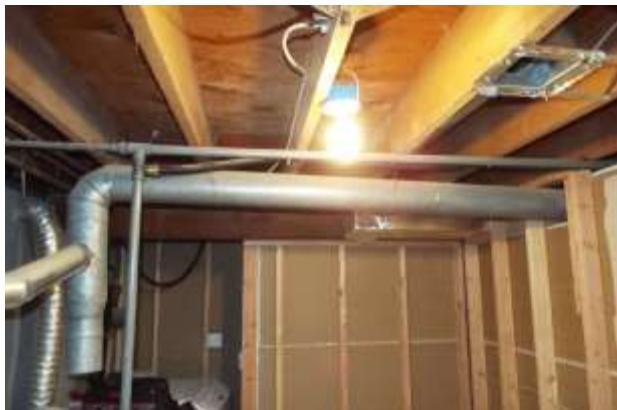
*Figure 2- The horizontal flue seen in this photo is pitched down. It's lower on the right than it is on the left.*
