## Regal Home Inspections, LLC

Find of the Week 1/26/2019

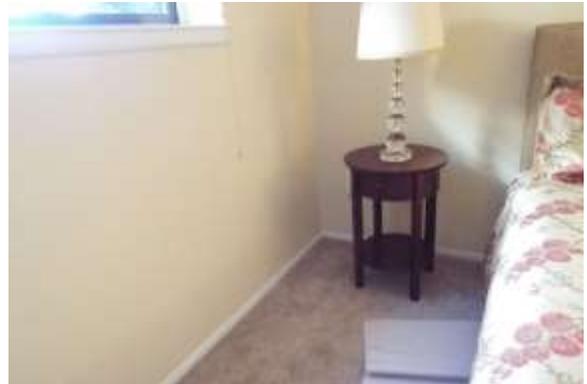
There was nothing visually that might indicate a problem. There was no staining as often is found on the surface of wet or moist drywall. Sometimes the paper of the drywall surface starts to ripple when it gets wet but there were no indications like these. This photo helps prove that point – nothing of interest from a visual perspective.

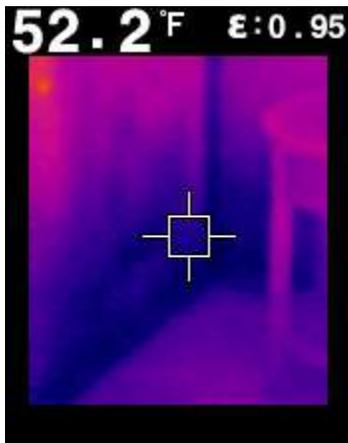
Figure 1 - Thermal Image Photo

However, the thermal imaging camera saw something completely different. Thermal imaging (TI) cameras look at heat differences. That

difference is called, "Delta T". While there was nothing to see by eye, to a thermal image camera, seeing in the infra-red (heat) spectrum, the picture was different. Nothing to cause alarm yet. For example, the Delta T indicated by the TI camera could be due to less insulation in that area. The TI camera doesn't know wet from dry but it does know an area that's 65 degrees as compared to a surrounding area that's, for example, 70 degrees. You can see the outline of the small table on the right in this TI photo, Figure 1. Also the vertical corner where the side wall and front (left wall) meet. However, there's a dark area against the wall on the left. The blue color low indicates that the blue area is colder than the red (or lavender) color that's higher on the wall. That difference is the Delta T that's brought to focus (literally and figuratively) by the TI camera. But that, again is not necessarily of significance.

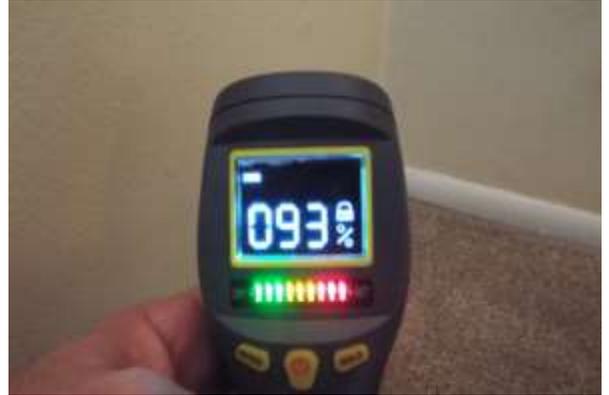
That's the next step. To try to quantify the infrared image. What is causing this? Sometimes, for example, in a ceiling or wall the Delta T could be due to missing insulation. There could be a fence outside and while the sun is hitting and heating the upper part of the wall the fence is causing the lower half to be in the shade and consequently colder. That situation could produce a similar image as the one above. However, the next step is the clincher. All NJ home inspectors are required to carry a moisture meter. Using the moisture meter confirms the fact that yes, there is moisture in the wall. The Delta T is being caused by water,

somehow, some way getting into the wall. Now remember this part of the wall is below ground. The moisture meter confirms that the moisture content of the drywall is 93%. The meter also provides a light bar that goes from green to yellow to red as the moisture level increases. This is nearly pegged all the way across the red. Additionally, there's an audible alarm.

So, in the report this was emphasized as being a very important finding and a contractor (along with the condominium association's maintenance staff) needs to figure out where the water is coming from and then A) Make the necessary repairs to prevent the water from getting in any longer and B) Repairing the damage. It was recommended that a qualified contractor expose the interior of the wall. If there's water there is possibly damage to the drywall, wood studs and the insulation. All should be replaced. The area needs to dry and in a worst-case scenario, if the water penetration has been ongoing, it's highly likely that microbial growths (such as mold) is growing inside the walls.
