Regal Home Inspections, LLC

Find of the Week 2/2/2019

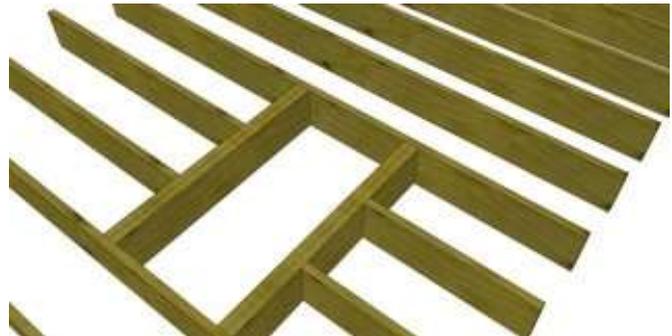
However, when the plumbers came in to run their drain and waste pipes AFTER the framers did their job, below the location where the plumber wanted to run a vertical pipe existed a joist. The proper practice should be for someone to create what's called a, "Plumber's box" as shown in the adjacent illustration. A plumber's box is a modification of the joist structure and design that creates space for the pipes WITHOUT decreasing the strength or compromising the integrity of the floor's intended structure.

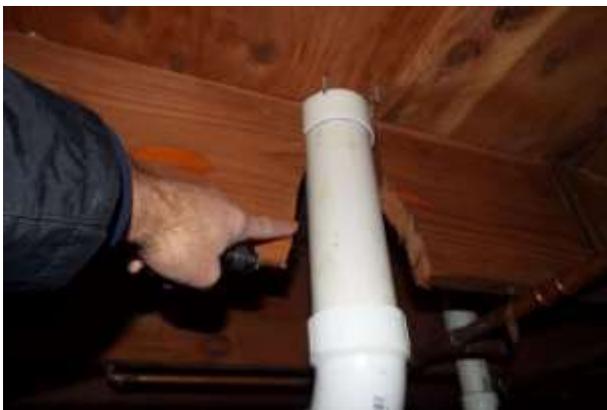
In this house, a joist was not only notched (Which, within certain parameters is allowed) but the joist was severed. Completely cut in half. Now because this was in a crawl space, no one probably never noticed. This particular house had recently undergone an inspection for its sale but that sale fell through. I was told of a couple of other reasons why the previous deal fell through (Roof issues for example) but this severed joist was not stated. A plumber's

severed, the finding was classified as, in accordance with NJ home inspection standards of practice as a, "Material Defect". It is structural and could compromise the integrity of the structure and safety of the occupants when objectively considered. While not necessarily in this case, a bathtub, for example, could be above this severed joist. A cast iron tub weighs 200 pounds or more. A bathtub with a volume of water that's 2' wide by 5' long by 1.5' deep works out to about 168 gallons which equals about 1300 lbs. Add a 150 pound person inside that tub and now this severed joist is holding up about 1650 pounds. This is how structural failures occur. Too much weight and inadequate structure.

In conclusion, structural elements are necessary. They are there for a reason and the size and type of the structural elements have likely either been engineered for that application or are the basic, design elements as required by construction standards (also know as, "Code"). To correct this defect, a plumber's box should be constructed to re-establish the design intent of the architect or engineer's original construction requirements.
