Regal Home Inspections, LLC

Property Inspection Report

Property address: **1 Any Street
Manalapan, NJ 07726**

Inspection date: **Sunday, September 29, 2019**

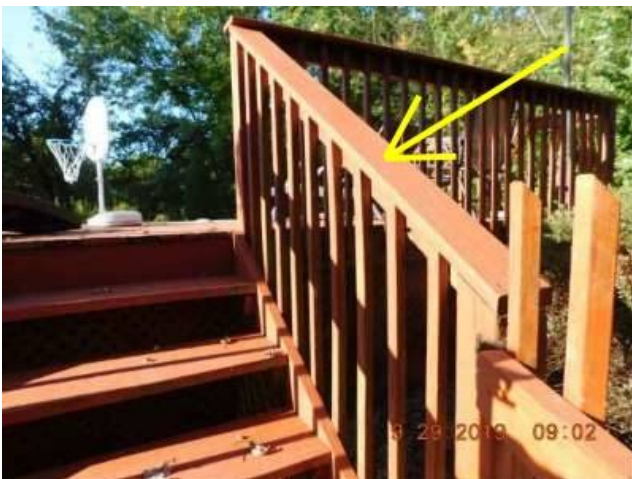
Photo 6-1

6) Material Defect/Safety, Repair/Replace - Handrails at one or more flights of stairs were not graspable and posed a fall hazard. Handrails should be 1 1/4 - 2 inches in diameter if round, or 2 5/8 inches or less in width if flat with recesses for fingers. Recommend that a qualified person install graspable handrails or modify existing handrails per standard building practices.

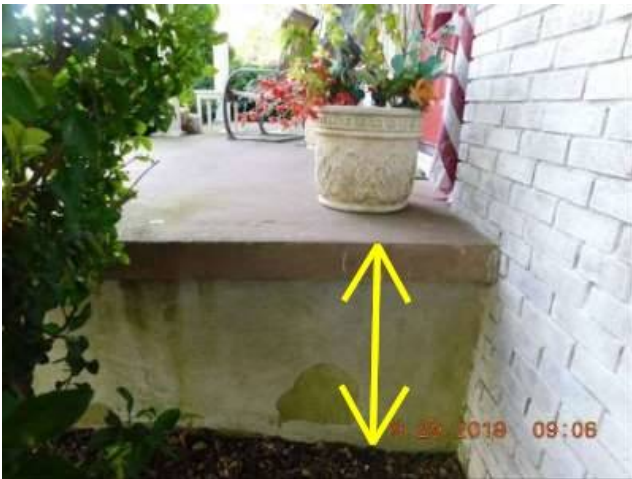
**Photo 7-1**

7) Material Defect/Safety, Repair/Replace - Guardrails at one or more locations with drop-offs higher than 30 inches were missing. This poses a fall hazard. Guardrails should be installed where walking surfaces are more than 30 inches above the surrounding grade or surfaces below. Recommend that a qualified contractor install guardrails where missing and per standard building practices.

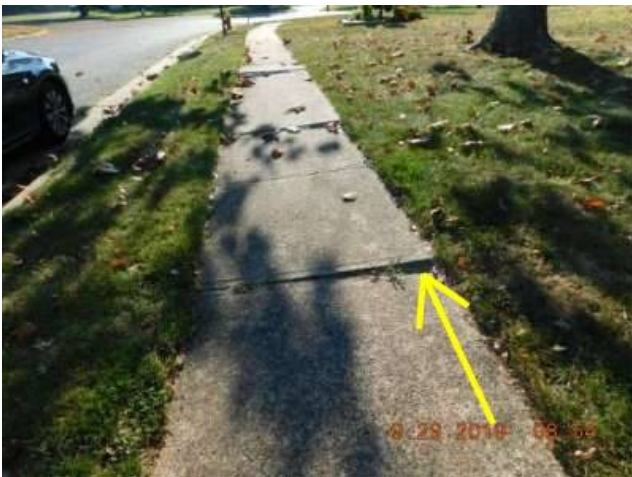
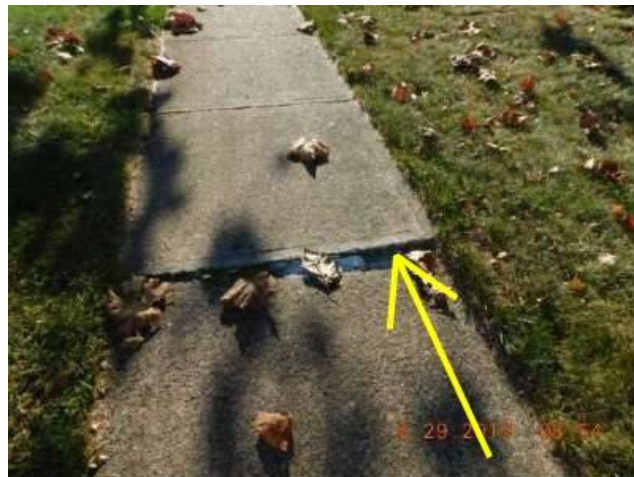
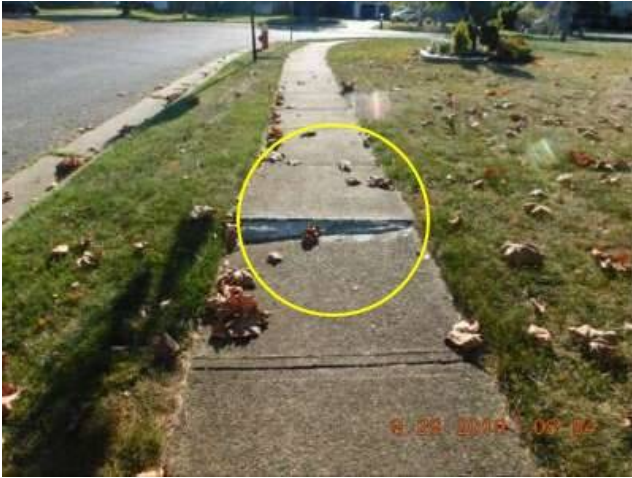
8) Material Defect/Safety, Repair/Maintain/Service - Cracks, holes, settlement, heaving and/or deterioration resulting in trip hazards were found in the sidewalks or patios. For safety reasons, recommend that a qualified contractor repair as necessary to eliminate trip hazards. Check with the local municipality to see if the homeowner is responsible for maintenance of the sidewalk at the curb in front of your house. If the homeowner is responsible and liable, Regal Home Inspections, LLC recommends that all sidewalk repairs be made prior to taking ownership of the house.

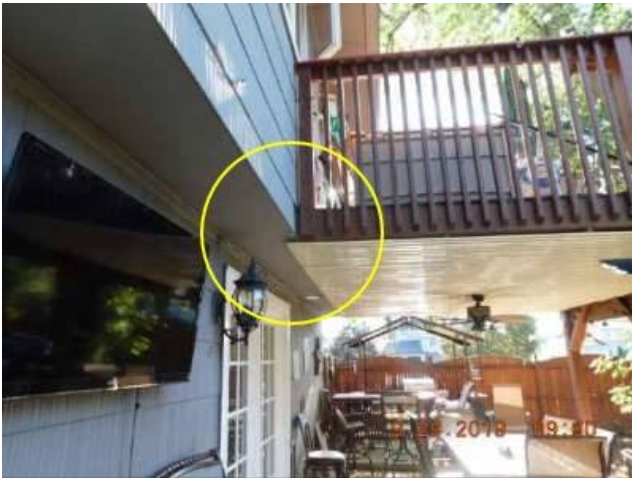
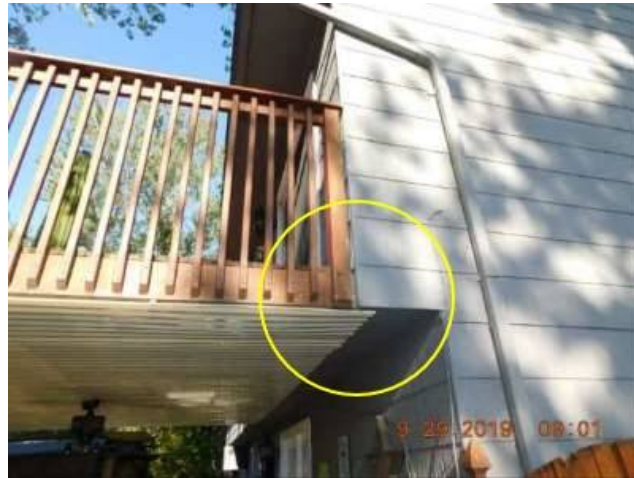
9) Material Defect/Major, Repair/Maintain/Service, Evaluate - The deck in the back is attached to the house at a point that is called a, "Cantilever". As described in the link below, decks should not be attached in this manner. It is often done however and is seen quite often in inspections. Current building practices do not allow this in many jurisdictions. Recommend that this be evaluated by a licensed, qualified contractor or structural engineer. Please refer to the link below for more information.

Structural engineering options include:[list]

- F. Dharmawan, PE, DW Smith Associates. Wall, NJ 732 962 2920
- Bill Longo, Lortech Construction Engineering, Freehold, NJ 732 863 1403

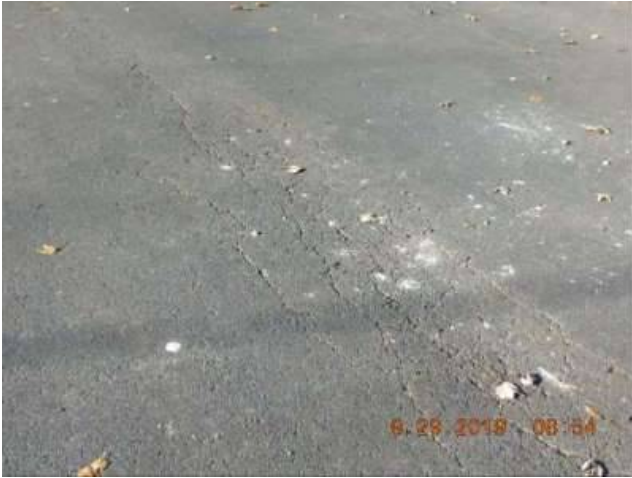
**Photo 10-1**

10) Comment/FYI - Minor deterioration (e.g. cracks, holes, settlement, heaving) was found in the driveway, but no trip hazards were found. The client may wish to have repairs made for cosmetic reasons.

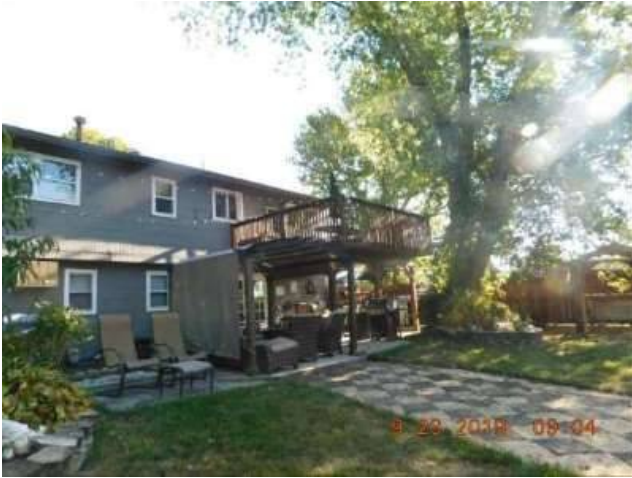
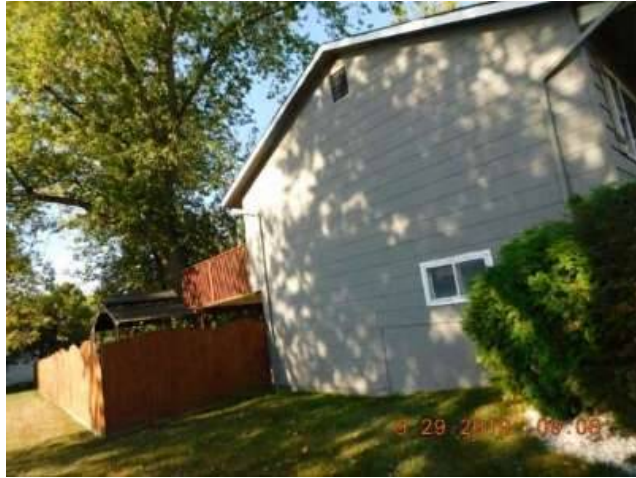
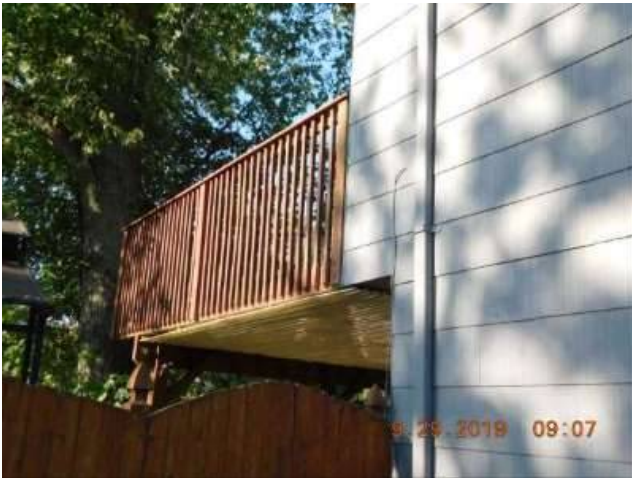
12) Maintain, Evaluate - Trees or branches were hanging over or were close to the building at one or more locations. Damage to the building can occur, especially during high winds, or may have already occurred (see other comments in this report). Recommend that a qualified tree service contractor or certified arborist remove trees as necessary to prevent damage to the building exterior. Please note that home insurance companies may have issues with trees too close to the house that can effect coverage and/or premiums. Consult (Evaluate) with your insurance company.

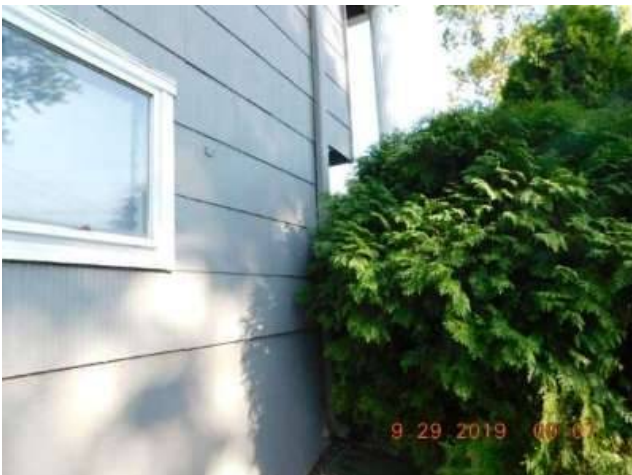
Photo 13-1

13) Maintain - Vegetation such as trees, shrubs and/or vines was in contact with or close to the building exterior. Vegetation can serve as a pathway for wood-destroying insects and can retain moisture against the exterior after it rains. This is a conducive condition for wood-destroying organisms. Recommend pruning, moving or removing vegetation as necessary to maintain at least 6 inches of space between it and the building exterior. A 1-foot clearance is better.

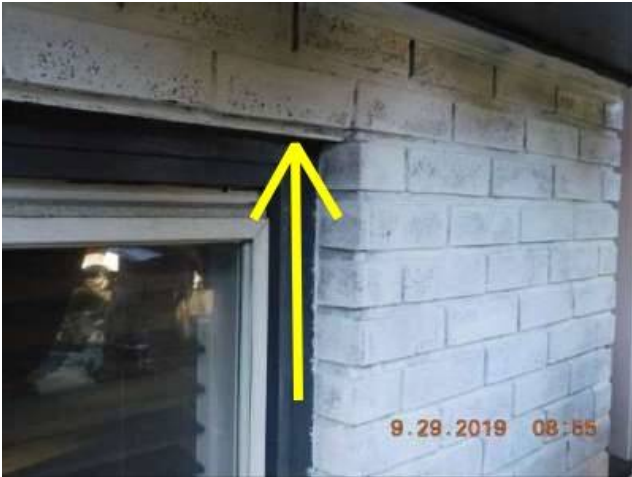
Photo 15-1

15) Comment/FYI - Lintels are structural elements that support the weight of the brick over openings like windows and doors. Lintels are made of iron and often rust. Lintels are also embedded approximately 6 inches past the openings on either side to anchor them structurally. Over time lintels will rust. The rust can increase the size of the lintel and often applies upward force to the bricks causing cracks. No cracks were seen here. Recommend maintaining the lintels by using a rust inhibiting paint and maintaining seals at the seams between the lintels and the brick.

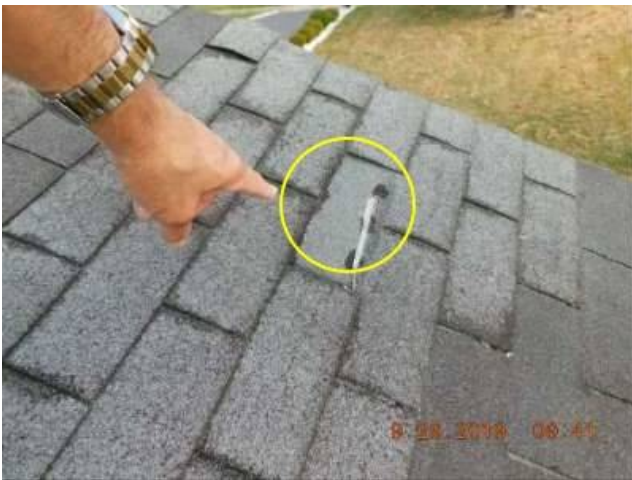
16) Material Defect/Major, Repair/Replace - Some composition shingles were broken or had substandard repairs. Leaks can occur as a result. This is a conducive condition for wood-destroying organisms. Recommend that a qualified contractor repair as necessary. For example, by replacing shingles.

This, combined with the apparent age of the roof, statements from the seller that they were told 3 years ago that the roof needed to be replaced and the nail pops and moss (see other items in this section) indicates that this is a material defect in accordance with the NJ home inspection standards of practice. Roof surface replacement (including repairs to the roof's plywood base, see Attic and Roof structure section) should be anticipated in the near future.

Photo 16-1 Broken shingle.

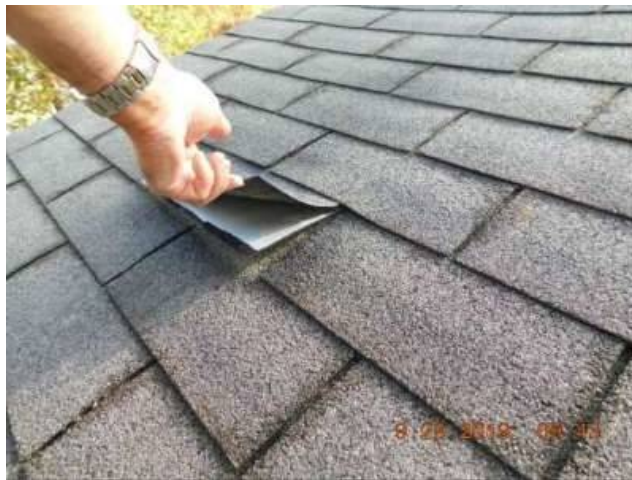
Photo 16-2 Substandard repair.

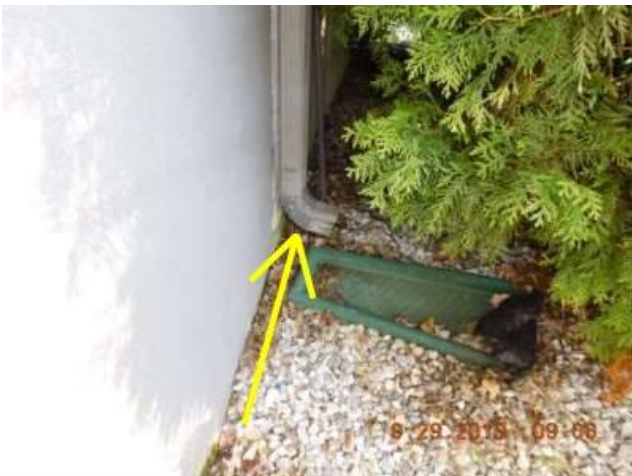
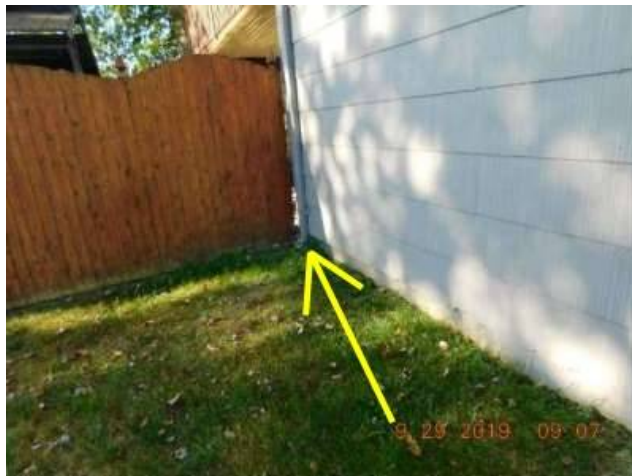
17) Repair/Replace - Extensions such as splash blocks or drain pipes for one or more downspouts were depositing water too close to the foundation. Water can accumulate around the building foundation or inside crawl spaces or basements as a result. Recommend that a qualified person install, replace or repair extensions as necessary so rainwater drains away from the structure.

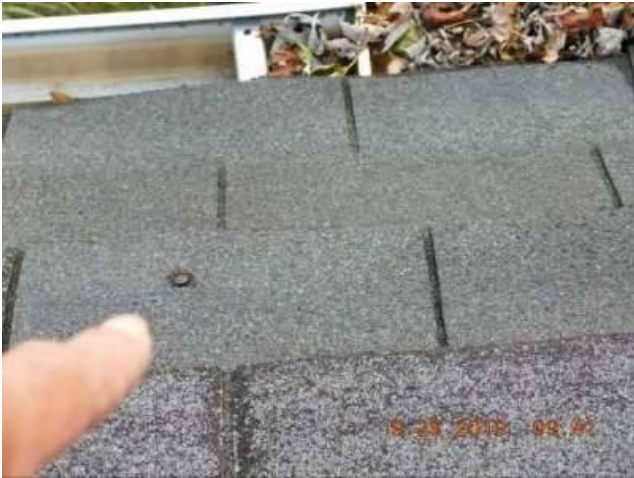
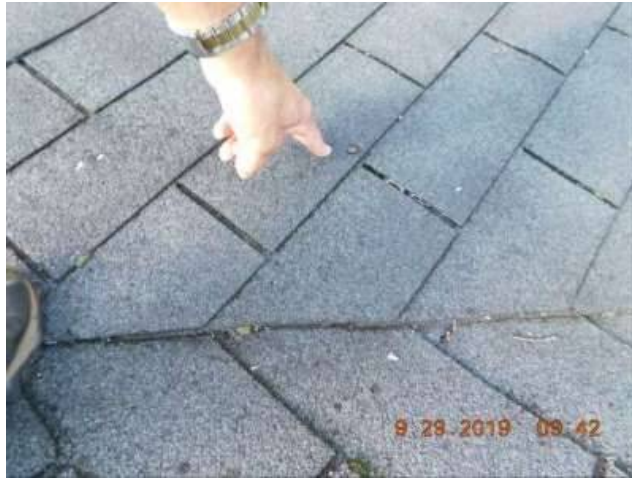
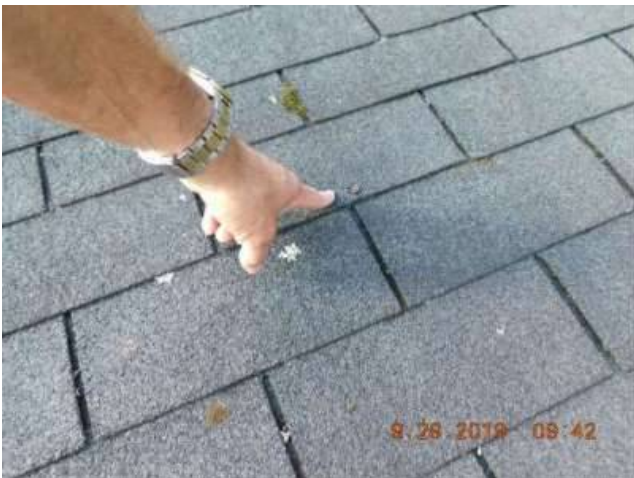
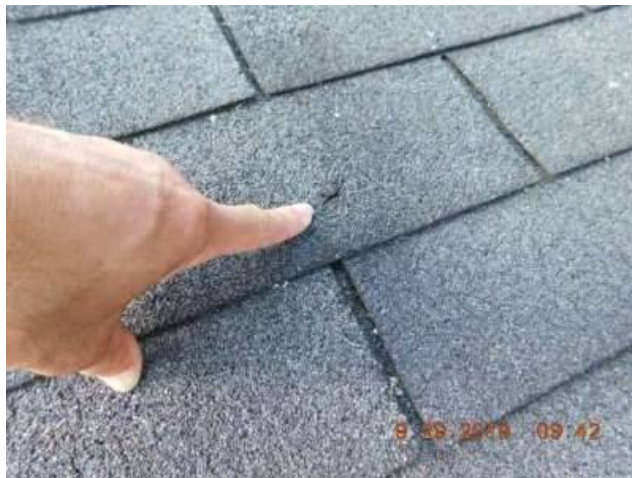
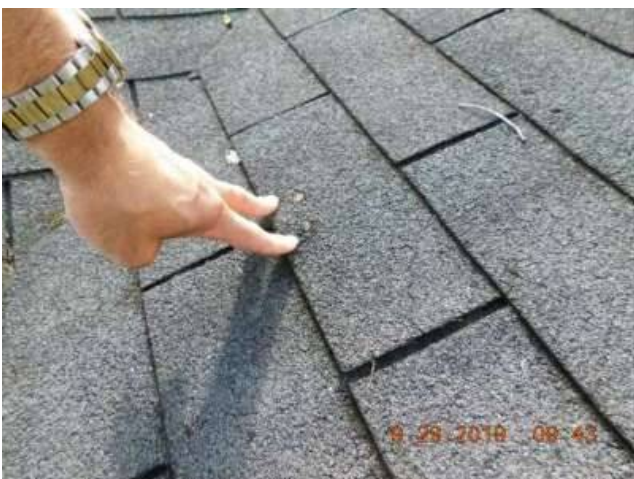
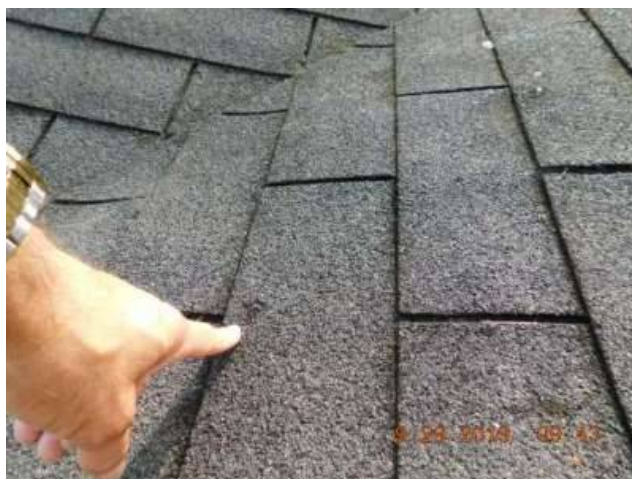
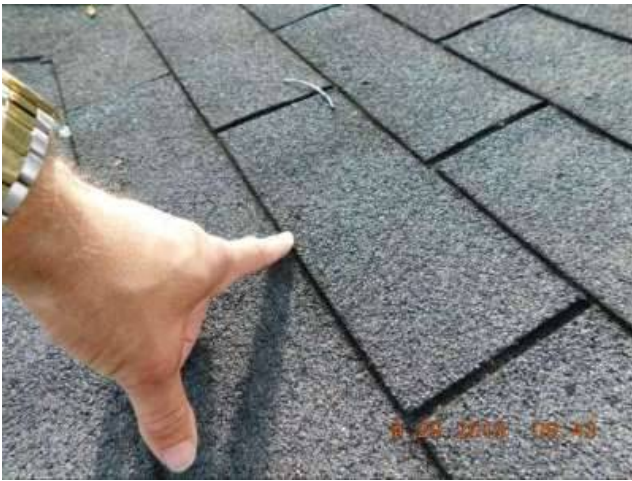
18) Repair/Maintain/Service - Nail heads were exposed at numerous shingles. More than just a few exposed nail heads may indicate a substandard roof installation or an aging roof. Recommend applying an approved sealant over exposed nail heads now and as necessary in the future to prevent leaks.

Photo 18-1 Some examples shown. Others exist.

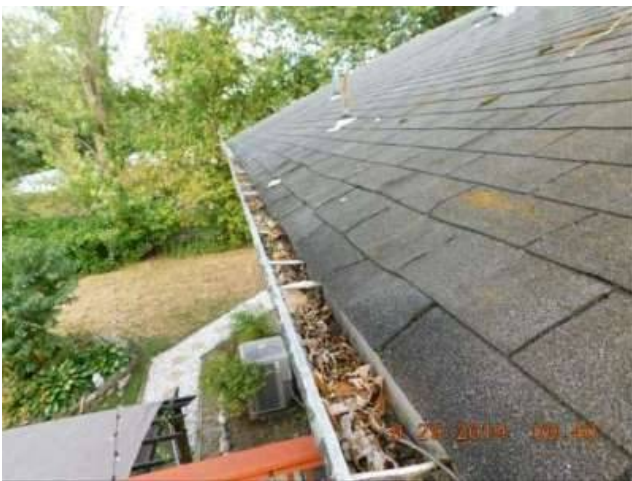
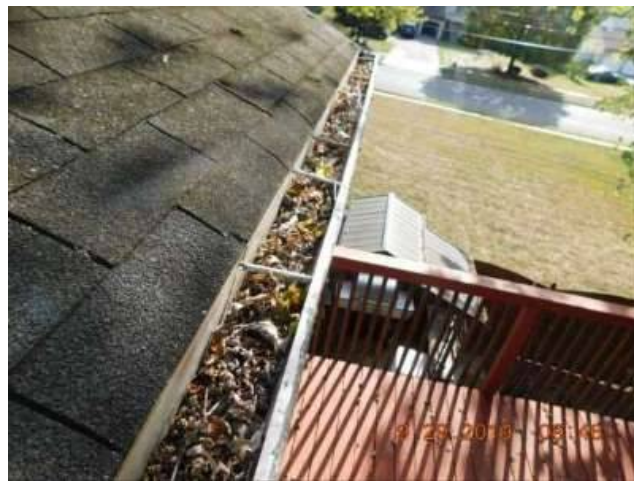
19) Maintain - Significant amounts of debris have accumulated in one or more gutters or downspouts. Gutters can overflow and cause water to come in contact with the building exterior, or water can accumulate around the foundation. This is a conducive condition for wood-destroying organisms. Recommend cleaning gutters and downspouts now and as necessary in the future.

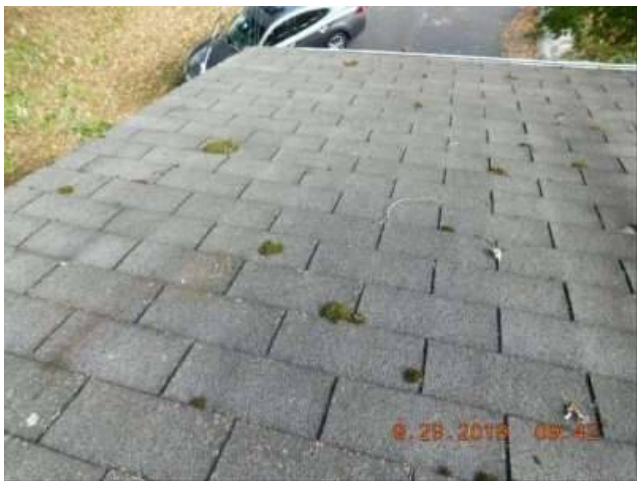
Photo 20-1

20) Maintain - Moss was growing on the roof. As a result, shingles can lift or be damaged. Leaks can result and/or the roof surface can fail prematurely. Efforts should be made to kill the moss during its growing season (wet months). Typically, zinc or phosphate-based chemicals are used for this and must be applied periodically.

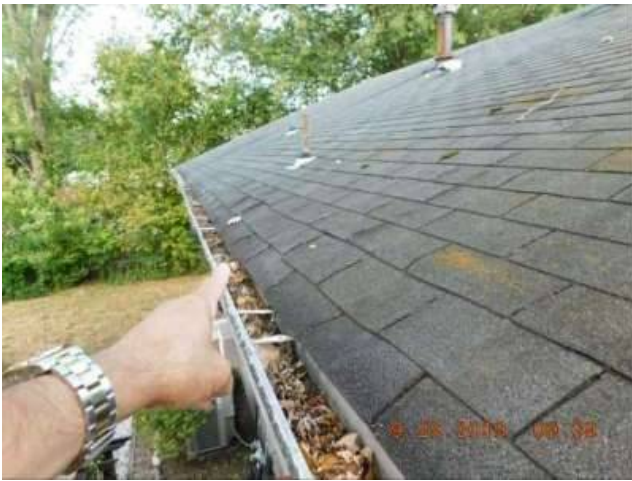
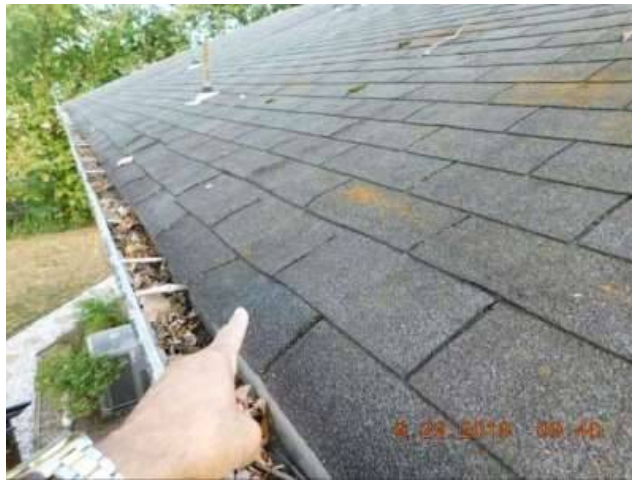
23) Repair/Replace, Evaluate - The roof decking was spongy, soft or springy in one or more areas when the inspector walked on those areas. This may be caused by deteriorated sheathing, damaged rafters or trusses, and/or otherwise substandard construction. Recommend that a qualified contractor evaluate and repair as necessary.

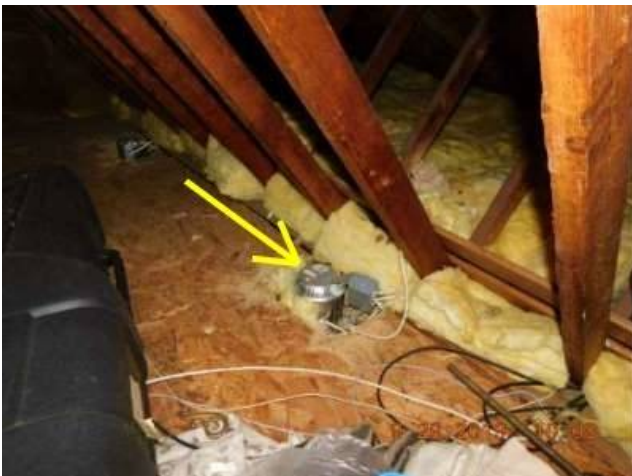
25) Repair/Maintain/Service, Evaluate - One or more recessed "can" lights were installed in the attic and there was no insulation around them. The inspector was unable to find a label or markings that indicated that these lights are designed to be in contact with insulation. If lights are not "IC" rated then putting insulation in contact may be a fire hazard. However, no insulation allows for warm moist 2nd floor air to rise into the attic. This A) Is energy inefficient and B) The rising, warm moist air will cause condensation in the attic in the cold of winter which, in turn, can cause mold. Recommend further evaluation by a qualified contractor to determine if these lights are rated for contact with insulation. If they aren't, or if their rating can't be determined, then recommend that a qualified person repair as necessary to prevent air from escaping into the attic. For example, by installing shields around lights and installing insulation over the shields.

**Photo 25-1** One shown. Others exist.

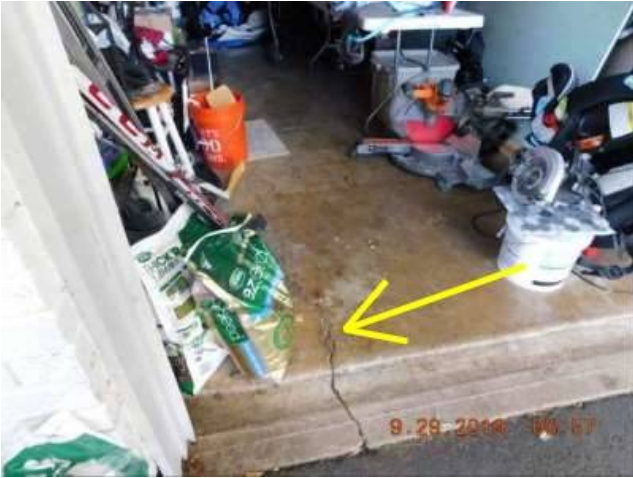
**Photo 27-1**

27) Comment/FYI - Minor cracks were found in the concrete slab floor. These are common and appeared to be only a cosmetic issue.

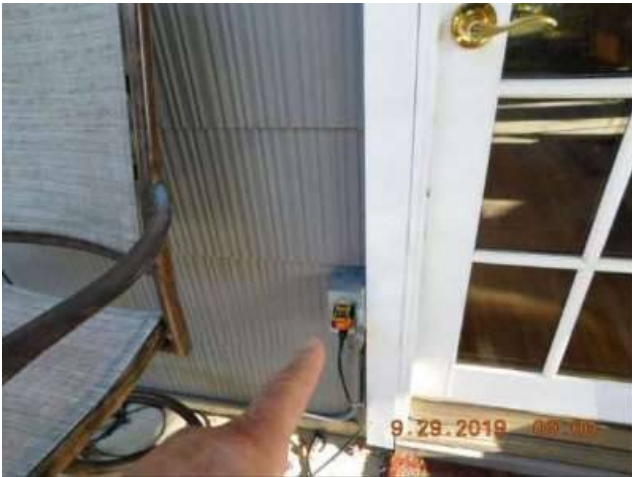
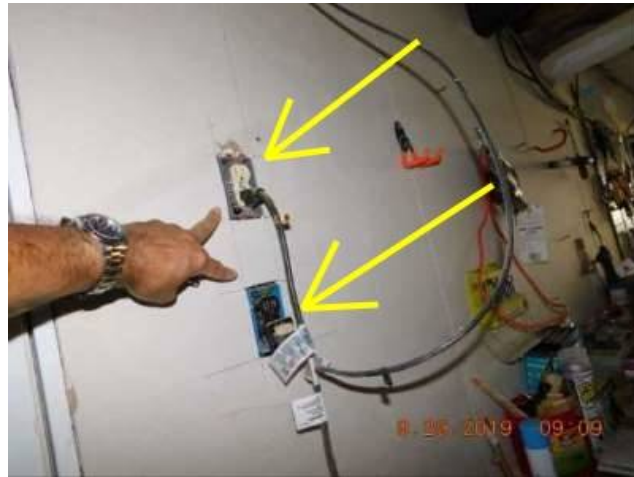
29) Material Defect/Safety, Repair/Replace, Evaluate - One or more electric receptacles (outlets) at the garage and exterior had no visible ground fault circuit interrupter (GFCI) protection. If not GFCI-protected, receptacles in wet areas pose a shock hazard. Recommend that a qualified electrician evaluate and install GFCI protection if necessary and per standard building practices. General guidelines for GFCI-protected receptacles include the following locations:

The age of the structure may predate all or portions of these requirements. The inspector recommends having a licensed electrician install GFCI protection as an upgrade to any circuits where there is a higher potential for electrical shock and GFCI protection does not currently exist. National electrical standards currently require that all outlets that serve the kitchen countertop surfaces be GFCI protected regardless of their proximity to a sink. Lack of GFCI protection where currently required is a safety issue for the occupant.

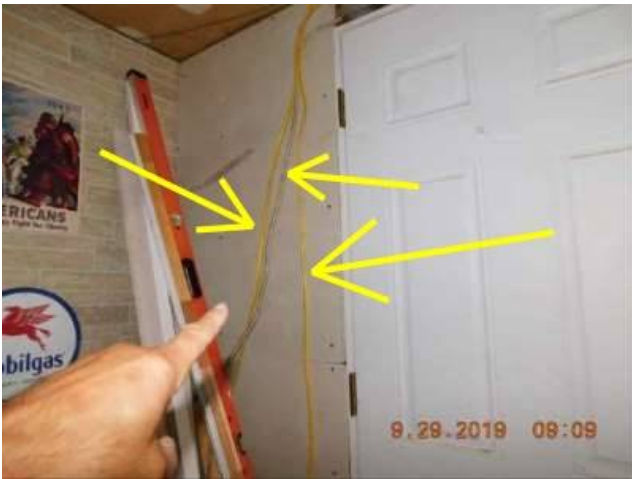
**Photo 30-1**

30) Material Defect/Safety, Repair/Replace - Non-metallic sheathed wiring was loose, unsupported, or inadequately supported at one or more locations. Such wiring should be trimmed to length if necessary and attached to runners or to solid backing with fasteners at intervals of 4 1/2 feet or less. Fasteners should be installed within 12 inches of all enclosures. Recommend that a qualified electrician repair per standard building practices.

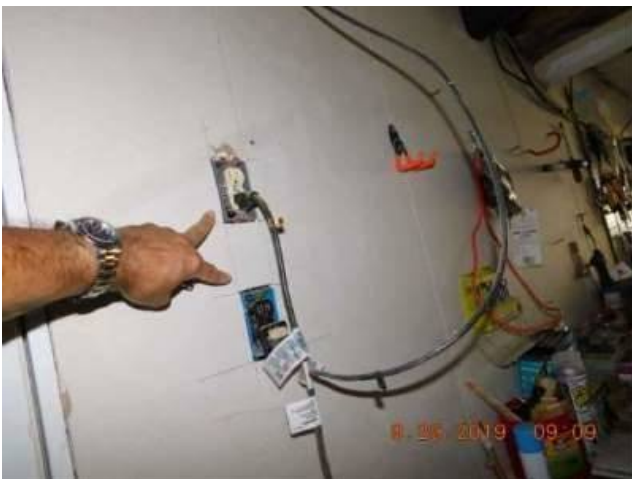
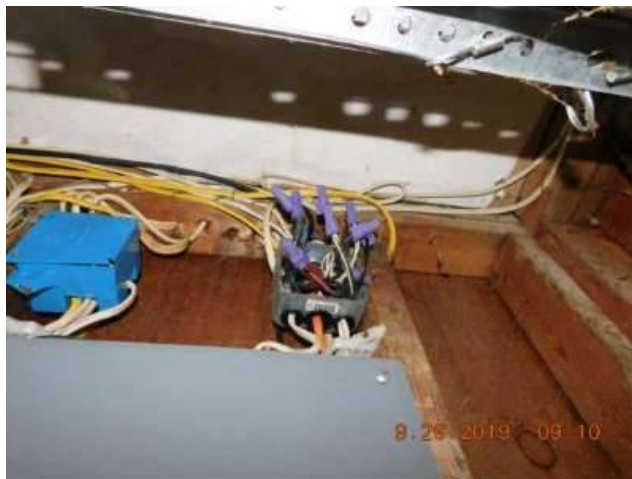
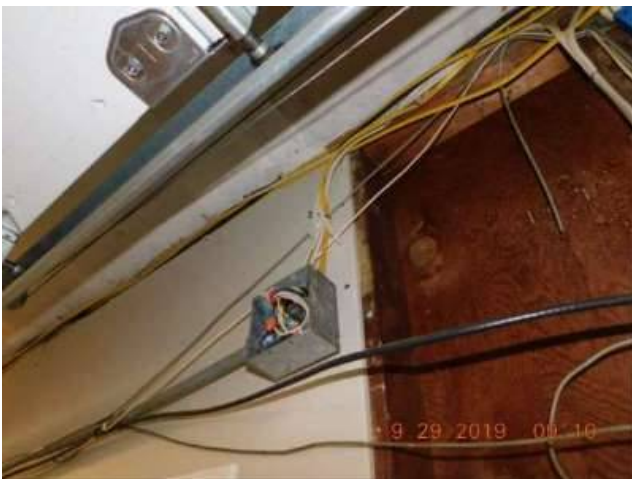
31) Material Defect/Safety, Repair/Maintain/Service - One or more cover plates for switches, receptacles (outlets) or junction boxes were missing or broken. These plates are intended to contain fire and prevent electric shock from occurring due to exposed wires. Recommend that a qualified person install cover plates where necessary.

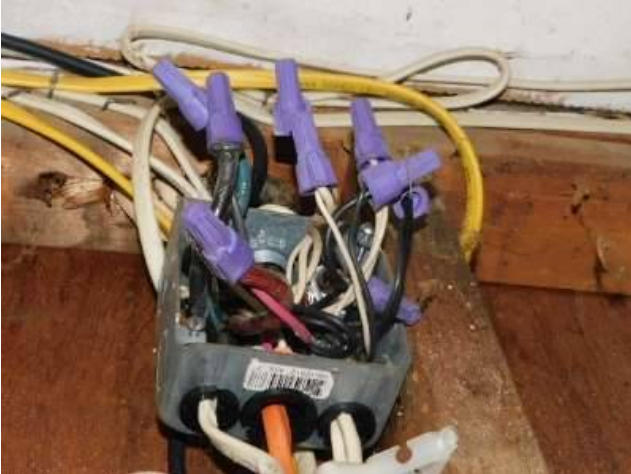
Photo 32-1

32) Material Defect/Safety, Evaluate - One or more branch circuits with solid-strand aluminum wires were found. Problems due to expansion and contraction with this type of wiring can cause overheating at connections between the wire and devices such as switches and receptacles (outlets), or at splices. The Consumer Products Safety Commission recommends pig-tailing onto the ends of the aluminum wire. This appears to have been done based on the purple wire nuts seen above the electrical panel. A qualified electrician should evaluate the full electrical system to ensure that both ends (We can only see one end) have been pigtailed. For more information on repairing aluminum wire please read the attached Consumer Product Safety Commission document.

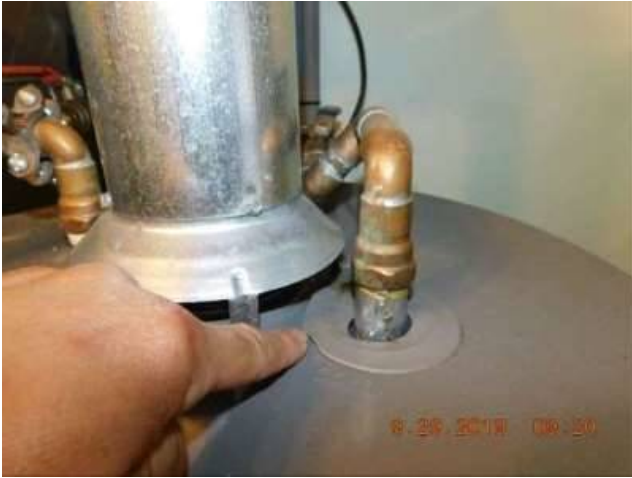
39) Material Defect/Safety, Repair/Replace, Evaluate - Exhaust gases were "back drafting" out of the water heater's draft hood. The flue pipe may be configured incorrectly, blocked or damaged. This finding is being made as a result of the melted plastic atop the water heater which indicates that some of the exhaust's hot air is escaping into the living space and not all, 100% going up the flue. This is a safety hazard due to the risk of exhaust gases entering living spaces. A qualified contractor should evaluate and repair as necessary.

Photo 39-1 This plastic ring is melted.

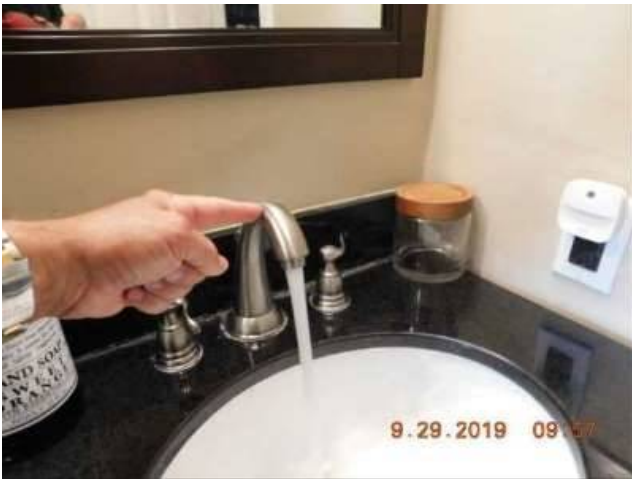
53) Repair/Replace - One or more spouts such as the sink spout at location B were loose. Recommend that a qualified person repair or replace as necessary.

Photo 53-1 Right sink.

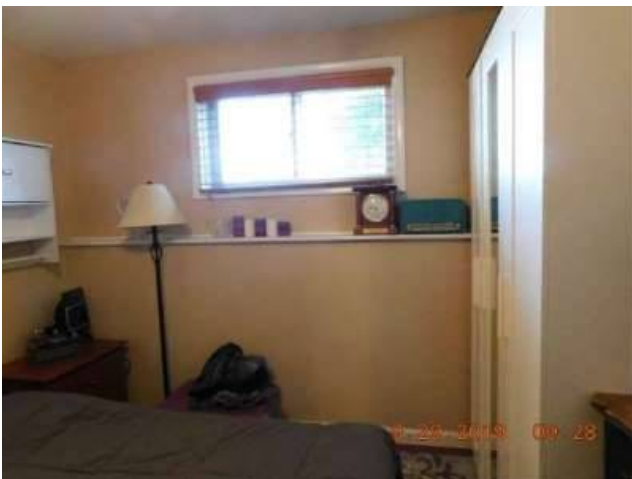
Photo 59-1

59) Material Defect/Safety, Repair/Replace - One or more bedrooms had windows that were too high off the floor. At least one window requires adequate egress in the event of a fire or emergency to allow escape or to allow access by emergency personnel. Such windows should have a maximum sill height of 44 inches off the floor. At a minimum, keep a chair or something that serves as a ladder below the window at all times. If concerned, have a qualified contractor repair or make modifications per standard building practices.

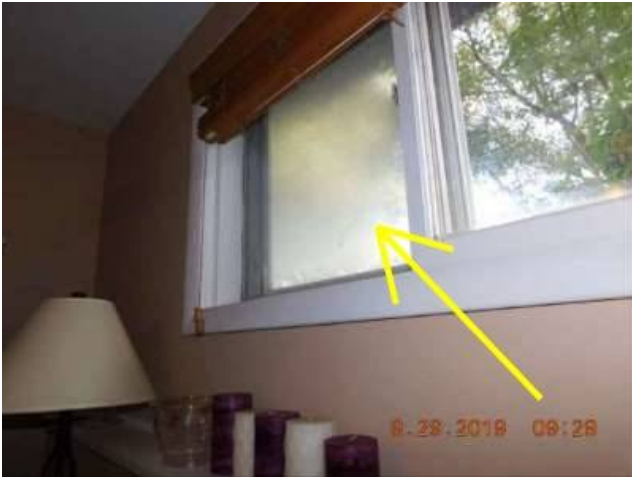
Photo 60-1

60) Repair/Replace, Evaluate - Condensation or staining was visible between multi-pane glass in one or more windows. This usually indicates that the seal between the panes of glass has failed or that the desiccant material that absorbs moisture is saturated. As a result, the view through the window may be obscured, the
