## Regal Home Inspections, LLC

## Property Inspection Report

Property address: **Main St  
Anytown USA**

Inspection date: **Saturday, February 27, 2021**

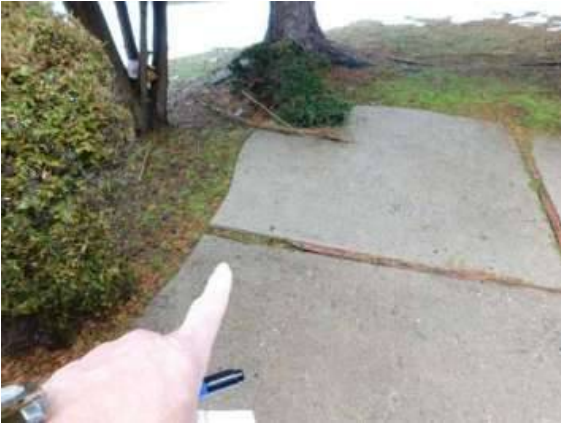
**Photo 6-1**

**6) Material Defect/Safety, Repair/Maintain/Service** - Cracks, holes, settlement, heaving and/or deterioration resulting in trip hazards were found in the sidewalks or patios. For safety reasons, recommend that a qualified contractor repair as necessary to eliminate trip hazards. Regal Home Inspections, LLC recommends that all sidewalk repairs be made prior to taking ownership of the house.

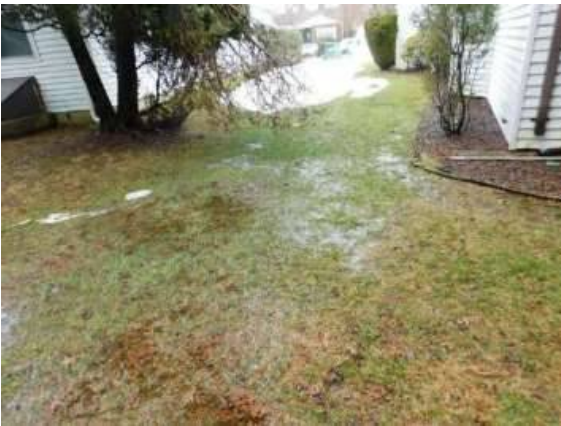
**Photo 7-1**

**7) Repair/Maintain/Service, Monitor** - Significant amounts of standing water or evidence of past accumulated water were found at one or more locations in the yard or landscaped areas, and no drain was visible. If evidence of past water was found (e.g. silt accumulation or staining), monitor these areas in the future during periods of heavy rain. If standing water exists, recommend that a qualified person repair as necessary. For example, installing one or more drains, or grading soil.

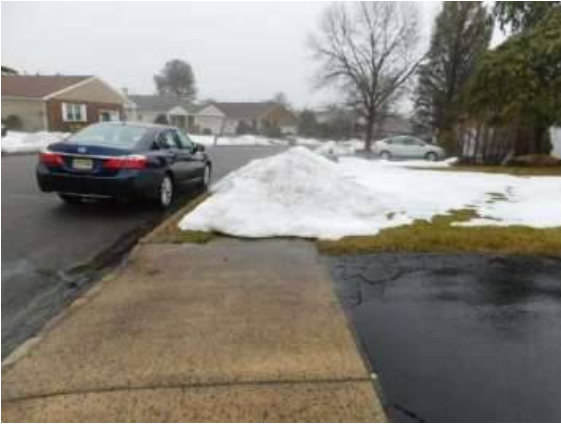
Photo 9-1

**9) Exclusion** - Areas of the sidewalk in front of the house were still snow covered. Please note that once the snow has melted, it's very possible that material defects like trip hazards or other damage may only then become apparent. Areas that are snow covered are excluded from this home inspection.

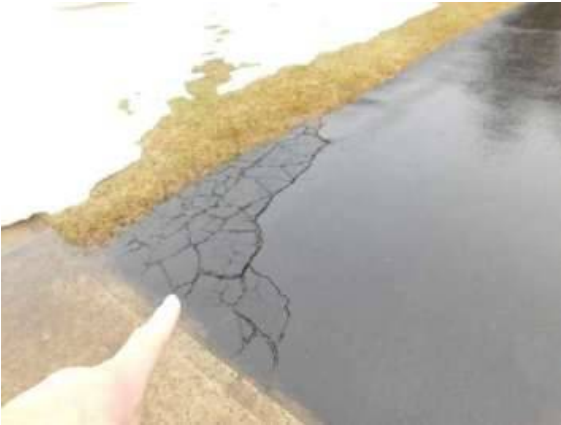
Photo 10-1

**10) Comment/FYI** - Minor deterioration (e.g. cracks, holes, settlement, heaving) was found in the driveway, but no trip hazards were found. The client may wish to have repairs made for cosmetic reasons.

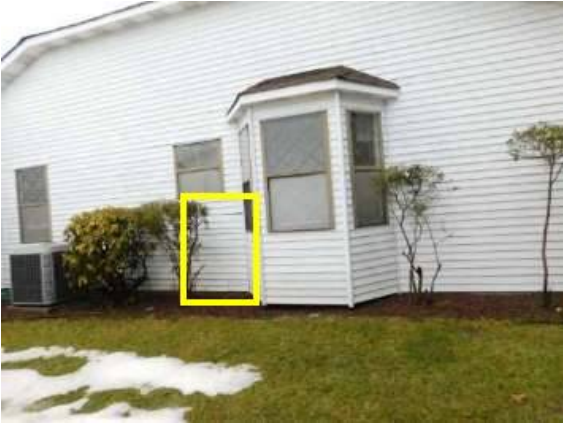
**11) Material Defect/Major, Replace** - Some sections of siding and/or trim were substandard, and allowing the wood sheathing below to be exposed. Exposed wood will deteriorate over time and in this case, could cause

**Photo 11-1** Close up of this area in the next photos.

damage to the wall, insulation and/or etc.. Recommend that a qualified person repair, replace or install siding or trim as necessary.

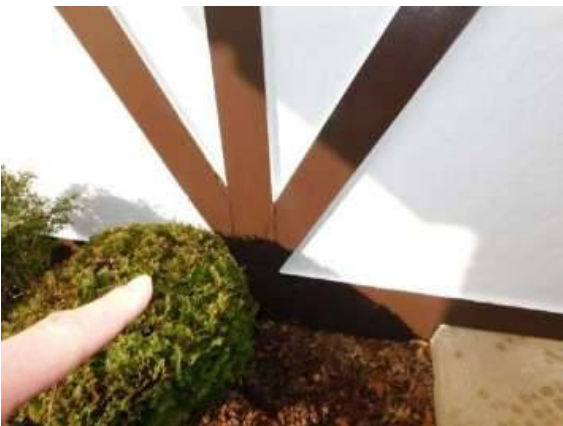
**Photo 12-1**

**12) Replace** - Fungal rot was found at one or more sections of siding or trim. Conductive conditions for rot should be corrected (e.g. wood-soil contact, reverse perimeter slope). Recommend that a qualified person repair as necessary. All rotten wood should be replaced.

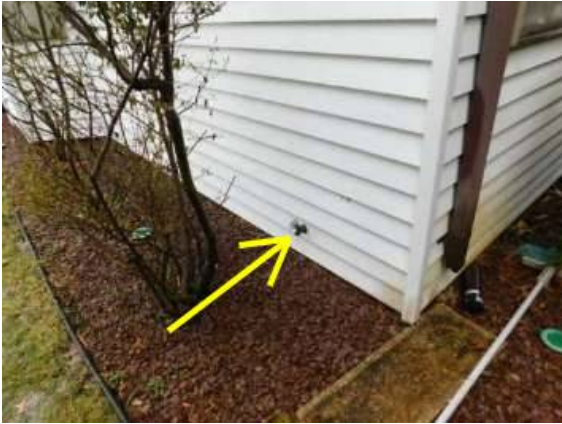
**Photo 13-1**

**13) Repair/Maintain/Service** - Soil was in contact with or less than 6 inches from siding or trim in numerous areas. Regardless of what material is used for siding, it should not be in contact with the soil. If made of wood, siding or trim will eventually rot. For other materials, ground or surface water can infiltrate siding or trim and

cause damage to the wall structure. Wood-destroying insects are likely to infest and damage the wall structure. This is a conducive condition for wood-destroying organisms. Recommend grading or removing soil as necessary to maintain a 6-inch clearance. Note that damage from fungal rot and/or insects may be found when soil is removed, and repairs may be necessary.

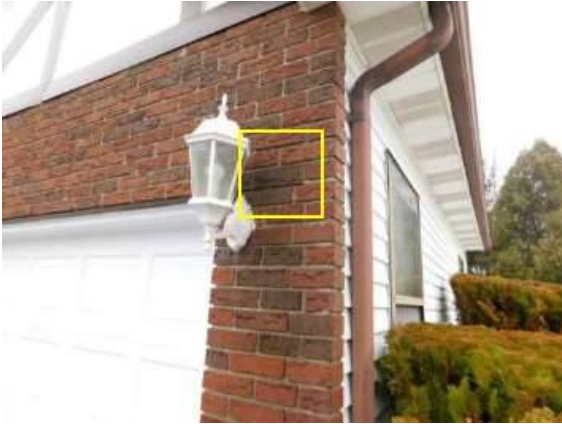
**15) Maintain, Comment/FYI** - Lintels are structural elements that support the weight of the brick over openings like windows and doors. Lintels are made of iron and often rust. Lintels are also embedded approximately 6

inches past the openings on either side to anchor them structurally. Over time lintels will rust. The rust can increase the size of the lintel and often applies upward force to the bricks causing cracks. No cracks seen here but exposed steel lintels were seen and gaps between the lintel and the brick above (Particularly over the garage door) where water can penetrate. Recommend maintaining the lintels by using a rust inhibiting paint and maintaining seals at the seams between the lintels and the brick.

**Photo 15-1** Close up of this area in the next photo.

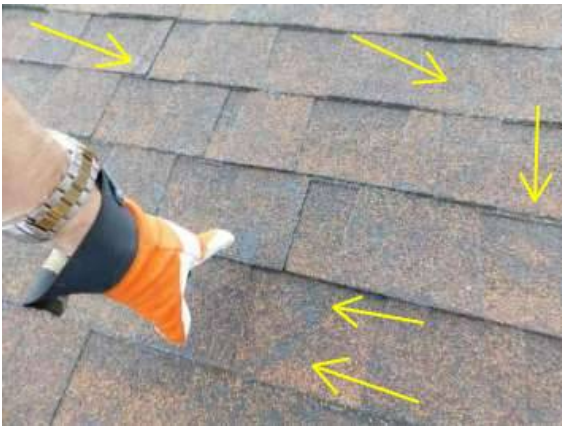
**16) Material Defect/Major, Replace** - Many composition shingles were worn with missing gravel. Leaks can occur as a result. This is a conducive condition for wood-destroying organisms. Recommend that a qualified contractor repair as necessary. For example, by replacing shingles.

This contributes to the conclusion that the roof surface is past its service life.

**Photo 16-1** As with many of these photos, one area is pointed to but there are other areas missing gravel in the same photo.

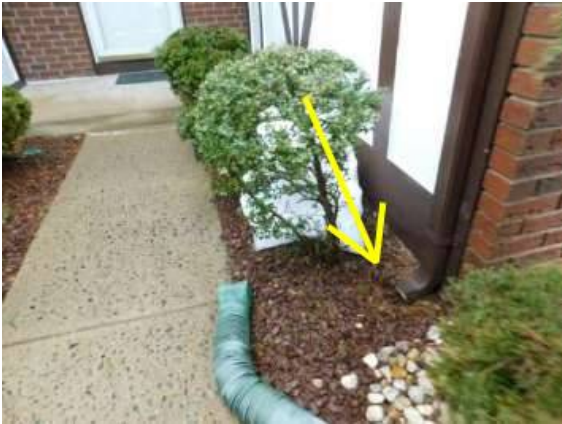
**Photo 17-1**

**17) Replace** - Extensions such as splash blocks or drain pipes for one or more downspouts were depositing water too close to the foundation. Water can accumulate around the building foundation or inside crawl spaces or basements as a result. Recommend that a qualified person install, replace or repair extensions as necessary so rainwater drains away from the structure.

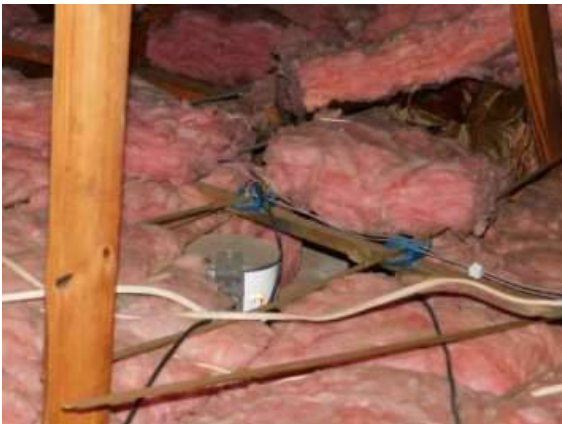
**Photo 21-1**

**21) Repair/Maintain/Service, Evaluate** - One or more recessed "can" lights were installed in the attic and there was no insulation around them. The inspector was unable to find a label or markings that indicated that these lights are designed to be in contact with insulation. If lights are not "IC" rated then putting insulation in contact may be a fire hazard. However, no insulation allows for warm moist 2nd floor air to rise into the attic. This A) Is energy inefficient and B) The rising, warm moist air will cause condensation in the attic in the cold of winter which, in turn, can cause mold. Recommend further evaluation by a qualified contractor to determine if these lights are rated for contact with insulation. If they aren't, or if their rating can't be determined, then recommend that a qualified person repair as necessary to prevent air from escaping into the attic. For example, by installing shields around lights and installing insulation over the shields.

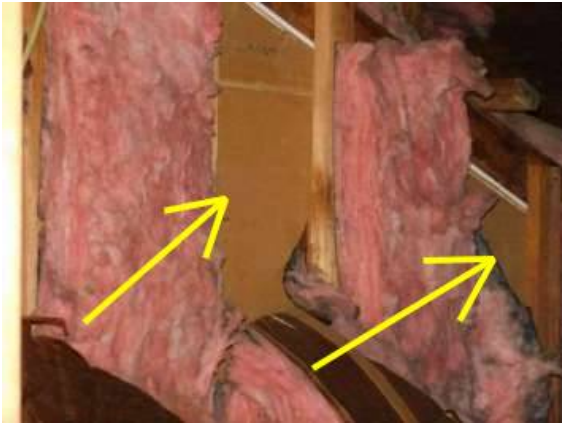
Photo 23-1

**23) Repair/Maintain/Service** - Attic insulation at one or more skylight chases or attic walls . Heating and cooling costs will likely be higher due to reduced energy efficiency. Recommend that a qualified person repair, replace or install insulation as necessary and per standard building practices.

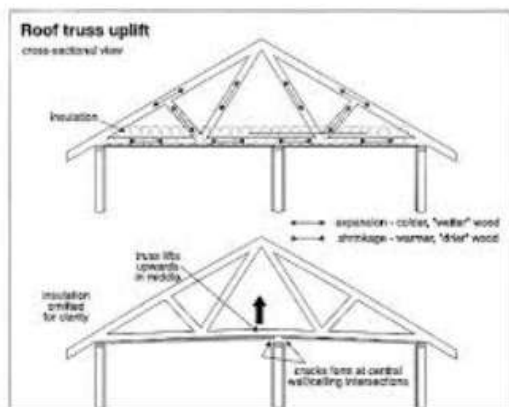
Photo 25-1

**25) Monitor** - The roof structure of this home has trusses. There is a phenomenon called truss uplift. It's explained at the link below. In essence, due to the fact that the bottom parts of the truss are embedded in insulation, in the winter, the upper parts of the trusses expand or contract differently than the truss cords embedded in the insulation. Consequently, the trusses flex. This can result in the appearance of cracks in ceilings or walls at specific times of the year due to the temperature differences between the parts of the trusses.

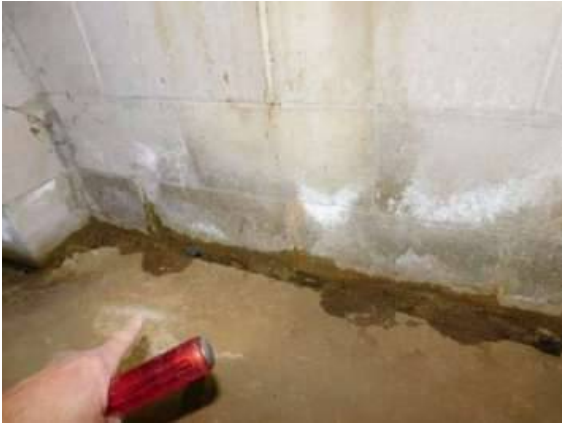
**Photo 26-1**

**26) Material Defect/Major, Repair/Maintain/Service, Evaluate** - High levels of moisture were found at one or more locations in the crawl space. Water from crawl spaces can evaporate and enter the structure above causing high levels of moisture in the structure. This is a conducive condition for wood-destroying organisms. While a minor amount of seasonal water is commonly found in crawl spaces, significant amounts should not be present.

See the Roof section and Grounds section for possible contributing factors. Namely, downspouts depositing water too close to the house and standing water in the side yard (Right side facing from the front).

Rain runoff is the most common cause of wet crawl spaces, but water can come from other sources such as groundwater or underground springs. Recommend that a qualified person correct any issues related to outside perimeter grading and/or roof drainage (see any other comments about this in this report). If standing water persists, then recommend that a qualified contractor who specializes in drainage issues evaluate and repair as necessary. Typically such repairs include:

- Repairing, installing or improving underground footing and/or curtain drains
- Applying waterproof coatings to foundation walls
- Digging trenches in the crawl space to collect or divert water
- Installing sump pumps

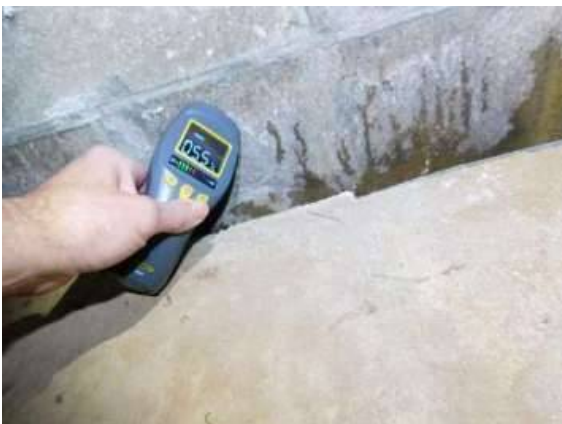
**Photo 26-5** The moisture meter confirms and quantifies the high levels of moisture seen.

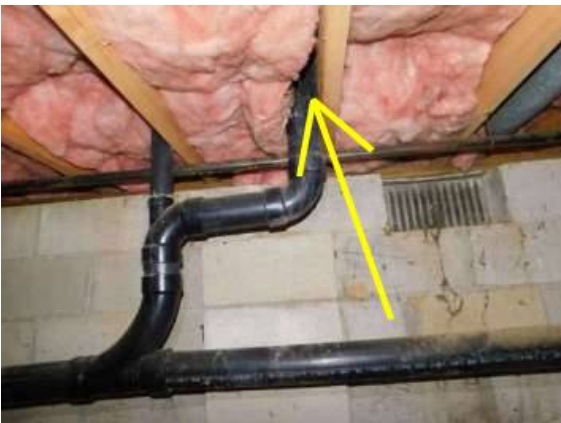
**27) Replace, Evaluate** - Fungal rot was found at one or more sections of floor sheathing. Recommend that a qualified contractor evaluate and repair as necessary. All rotten wood should be replaced.

This is below the Master bathroom's toilet which, as noted in the Bathroom section, is very loose.

**Photo 27-1** Close up of this area in the next photo.

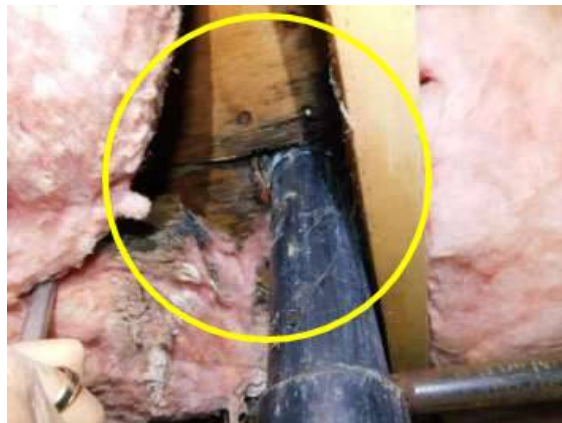
**Photo 27-2** This is below the loose toilet in the Master bath.

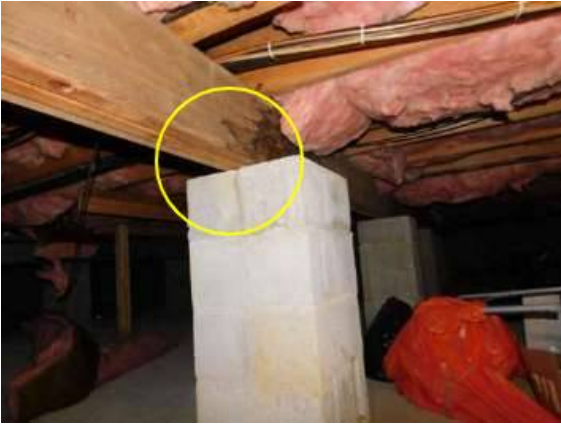
Photo 28-1

**28) Replace** - One or more support posts were not positively secured to the beam above. While this is common in older homes, current standards require positive connections between support posts and beams above for earthquake reinforcement. Recommend that a qualified contractor repair per standard building practices. For example, by installing metal plates, plywood gussets or dimensional lumber connecting posts and beams.

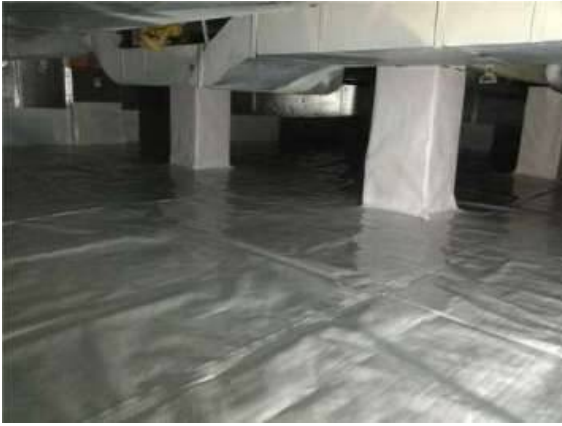
**Photo 30-1** This is an example of a crawl space after a full water proofing. It remains cleaner, dryer and a more stable environment (Temperature, humidity, etc.) than exists now.

Please note that [www.quality1stbasementsystems.com](http://www.quality1stbasementsystems.com) will recommend adding a sump pump and active dehumidification to keep the crawl space dry. They may also recommend sealing the vents and insulating the foundation walls instead of venting to control moisture.

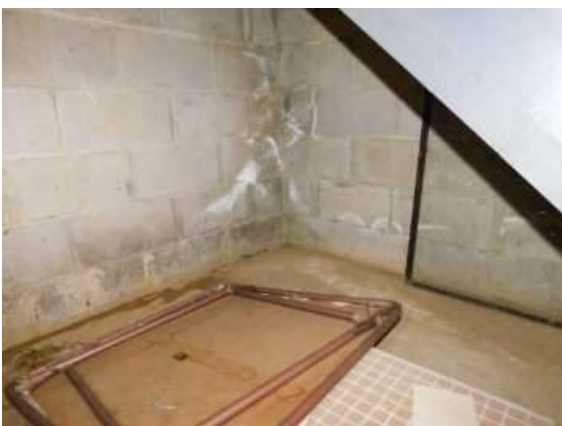
**Photo 31-1** The white, powdery substance on the foundation walls (and sometimes floor) is efflorescence. Calcium, minerals and salt that gets pulled out of the masonry materials as the moisture moves through it.

Recommend ensuring that the grading slopes water away from the house. Internal foundation wall sealants do not stop efflorescence. In fact the minerals will continue to accumulate below any finished coatings. Controlling the water outside is the best solution.

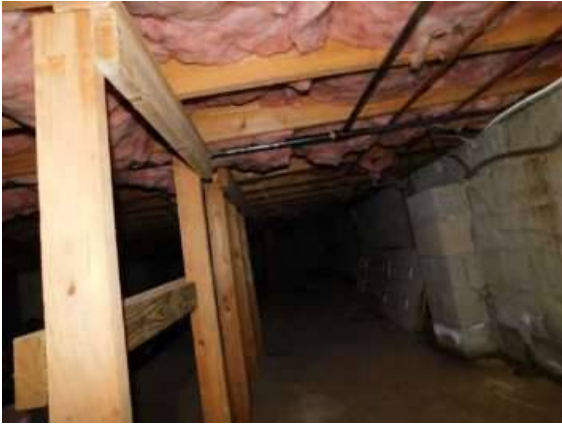
Photo 32-1

**32) Evaluate** - Supplemental floor support was seen. Wood base plates, wood studs and a wood plate above supporting the beams. Recommend that this be evaluated by a qualified contractor such as the crawl space company identified in this section.

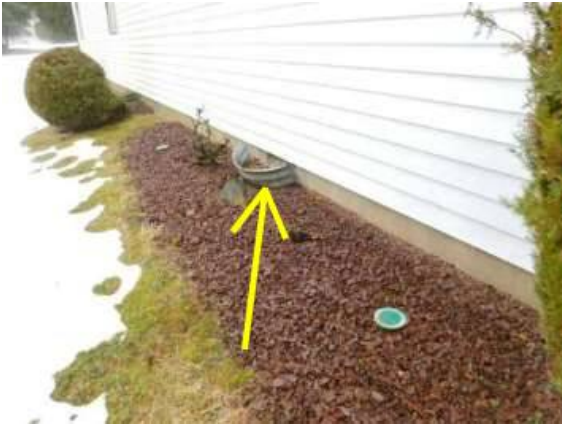
Photo 33-1

**33) Comment/FYI** - One or more crawl space vents were intentionally blocked (e.g. removable panels, rigid foam). This restricts ventilation in the crawl space and can result in increased levels of moisture inside. This is a conducive condition for wood-destroying organisms. Such vents should be left open at all times except during severe freezing weather. Recommend removing materials or items blocking vents as necessary.

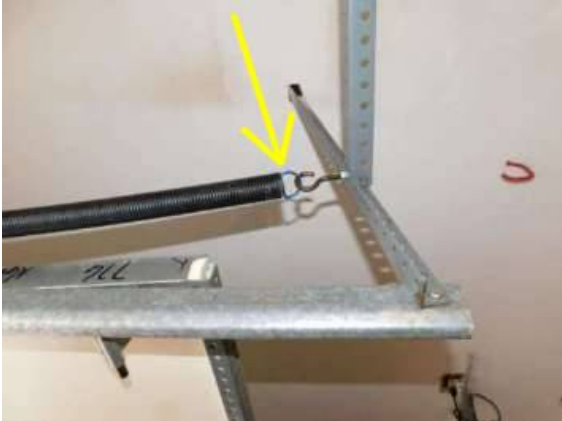
The door on the left side facing out had the containment cables.

**Photo 35-1** No containment cable seen.

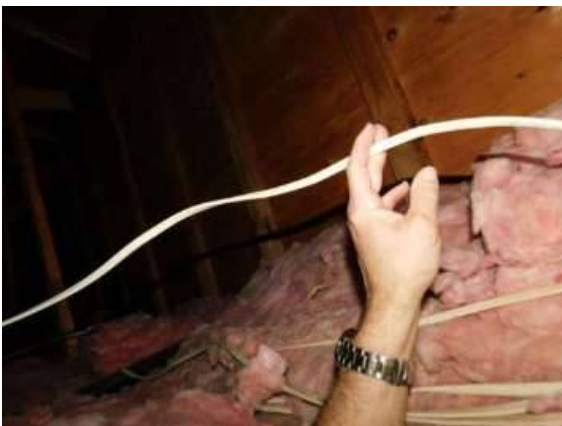
Photo 36-1

**36) Material Defect/Safety, Replace, Evaluate** - Substandard wiring was found at the attic. For example, loose wiring. This is a safety hazard. Recommend that a qualified electrician evaluate and repair as necessary and per standard building practices.

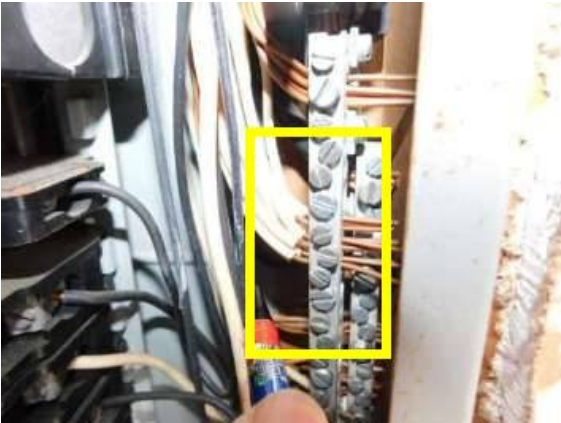
**Photo 37-1**

**37) Material Defect/Safety, Replace** - Neutral wires were doubled or bundled together under the same lug on the neutral bus bar in panel(s) A. This is a potential safety hazard in the event that one of the circuits needs to be isolated during servicing. For one neutral to be disconnected, other neutrals from energized circuits sharing the same lug will be loosened. Power surges may result on the energized circuits and result in damage or fire. Also, multiple wires under the same lug may not be secure, resulting in loose wires, arcing, sparks and fire. Recommend that a qualified electrician repair per standard building practices.

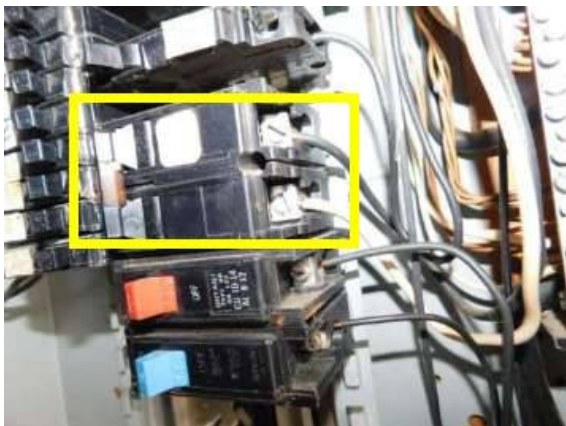
There is a 10gauge wire in a 40amp circuit breaker.

**Photo 38-1** Close up of this area in the next photo.

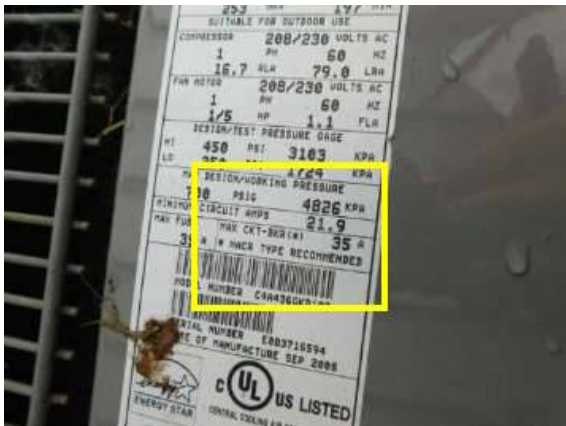
**39) Material Defect/Safety, Replace** - The AC unit's data plates indicate the minimum and maximum circuit breaker size, measured in amperes (amps) that the units should be wired to. The AC unit's data plate indicates a maximum 35amps for the AC. The circuit breaker in panel A is 40amps. It is the wrong size for the appliance it is serving. A licensed electrician should evaluate and repair so that the correct size breaker is used for the AC. The current condition is a fire hazard.

**Photo 39-1** Close up of this area in the next photo.

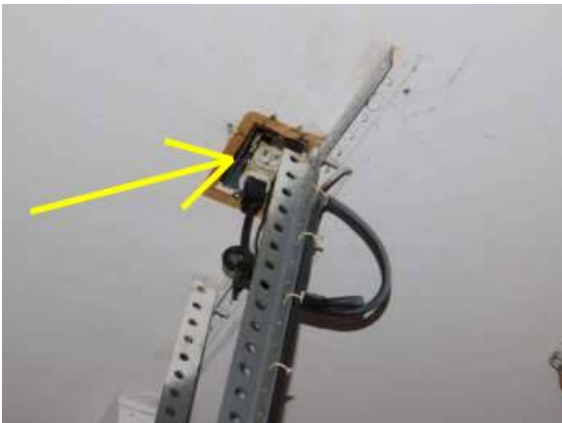
**Photo 40-1**

**40) Material Defect/Safety, Repair/Maintain/Service** - One or more cover plates for switches, receptacles (outlets) or junction boxes were missing or broken. These plates are intended to contain fire and prevent electric shock from occurring due to exposed wires. Recommend that a qualified person install cover plates where necessary.

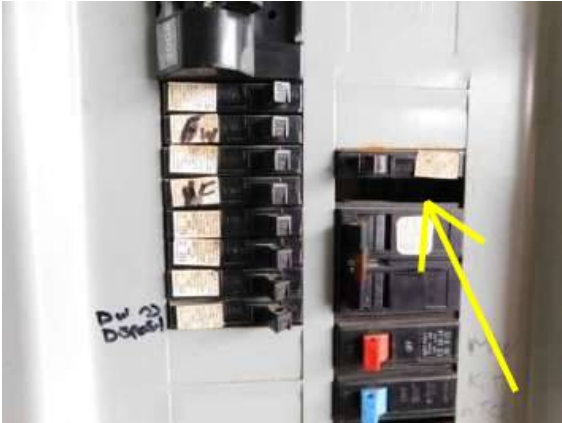
**Photo 41-1**

installed were open in panel(s) A. Energized equipment was exposed and is a shock hazard. Recommend that a qualified person install closure covers where missing.

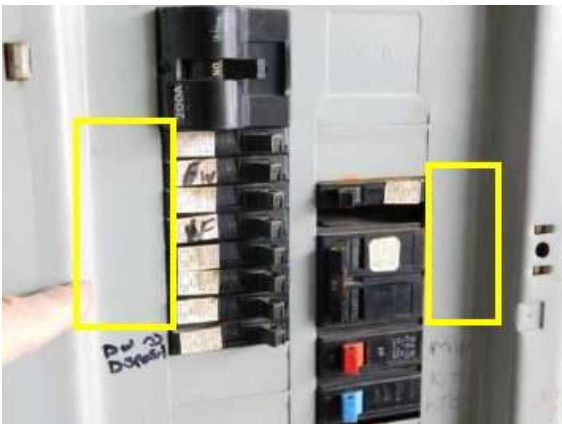
**Photo 42-1**

**42) Repair/Maintain/Service, Evaluate** - The legend for circuit breakers in panel(s) A was incomplete. This is a potential shock or fire hazard in the event of an emergency when power needs to be turned off. Recommend correcting the legend so it's accurate, complete and legible. Evaluation by a qualified electrician may be necessary.

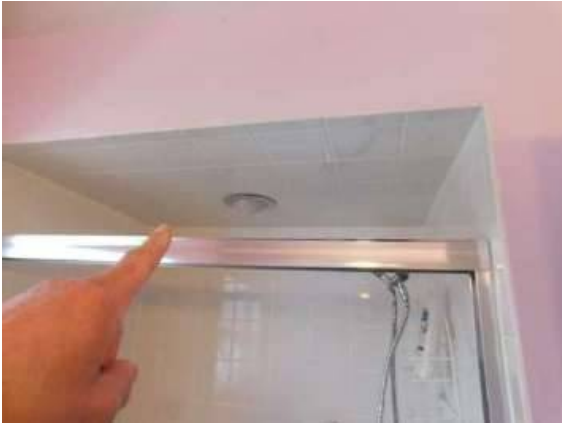
Photo 44-1

**44) Evaluate** - One or more light fixtures were inoperable (didn't turn on when nearby switches were operated or switches were not located). Recommend further evaluation by replacing bulbs and/or consulting with the property owner. If replacing bulbs doesn't work and/or no other switch(es) can be found, then recommend that a qualified electrician evaluate and repair or replace light fixtures as necessary.

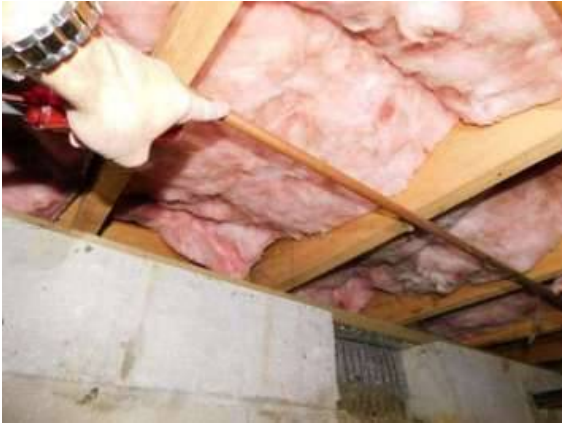
**Photo 46-1**

A few examples are shown.

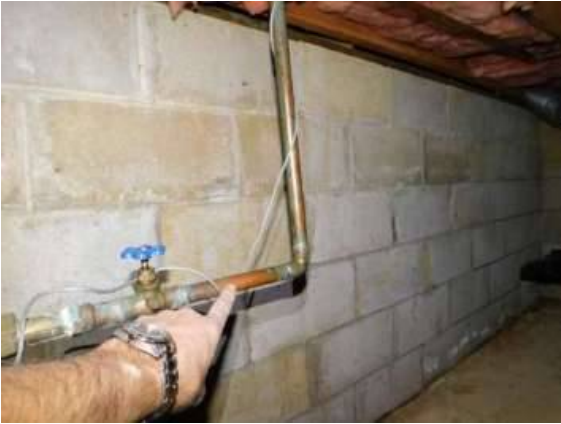
**Photo 47-1**

**47) Repair/Maintain/Service** - One or more copper water supply pipes had substandard support or were loose. Leaks can occur as a result. Copper supply pipes should have approved hangers every 6-8 feet. If hangers are in contact with the copper pipe, they should be made of a material that doesn't cause the pipes or hangers to corrode due to contact of dissimilar metals. Recommend that a qualified person install hangers or secure pipes per standard building practices.

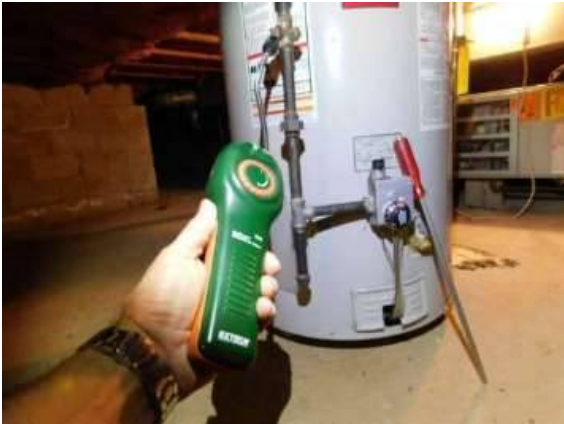
Photo 50-1

Green meter with orange dial can be seen in the photos. The probe extends to the gas piping for testing for leaks. None were detected. Few examples shown below.

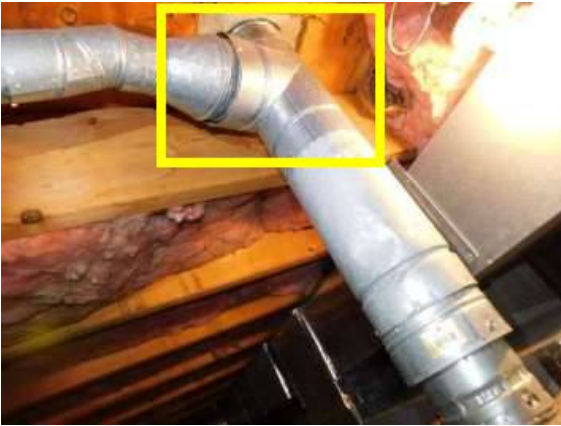
**Photo 53-1**

**53) Material Defect/Safety, Replace** - The water heater's vent (metal flue exhaust) joins into the larger flue of the furnace using a 90 degree (T) connection. The connection should be a 45degree (Y) connection pointing in the flow of the rising gasses. Turbulence is caused when the water heater exhaust enters at the T. With the natural draft hood of the water heater, exhaust gasses can be pushed down and out the open, natural draft hood. A qualified HVAC technician should replace the T connection with a Y connection to join the water heater into the heating appliance.

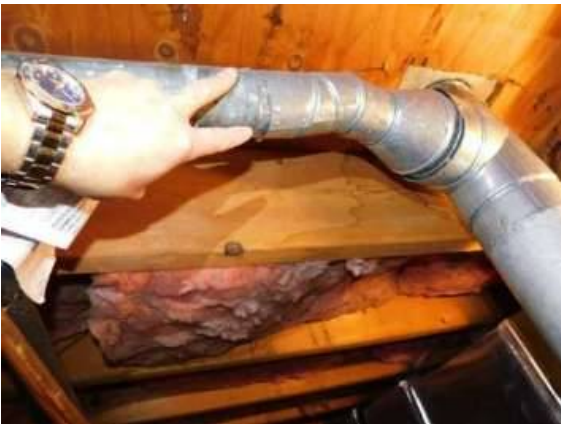
**54) Material Defect/Safety, Repair/Maintain/Service, Evaluate** - The flue pipe connections must be held together with at least, 3 sheet metal screws. There's at least one flue pipe connection that does not have any screws or too few screws. Recommend that the connection be held together with screws as they should. If not properly held together, flue pipe sections can separate allowing harmful exhaust gasses to enter the living space. Therefore this is a safety issue. A qualified plumber or HVAC contractor should evaluate and repair.

**Photo 54-1** In these 3 examples, this connection has 2 screws...

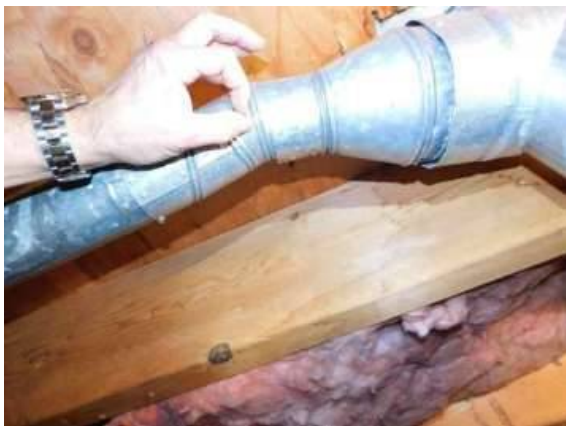
Photo 54-3 ...and none.

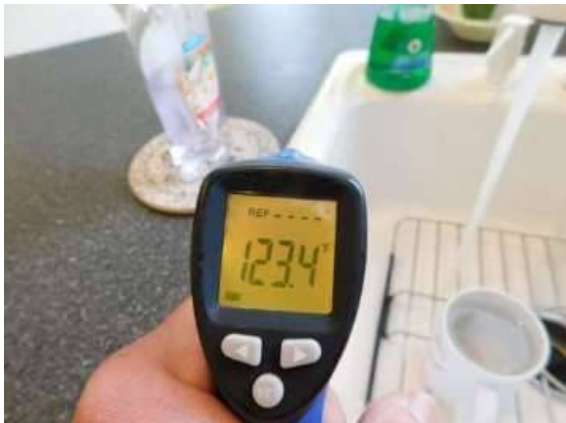
Photo 55-1

**55) Material Defect/Safety** - The hot water temperature was greater than 120 degrees Fahrenheit. This is a safety hazard due to the risk of scalding. The thermostat should be adjusted so the water temperature doesn't exceed 120 degrees.

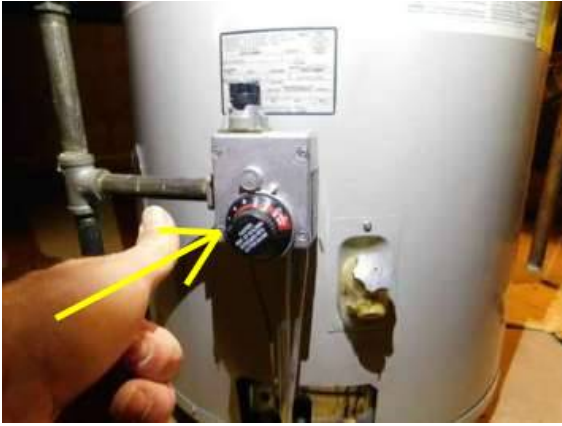
**Photo 55-5** The thermostat at the base of the water heater should be adjusted.

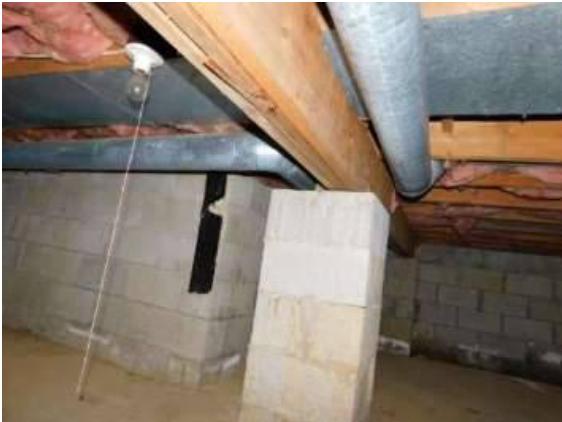
**Photo 57-1**

A few examples are shown.

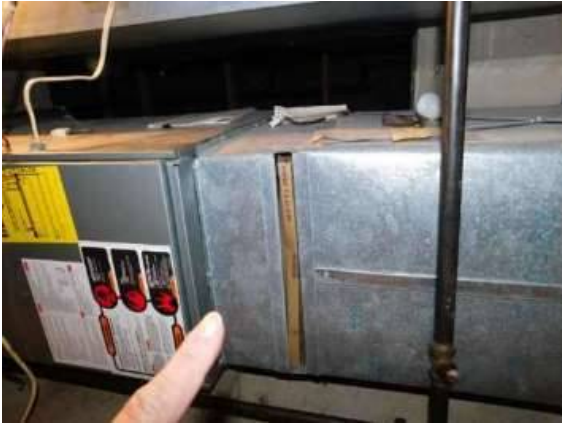
**Photo 60-1**

**60) Repair/Maintain/Service** - One or more forced air furnace's filter chamber does not have a cover. Without a cover to seal the filter chamber the air filtering system does not operate properly and consequently the air quality and efficient air flow may be compromised. Recommend sealing the chamber. One option is <https://www.allergyzone.com/collections/clean-air-accessories/products/filterlock-furnace-filter-slot-seal> Recommend that this cover, or something similar, be used to seal the opening over the air filter.

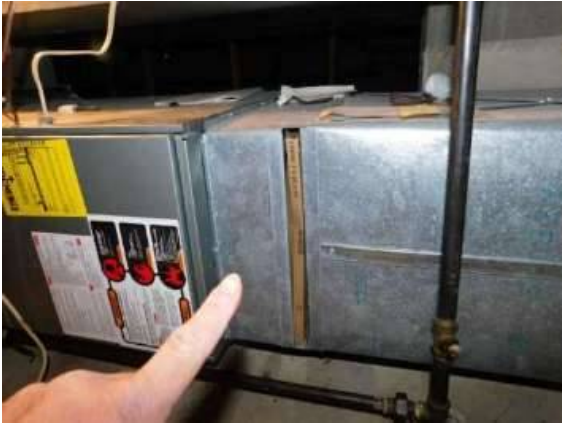
**Photo 62-1**

**62) Maintain** - Recommend replacing or washing HVAC filters upon taking occupancy depending on the type of filters installed (disposable or reusable). Regardless of the type, recommend checking filters monthly in the future and replacing or washing them as necessary and in accordance with the filter manufacturer's instructions. How frequently they need replacing or washing depends on the type and quality of the filter, how the system is configured (e.g. always on vs. "Auto"), and on environmental factors (e.g. pets, smoking, frequency of house cleaning, number of occupants, the season).

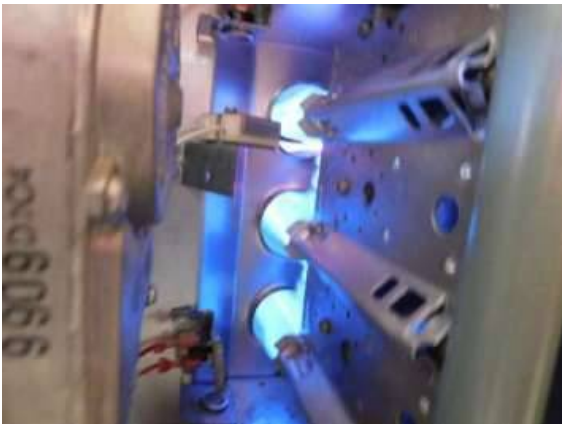
Photo 68-1

68) **Comment/FYI** - The furnace's burners were blue in color indicating proper fuel combustion.

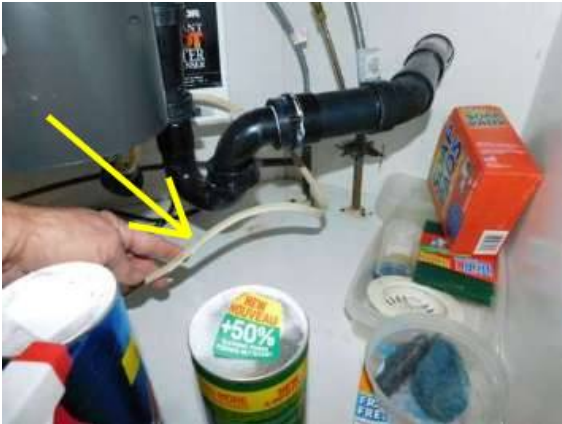
Photo 69-1

**69) Material Defect/Safety, Replace** - Electrical wiring for the under-sink food disposal was substandard. Non-metallic sheathed wiring was loose, exposed and subject to damage. The wiring can be damaged by repeated bending or contact with sharp objects. BX-armored conduit should be installed to protect wiring, or a flexible appliance cable should be installed. This is a potential shock hazard. Recommend that a qualified contractor repair per standard building practices.

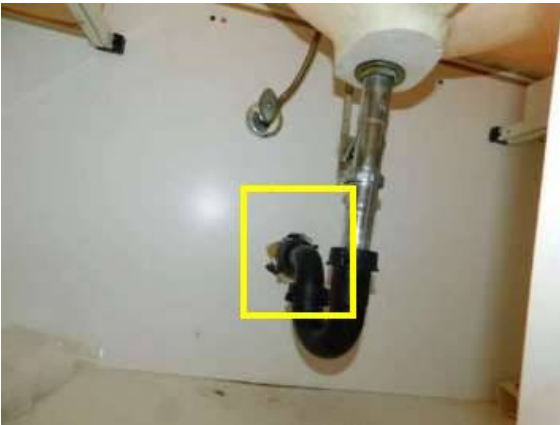
**73) Repair/Maintain/Service** - One or more sink drains were leaking at location(s) B. A qualified person should repair as necessary.

**Photo 73-1** Close up of this area in the next photo.

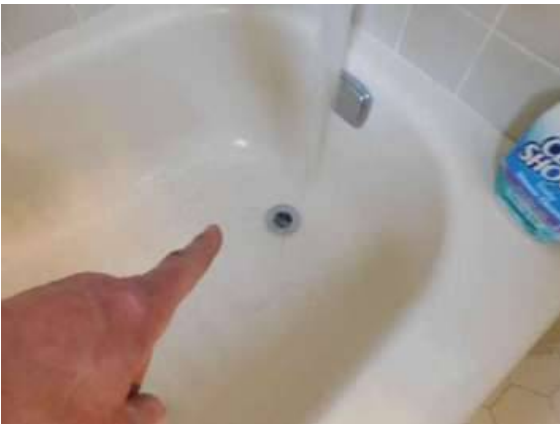
**Photo 74-1**

**74) Repair/Maintain/Service** - The bathtub drain stopper mechanism at location(s) A was missing. Recommend that a qualified person repair or replace as necessary.
