Regal Home Inspections, LLC

Property Inspection Report

Property address: **1 Any Street Ct
Anytown, NJ**

Inspection date: **Sunday, February 28, 2021**

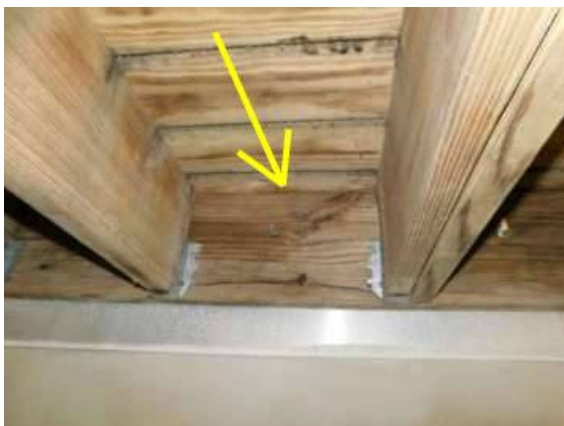
Photo 6-4

6) Material Defect/Safety, Replace - Flashing appeared to be missing from above one or more deck or porch ledger boards, or could not be verified. Missing flashing at this location can cause moisture to accumulate between the ledger boards and the building. Fungal rot may occur in this area and cause the ledger board fasteners to fail. The deck may separate from the building in this event. This is a potential safety hazard. Recommend that a qualified contractor install flashing above ledger boards per standard building practices. For more information, visit: <https://www.decks.com/how-to/28/flashing-the-ledger-board>

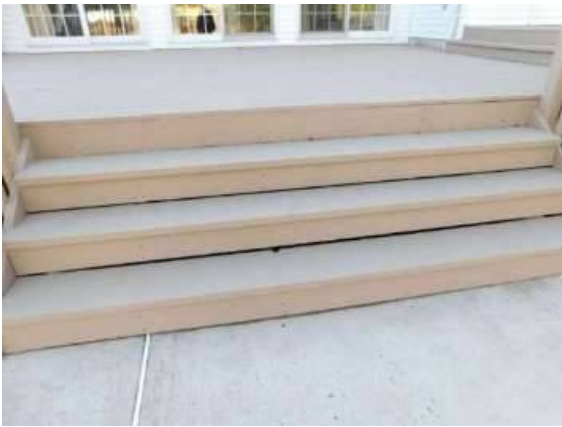
**Photo 7-1**

7) Material Defect/Safety, Replace - The risers for stairs at one or more locations varied in height and pose a fall or trip hazard. Risers within the same flight of stairs should vary by no more than $\frac{3}{8}$ inch. At a minimum, be aware of this hazard, especially when guests who are not familiar with the stairs are present. Recommend that a qualified contractor repair per standard building practices.

The risers vary from approximately $7 \frac{3}{8}$ inches to 8 inches.

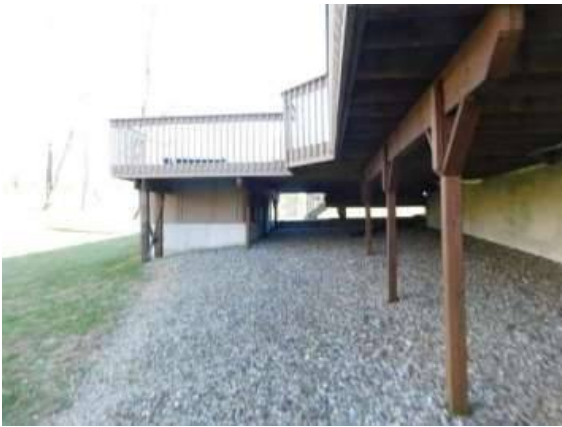
**Photo 8-3**

8) Repair/Maintain/Service - Soil was in contact with or too close to wooden deck or porch substructure components such as the deck posts. This is a conducive condition for wood-destroying organisms. Clearances to soil should be as follows:

Pressure treated wood is typically rated for 25 year contact with soil, but the cut ends hidden below grade may not have been treated and can rot quickly. Support posts should be elevated above grade on concrete piers or footings, and be separated from the concrete by metal brackets or an impermeable membrane such as shingle scraps. For other components, soil should be graded and/or removed to maintain these clearances if possible. Otherwise, replacing non-treated wood with treated wood, or installing borate-based products such as Impel rods may help to prevent infestation and damage.

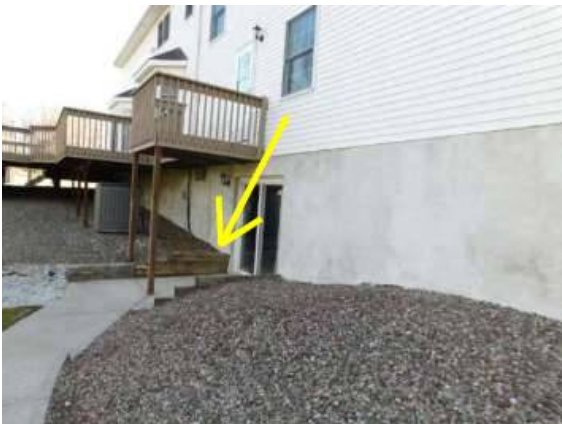
**Photo 9-1**

9) Repair/Maintain/Service - There is a small, wood retaining wall in the back. It is leaning. However, as noted above, it does not present an immediate, detrimental effect on the condition of the residential building's structure or stability.

Recommend that a landscape contractor excavate the soil and stones behind the wall, straighten it out and replace the soil and stones.

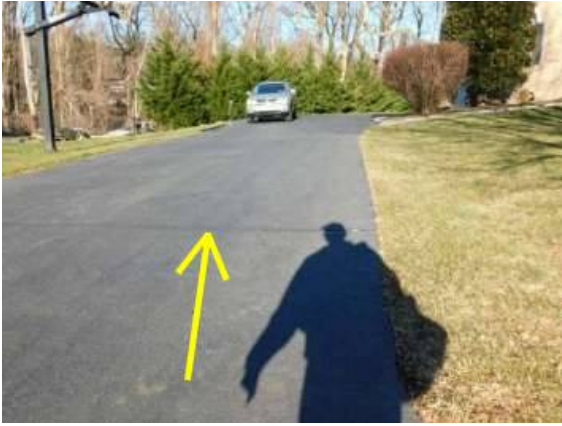
**Photo 11-1**

11) Comment/FYI - Minor deterioration (e.g. cracks, holes, settlement, heaving) was found in the driveway, but no trip hazards were found. The client may wish to have repairs made for cosmetic reasons.

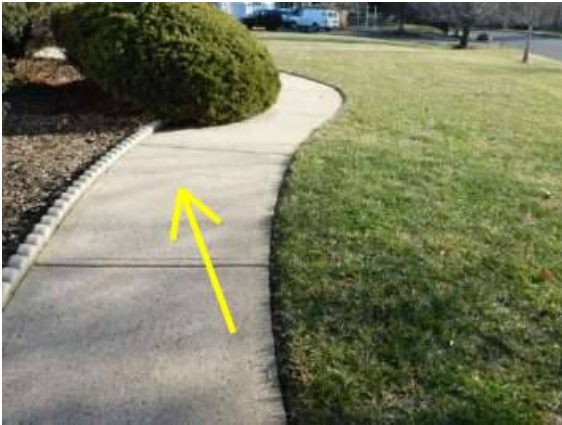
**Photo 12-1**

12) Comment/FYI - Minor deterioration (e.g. cracks, holes, settlement, heaving) was found in sidewalks or patios, but no trip hazards were found. The client may wish to have repairs made for cosmetic reasons.

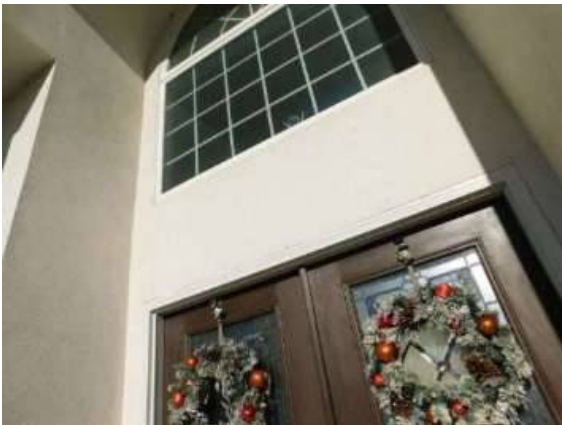
15) Repair/Maintain/Service, Maintain, Evaluate - Holes were found in one or more areas of the expanded foam insulation system (EIFS) exterior finish. In damp climates, moisture can enter cracks or damaged areas and further deteriorate the finish. Also, the wall behind the finish can become damaged from moisture intrusion. Note that areas behind the finish are inaccessible and excluded from this inspection. Recommend that a qualified contractor evaluate and make repairs and/or replace the EIFS siding as necessary. For example, seal the holes seen and any others that may exist.

Photo 15-1 Close ups of this area in the next photos.

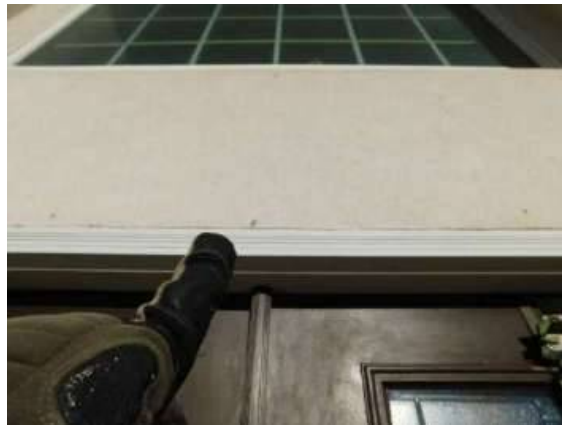
Photo 15-2 Some examples shown of holes in the EIFS and small areas of damage (The damage was smaller than the size of a dime).

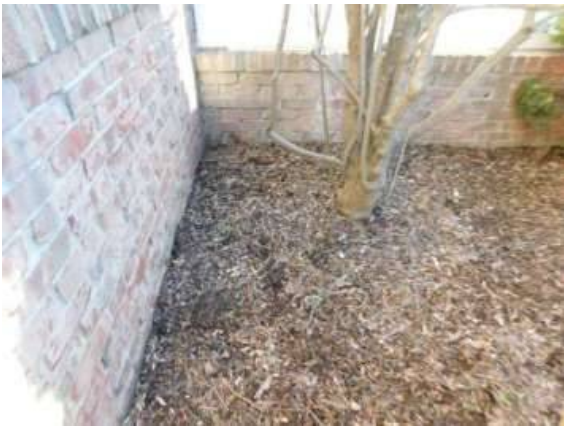
Photo 16-1

16) Repair/Maintain/Service, Evaluate - The masonry (brick) veneer extended below the soil at one or more exterior walls. Masonry veneers should be installed so the bottom edge is at least a few inches above the soil so that any water accumulated inside the wall structure can drain from weep holes, and so termites don't enter the structure through mortar joints or cracks in the veneer. If soil, decorative bark, etc. has been back-filled against the veneer, it should be graded or removed as necessary to expose weep holes and to maintain a few inches of clearance between the veneer and the soil below. Additionally there were no weep holes seen. Weep holes are gaps in the vertical mortar joints that occur at intervals along the brick wall. Recommend evaluation by a masonry contractor to see if weep holes exist (if they're installed) and create them if they are not. Brick (and other building material) have what's called a Hygric Buffer Capacity (HBC). That's the water capacity of building material. Brick absorbs water. In a 2000 square foot brick house, the brick can hold up to 500 gallons of water (that's the HBC of the brick). The water in the brick moves into the house as the brick heats up. This is why the breather space and weep holes are important. The brick design has to be able to eliminate the moisture.

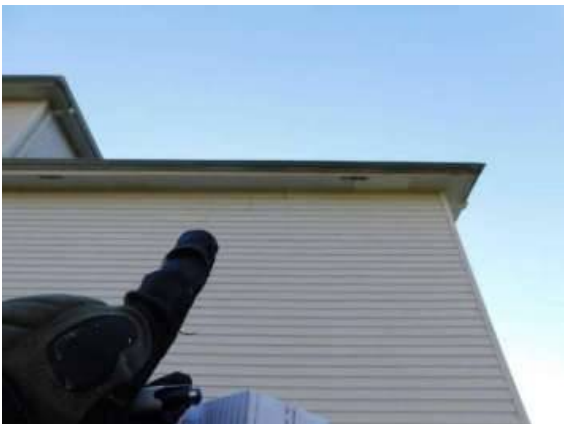
Photo 17-1

17) Repair/Maintain/Service - One or more holes or gaps were found in siding or trim. Water may enter the structure or get behind the siding. Recommend that a qualified person repair as necessary.

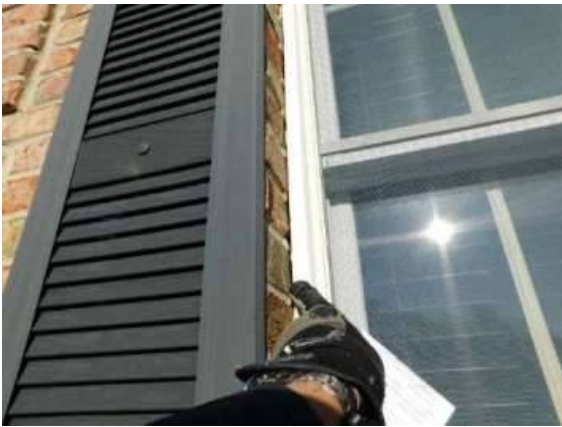
19) Maintain - Caulk was missing in some areas. For example, around windows. Recommend that a qualified person renew or install caulk as necessary. Where gaps are wider than 1/4 inch, an appropriate material other than caulk should be used.

Photo 19-1 A few examples are shown.

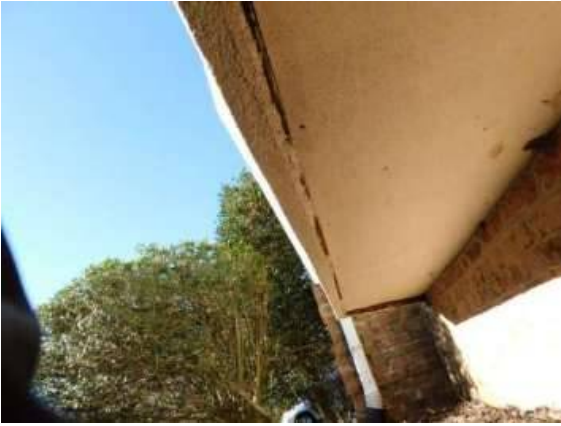
**Photo 20-11**

20) Evaluate - Some or all of the exterior finish appeared to be synthetic stucco and appears to be expanded foam insulation system (EIFS). Only an in depth analysis of the siding material can determine the exact composition. If it is EIFS it is a synthetic stucco that is prone to failure, especially in damp climates. Typically, cracks occur in the finish and allow moisture to penetrate the foam backing. This often produces fungal rot which causes structural damage to wooden wall structures behind the EIFS. It can also result in mold growth.

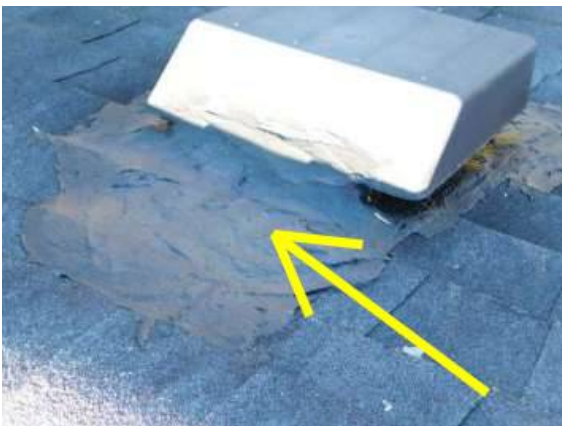
Photo 23-1

23) Material Defect/Major, Replace, Evaluate - Substandard repairs were found at one or more locations on the roof surface. Leaks can occur as a result. Staining from roof leaks were seen in the attic. This is a conducive condition for wood-destroying organisms such as mold. Recommend that a qualified contractor evaluate and repair per standard building practices. Please note that the advice is to have the roof surface replaced. This should include upgrading the flashings and seals around the roof penetrations.

These contribute significantly to the overall conclusion that the roof surface is beyond its service life and should be replaced.

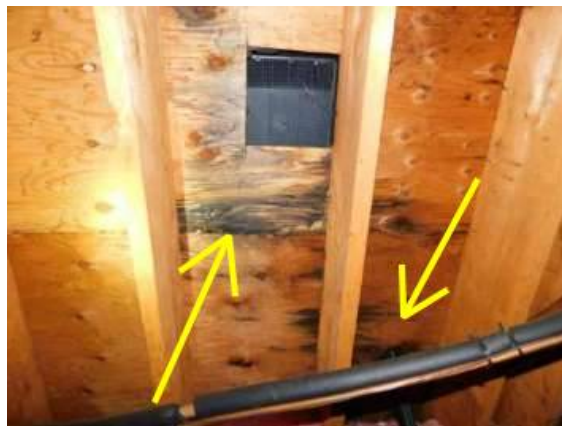
Photo 23-2 Water stains seen inside the attic around a box vent like the one seen in the previous photo with substandard leak repairs.

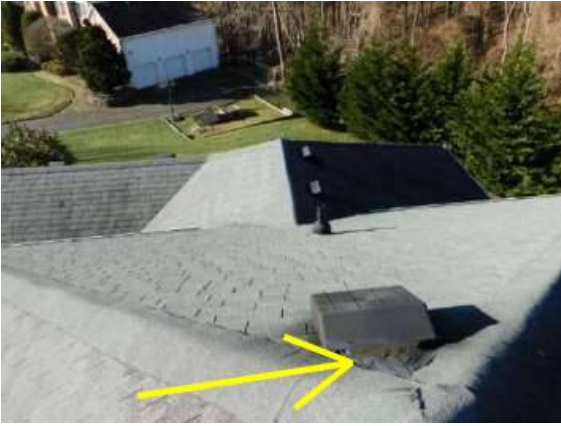
Photo 23-3 Here and the next photos are examples of other, substandard repairs around other box vents.

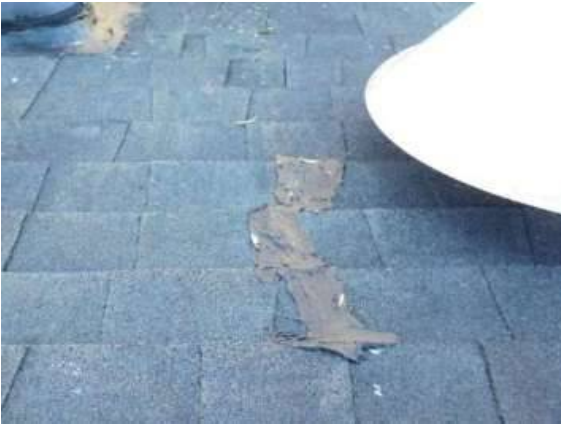
Photo 23-5 Substandard repair. Roof cement, used here and in many other photos in this report, will dry, crack and potentially leak over time. Roof cement is not a long term, durable repair.

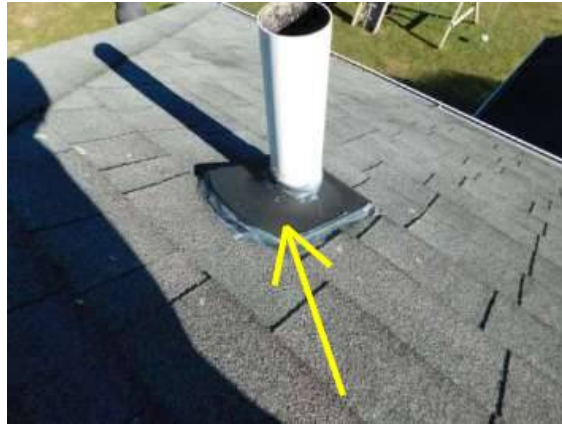
Photo 23-6 Substandard flashing.

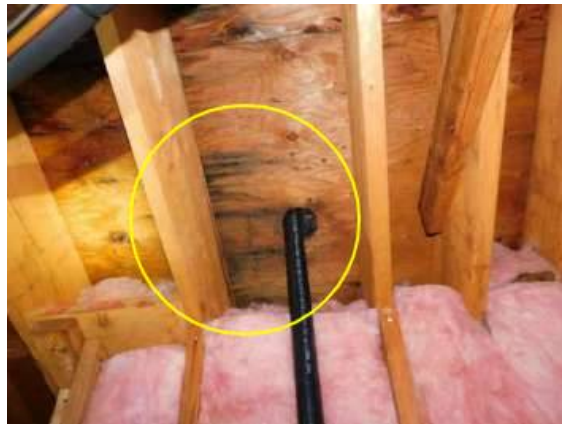
Photo 23-8 Other examples of water stains from leaks around other pipe boots and roof penetrations.

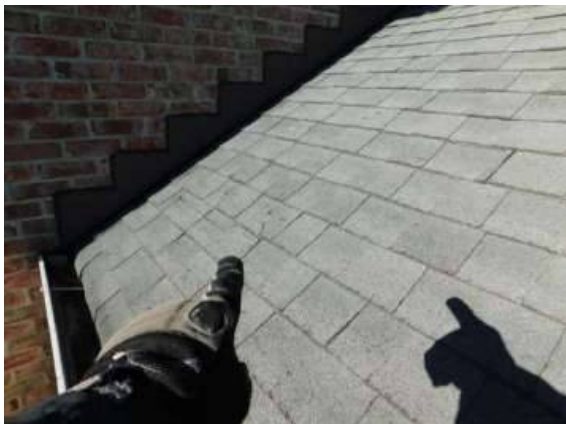
Photo 24-1

24) Material Defect/Major, Replace - Many composition shingles were cracked, broken, damaged and worn. Leaks can occur as a result. This is a conducive condition for wood-destroying organisms. Recommend that a qualified, reputable roofing contractor repair as necessary. For example, by replacing shingles.

These contribute significantly to the overall conclusion that the roof surface is beyond its service life and should be replaced.

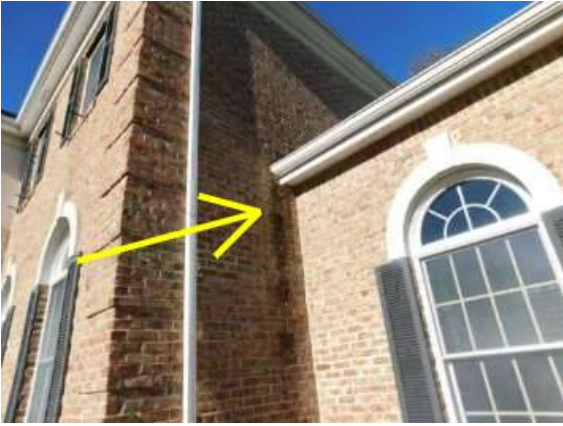
26) Repair/Maintain/Service, Evaluate - Recommend having kick out flashing at the end of the gutter to prevent the rain water from over-running the gutter or passing between the gutter end and the wall. That usually results, as seen here, in the staining. Properly installed kick out flashing routes the water coming off the roof into the gutter for proper disposal and prevents the water from getting between the gutter end and the wall. A qualified roofer or siding contractor should evaluate and repair as that professional deem necessary.

Photo 26-1 Close up of this area in the next photo.

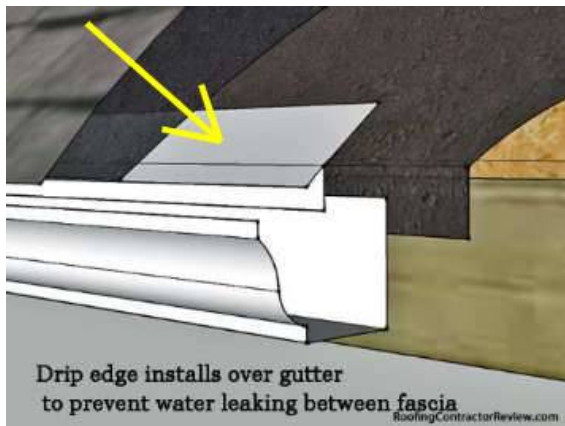
**Photo 27-1**

27) Repair/Maintain/Service - There is no drip edge flashing. Drip edge flashing is intended to protect the edge of the plywood roof sheathing where the shingles end and help ensure that all rain water goes into the gutter. It's often not installed by roofers so they can save money but is a good practice to ensure a more water repellent roof. Properly installed drip edge flashing should be installed around the entire perimeter of the roof. One edge should go between the plywood sheathing and the roof surface (shingles, etc.) and then bend downward into the back of the gutter or along the outside of the rake board. In this installation, when the shingles are lifted, bare plywood is exposed.

If the roof is replaced you should request that drip edge flashing be installed.

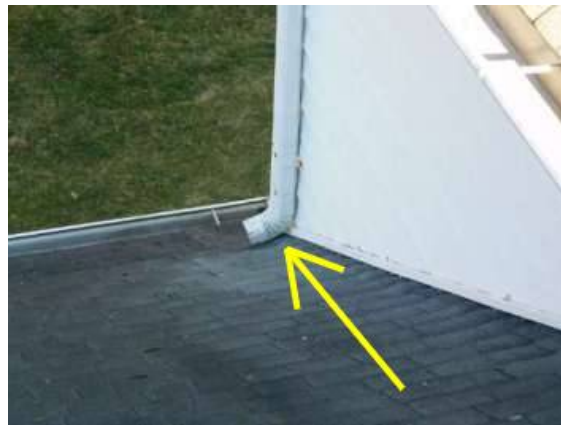
**Photo 28-2****Photo 28-1**

28) Repair/Maintain/Service - Ideally the downspout should not deposit water on the roof as seen in the photo below. The roof is designed to shed water that is flowing down. When the water emerges from the downspout it is going side-ways into the shingle. This will also cause accelerated shingle wear and gravel loss at this location. The illustration, courtesy of the National Association of Home inspectors shows improper ways that gutters deposit water on a roof as we have here. Recommend that a roofing/gutter contractor install a downspout or leader to carry the water to the lower gutter.

Gutter Improperly Discharging onto Roof

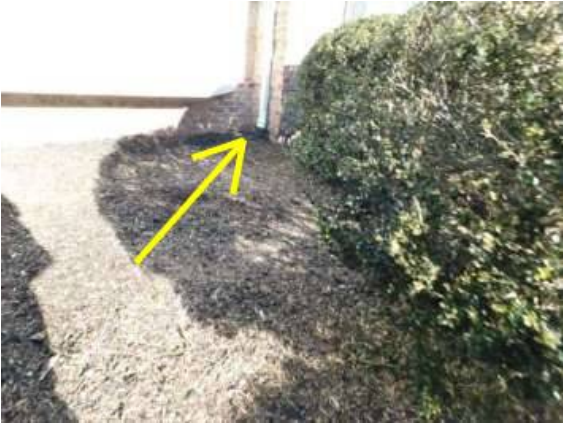
**Photo 29-1**

29) Exclusion, Monitor - Please note that one or more downspouts go into the soil. Once they go into the ground they are no longer visually accessible for inspection and therefore excluded. Their condition under the soil can't be determined in this inspection. Recommend monitoring their operation during periods of heavy rain. If they overflow then maintenance and repair is necessary. Blockages may exist and can only be detected during heavy rains.

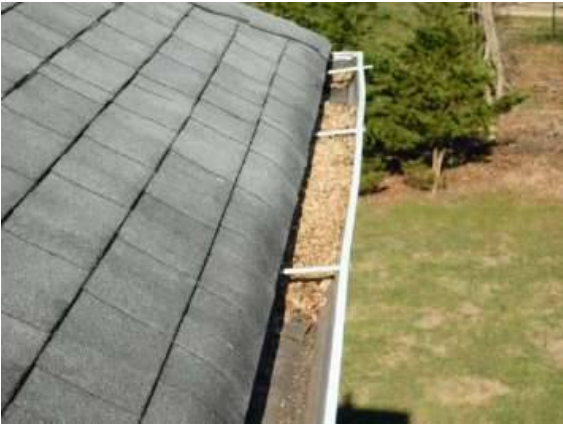
**Photo 30-1**

30) *Maintain* - Significant amounts of debris have accumulated in one or more gutters or downspouts. Gutters can overflow and cause water to come in contact with the building exterior, or water can accumulate around the foundation. This is a conducive condition for wood-destroying organisms. Recommend cleaning gutters and downspouts now and as necessary in the future.

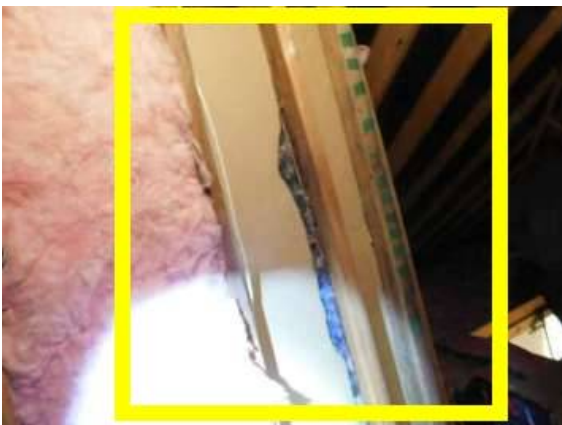
36) Repair/Maintain/Service - Attic insulation at an attic wall area was missing. Heating and cooling costs will likely be higher due to reduced energy efficiency. Heat will radiate into the living space in the summer and cold in the winter. Recommend that a qualified person repair, replace or install insulation as necessary and per standard building practices.

Photo 36-1 Adjacent to the furnace.

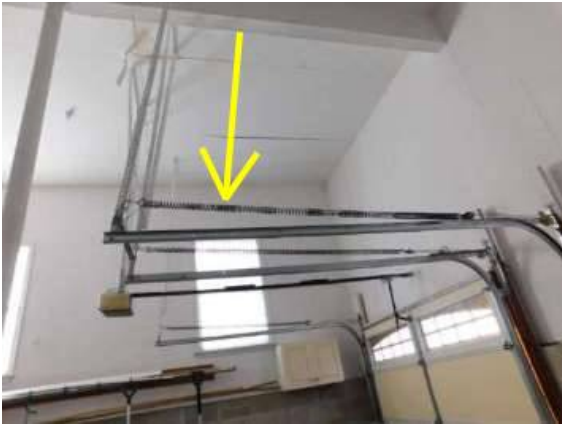
41) Material Defect/Safety, Replace - One or more extension springs supporting garage vehicle door(s) were stretched. This is an indication that the spring(s) have been weakened. Stretched extension springs are a potential safety hazard in the event that they break. The vehicle door could fall shut or a spring could strike someone nearby when it breaks. Recommend that a qualified contractor replace stretched extension springs.

Photo 41-1 Close ups of this area in the next photos.

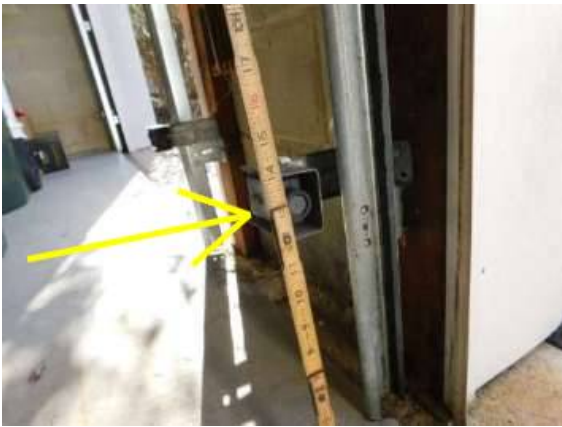
Photo 44-1

44) Material Defect/Safety, Repair/Maintain/Service - The photoelectric sensors that trigger the auto-reverse feature on one or more garage vehicle doors' automatic openers were located higher than 4-6 inches from the floor. This is a potential safety hazard. A qualified person should relocate sensors so they are 4-6 inches from the floor per standard building practices.

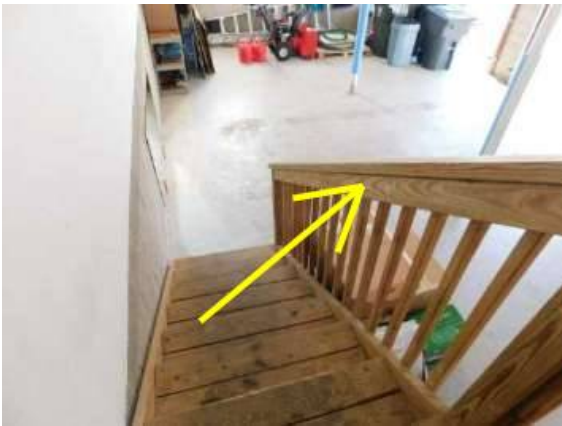
Photo 45-1

45) Material Defect/Safety, Repair/Maintain/Service - Handrails at one or more flights of stairs were not graspable and posed a fall hazard. Handrails should be 1 1/4 - 2 inches in diameter if round, or 2 5/8 inches or less in width if flat with recesses for fingers. Recommend that a qualified person install graspable handrails or modify existing handrails per standard building practices.

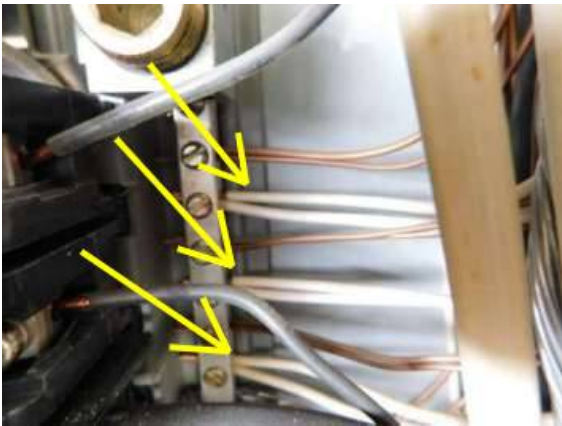
Photo 50-1

50) Material Defect/Safety, Replace - Neutral wires were doubled or bundled together under the same lug on the neutral bus bar in panel(s) A. This is a potential safety hazard in the event that one of the circuits needs to be isolated during servicing. For one neutral to be disconnected, other neutrals from energized circuits sharing the same lug will be loosened. Power surges may result on the energized circuits and result in damage or fire. Also, multiple wires under the same lug may not be secure, resulting in loose wires, arcing, sparks and fire. Recommend that a qualified electrician repair per standard building practices.

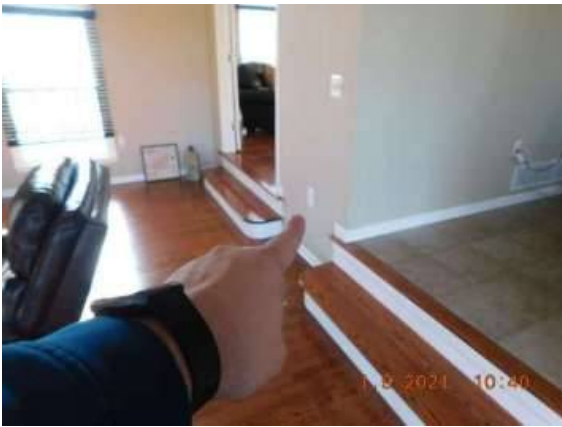
**Photo 52-1**

52) Material Defect/Safety, Replace - One or more electric receptacles (outlets) and/or the boxes in which they were installed were loose and/or not securely anchored. Wire conductors can be damaged due to repeated movement and/or tension on wires, or insulation can be damaged. This is a shock and fire hazard. Recommend that a qualified electrician repair as necessary.

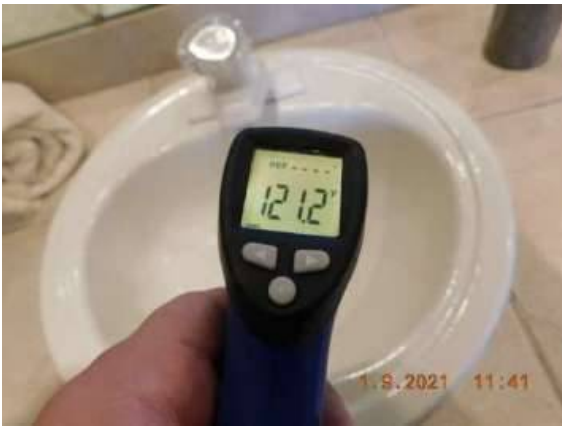
Photo 64-1

64) Material Defect/Safety - The hot water temperature was greater than 120 degrees Fahrenheit. This is a safety hazard due to the risk of scalding. The thermostat should be adjusted so the water temperature doesn't exceed 120 degrees.

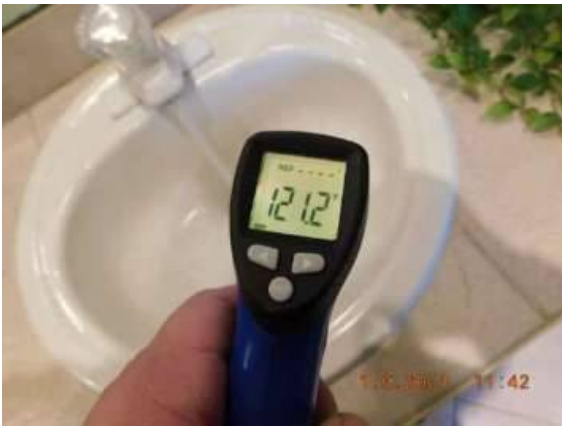
Photo 65-1 There was a fourteen degree difference between the hottest temperatures measured between the sinks at the master bathroom at the shower (which measured at 107).

Recommend evaluation by a licensed plumber and the blender valves be properly adjusted and then the water heater can be adjusted so that the water at all fixtures is correct.

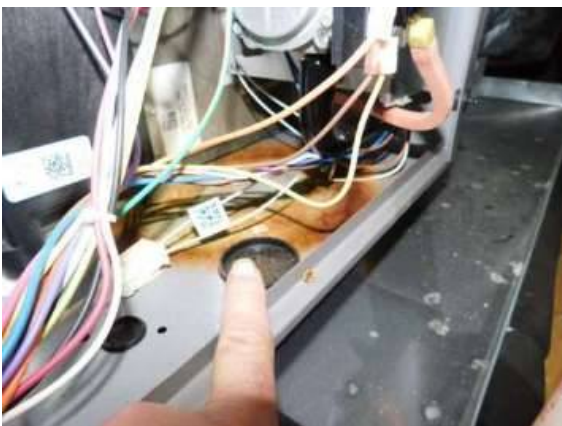
Photo 73-1

73) Repair/Maintain/Service, Evaluate - Rust was found in the attic furnace chamber. Portions of the condensate discharge may be leaking into the chamber which can eventually lead to rusting. A licensed HVAC technician needs to come in and evaluate the furnace for proper function and make repairs or replace as necessary.

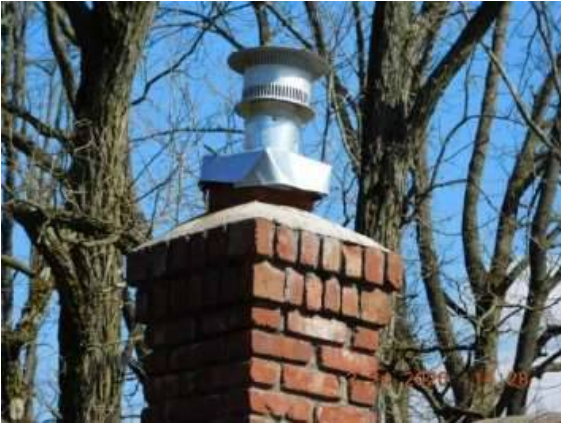
Photo 86-1 This is an example of a metal flue from a DIFFERENT property. No metal flue was seen for the gas burning appliances at this property.

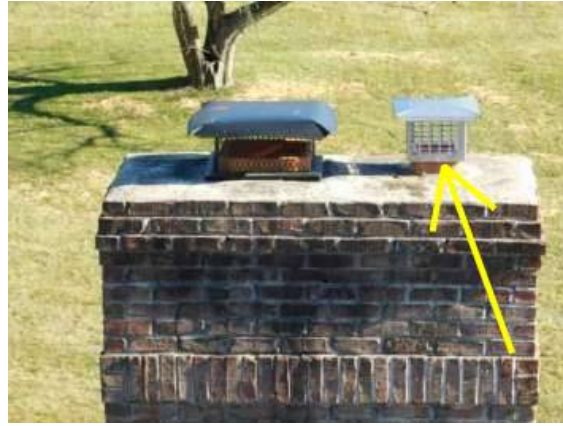
Photo 86-2 The masonry chimney at this location has a rain cap which is appropriate for a wood burning fireplace but not for venting gas appliances as we have here.

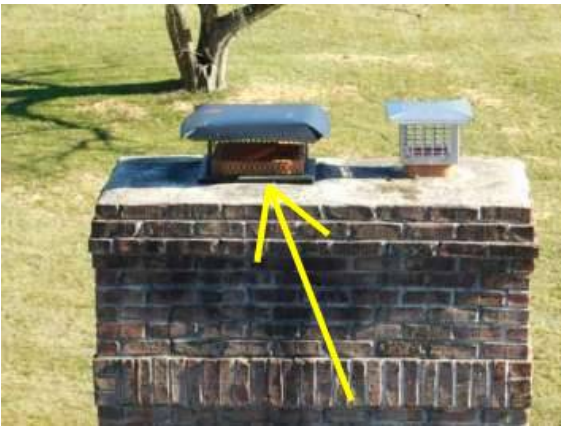
87) Repair/Maintain/Service - One or more gas-fired appliances such as the converted gas fireplace used a masonry chimney for venting, and no metal flue liner was visible. Metal liners should be installed to prevent drafting problems from an over-sized flue, to prevent corrosive exhaust gases from damaging the masonry chimney, and to prevent exhaust gases from leaking through gaps or seams in the chimney. This is a potential safety hazard. Recommend that a qualified contractor repair per standard building practices. For example, by installing a metal liner. For more information visit http://www.csia.org/chimney_liners.html

Photo 87-1 The masonry chimney at this location has a rain cap which is appropriate for a wood burning fireplace but not for venting gas fireplace as we have here.

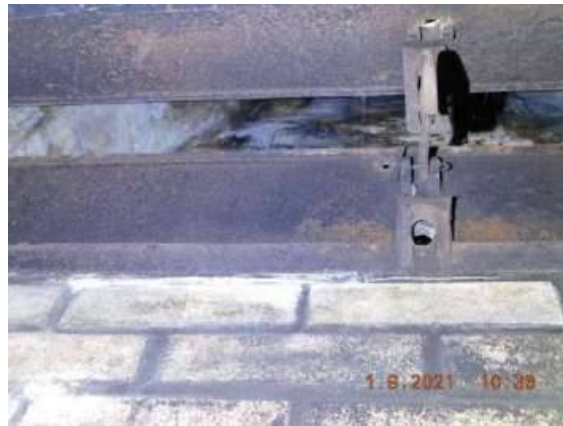
Photo 87-2 This and the following photo were taken at the fireplace looking up the chimney. No metal flue is visible.

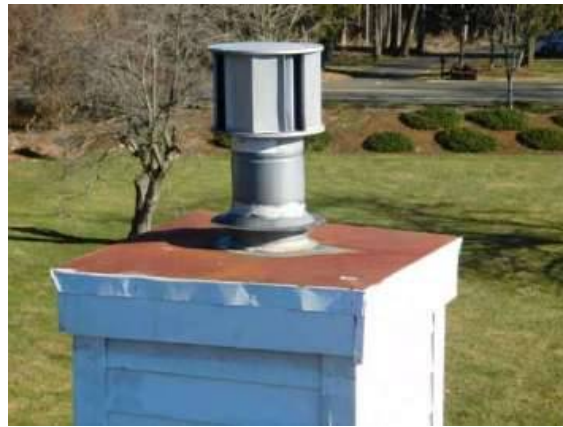
**Photo 87-4** This is the metal flue for the master bedroom fireplace. We should see something similar for the Family room fireplace that was converted from wood to gas.

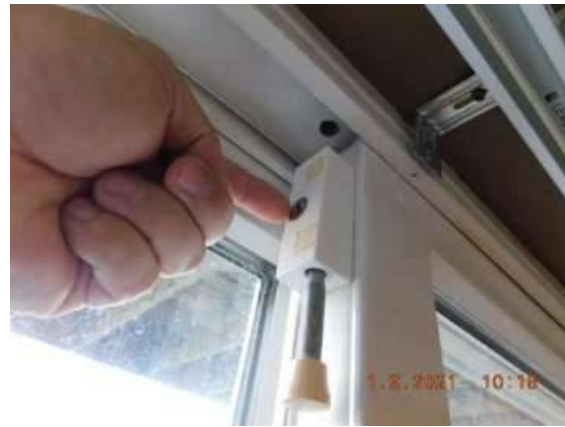
102) Material Defect/Safety, Replace - One or more exterior doors had double-cylinder deadbolts installed, where a key is required to open them from both sides. This can be a safety hazard in the event of an emergency because egress can be obstructed or delayed. Recommend replacing double-cylinder deadbolts with single-cylinder deadbolts where a handle is installed on the interior side.

Photo 102-1 This and the following photo were taken in the basement.

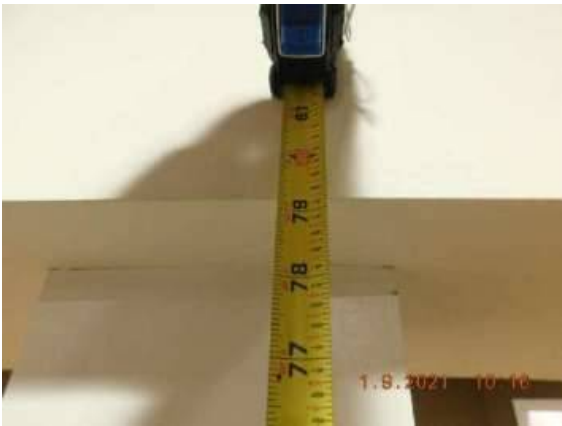
Photo 106-1

106) Comment/FYI - One or more rooms or hallways had ceilings that were too low. Standards vary for minimum ceiling heights, but generally they should be at least 7 feet high except in areas with sloped ceilings where at least half of the area should have 7 foot or higher ceilings. This may pose a safety hazard to tall people.
