Regal Home Inspections, LLC

Property Inspection Report

Property address: Any Street

Inspection date: Sunday, July 25, 2021

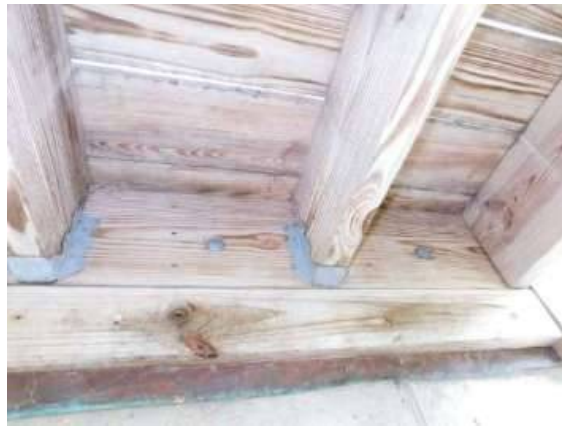
9) Material Defect/Safety, Replace - Flashing appeared to be missing from above one or more deck or porch ledger boards, or could not be verified. Missing flashing at this location can cause moisture to accumulate between the ledger boards and the building. Fungal rot may occur in this area and cause the ledger board fasteners to fail. The deck may separate from the building in this event. This is a potential safety hazard. Recommend that a qualified contractor install flashing above ledger boards per standard building practices. For more information, visit: <https://www.decks.com/how-to/28/flashing-the-ledger-board>

Photo 9-1 The flashing highlighted here is missing from under the back porch.

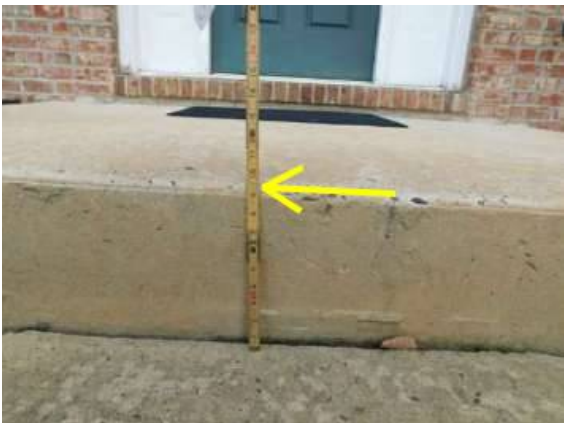
Photo 10-1

10) Material Defect/Safety, Replace - Risers for stairs at one or more locations were higher than 8 1/4 inches and posed a fall or trip hazard. Risers should be 8 1/4 inches or shorter. At a minimum, be aware of this hazard, especially when guests who are not familiar with the stairs are present. Recommend that a qualified contractor repair per standard building practices.

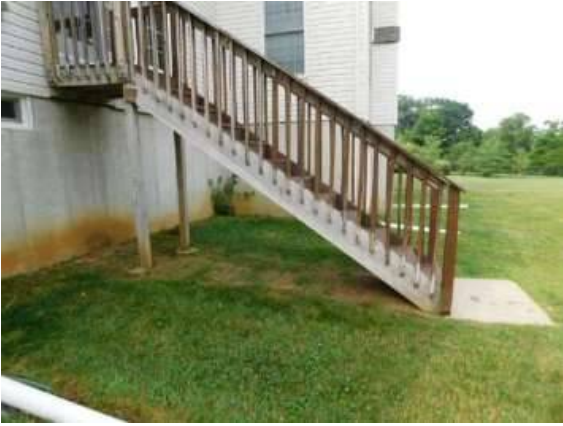
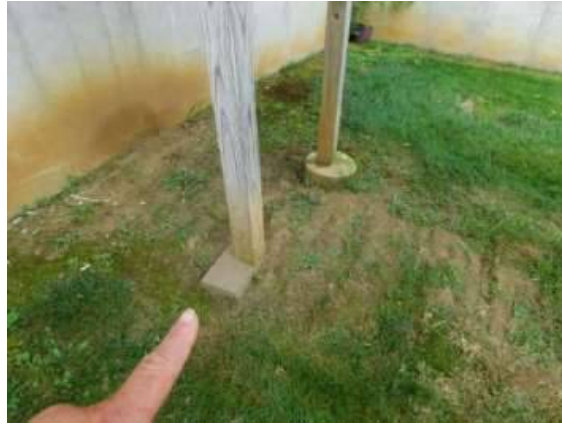
11) Material Defect/Safety, Repair/Maintain/Service - One or more sets of steps and the back porch is unstable due to missing or substandard bracing, or lack of proper support of the steps. This is a safety hazard since severe movement may cause the decks or porches to collapse. A qualified contractor should repair as necessary.

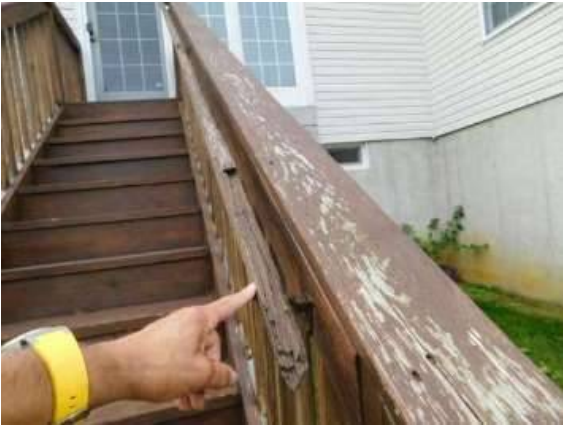
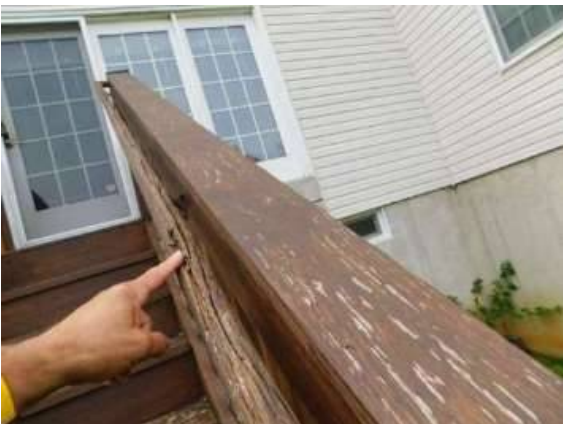
12) Material Defect/Safety, Repair/Maintain/Service - Handrails at one or more flights of stairs were damaged. This is a safety hazard. Recommend that a qualified person repair as necessary.

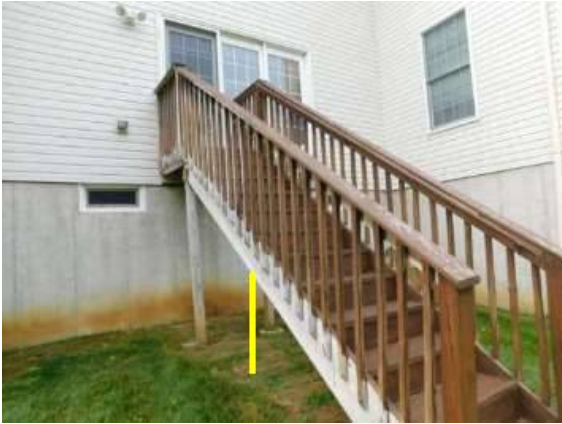
**Photo 13-1**

13) Repair/Maintain/Service - The back steps should have a mid span support added when the other, step issues are addressed. The stringers are at least 12 steps long. A mid span support of the stringers will add strength to the stairway.

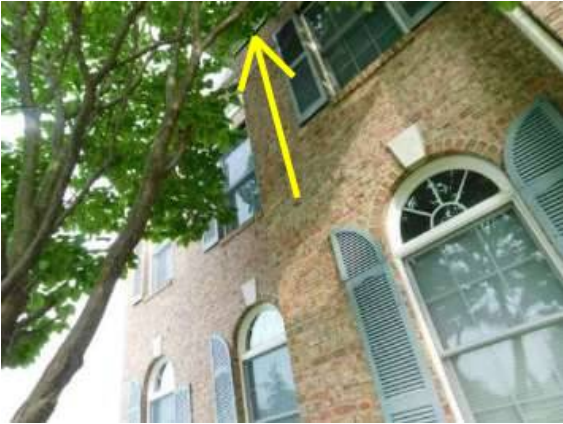
14) Replace - Few sections of siding and/or trim were damaged. Recommend that a qualified person repair, replace or install siding or trim as necessary.

Photo 14-1 Close up of this area in the next photo.

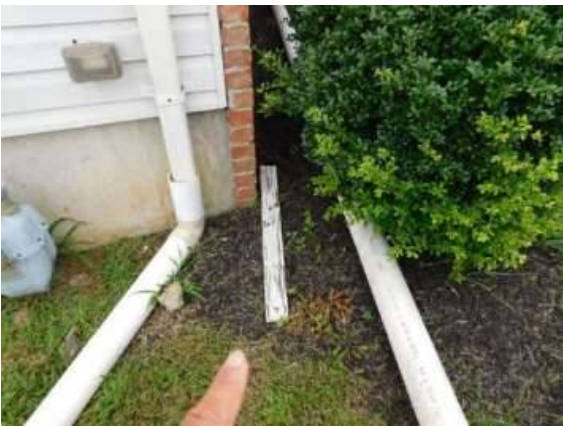
It appears that the piece of wood in the 3rd photo below fell off the trim at the eave.

Photo 14-3 Looks like this may be the piece of wood that fell off.

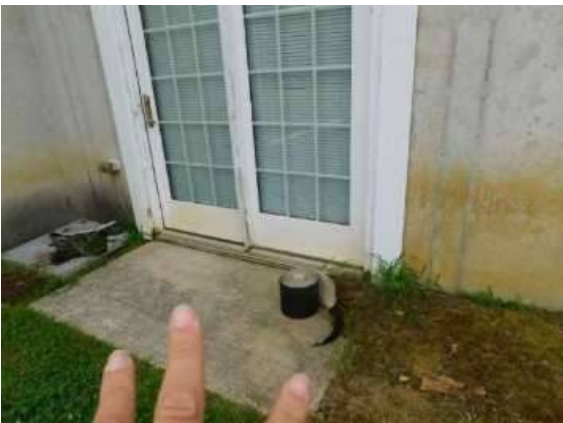
15) Replace - Fungal rot was found at the bottom of all three door jambs. Conducive conditions for rot should be corrected (e.g. wood-soil contact, reverse perimeter slope). Recommend that a qualified person repair as necessary. All rotten wood should be replaced.

Photo 15-1 Fungal rot at the bottom of all three jambs.

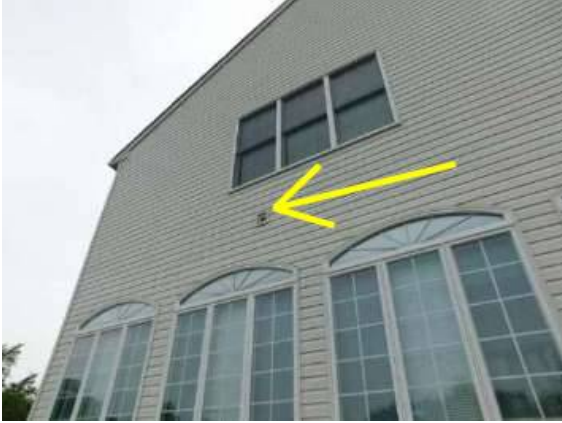
16) Replace - One or more exhaust duct end caps were damaged. Their purpose is to prevent unconditioned air from entering the building, and keep out birds, rodents and bugs. Blocked ducts can cause fan motors and/or clothes dryers to overheat and can pose a fire hazard. Recommend that a qualified person repair or

Photo 16-1 Close up of this area in the next photo.

replace caps as necessary.

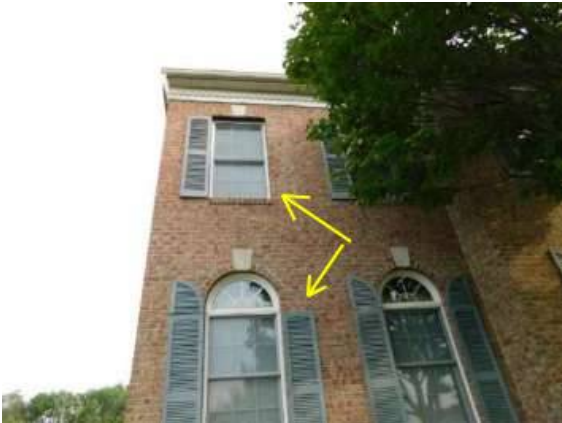
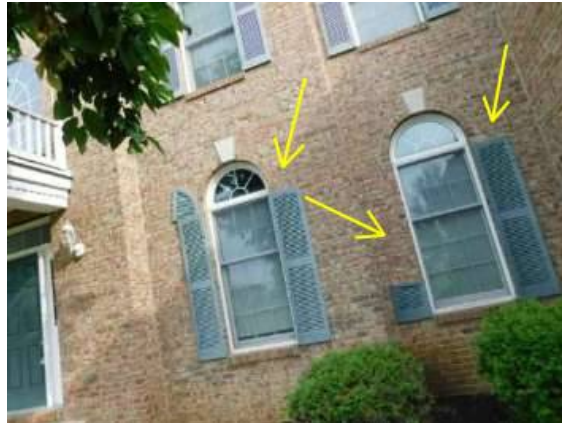
Although usually excluded as noted above, it was noticed that some of the shutters were missing or damaged.

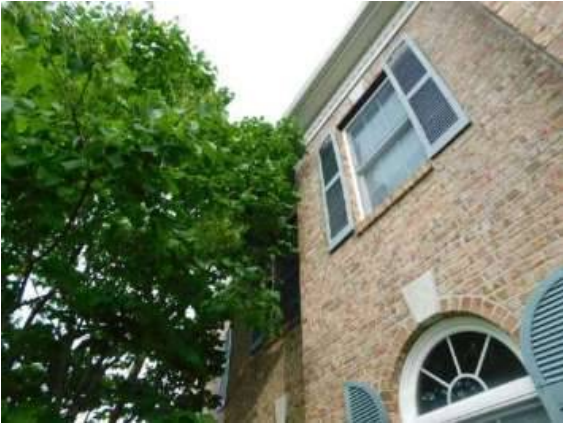
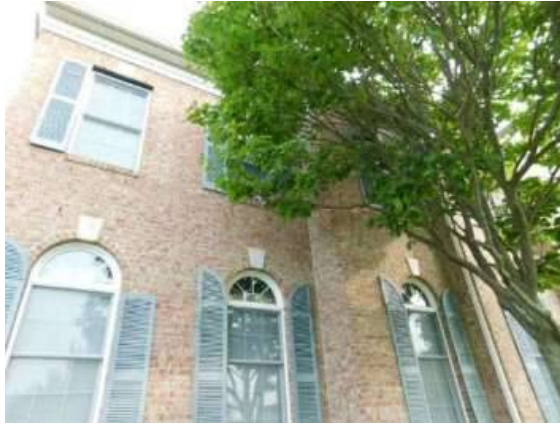
19) Maintain, Evaluate - Trees were in contact with or were close to the building at one or more locations. Damage to the building can occur, especially during high winds, or may have already occurred (see other comments in this report). Recommend that a qualified tree service contractor or certified arborist remove trees as necessary to prevent damage to the building exterior. Please note that home insurance companies may have issues with trees too close to the house that can effect coverage and/or premiums. Consult (Evaluate) with your insurance company.

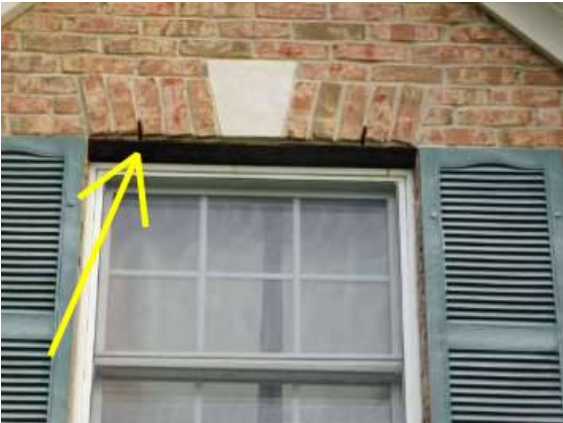
Photo 20-1

20) Maintain, Comment/FYI - Lintels are structural elements that support the weight of the brick over openings like windows and doors. Lintels are made of iron and often rust. Lintels are also embedded approximately 6 inches past the openings on either side to anchor them structurally. Over time lintels will rust. The rust can increase the size of the lintel and often applies upward force to the bricks causing cracks. No cracks were seen here. Recommend maintaining the lintels by using a rust inhibiting paint and maintaining seals at the seams between the lintels and the brick. A few examples shown below.

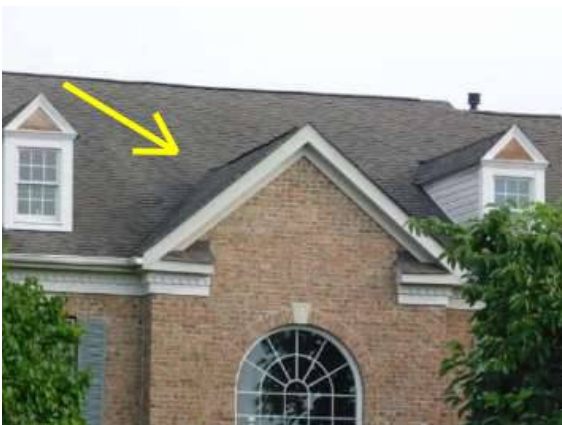
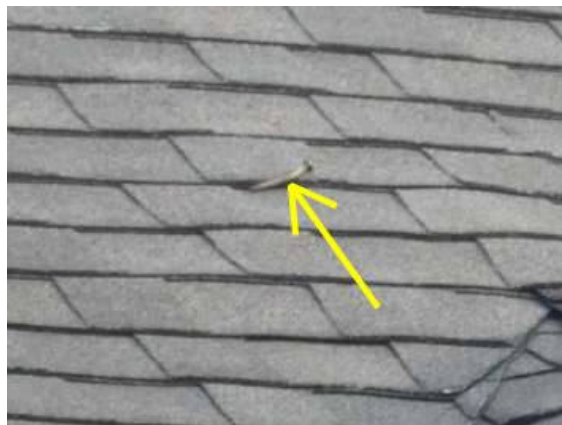
21) Material Defect/Major, Repair/Maintain/Service, Evaluate - On close inspection of the roof surface from the photos, it was noticed that there is a nail protruding from the roof. This is a conducive condition for leaks. Required that a qualified roofing contractor remove and seal to prevent leaks. Additionally, it's required that the roofer make their way into the area below the nail, in the attic, to ensure that leaks have not occurred. As noted in the Attic and Roof Structure section, most of the attic did not have any flooring and by law, the home inspectors do not walk in areas of the attic that do not have secure flooring.

Photo 21-1 Close up of this area in the next photo.

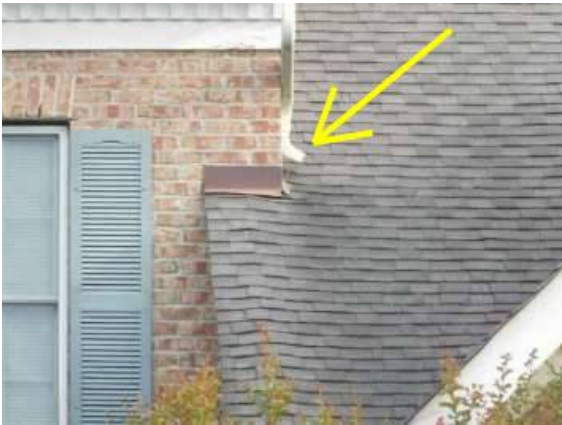
Photo 22-1

22) Repair/Maintain/Service - Ideally the downspout should not deposit water on the roof as seen in the photo below. The roof is designed to shed water that is flowing down. When the water emerges from the downspout it is going side-ways into the shingle. This will also cause accelerated shingle wear and gravel loss at this location. The illustration, courtesy of the National Association of Home inspectors shows improper ways that

gutters deposit water on a roof as we have here. Recommend that a roofing/gutter contractor install a downspout or leader to carry the water to the lower gutter.

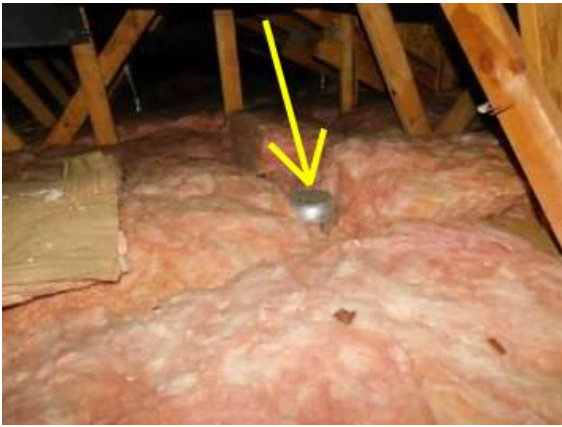
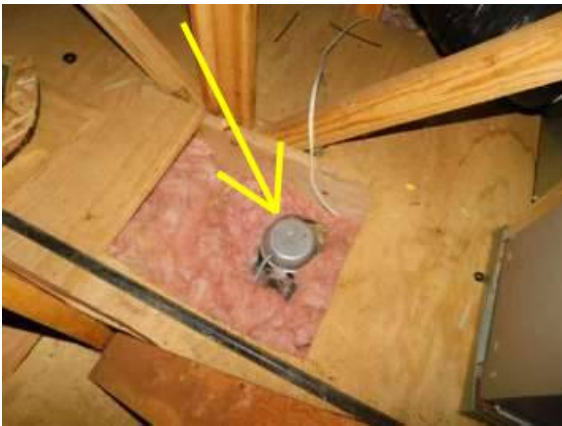
25) Repair/Maintain/Service, Evaluate - One or more recessed "can" lights were installed in the attic and there was no insulation around them. The inspector was unable to find a label or markings that indicated that these lights are designed to be in contact with insulation. If lights are not "IC" rated then putting insulation in contact may be a fire hazard. However, no insulation allows for warm moist 2nd floor air to rise into the attic. This A) Is energy inefficient and B) The rising, warm moist air will cause condensation in the attic in the cold of winter which, in turn, can cause mold. Recommend further evaluation by a qualified contractor to determine if these lights are rated for contact with insulation. If they aren't, or if their rating can't be determined, then recommend that a qualified person repair as necessary to prevent air from escaping into the attic. For example, by installing shields around lights and installing insulation over the shields.

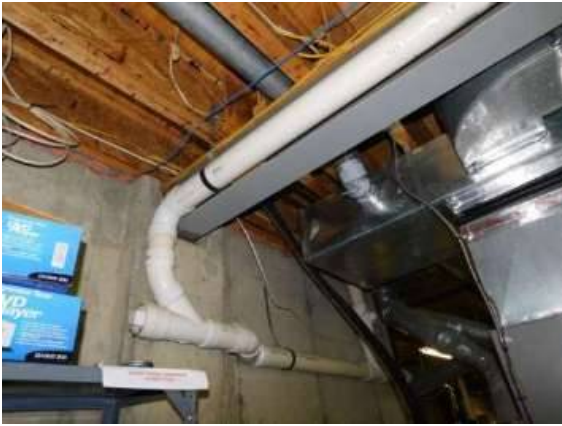
Photo 29-5

29) Repair/Maintain/Service, Evaluate - The floor structure has engineered joists. Squash blocks are often required at the load bearing ends of the engineered joists and at other points where the engineered joist is supporting a bearing wall above. The squash blocks help carry the load of the bearing walls. The primary design aspect of the engineered joists is to carry the load of the floor above and not, the bearing wall.

There are exposed areas of the engineered joist around the perimeter above the foundation and above the beam in the central part of the basement and no squash blocks are seen. The structural engineer or highly qualified framing contractor should evaluate and recommend repairs if that professional deems necessary.

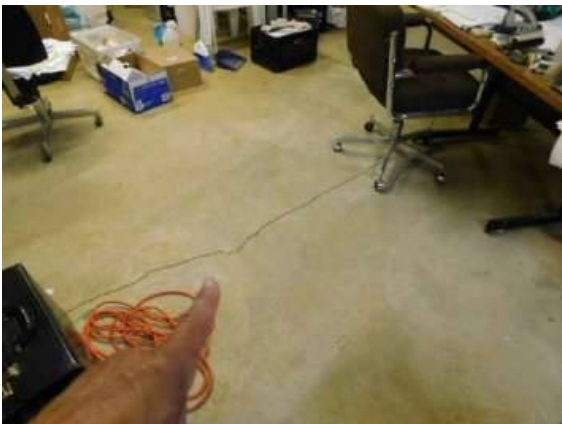
Photo 30-1

30) Repair/Maintain/Service - Minor cracks were found in the concrete slab floor. These are common however, they should be sealed to prevent water entry as well as the potential for radon.

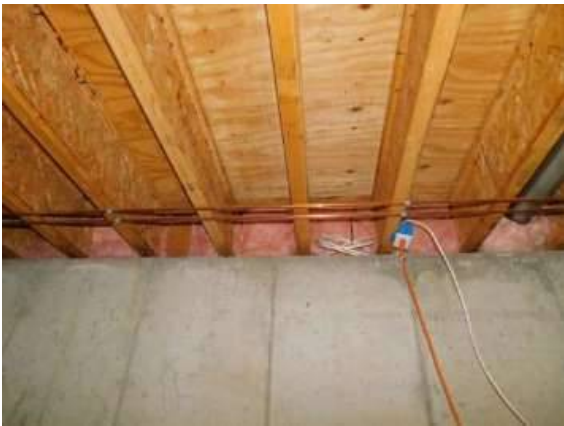
Photo 32-1

32) Comment/FYI - There was fiberglass insulation seen atop the foundation along the rim joist.

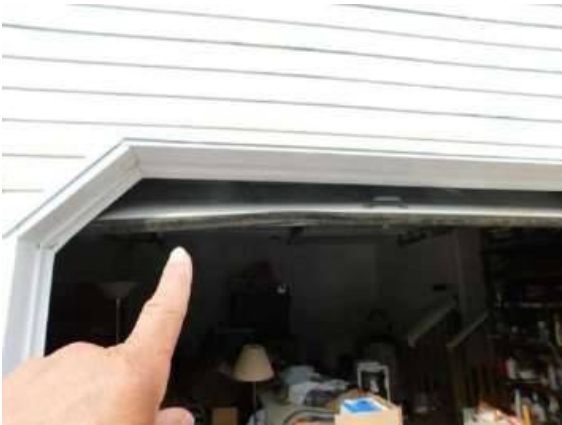
Photo 34-1

34) Replace - One or more garage vehicle doors were damaged or deteriorated. Recommend that a qualified contractor repair or replace door(s) as necessary.

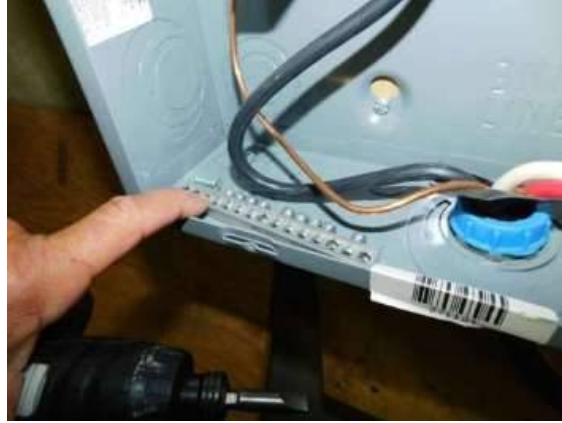
Photo 37-2 The ground bar that should be screwed to the metal panel is loose on the bottom of the panel.

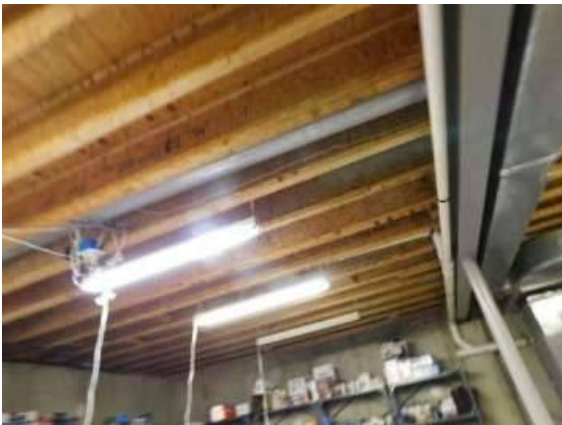
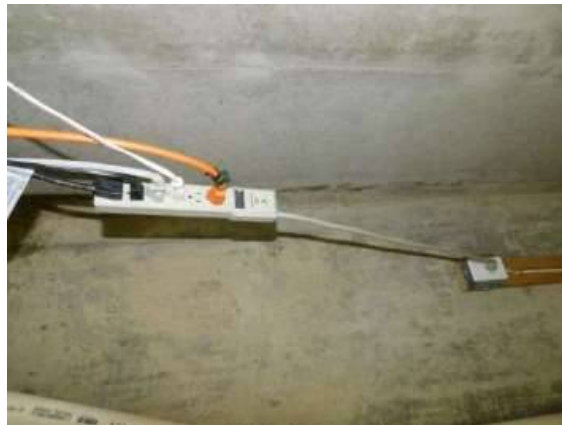
38) Material Defect/Safety, Replace - Extension cords were being used as permanent wiring particularly in the basement. They should only be used for portable equipment on a temporary basis. Using extension cords as permanent wiring is a potential fire and shock hazard, and indicates that wiring is inadequate and needs updating. Extension cords may be undersized. Connections may not be secure resulting in power fluctuations, damage to equipment, overheating and sparks that could start a fire. Recommend that a qualified electrician repair per standard building practices and eliminate extension cords for permanently installed equipment.

Photo 38-1 Two examples shown. Many exist.

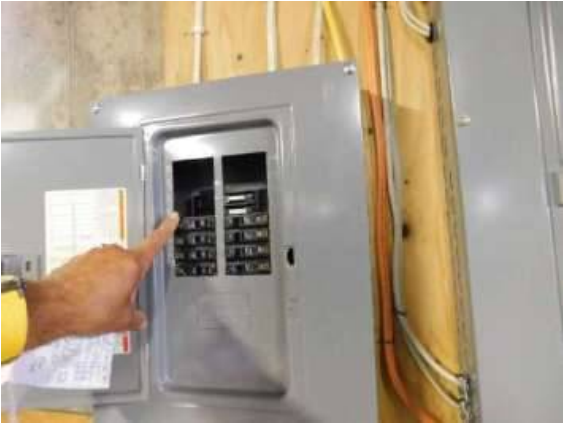
**Photo 39-1**

39) Material Defect/Safety, Repair/Maintain/Service - One or more slots where circuit breakers are normally installed were open in panel(s) B. Energized equipment was exposed and is a shock hazard. Recommend that a qualified person install closure covers where missing.

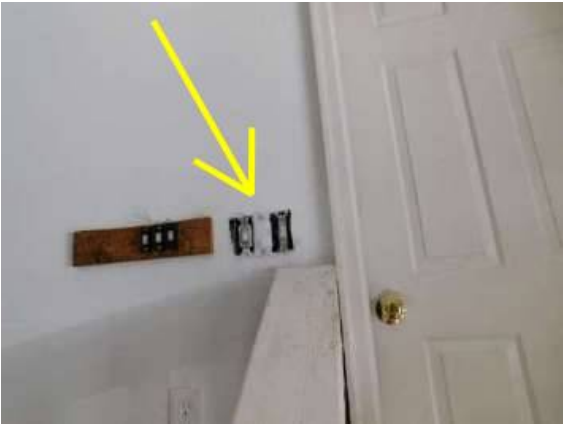
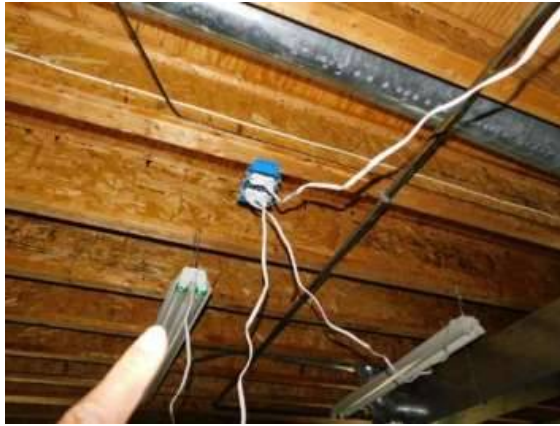
40) Material Defect/Safety, Repair/Maintain/Service - One or more cover plates for switches, receptacles (outlets) or junction boxes were missing or broken. These plates are intended to contain fire and prevent electric shock from occurring due to exposed wires. Recommend that a qualified person install cover plates where necessary.

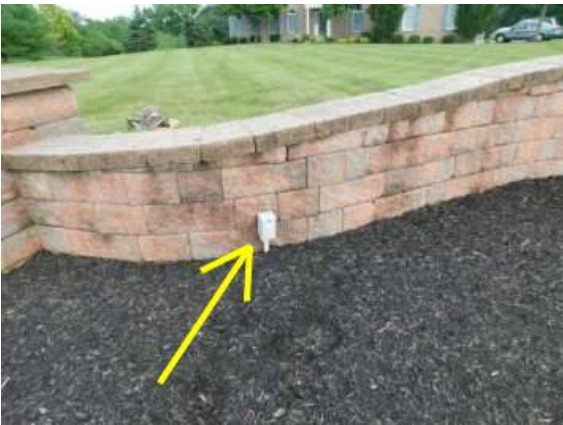
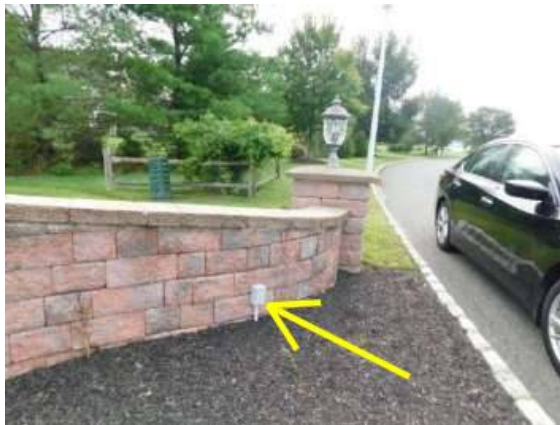
41) Replace, Evaluate - One or more electric receptacles (outlets) appeared to have no power. Recommend asking the property owner about this. Switches or timers may need to be operated to make some exterior receptacles energized. If necessary, recommend that a qualified electrician evaluate and repair.

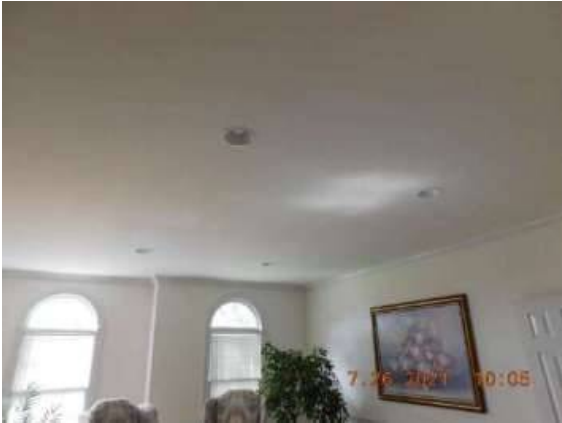
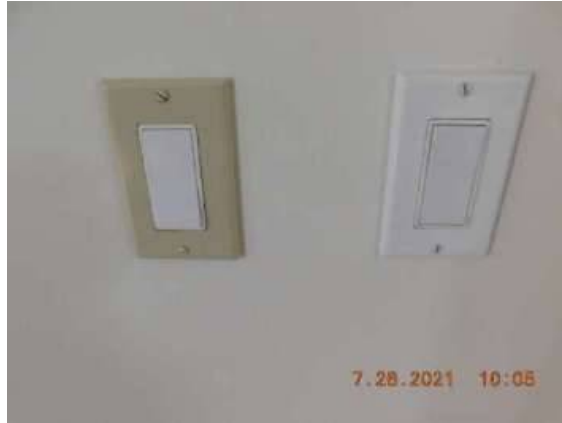
off correctly from both switches. This may be a safety hazard due to inadequate lighting. Recommend that a qualified electrician repair as necessary.

Photo 42-2 Both of these switches control the lights shown in the previous photo.

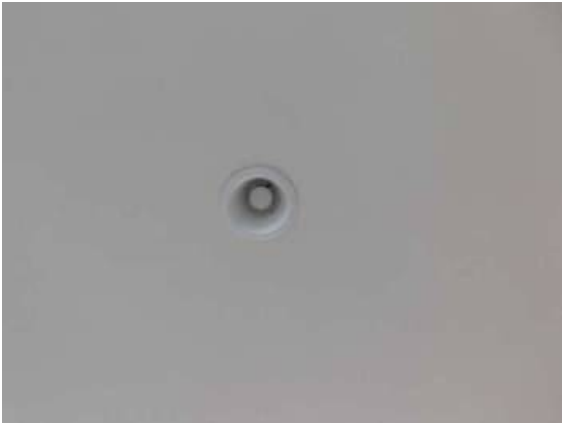
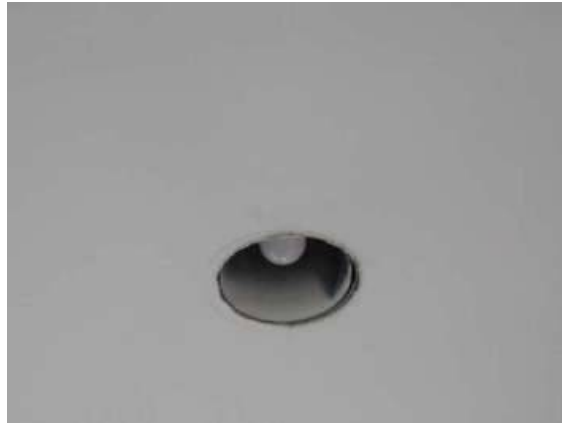
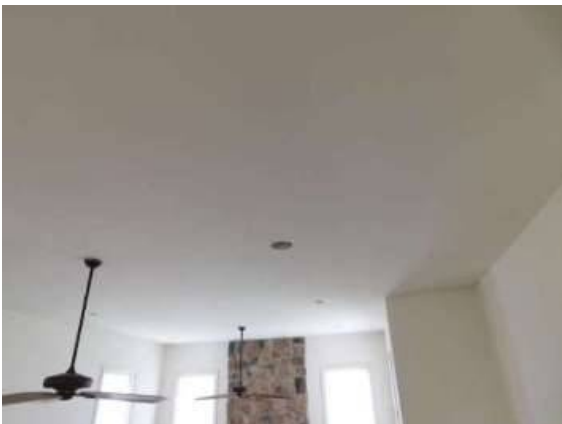
43) Repair/Maintain/Service - One or more trims pieces for a light fixture was missing. Recommend replacing as necessary to. As seen from the 2nd floor hall. The center hall ceiling has a recessed light that's missing the trim piece.

Photo 43-1 Light with the finishing trim.

Photo 43-2 And missing the finish trim.

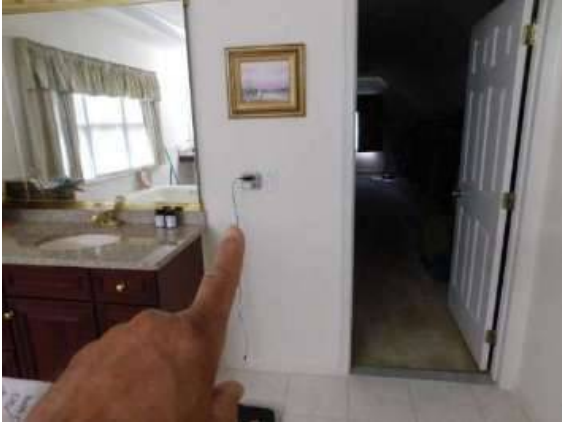
Photo 46-1

46) Comment/FYI - The GFCI outlet in the Master bath controls lights in the Master bath as well as the outlets in all the other bathrooms.

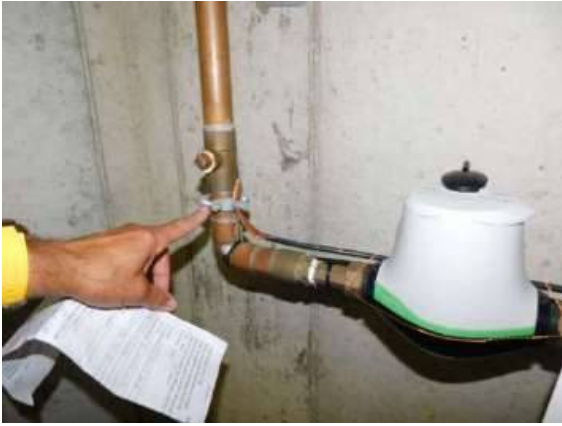
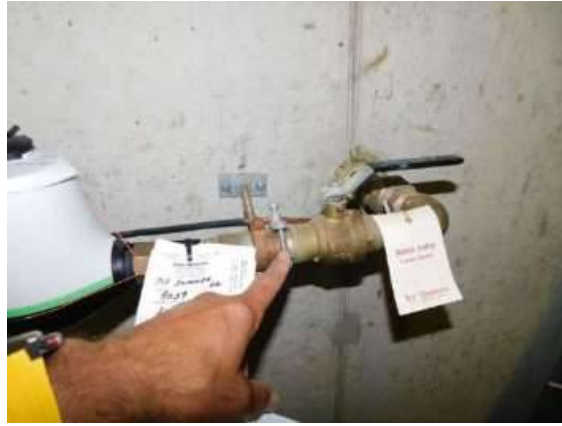
47) Repair/Maintain/Service - One or more bonding or grounding clamp(s) attached to copper water-supply pipes appeared to be made of steel. When these electrically energized dissimilar metals are in contact with each other, corrosion can occur on the water-supply pipes and result in leaks. Recommend that a qualified person replace steel clamps on copper pipes as necessary, with clamps made of brass, bronze or copper.

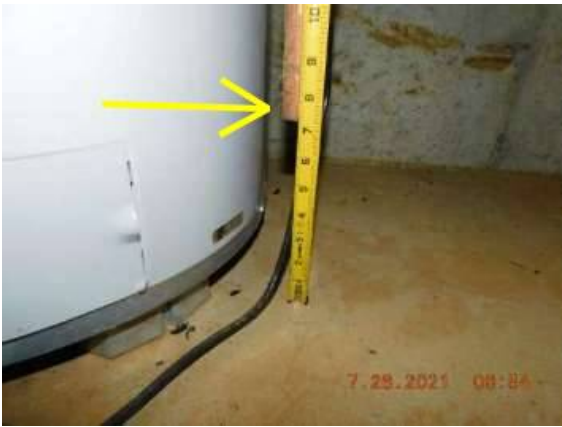
**Photo 51-1**

51) Material Defect/Safety, Replace - The temperature-pressure relief valve drain line was too short. This is a potential safety hazard due to the risk of scalding if someone is standing next to the water heater when the valve opens. Recommend that a qualified plumber repair per standard building practices. For example, by extending the drain line to within 6 inches of the floor, or routing it to drain outside.

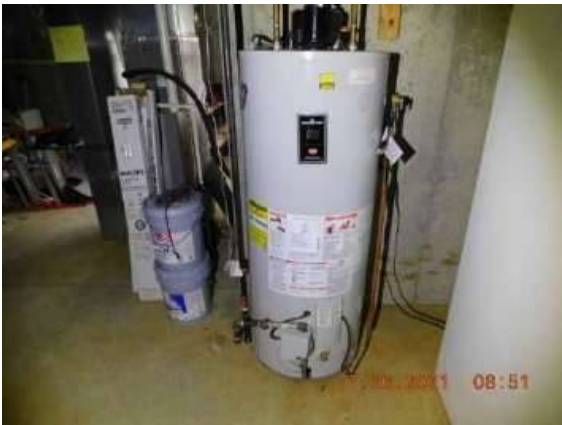
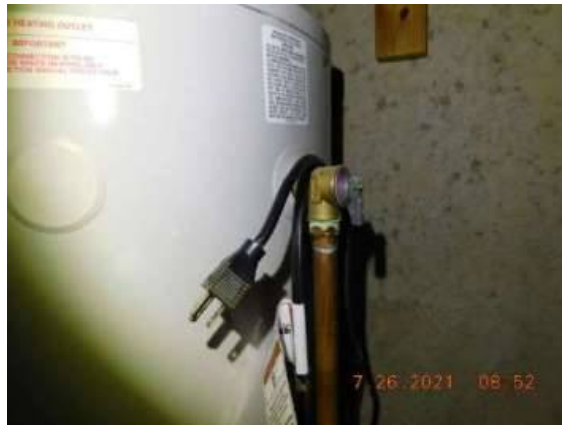
52) Material Defect/Safety, Exclusion, Evaluate, Comment/FYI - The water heater's power PVC chord was unplugged (for the unit near the electric panels). The water heater and hot water supply system (e.g. faucets, controls) were not fully evaluated because of this. Recommend that a full evaluation be made by a qualified person when conditions have been corrected so the water heater is operable. Note that per the standards of practice for various professional home inspection organizations, the inspector does not operate shut-off valves, pilot lights or over-current protection devices, or any controls other than "normal controls," or operate "any system or component which is shut down."

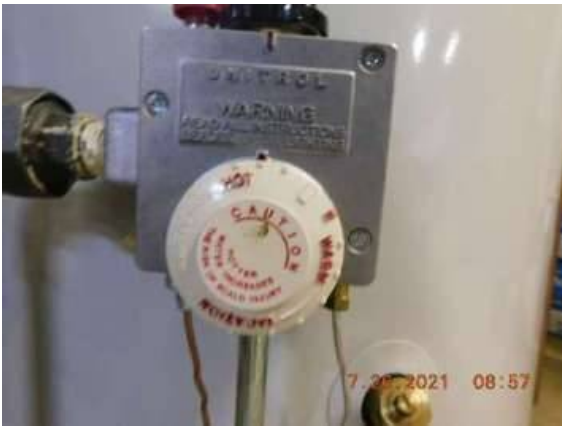
Photo 53-1 The thermostat for the office side water heater was set near the manufacturer's "HOT" setting. It should be lowered to a less hot setting.

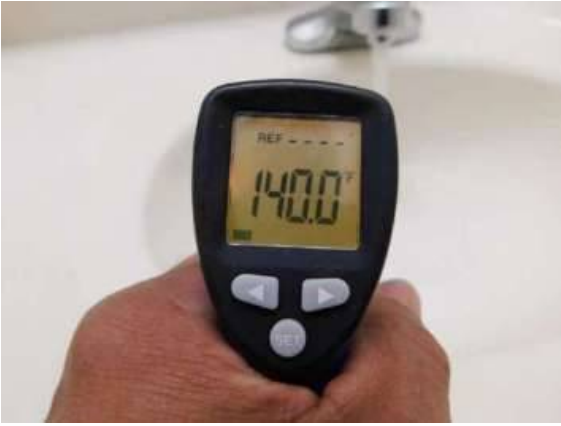
Photo 54-1 There is a roughly thirty degree difference between the hottest temperatures measured at the sink and tub at one of the second floor En Suite bathrooms.

Recommend evaluation by a licensed plumber and the blender valves be properly adjusted and then the water heater can be adjusted so that the water at all fixtures is correct.

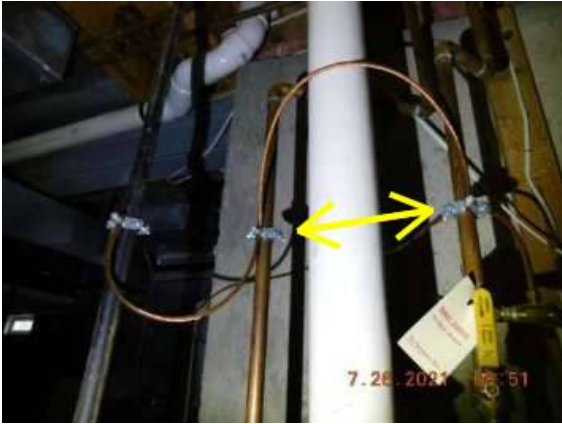
Photo 55-1

55) Repair/Maintain/Service - One or more bonding or grounding clamp(s) attached to copper water-supply pipes appeared to be made of steel. When these electrically energized dissimilar metals are in contact with each other, corrosion can occur on the water-supply pipes and result in leaks. Recommend that a qualified person replace steel clamps on copper pipes as necessary, with clamps made of brass, bronze or copper.

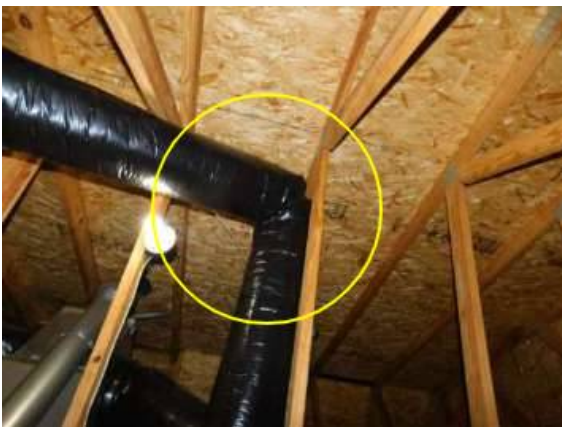
58) Repair/Maintain/Service, Evaluate - One or more heating or cooling ducts were crushed, kinked and/or in the attic. This appears to be resulting in reduced energy efficiency. As shown below, there were numerous examples seen of ducts that violate the generally accepted installation procedures for air duct; Namely that they exceed the bend radius resulting in a decrease in air flow. Additionally, some ducts appear to have multiple violations of the bend radius guidelines. Recommend that qualified HVAC contractor evaluate and repair or replace ducts or components as necessary.

Photo 58-1 This bend is slightly sharper than 90 degrees.

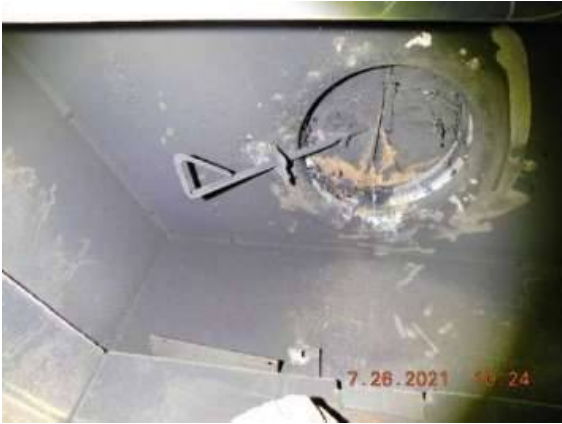
Photo 67-1

67) Material Defect/Safety, Replace - A fireplace was equipped with a gas burner and the chimney damper could close. This is a safety hazard due to the possibility of burner or pilot light exhaust gases entering living spaces. Modifications should be made to prevent the damper from ever closing to prevent this. A qualified contractor should repair per standard building practices so the damper cannot close.

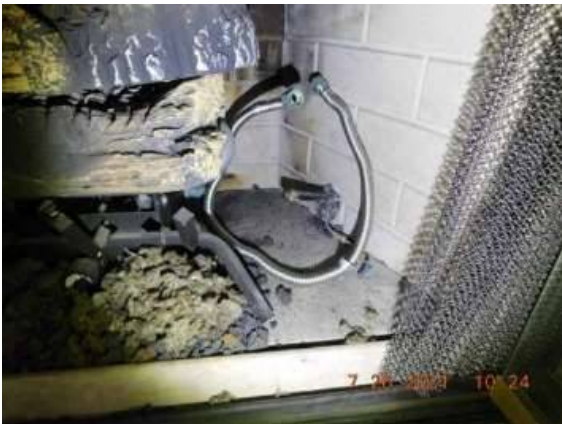
Photo 69-1

69) Evaluate - The gas fireplace was not fully evaluated because the main gas line for the fireplace was disconnected and therefore, the pilot light was off. The inspector only operates normal controls (e.g. on/off switch or thermostat) and does not light pilot lights or, "operate [gas] shut-off valves" or "operate any system or component which is shut down" in accordance with NJ home inspection laws. Recommend that the client review all documentation for such gas appliances and familiarize themselves with the lighting procedure. If necessary, a qualified specialist should assist in lighting such appliances, and make any needed repairs.

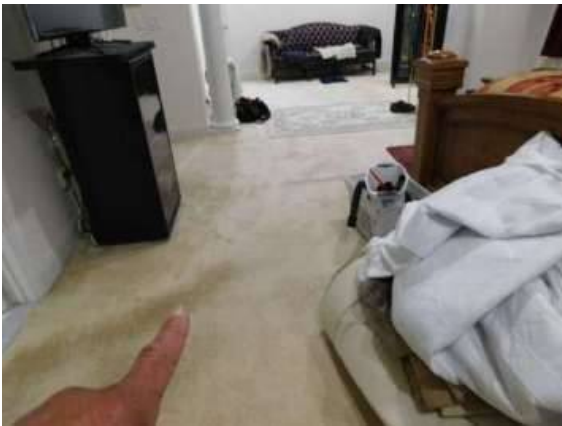
Photo 80-1

80) Replace, Evaluate - Squeaking or creaking noises occur when walking on one or more sections of flooring. This is usually caused by substandard construction practices where the sub-floor decking is not adequately fastened to the framing below. For example, not enough glue was used and/or nails were used rather than screws. In most cases, this is only an annoyance rather than a structural problem. Various solutions such as [Squeeeeeek No More and Counter Snap fasteners](#) exist to correct this. Repairs to eliminate the squeaks or creaks may be more or less difficult depending on the floor covering and the access to the underside of the sub-floor. Recommend that a qualified contractor evaluate and repair as necessary.

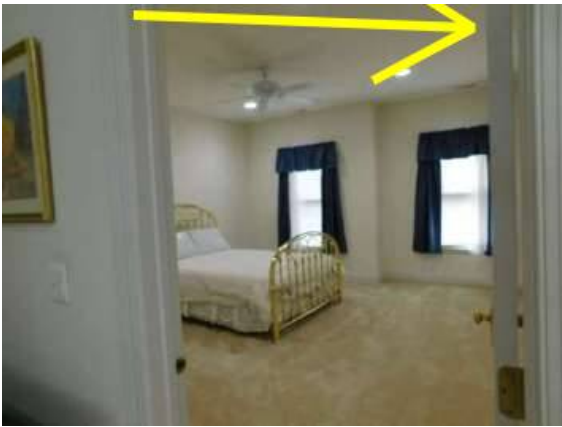
**Photo 82-1**

82) Repair/Maintain/Service - One or more interior doors were sticking in the door jamb and were difficult to operate. Recommend that a qualified person repair as necessary. For example, by trimming doors.
