Regal Home Inspections, LLC

Property Inspection Report Seller's Inspection

**Property address: 6 Any Street
Marlboro, NJ 07746**

Inspection date: Sunday, November 14, 2021

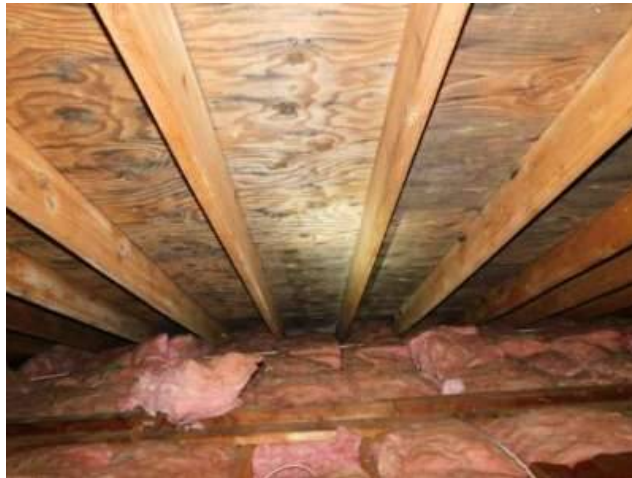
**Photo 1-6**

1) Repair/Maintain/Service, Evaluate - Microbial growths (Which could possibly be mold) were found at one or more locations in the attic. It is beyond the scope of this inspection to identify what substance or organism this staining is. However such staining is normally caused by excessively moist conditions, which in turn can be caused by plumbing or building envelope leaks and/or substandard ventilation. These conducive conditions should be corrected before making any attempts to remove or correct the staining. Normally affected materials such as drywall are removed, enclosed affected spaces are allowed to dry thoroughly, a mildewcide may be applied, and only then is drywall reinstalled. For evaluation and possible mitigation, consult with a qualified industrial hygienist or mold/moisture mitigation specialist.

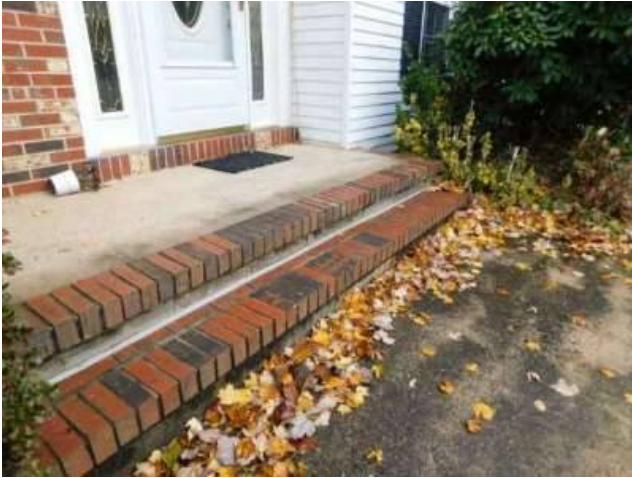
7) Material Defect/Safety, Repair/Maintain/Service - The risers for stairs at the front varied in height and pose a fall or trip hazard. Risers within the same flight of stairs should vary by no more than 3/8 inch. At a minimum, be aware of this hazard, especially when guests who are not familiar with the stairs are present. Recommend that a qualified contractor repair per standard building practices.

Photo 7-1 Close up of these steps in the next photos.

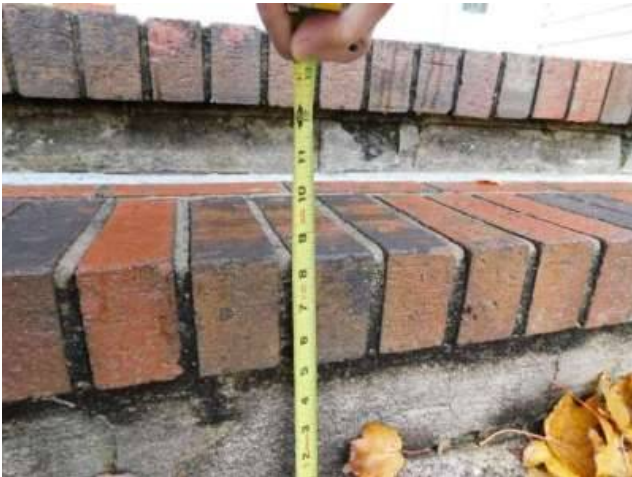
Photo 7-3 Approx. 8 & 1/4 inches.

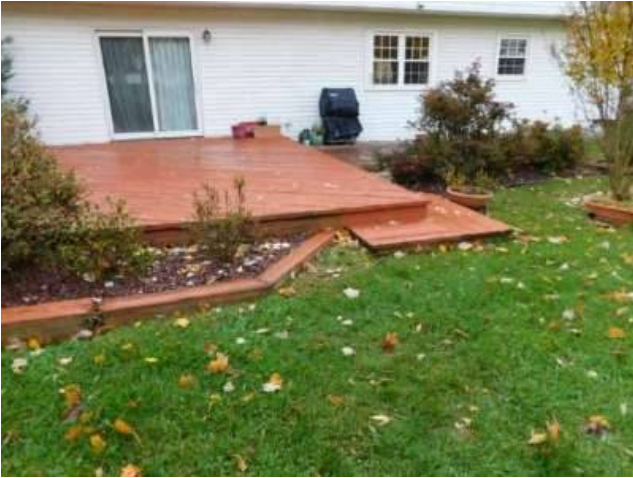
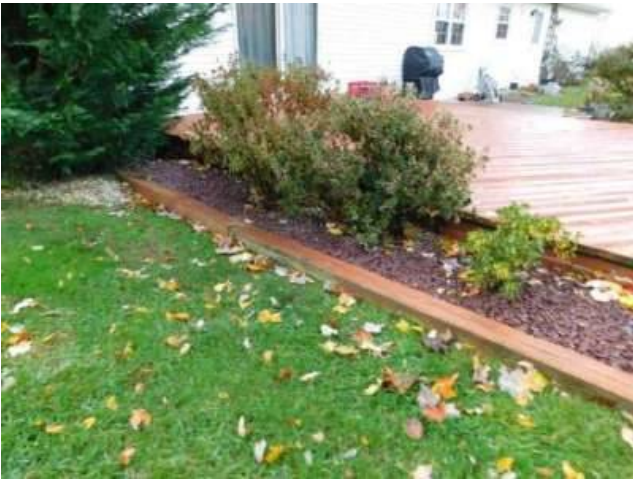
8) Repair/Maintain/Service - Soil was in contact with or too close to wooden deck substructure components. This is a conducive condition for wood-destroying organisms. Clearances to soil should be as follows:

It appears that this deck may be made with stringers. Stringers are joists that are resting on the ground. These are particularly susceptible to rot.

Pressure treated wood is typically rated for 25 year contact with soil, but the cut ends hidden below grade may not have been treated and can rot quickly. Support posts should be elevated above grade on concrete piers or footings, and be separated from the concrete by metal brackets or an impermeable membrane such as shingle scraps. For other components, soil should be graded and/or removed to maintain these clearances if possible. Otherwise, replacing non-treated wood with treated wood, or installing borate-based products such as Impel rods may help to prevent infestation and damage.

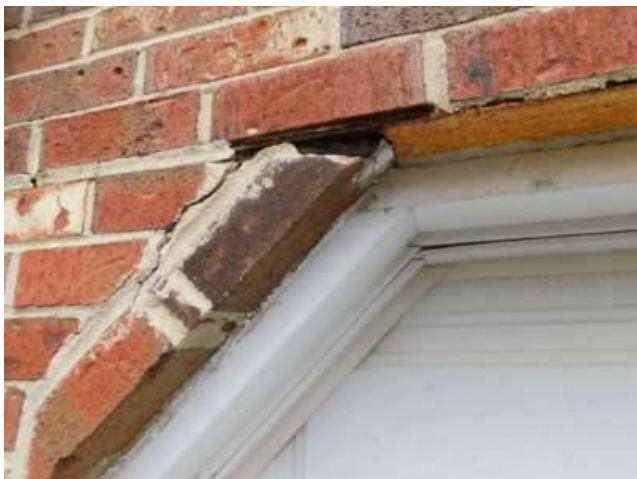
Photo 11-1

11) Repair/Maintain/Service, Maintain - Lintels are structural elements that support the weight of the brick over openings like windows and doors. Lintels are made of iron and often rust. Lintels are also embedded approximately 6 inches past the openings on either side to anchor them structurally. Over time lintels will rust. The rust can increase the size of the lintel and often applies upward force to the bricks causing cracks. Some cracking seen here. Required that a qualified mason repair by sealing all gaps and sealing the exposed lintels from moisture that will continue the corrosion. Thereafter, recommend maintaining the lintels by using a rust inhibiting paint and maintaining seals at the seams between the lintels and the brick.

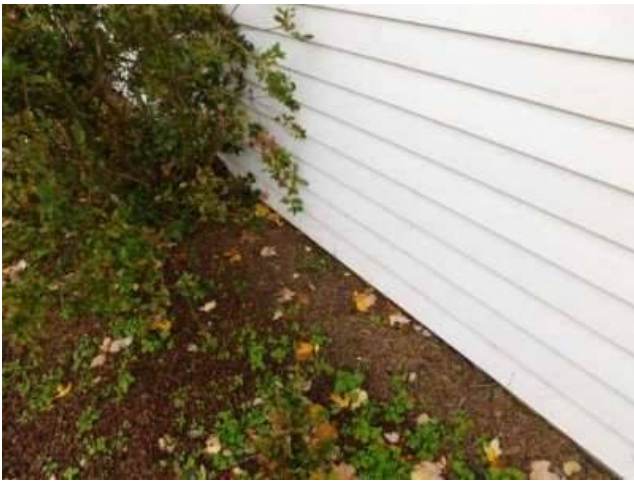
**Photo 12-1**

12) Repair/Maintain/Service - Soil was in contact with or less than 6 inches from siding or trim. Regardless of what material is used for siding, it should not be in contact with the soil. If made of wood, siding or trim will eventually rot. For other materials, ground or surface water can infiltrate siding or trim and cause damage to the wall structure. Wood-destroying insects are likely to infest and damage the wall structure. This is a conducive condition for wood-destroying organisms. Recommend grading or removing soil as necessary to maintain a 6-inch clearance. Note that damage from fungal rot and/or insects may be found when soil is removed, and repairs may be necessary.

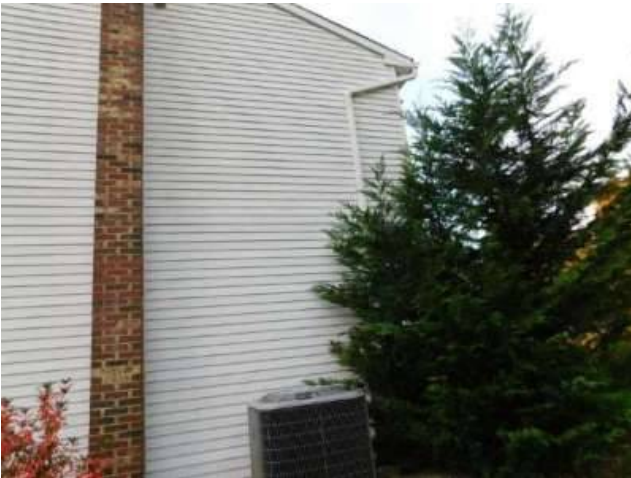
Photo 15-1

15) Maintain - Vegetation such as trees, shrubs and/or vines was in contact with or close to the building exterior. Vegetation can serve as a pathway for wood-destroying insects and can retain moisture against the exterior after it rains. This is a conducive condition for wood-destroying organisms. Recommend pruning, moving or removing vegetation as necessary to maintain at least 6 inches of space between it and the building exterior. A 1-foot clearance is better.

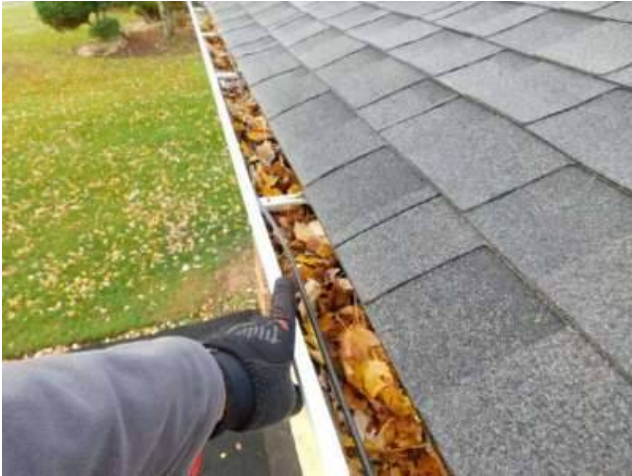
Photo 16-1

16) Maintain - Significant amounts of debris have accumulated in one or more gutters or downspouts. Gutters can overflow and cause water to come in contact with the building exterior, or water can accumulate around the foundation. This is a conducive condition for wood-destroying organisms. Recommend cleaning gutters and downspouts now and as necessary in the future.

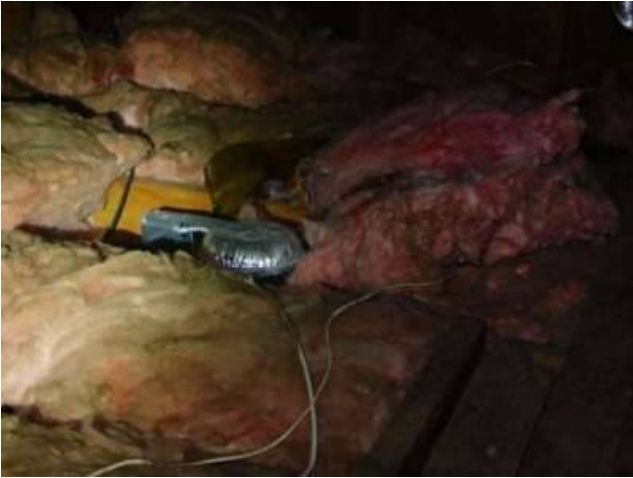
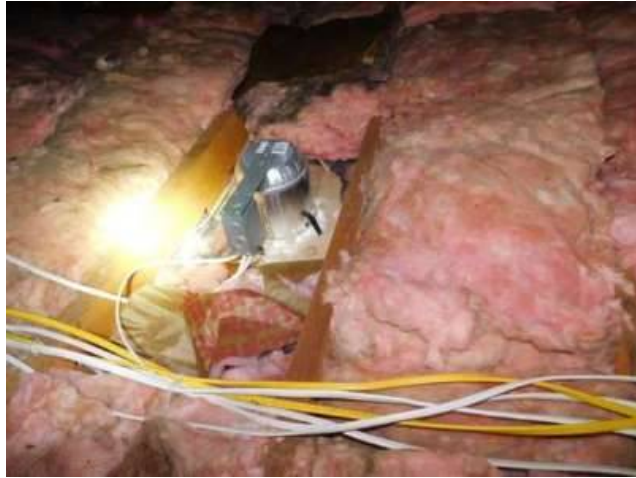
20) Repair/Maintain/Service, Evaluate - One or more recessed "can" lights were installed in the attic and there was no insulation around them. The inspector was unable to find a label or markings that indicated that these lights are designed to be in contact with insulation. If lights are not "IC" rated then putting insulation in contact may be a fire hazard. However, no insulation allows for warm moist 2nd floor air to rise into the attic. This A) Is energy inefficient and B) The rising, warm moist air will cause condensation in the attic in the cold of winter which, in turn, can cause mold. Recommend further evaluation by a qualified contractor to determine if these lights are rated for contact with insulation. If they aren't, or if their rating can't be determined, then recommend that a qualified person repair as necessary to prevent air from escaping into the attic. For example, by installing shields around lights and installing insulation over the shields.

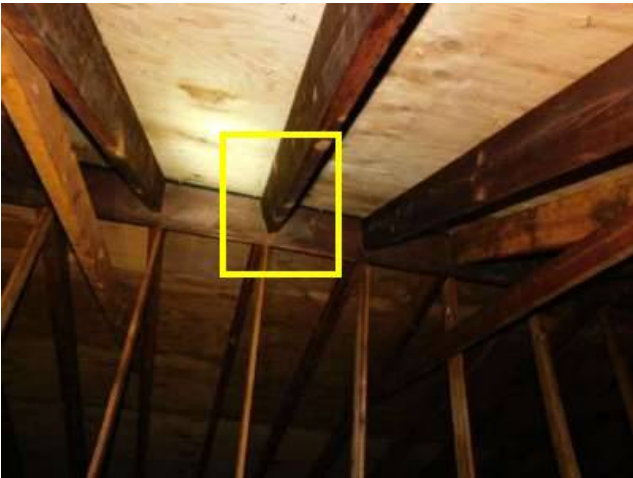
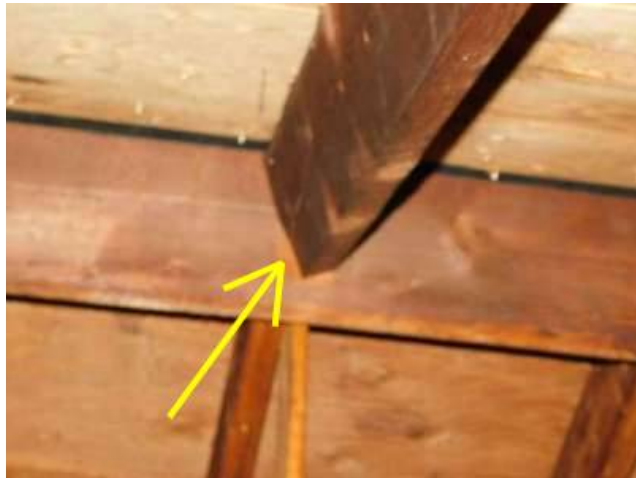
22) Repair/Maintain/Service - One or more rafters in the roof structure were twisted. This may weaken the roof structure or effect the plywood's attachment to the rafters or cause the nails that hold the shingles down to pull out. Recommend that a qualified contractor repair as necessary. For example, by installing blocking between adjacent rafters to prevent them from twisting.

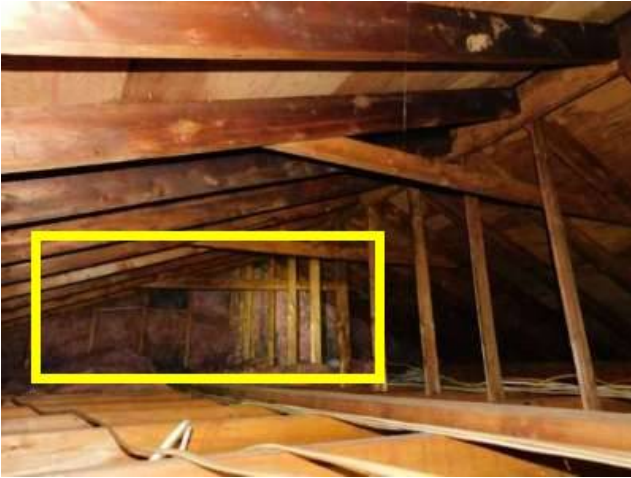
**Photo 23-1**

23) Repair/Maintain/Service - Attic insulation at one or more skylight chases or attic walls was substandard as seen in the garage. Heating and cooling costs will likely be higher due to reduced energy efficiency. Recommend that a qualified person repair, replace or install insulation as necessary and per standard building practices.

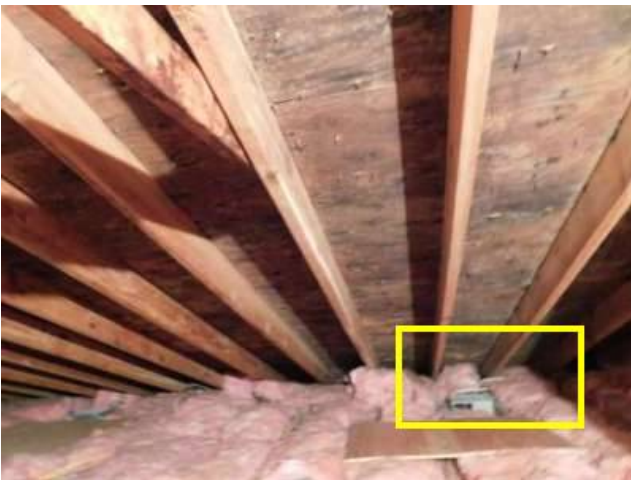
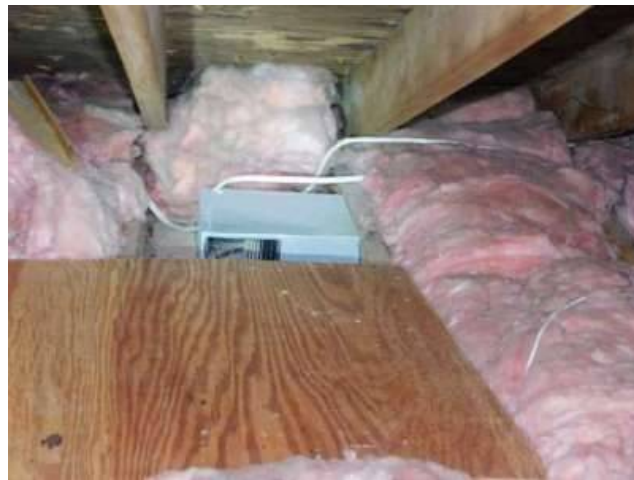
24) Repair/Maintain/Service - Both bathroom exhaust vents discharge into the attic. One is shown below. The duct must be exhausted to the building's exterior. Exhausting the warm, moist air from a bathroom into the attic can cause condensation in the winter on the inside of the roof surface where the warm moist air abuts the cold winter air outside. This will create a condition that is conducive to mold growth and damage the plywood roof sheathing. That condition was seen at this location. Please refer to the General Information section. Recommend that a qualified contractor install exhaust hoods so the warm, moist air discharges to the exterior.

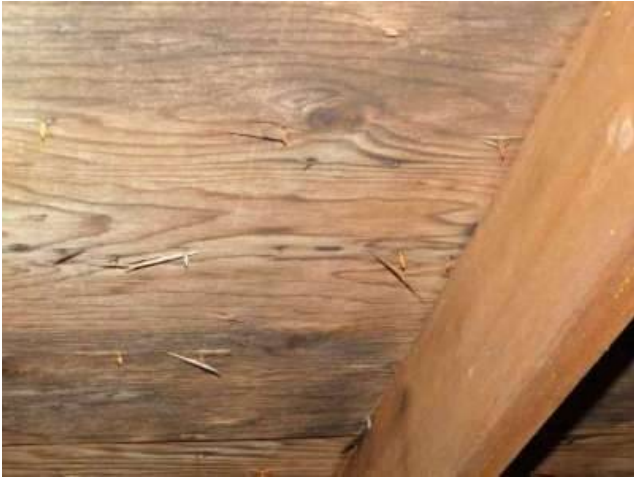
**Photo 25-1**

25) Repair/Maintain/Service - The ill effects of a combination of living space air escaping into the attic (poor ceiling insulation and not an insulated attic hatch are prime causes) and inadequate ventilation can be seen in the staining around the nail shanks on the interior of the upper attic roof sheathing/plywood. When the warm moist air rises through the uninsulated attic hatch, through recessed lights, poorly insulated ceilings, etc. and hits against the very cold roof surface/plywood sheathing in the cold of winter, the warm moist air condenses. This condensation can be seen as frost on the nail shanks. As the attic space heats up, the frost melts and once can actually see a drop of water hanging from the nail. This causes the black staining on the plywood and the nails to rust. The rust is caused by water on the inside, not because of a leak and water coming in from the outside. The best way to prevent this is to A) Heavily insulate the ceiling above the second floor living area including the hatch and B) Having as much ventilation as possible in the attic space. In the winter, the attic area should be the same temperature inside the attic as it is outside the attic. This along with good second level ceiling insulation will prevent the condensation.

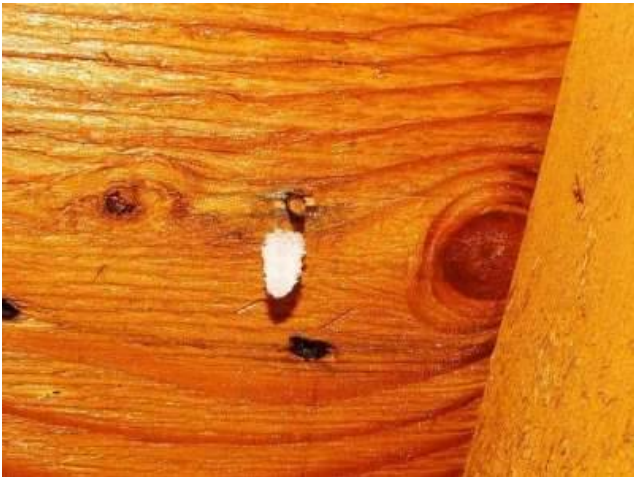
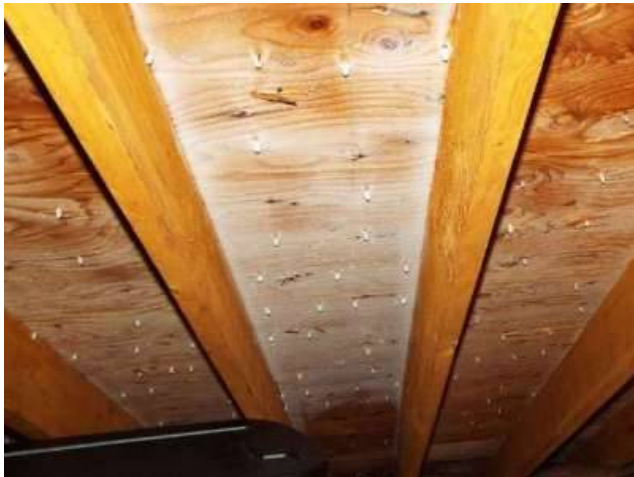
Photo 25-5 Here and the next photo are examples from another house a few winters ago. This is frost on a nail. The next is frost on the plywood and on the nails.

Photo 25-6 This is the same condition that's causing the microbial growths as reported in this inspection report.

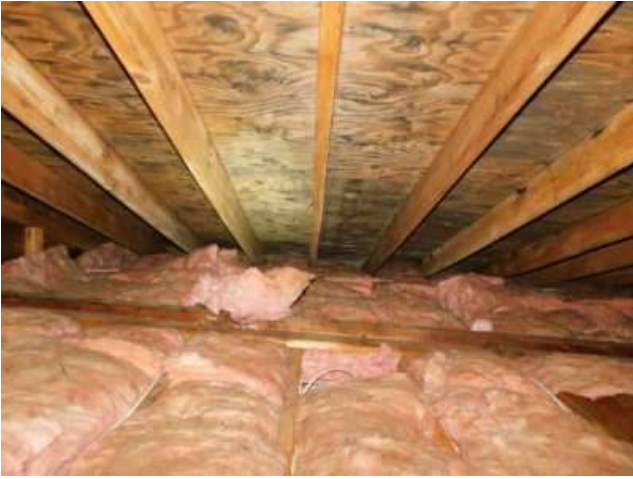
Photo 26-1

Moisture from condensation is also likely to accumulate in the roof structure and/or attic and can be a conducive condition for wood-destroying organisms. Recommend that a qualified person repair as necessary so air flows freely through all vents. For example, by moving or removing insulation and installing cardboard baffles.

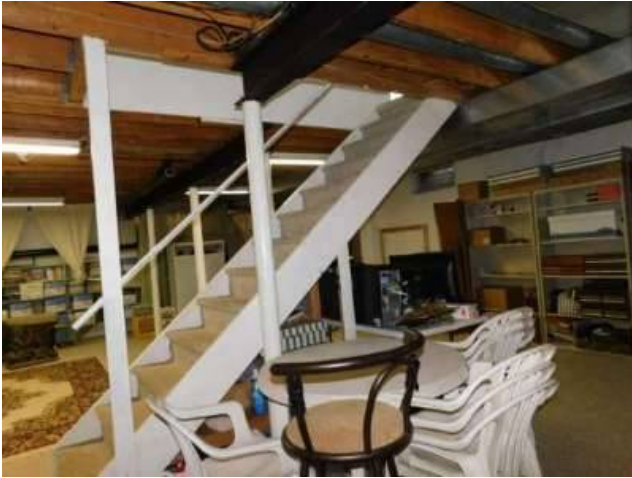
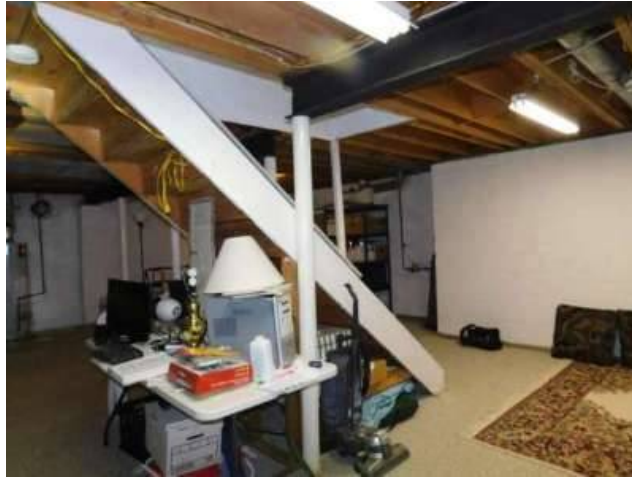
27) Material Defect/Safety, Replace - Handrails at one or more flights of stairs were missing. This is a potential fall hazard. Handrails should be installed at stairs with four or more risers or where stairs are greater than 30 inches high. Recommend that a qualified contractor install handrails where missing and per standard building practices.

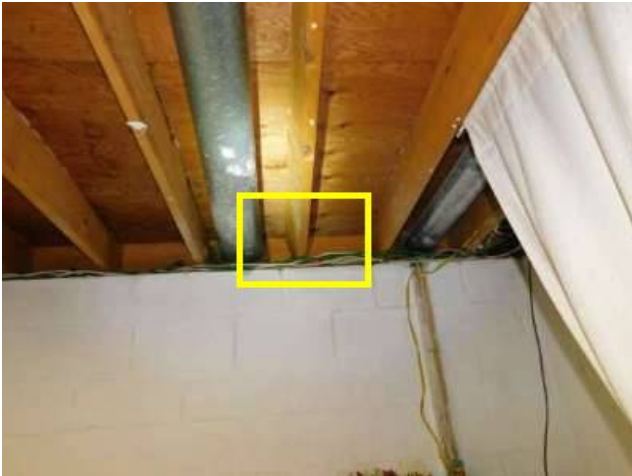
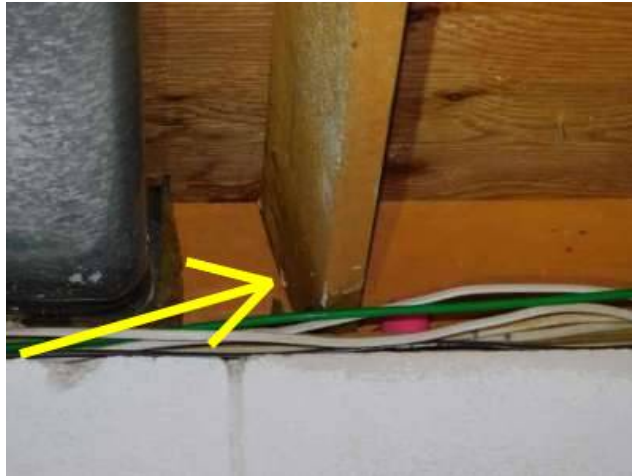
28) Repair/Maintain/Service, Evaluate - One or more joists in the floor structure were twisted. This may weaken the floor structure or effect the floor's condition above. Recommend that a qualified contractor repair as necessary. For example, by installing blocking between adjacent joists to prevent them from twisting.

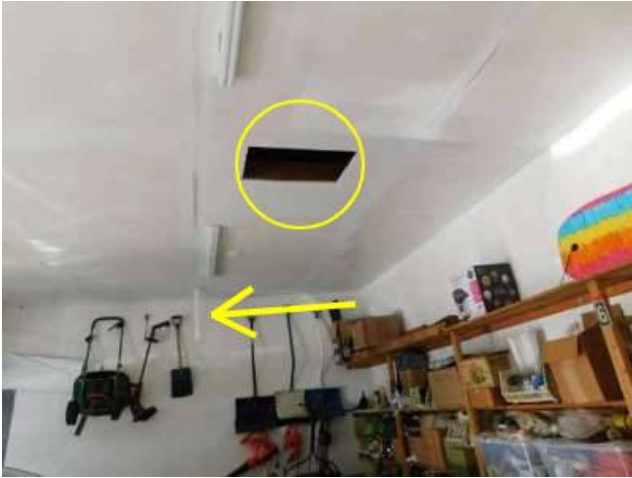
31) Material Defect/Safety, Repair/Maintain/Service - The attic access hatch cover in the attached garage ceiling was missing. Current standard building practices call for wooden-framed ceilings and walls that divide the house and garage to provide limited fire-resistance rating to prevent the spread of fire from the garage to the house. This includes having an access hatch cover installed that is in good condition, with similar fire-resistance.

There were also some ceiling spackle, taping seams that were peeling back. These too need to be properly repaired to provide the needed fire protection.

Photo 31-1 The hatch in this photo (Inside the circle) and the tape seams (Arrow) require repair.

Recommend that a qualified person replace or repair hatch cover(s) per standard building practices.

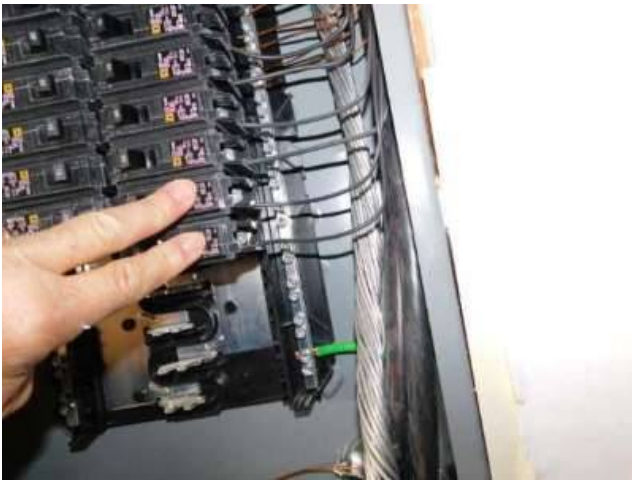
Photo 34-1

There are at least 2, 14 gauge wires connected to 20amp circuit breakers.

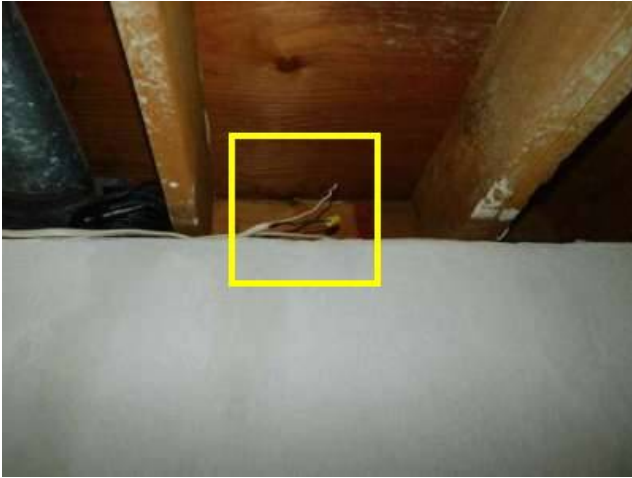
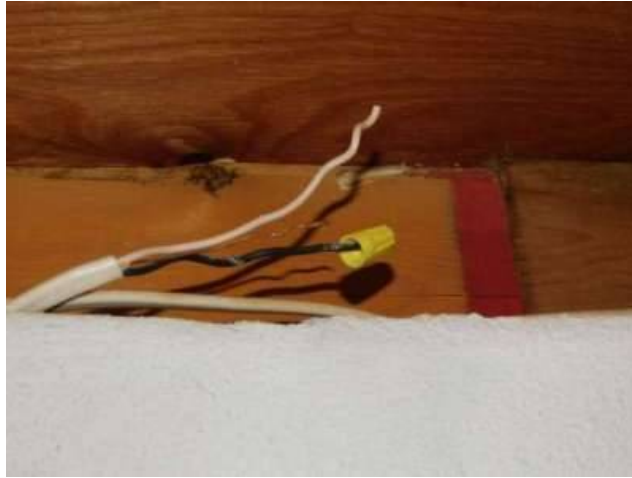
35) Material Defect/Safety, Replace - Bare wire ends, or wires with a substandard termination, were found at one or more locations. This is a potential shock hazard. Required that a licensed electrician repair as necessary. For example, by cutting wires to length and terminating with wire nuts in a permanently mounted, covered junction box.

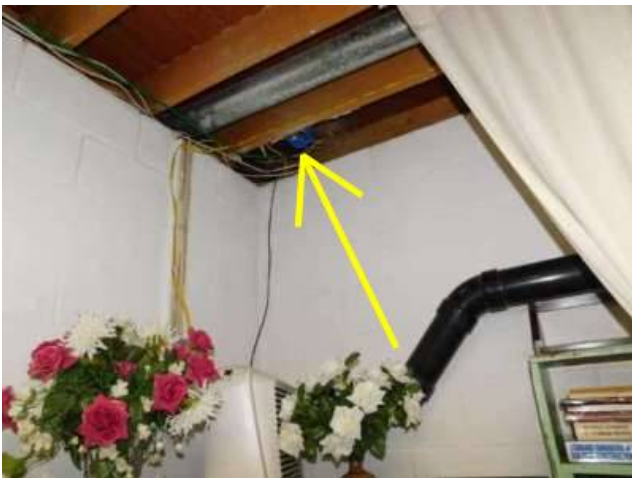
Photo 37-1

37) Material Defect/Safety, Repair/Maintain/Service - One or more cover plates for switches, receptacles (outlets) or junction boxes were missing or broken. These plates are intended to contain fire and prevent electric shock from occurring due to exposed wires. Required that a licensed electrician install cover plates where necessary.

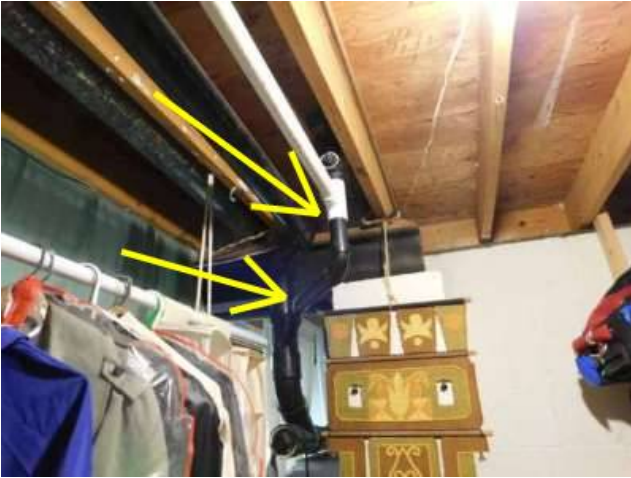
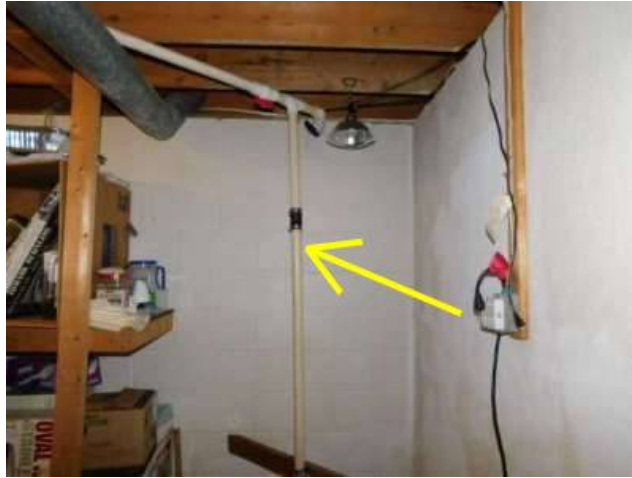
41) Repair/Maintain/Service, Evaluate - The drain location for the sump pump's discharge pipe may be in a substandard manner and violate local plumbing standards. Requires consultation with a licensed plumber familiar with Marlboro's local plumbing rules to determine if the location of the sump pump discharge pipe, into the public waste is allowed. Discharge pipes should usually terminate well away from foundations to soil sloping down and away so water doesn't accumulate around the foundation or in crawl spaces or basements, not into the public waste. If its termination does violate local standards, it's required that a licensed plumber repair per standard building practices.

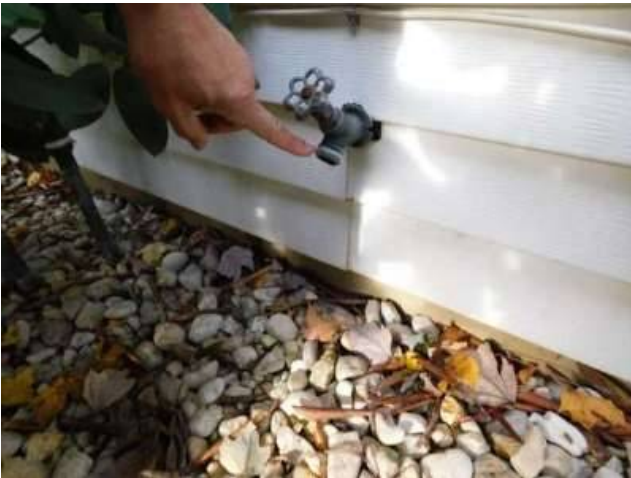
**Photo 42-1** Front.

42) Repair/Maintain/Service - One or more hose bibs (outside faucets) leaked while off (Leaking upon arrival). When hose bibs leak while turned off, it's often caused by a worn valve seat or a loose bonnet. When hose bibs leak while turned on, it may be due to worn "packing" around the stem or a defective backflow prevention device. Recommend that a qualified plumber repair as necessary.

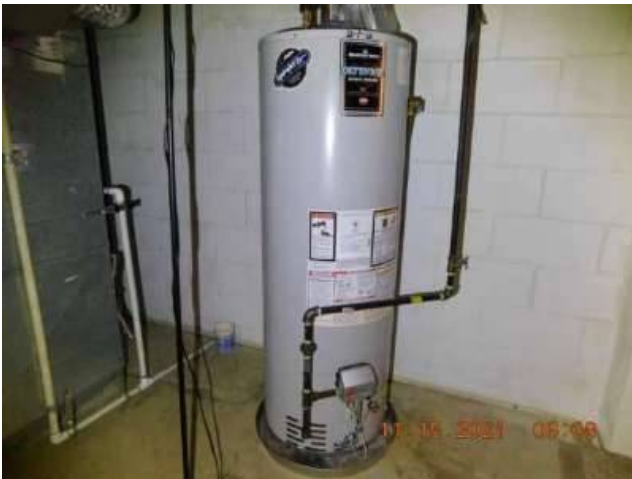
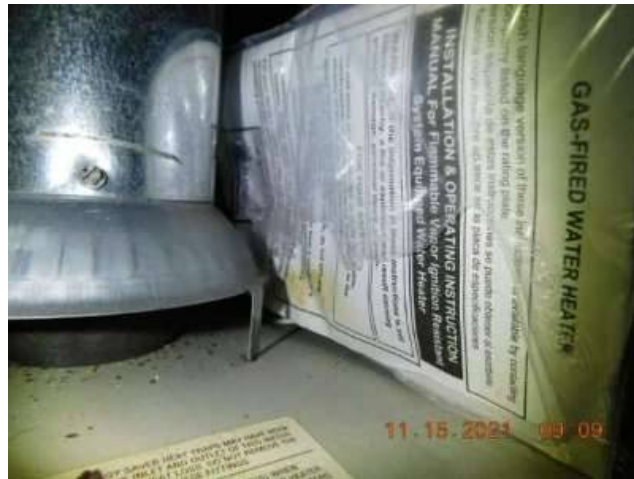
49) Material Defect/Safety, Replace, Evaluate - Exhaust gases were "back drafting" out of the water heater's draft hood. The flue pipe may be configured incorrectly, blocked or damaged. This is a safety hazard due to the risk of exhaust gases entering living spaces. A qualified contractor should evaluate and repair as necessary.

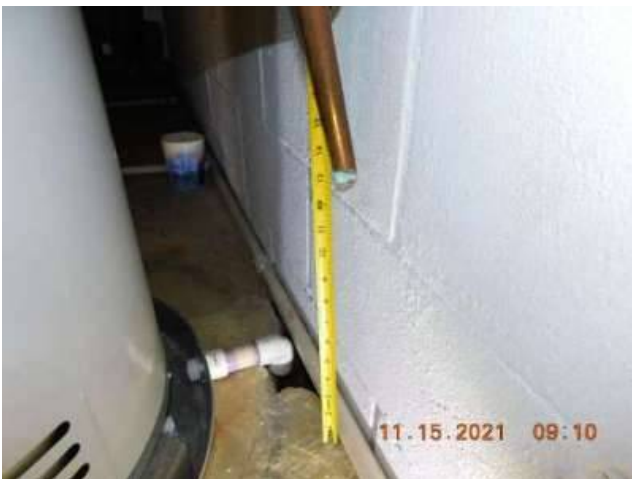
Photo 50-1

50) Material Defect/Safety, Replace - The temperature-pressure relief valve drain line was too short. This is a potential safety hazard due to the risk of scalding if someone is standing next to the water heater when the valve opens. Recommend that a qualified plumber repair per standard building practices. For example, by extending the drain line to within 6 inches of the floor, or routing it to drain outside.

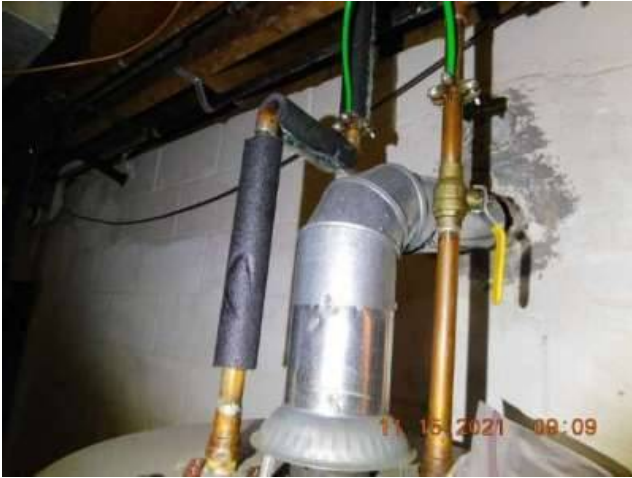
**Photo 51-1**

51) Material Defect/Safety, Exclusion - Foam insulation on water supply lines above the gas-fired water heater was too close to the draft hood. This insulation is flammable and a fire hazard. Insulation should be removed so it's at least 6 inches from the draft hoods.

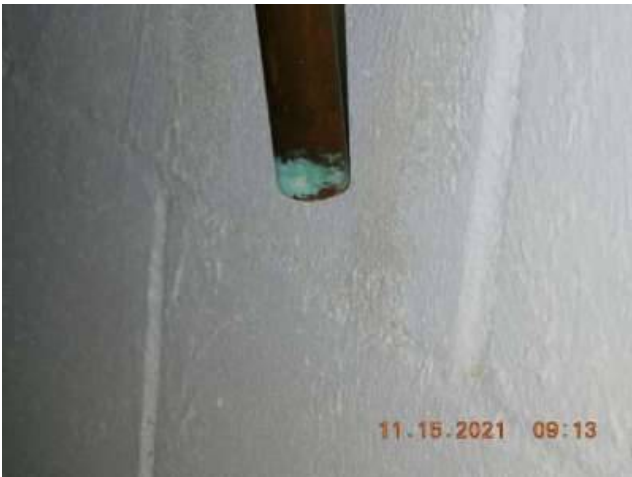
Photo 53-1

53) Replace - The temperature-pressure relief valve was leaking, based on corrosion seen at the end of the drain line. Recommend that a qualified plumber repair as necessary. For example, by replacing the valve.

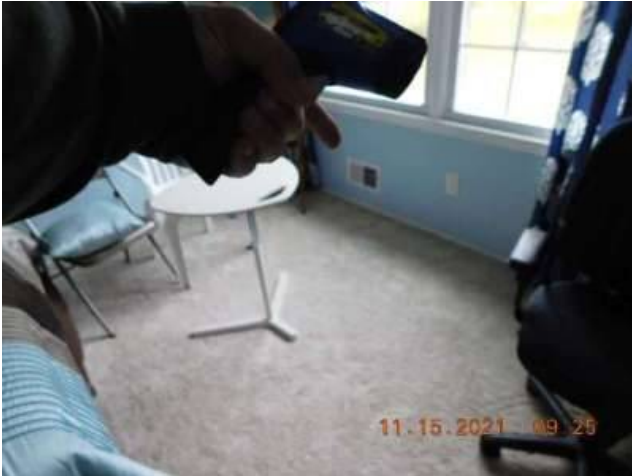
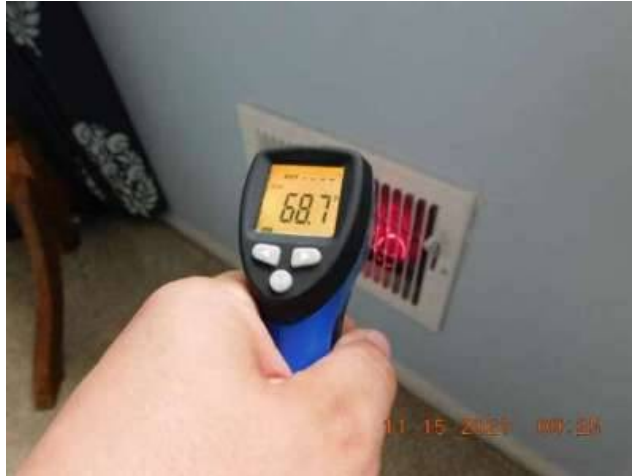
56) Replace, Evaluate - One or more heating or cooling air supply registers had a weak air flow, or no apparent flow. This may result in an inadequate air supply. Recommend asking the property owner about this. Adjustable damper(s) in ducts may exist and be reducing the flow. If dampers exist, then they should be opened to attempt to improve the air flow. If the property owner is unaware of such dampers, or if adjusting dampers does not improve the air flow, then recommend that a qualified HVAC contractor evaluate and repair or make modifications as necessary.

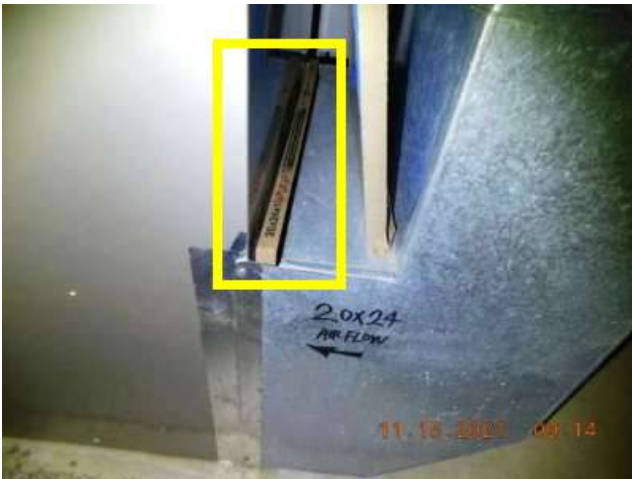
Photo 59-1

59) Repair/Maintain/Service - One or more forced air furnace's filter chamber does not have a cover. Without a cover to seal the filter chamber the air filtering system does not operate properly and consequently the air quality and efficient air flow may be compromised. Recommend sealing the chamber. One option is <https://www.allergyzone.com/collections/clean-air-accessories/products/filterlock-furnace-filter-slot-seal> Recommend that this cover, or something similar, be used to seal the opening over the air filter.

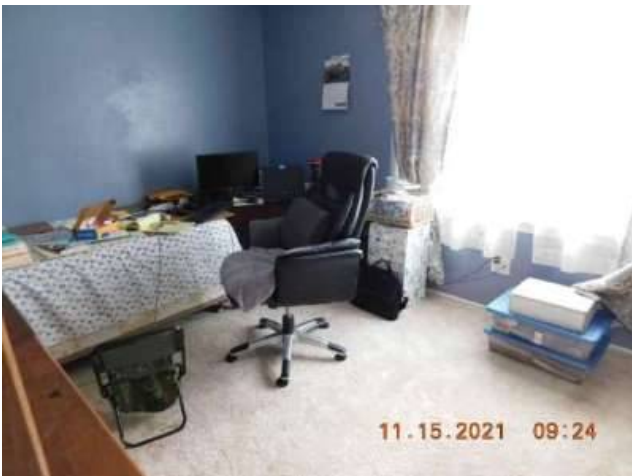
Photo 60-1 No air supply registers were accessible in this room.

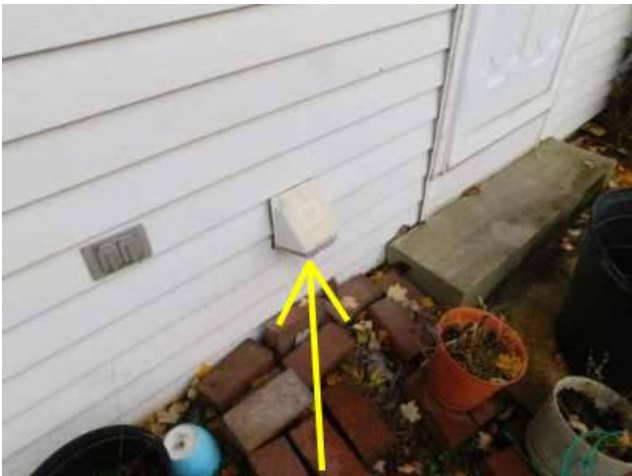
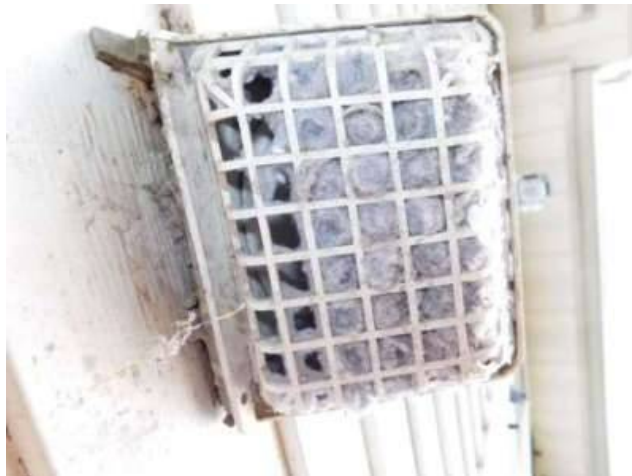
69) Repair/Maintain/Service - The clothes dryer exhaust duct was clogged, kinked, crushed, or damaged. Air flow will be restricted as a result and the clothes dryer may overheat. This is a safety hazard due to the risk of fire. Recommend that a qualified person clean, replace, or repair the duct as necessary.

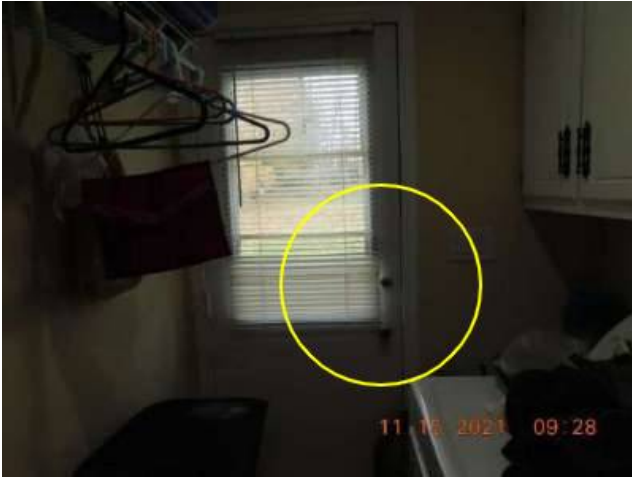
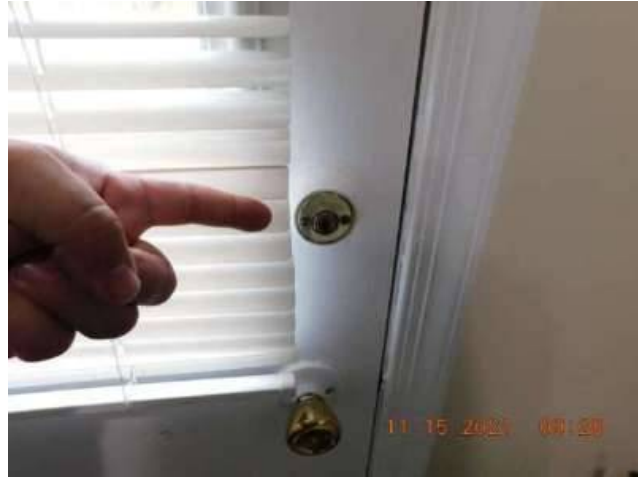
73) Material Defect/Safety, Replace - One or more exterior doors had double-cylinder deadbolts installed, where a key is required to open them from both sides. This can be a safety hazard in the event of an emergency because egress can be obstructed or delayed. Recommend replacing double-cylinder deadbolts with single-cylinder deadbolts where a handle is installed on the interior side.

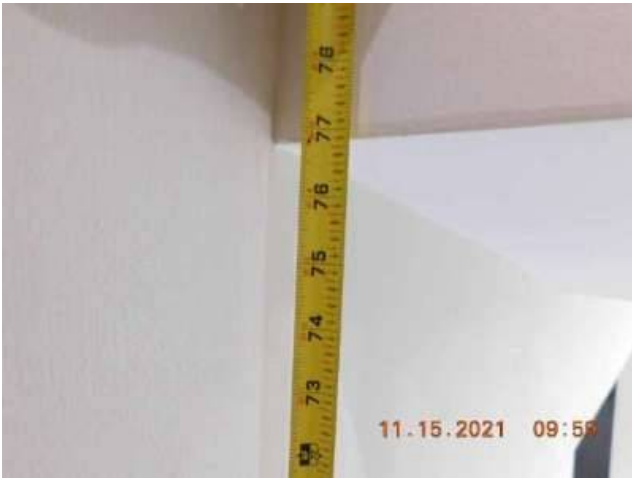
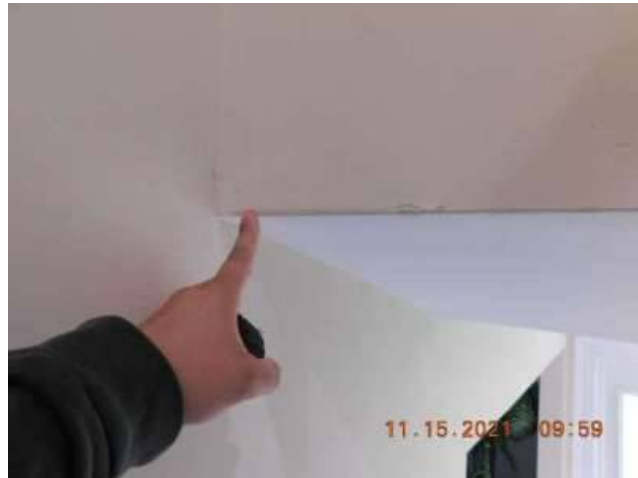
74) Material Defect/Safety, Replace - The ceiling height over stairs at one or more locations was too low and poses a safety hazard, especially for tall people. Ceilings over stairs should be at least 6 feet 8 inches high. At a minimum, be aware of this hazard, especially when guests who are not familiar with the stairs are present. Recommend that a qualified contractor repair per standard building practices.

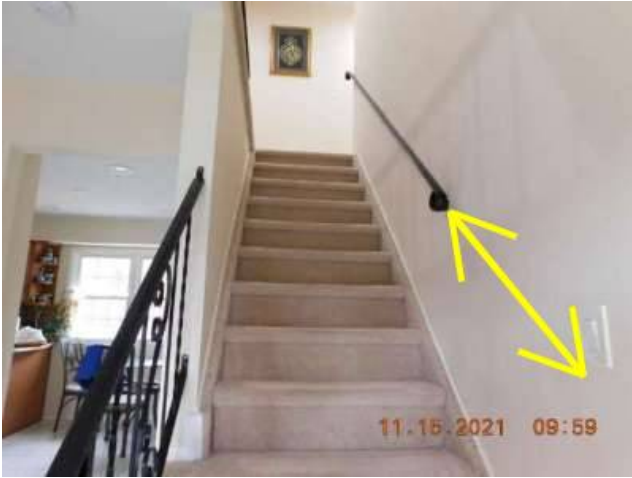
**Photo 75-1**

75) Material Defect/Safety, Replace - Handrails at one or more flights of stairs were not continuous or did not extend the full length of the stairs. This is a potential fall hazard. Handrails should be continuous for the entire length of the stairs. Recommend that a qualified contractor replace or repair handrails per standard building practices.

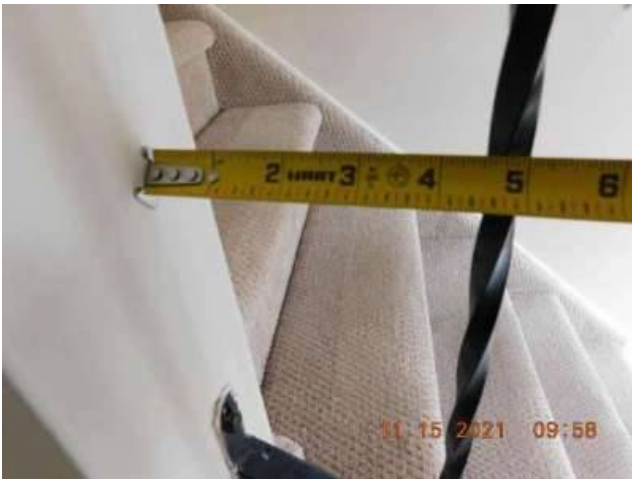
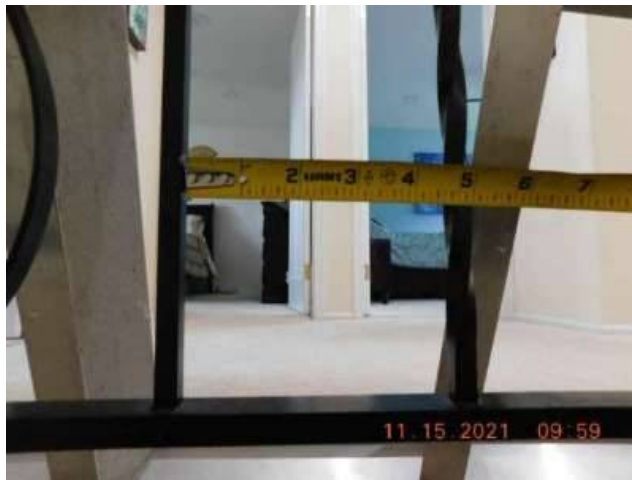
77) Material Defect/Safety, Replace - Guardrails at one or more locations with drop-offs higher than 30 inches had gaps that were too large. This poses a safety hazard for children (e.g. falling, getting stuck in railing). Guardrails should not have gaps or voids that allow passage of a sphere equal to or greater than 4 inches in diameter, or 6 inches in diameter at triangular spaces between stair edges and guardrails. Recommend that a qualified contractor repair or replace guardrails per standard building practices.

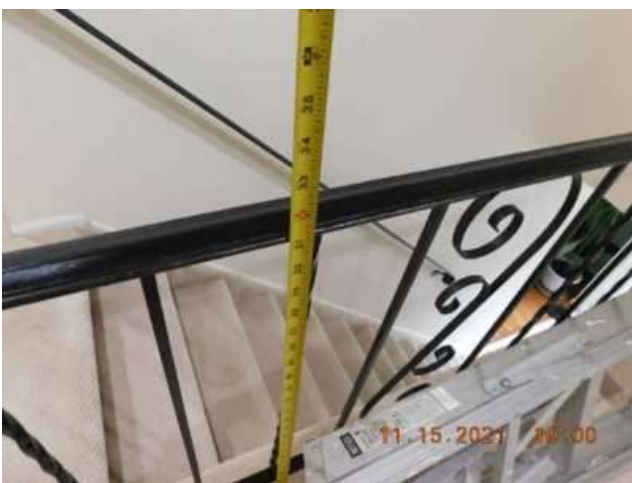
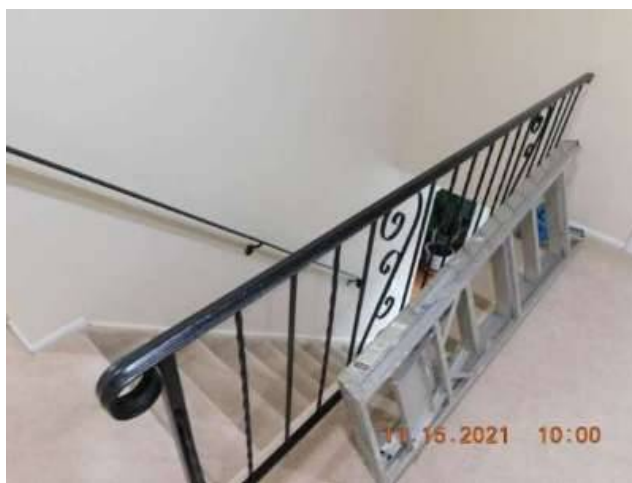
78) Material Defect/Safety, Replace - Guardrails at one or more locations with drop-offs higher than 30 inches were too low. This poses a fall hazard. Guardrails should be at least 36 inches in height. Recommend that a qualified contractor replace or repair guardrails per standard building practices.
