Regal Home Inspections, LLC

37 Ridge Road

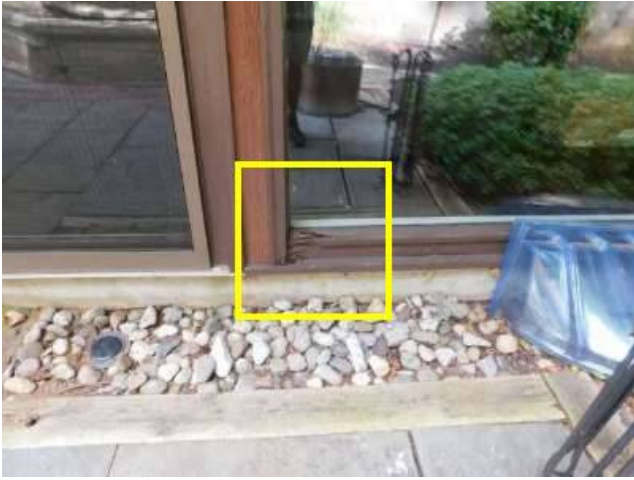
Photo 1-1 Close up of this area in the next photo.

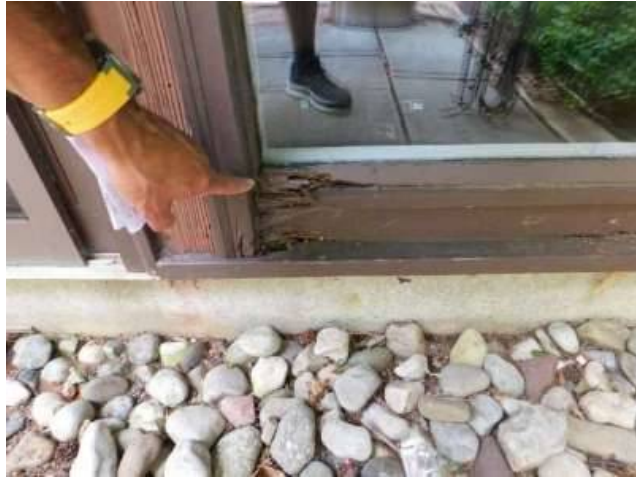
Photo 1-2 Carpenter ant damage identified by the WDI inspector.

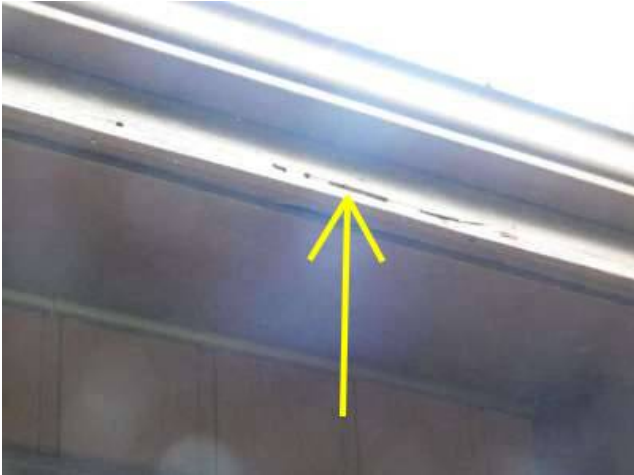
Photo 1-3 Carpenter bee damage seen at the front eave.

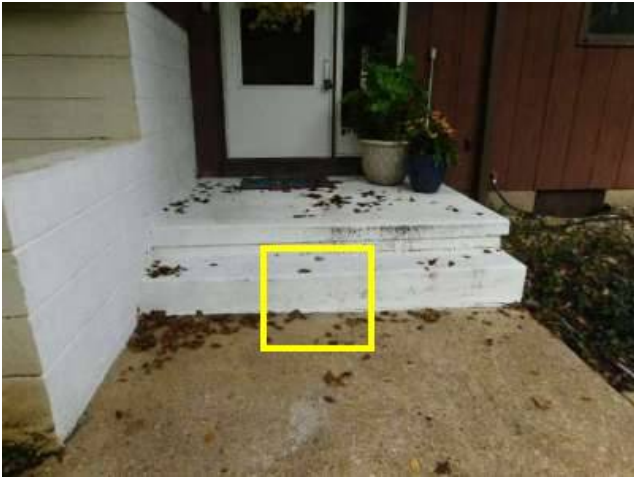
Photo 11-1 Close up of this area in the next photo.

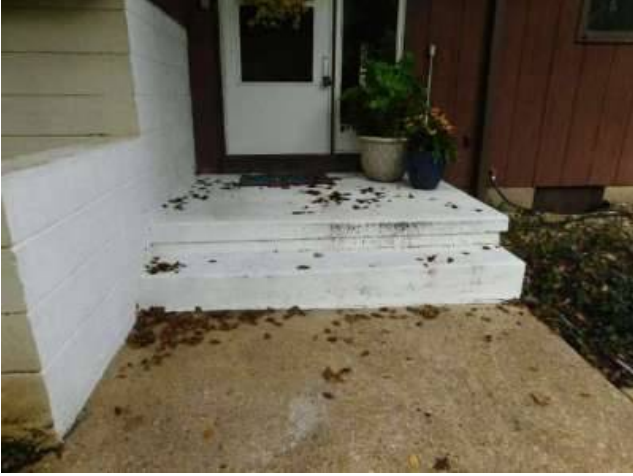
12) Material Defect/Safety, Replace - The risers for stairs at one or more locations varied in height and pose a fall or trip hazard. Risers within the same flight of stairs should vary by no more than 3/8 inch. At a minimum, be aware of this hazard, especially when guests who are not familiar with the stairs are present. Required that a qualified contractor repair per standard building practices.

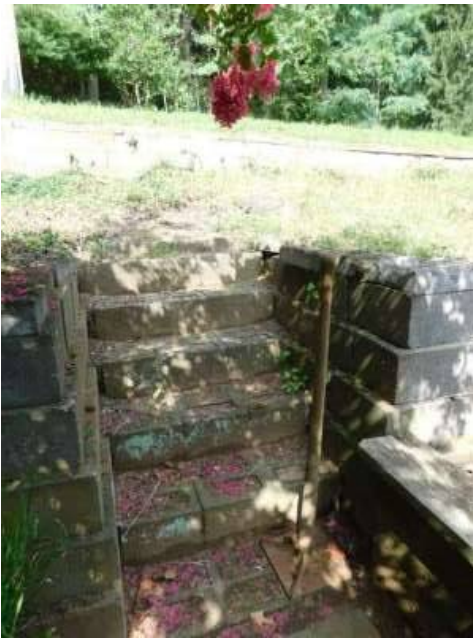
13) Material Defect/Safety, Replace - Handrails at one or more flights of stairs were missing. This is a potential fall hazard. Handrails should be installed at stairs with four or more risers or where stairs are greater than 30 inches high. Required that a qualified contractor install handrails where missing and per standard building practices.

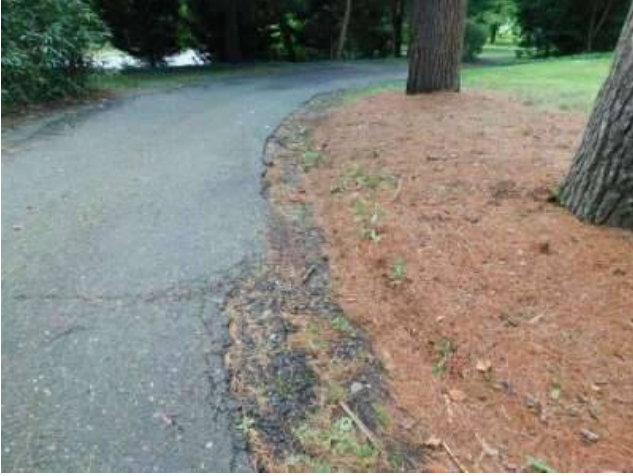
14) Repair/Maintain/Service - Cracks, holes, settlement, heaving and/or deterioration were found in the driveway. Required that qualified contractor repair as necessary. However, there weren't any trip hazards identified at the time of the inspection.

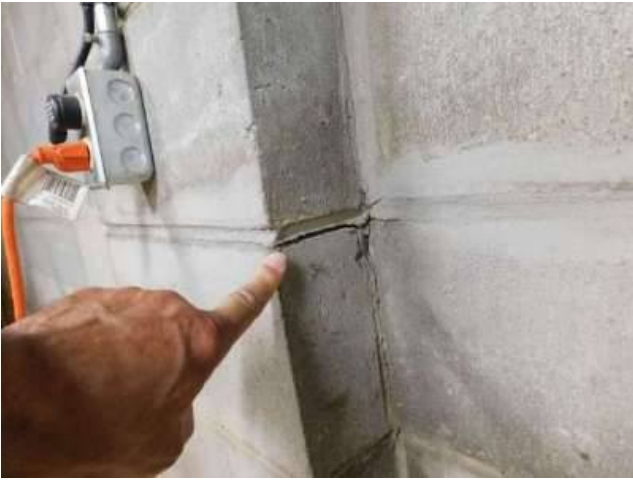
Photo 15-1 A gap at one of the buttresses along the back wall was the first indication of a horizontal crack.

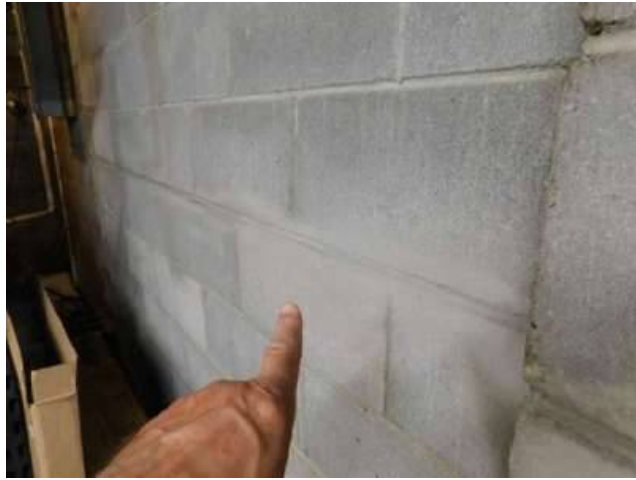
Photo 15-2 The same, horizontal mortar line has clearly been patched. A hairline horizontal crack can also be seen a couple of courses of blocks above.

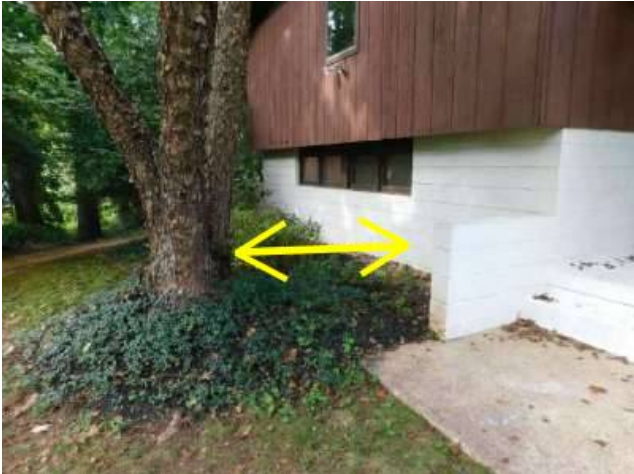
damage to foundations.

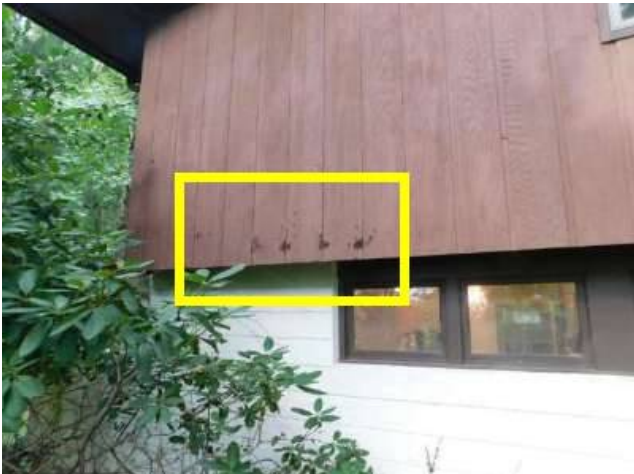
17) **Replace** - Some sections of siding and/or trim were deteriorated. Required that a qualified person repair, replace or install siding or trim as necessary.

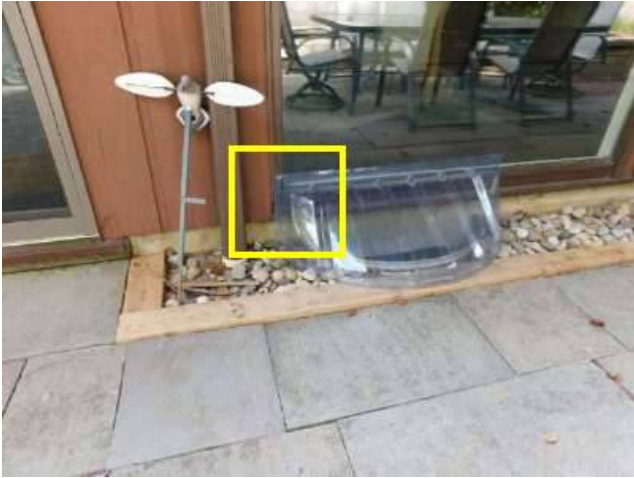
Photo 18-1 Close up of this area in the next photo.

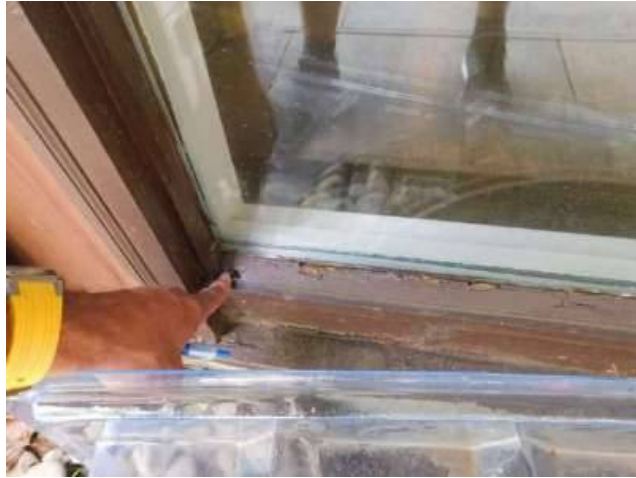
Photo 18-2 Please note that this is similar damage as seen on another window frame and attributed to carpenter ants as seen in the General Information section, Item 1.

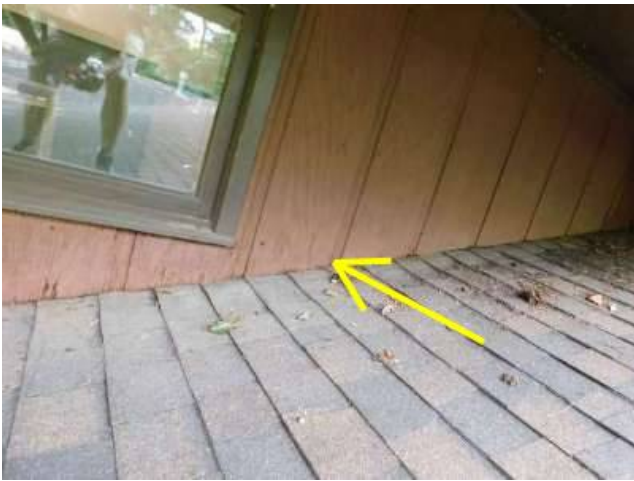
Requires repair by a siding contractor.

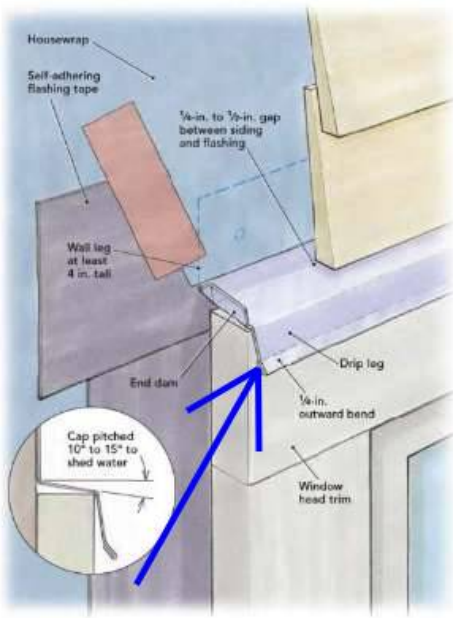
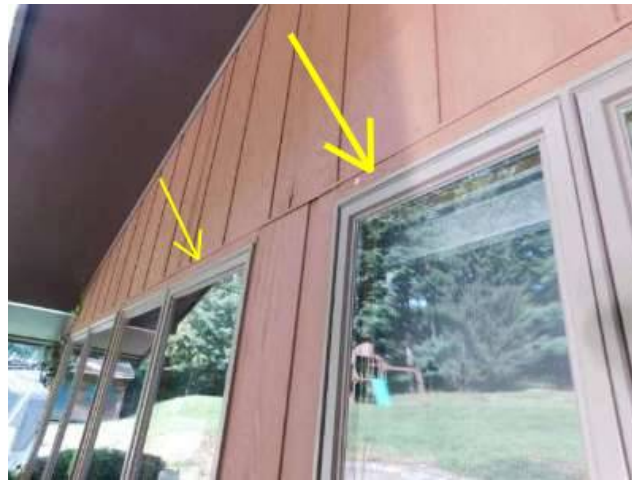
20) Repair/Maintain/Service - There was no head flashing seen above the windows. Flashing helps ensure that the house is water repellent. There does not appear to be flashing above the windows. All wall penetrations like windows and doors should have head flashing. Requires that a siding contractor evaluate and see if it can be added. Usually, it's not possible to add flashing at this point. Therefore, the seams between the vinyl siding and the window should have caulking and maintenance of that caulking is recommended.

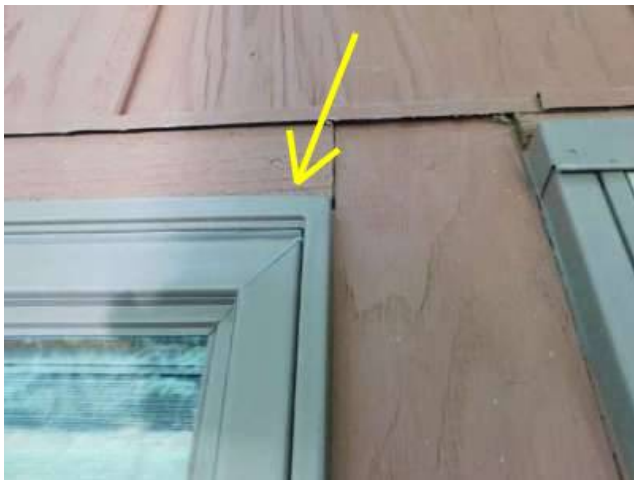
Photo 20-1 The flashing highlighted here is missing from over the windows.

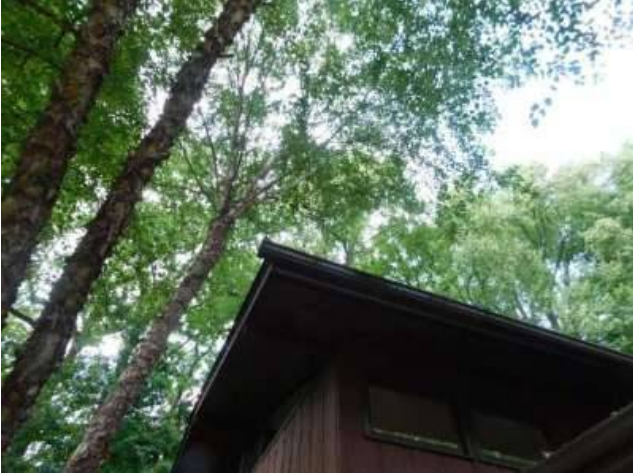
23) Maintain, Evaluate - Trees were in contact with or were close to the building at one or more locations. Damage to the building can occur, especially during high winds, or may have already occurred (see other comments in this report). Required that a qualified tree service contractor or certified arborist remove trees as necessary to prevent damage to the building exterior. Please note that home insurance companies may have issues with trees too close to the house that can affect coverage and/or premiums. Consult (Evaluate) with your insurance company.

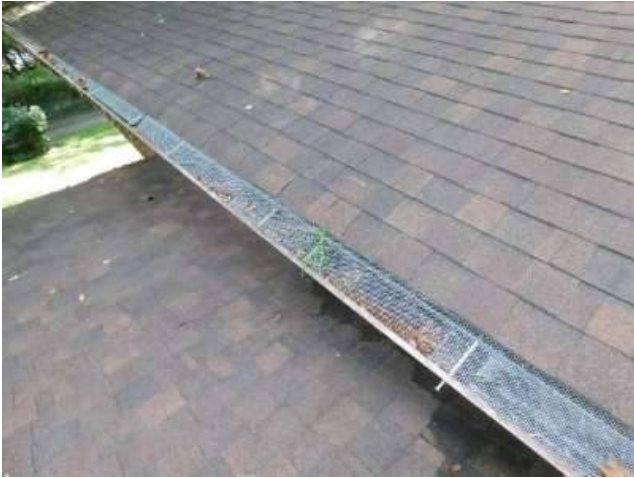
requiring cleaning gutters and downspouts now and as necessary in the future, **the client is urged to arrange for a reputable, roofing contractor to inspect the wood elements around the roof's perimeter and particularly in the areas where the clogged gutters exist. This proactive measure will help identify any damage or potential risks, allowing for timely repairs and maintenance to safeguard your property against damage.**

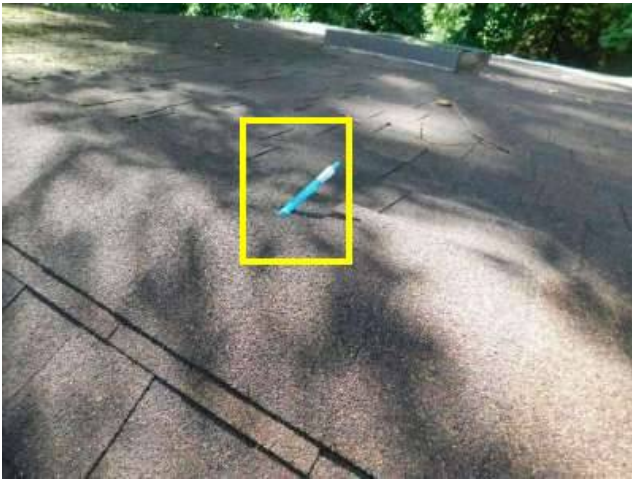
Photo 25-1 Seen in the ridge on the bedroom side of the roof. Close up of this area in the next photo.

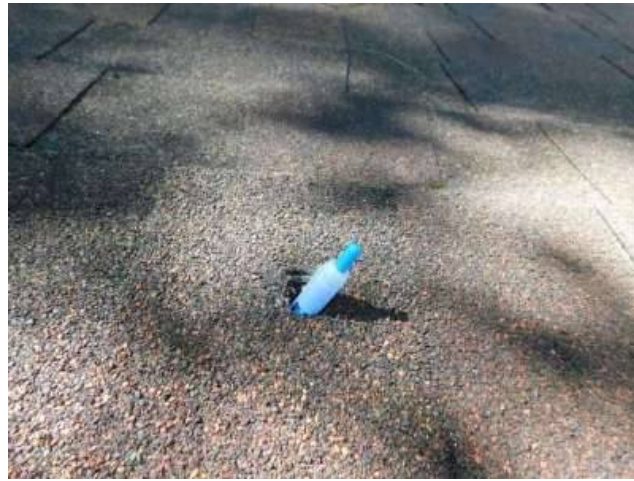
Photo 25-2 The pen is 5 & 1/2 inches long. Maybe an inch and a half is exposed.

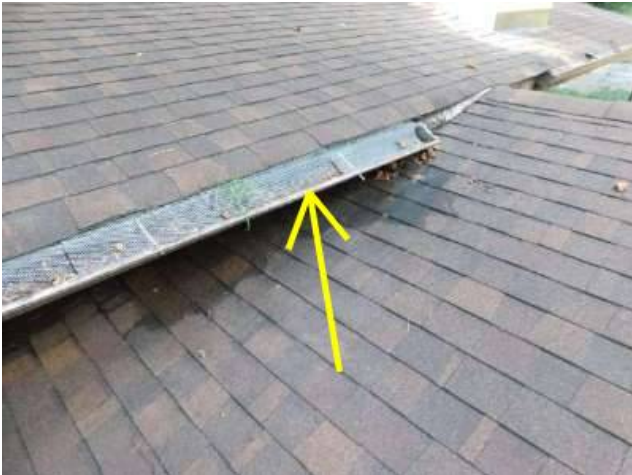
Photo 26-1 Debris and weeds seen in the gutter.

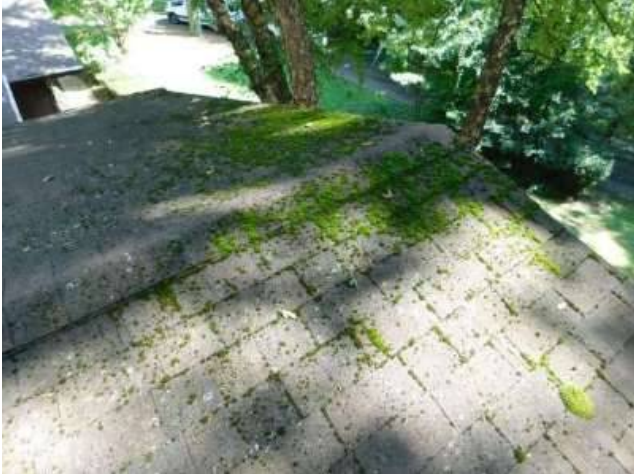
Requires the services of a roof cleaning company.

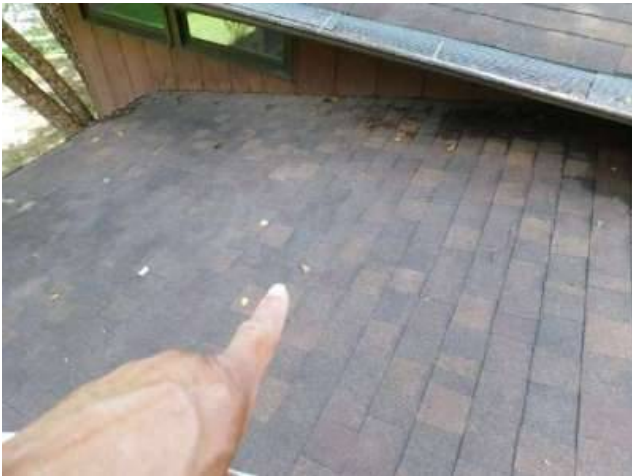
31) Material Defect/Major, Replace, Evaluate - The roof decking was spongy, soft or springy in one or more areas when the inspector walked on those areas. This may be caused by deteriorated sheathing, damaged rafters or trusses, and/or otherwise substandard construction. Required that a qualified roofing contractor evaluate and repair as necessary. Please be prepared and understand that repairing the spongy decking requires replacing the roof as well.

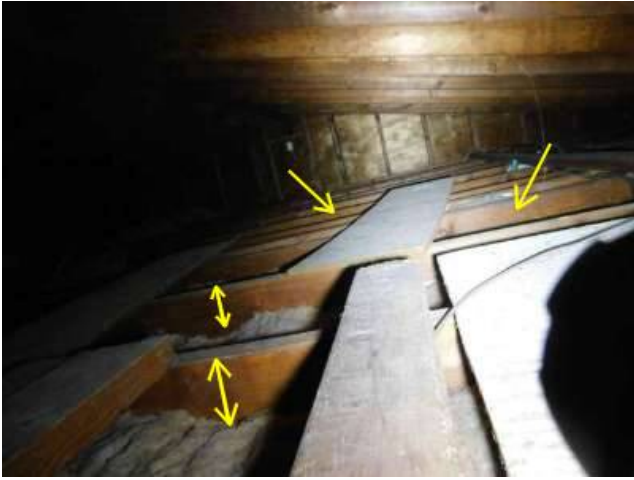
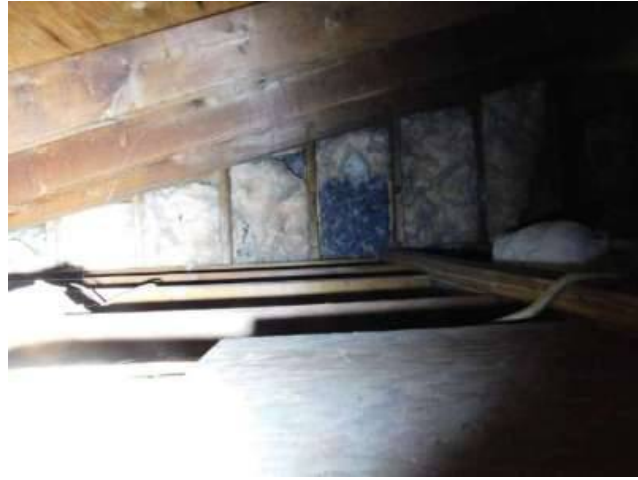
Photo 32-1 The ceiling joists seen here appear to be 2 x 8. With an estimated 3 - 5 inches of joist visible, this means that there is 3 - 5 inches of insulation.

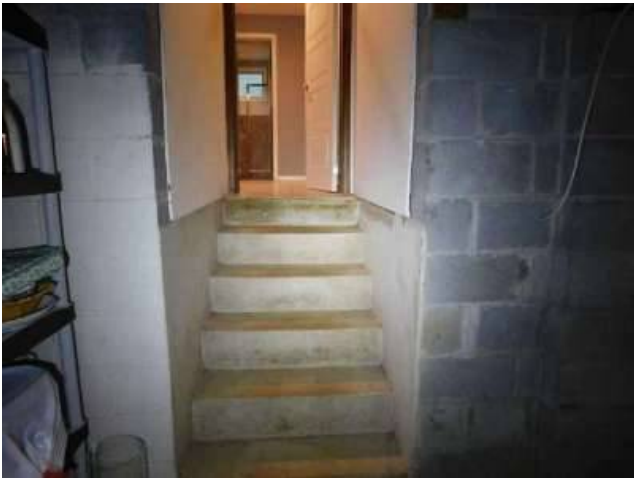
36) Material Defect/Safety, Replace - Handrails at one or more flights of stairs were missing. This is a potential fall hazard. Handrails should be installed at stairs with four or more risers or where stairs are greater than 30 inches high. Required that a qualified contractor install handrails where missing and per standard building practices.

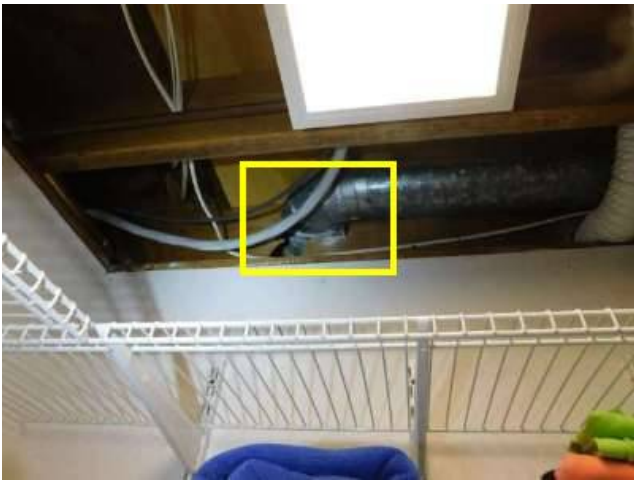
Photo 37-1 Close up of this area in the next photo.

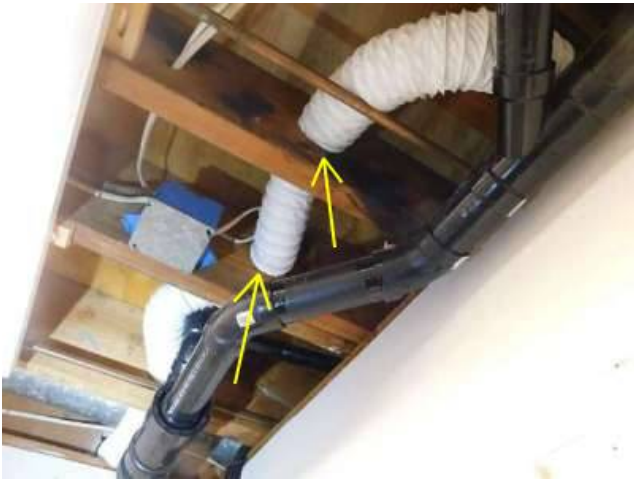
Photo 37-3 The holes made to route the exhaust duct may be too large for the joists. "The maximum hole diameter is 1/3 of the depth of the joist."

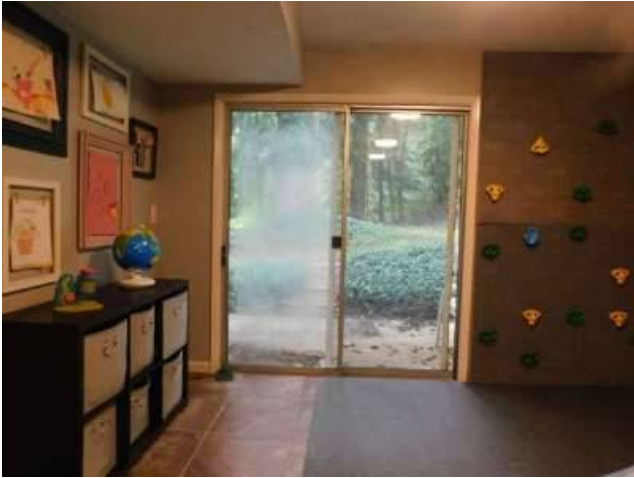
38) Repair/Maintain/Service - One or more exterior doors were difficult to open or close. Required that a qualified person repair as necessary.

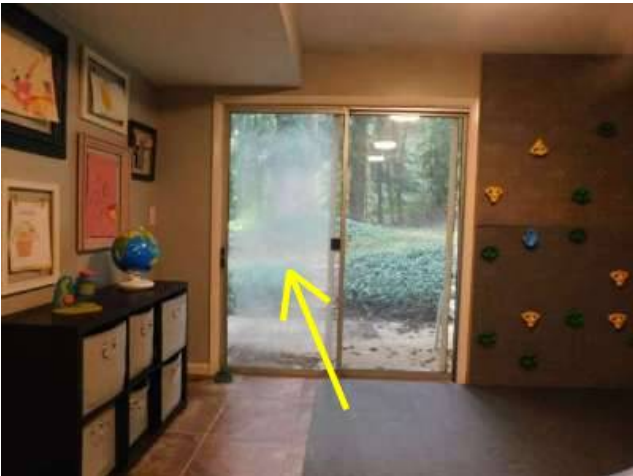
Be aware that evidence of failed seals or desiccant may be more or less visible depending on the temperature, humidity, sunlight, etc. Windows or glass-paneled doors other than those that the inspector identified may also have failed seals and need glass replaced. It is beyond the scope of this inspection to identify every window with failed seals or desiccant.

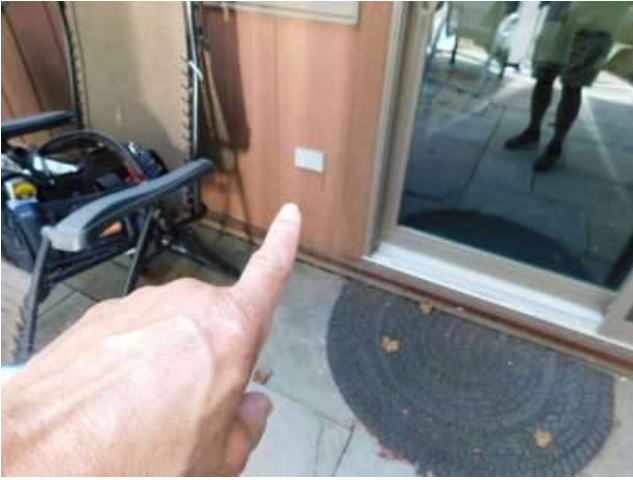
47) Material Defect/Safety, Replace, Evaluate - One or more ground fault circuit interrupter (GFCI) receptacles (outlets) wouldn't trip with the TEST button and wouldn't trip with a test instrument at the exterior and kitchen. This is a potential shock hazard. Required that a licensed electrician evaluate and repair as necessary.

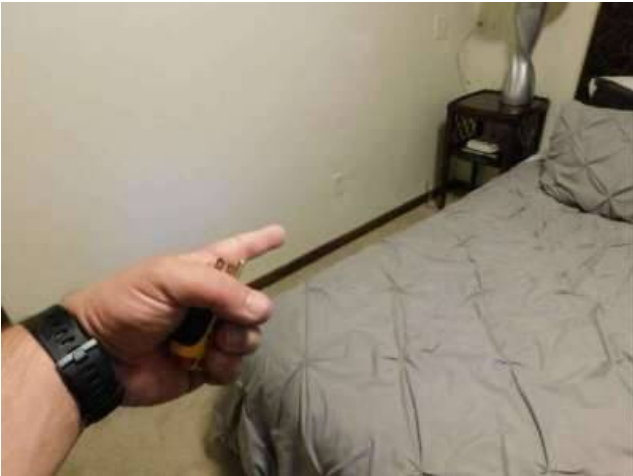
Photo 48-1 Seen in the bedroom near the laundry room.

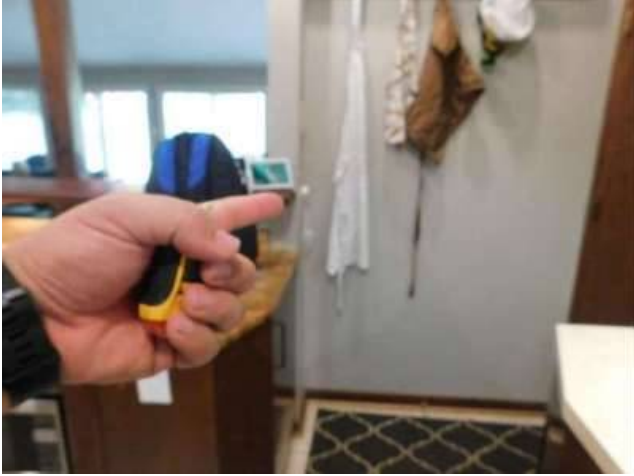
The age of the structure may predate all or portions of these requirements. The inspector recommends having a licensed electrician install GFCI protection as an upgrade to any circuits where there is a higher potential for electrical shock and GFCI protection does not currently exist. National electrical standards currently require that all outlets that serve the kitchen countertop surfaces be GFCI protected regardless of their proximity to a sink. Lack of GFCI protection where currently required is a safety issue for the occupant.

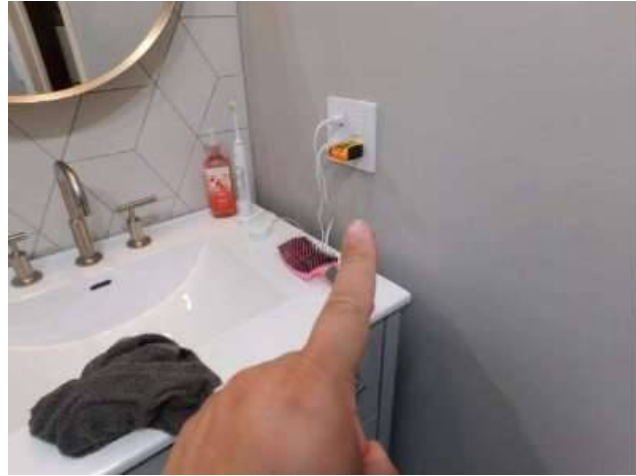
Photo 49-5 This and the following photo were taken in the master bathroom. The right half of the outlet is not GFCI protected but the left half is.

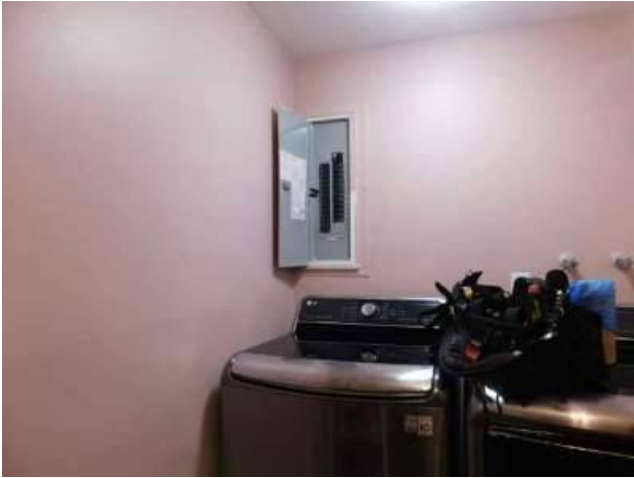
"Blocking electrical panels that house circuit breakers ... is a violation of both Occupational Safety and Health Administration (OSHA) regulations and National Fire Protection Association (NFPA) codes. These regulations require accessibility to the front of electrical panels to have a minimum of three feet of clearance and a minimum width to be the width of the equipment or 2.5 feet, whichever is greater. This assures that in case of an electrical emergency, there is a clear working space in front for quick access to the circuit breakers. Having up-to date directories of circuit breakers also saves time."

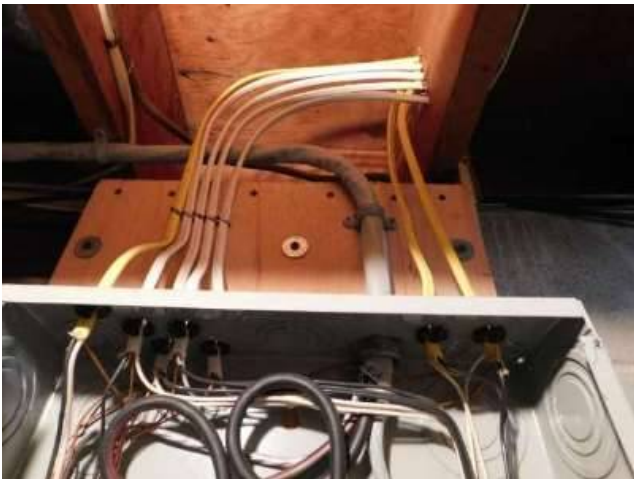
Photo 51-1 Notice the difference between how the 5 cables on the left (Next photo) are secured vs. the 2 cable on the right (Last photo).

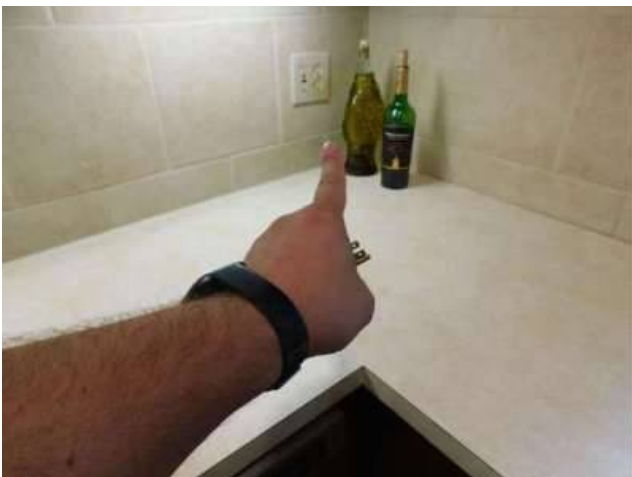
52) Material Defect/Safety, Replace - One or more electric receptacles (outlets) and/or the boxes in which they were installed were loose and/or not securely anchored. Wire conductors can be damaged due to repeated movement and/or tension on wires, or insulation can be damaged. This is a shock and fire hazard. Required that a licensed electrician repair as necessary.

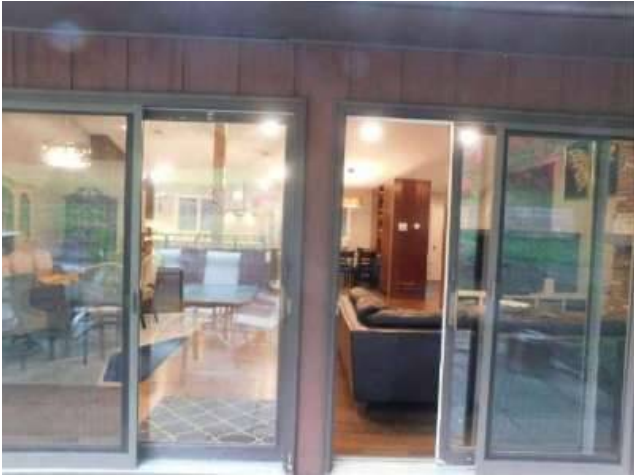
53) Material Defect/Safety, Replace - Lighting was missing at an entry door. For safety and convenience, required that a licensed electrician install lighting as necessary, and per standard building practices.

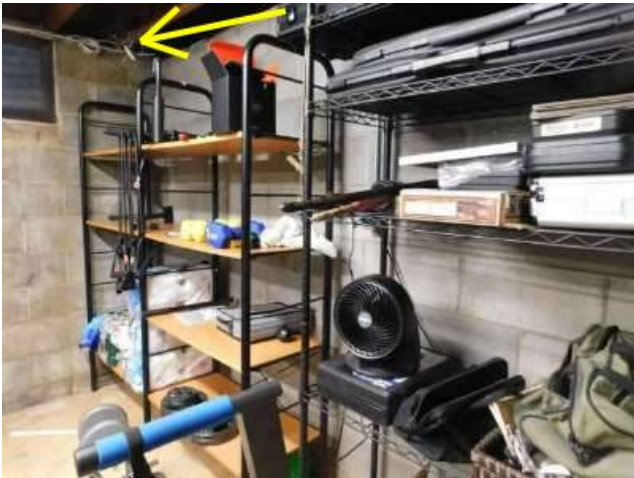
54) Material Defect/Safety, Repair/Maintain/Service - Bare wire ends, or wires with a substandard termination, were found in the basement above the foundation. It appears that some cables have been taken out of service and left in place, nailed to the sill plate. This is a potential shock hazard. Required that a licensed electrician repair as necessary. For example, by cutting wires to length and terminating with wire nuts in a permanently mounted, covered junction box.

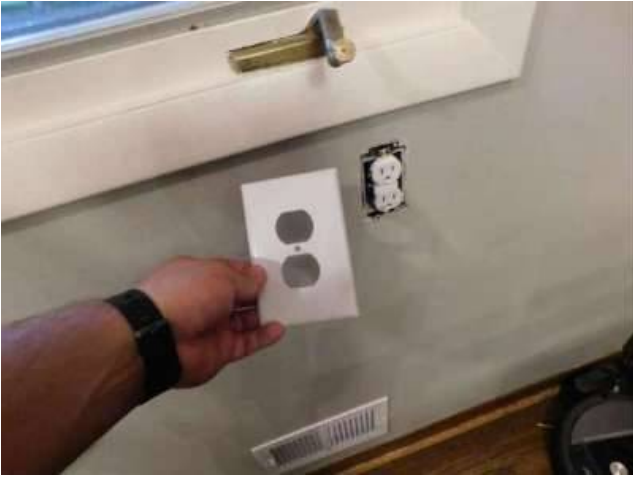
Seen near the windows by the kitchen.

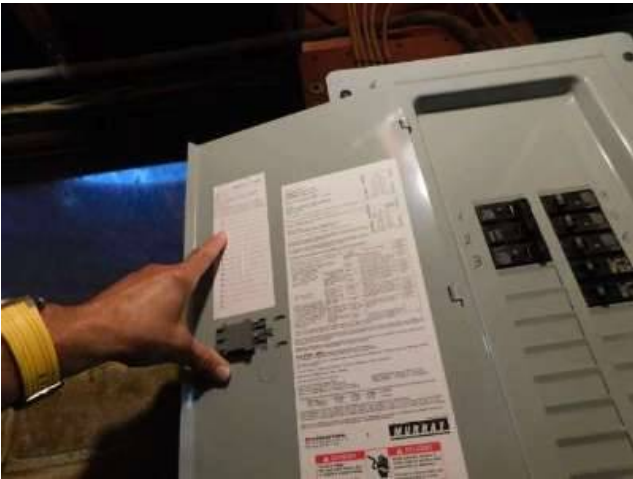
57) Repair/Maintain/Service, Evaluate - The legends for circuit breakers in Panels A and B were incomplete. This is a potential shock or fire hazard in the event of an emergency when power needs to be turned off. Required correcting the legend so it's accurate, complete and legible. Evaluation by a qualified electrician may be necessary.

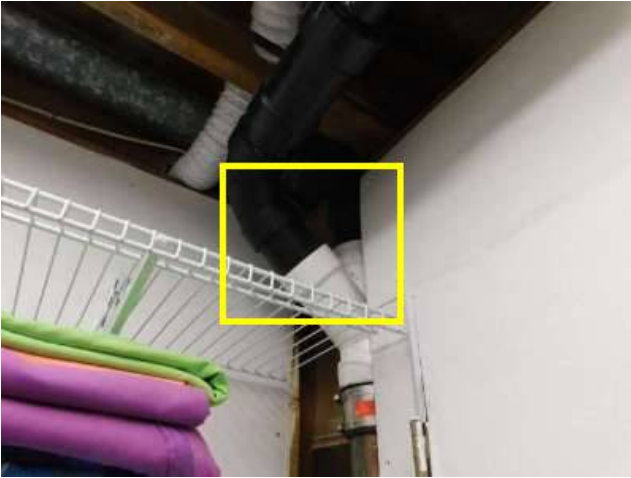
Photo 61-1 Close up of this area in the next photo. Laundry area.

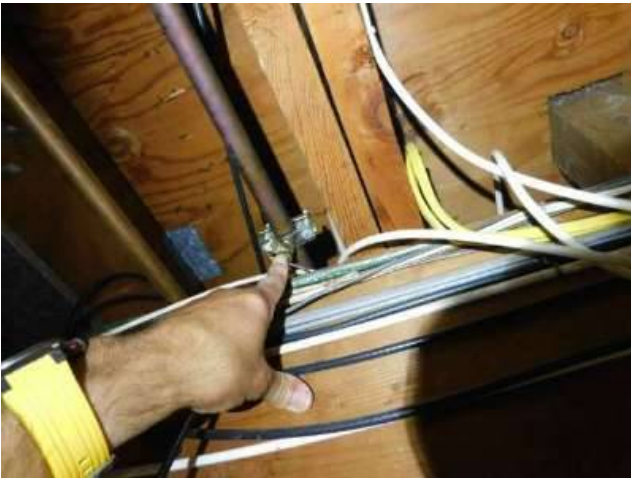
62) Repair/Maintain/Service - There was at least one (1) unused saddle valve seen connected to a copper, water supply pipe. Saddle valves often develop leaks. Required that all, un-necessary, unused saddle valves be removed by a licensed plumber.

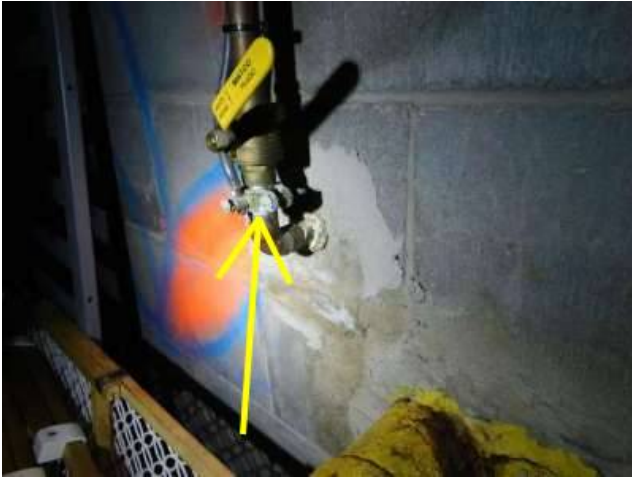
63) Repair/Maintain/Service - One or more bonding or grounding clamp(s) attached to copper water-supply pipes appeared to be made of steel. When these electrically energized dissimilar metals are in contact with each other, corrosion can occur on the water-supply pipes and result in leaks. Required that a licensed plumber replace steel clamps on copper pipes as necessary, with clamps made of brass, bronze or copper.

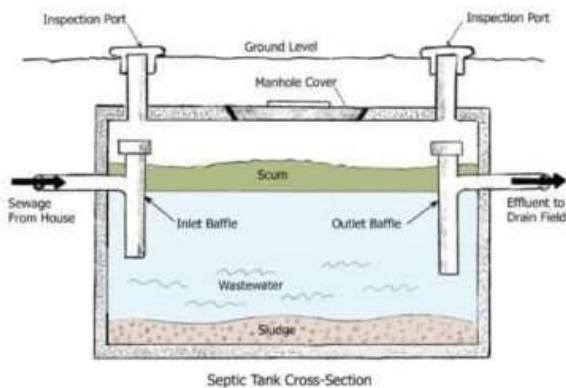
Photo 64-1 This is an illustration of the septic tank only. Other important components potentially include distribution boxes, (aka "D box") and the leach or drain field.

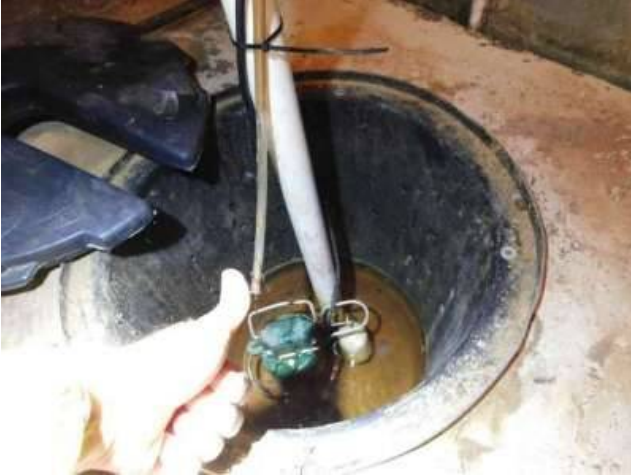
Therefore, the client is urged to have a licensed plumber service the sump pump as soon as possible after taking ownership of the house. Failure to do so may result in flooding if the pump isn't in working order.

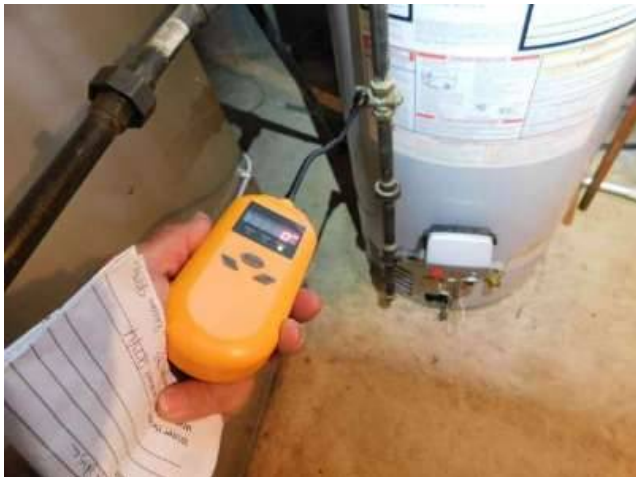
The meter can be seen in the photos. The probe extends to the gas piping for testing for leaks. None were detected. Few examples shown below.

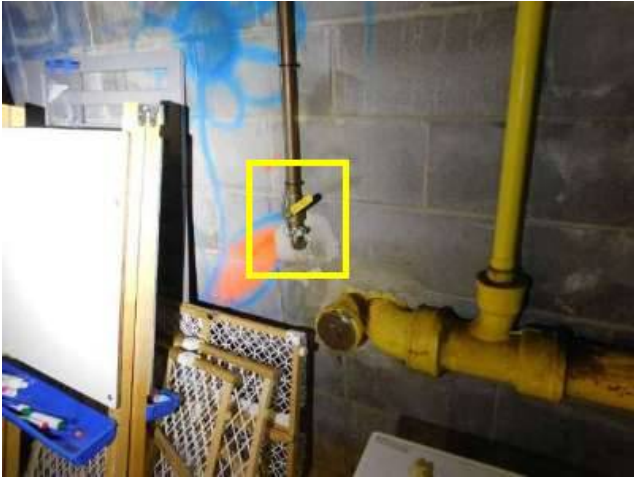
Photo 69-1 Close up of this area in the next photo.

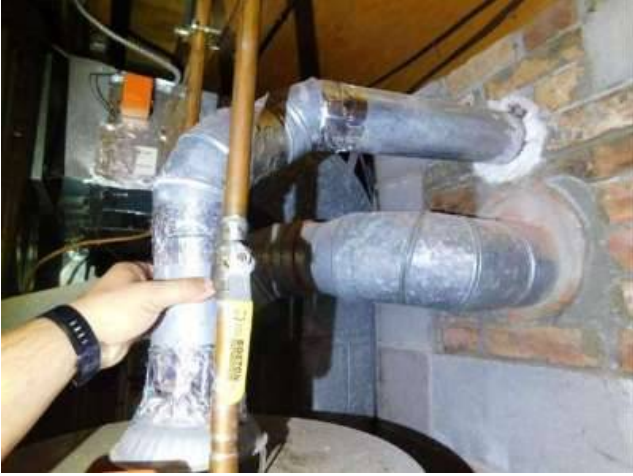
70) Material Defect/Safety, Repair/Maintain/Service, Evaluate - The flue pipe connections must be held together with at least, 3 sheet metal screws. There's at least one flue pipe connection that does not have any screws or too few screws. Required that the connection be held together with screws as they should. If not properly held together, flue pipe sections can separate allowing harmful exhaust gasses to enter the living space. Therefore this is a safety issue. A qualified plumber or HVAC contractor must evaluate and repair.

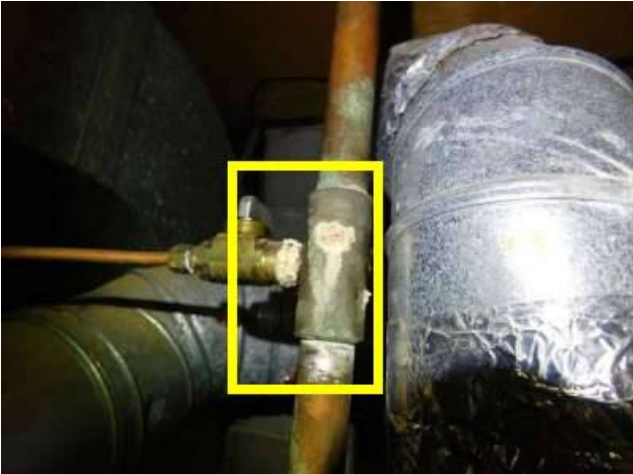
71) Replace, Evaluate - Significant corrosion or rust was found at the supply pipes or fittings. This can indicate past leaks, or that leaks are likely to occur in the future. Required that a licensed plumber evaluate and replace components or make repairs as necessary.

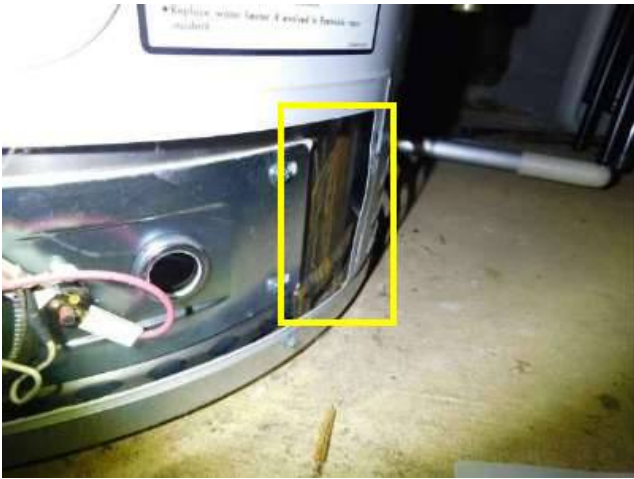
Photo 72-1 Close up of this area in the next photo.

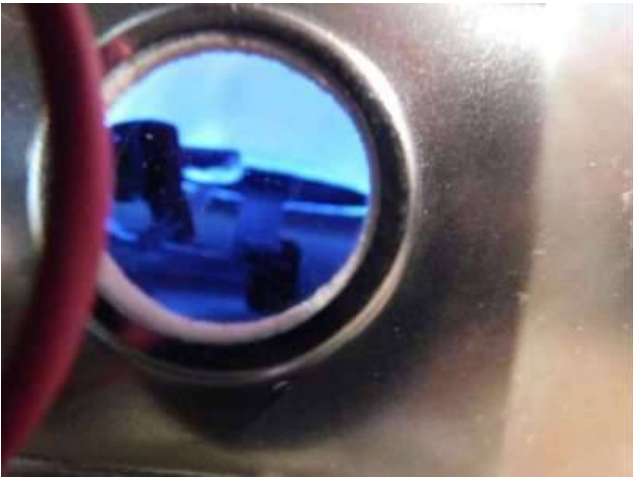
75) Comment/FYI - The water heater's burner flame was blue in color indicating proper combustion. As seen through the water heater's sight glass.

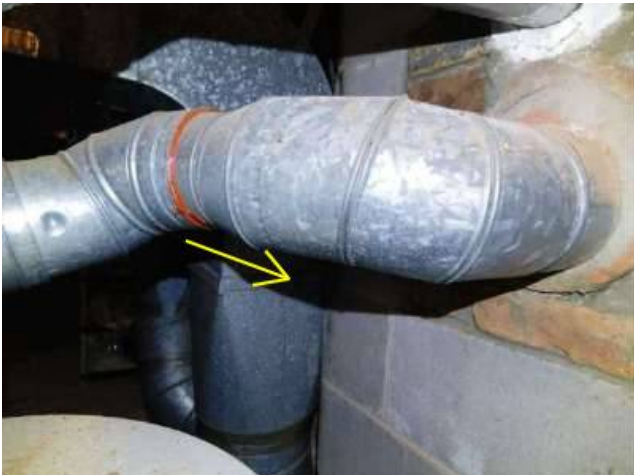
76) Material Defect/Safety, Repair/Maintain/Service, Evaluate - One or more portions of the metal flue for the furnace were not properly sloped. Flues should slope up as they move away from the furnace. One or more portions of flue pipe appears to slope downward or have no slope. If not properly sloped, harmful exhaust gasses can enter the living space. Therefore, this is a safety issue. A licensed and qualified plumber or HVAC contractor must evaluate and repair as that professional deems necessary to allow for proper pitch and exhaust gasses flow.

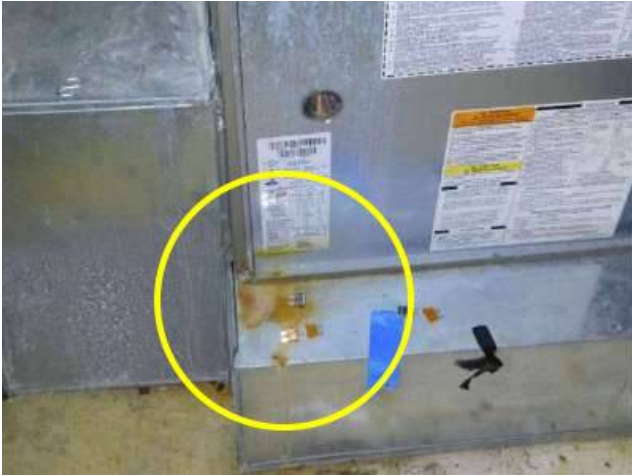
78) Replace, Repair/Maintain/Service, Evaluate - Water was found in the basement furnace. Portions of the condensate discharge may be leaking into the chamber which can eventually lead to rusting. A licensed HVAC technician must evaluate the furnace for proper function and make repairs or replace as necessary.

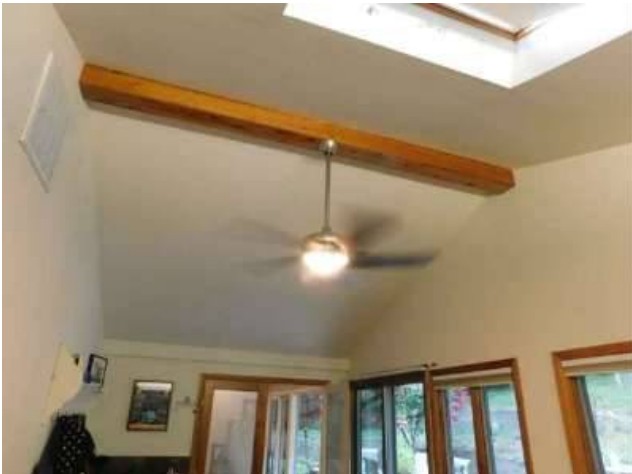
79) Replace, Repair/Maintain/Service - One or more ceiling fans wobbled during operation. This is a potential safety hazard and may be caused by loose fasteners, blades, rod-fan body junction, the fan itself being loose, or bent, misaligned or unbalanced blades. Required that a qualified person repair or replace as necessary.

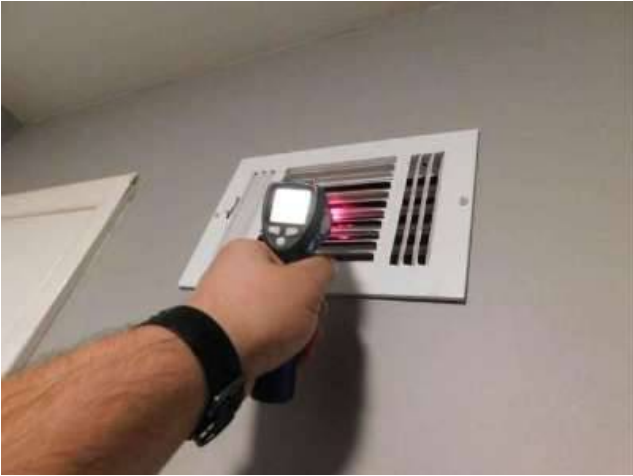
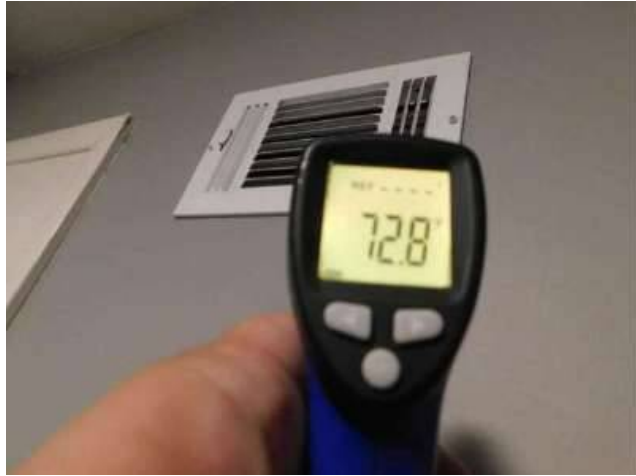
The vent shown below appears to be the only return vent.

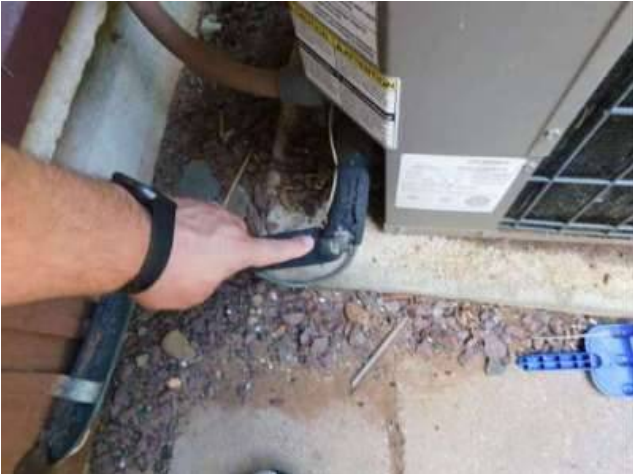
82) Repair/Maintain/Service - Insulation on the air conditioning condensing unit's refrigerant lines was deteriorated or missing in some areas. This may result in reduced efficiency and increased energy costs. Requires that a qualified person replace or install insulation as necessary.

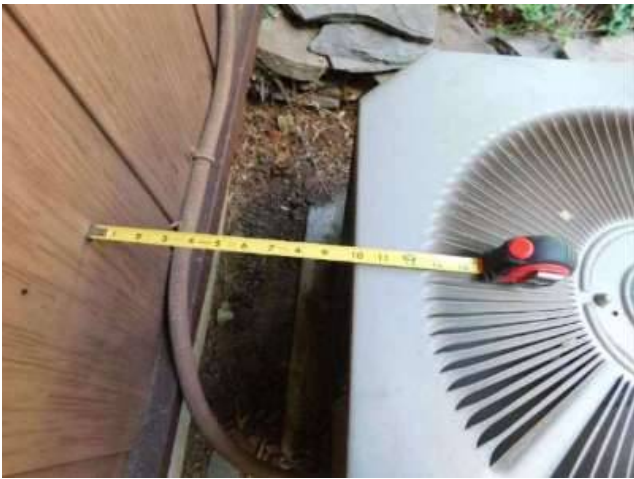
83) Repair/Maintain/Service - Permanent structures were too close to the air conditioning condensing unit. There should be at least 12 inches of clearance on all sides and at least 4-6 feet above. Inadequate clearances around and above can result in reduced efficiency, increased energy costs and/or damage to equipment. Requires making repairs or modifications as necessary to maintain these clearances, by a qualified, HVAC contractor as necessary.

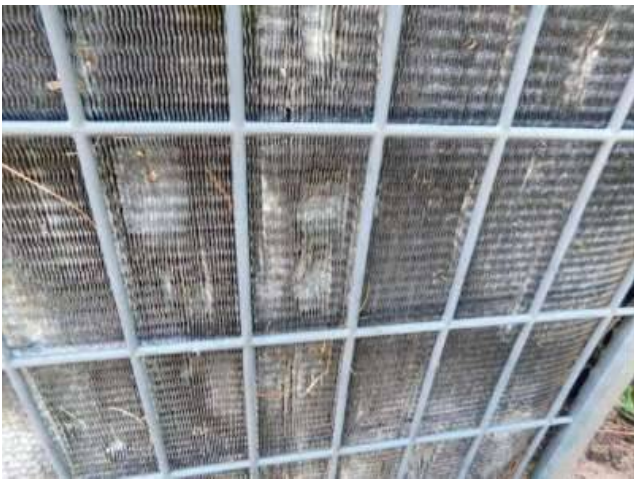
84) Repair/Maintain/Service - The fins at the air conditioner were damaged. Recommend that a qualified HVAC contractor repair fins as necessary.

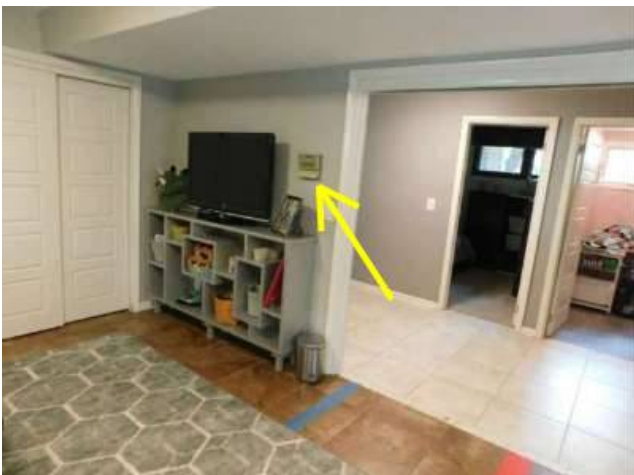
85) Repair/Maintain/Service - One or more thermostats were loose. Recommend repairing thermostats as necessary.

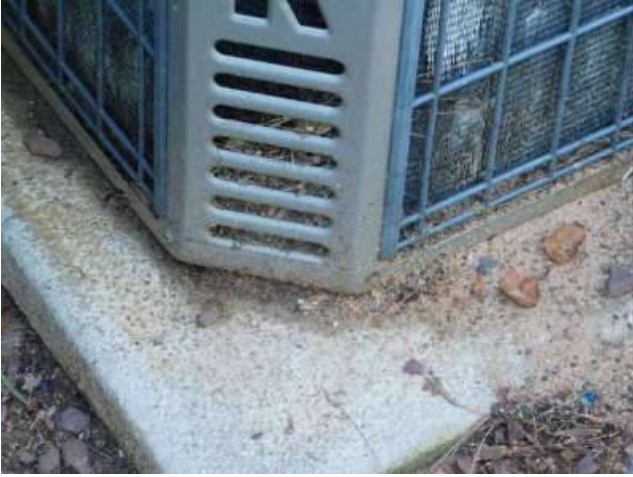
86) Repair/Maintain/Service - The condenser fins at the air conditioner compressor were dirty. This can sap efficiency and shorten the lifespan of the unit. Recommend that a qualified person clean fins as necessary.
