Regal Home Inspections, LLC

37 Ridge Road

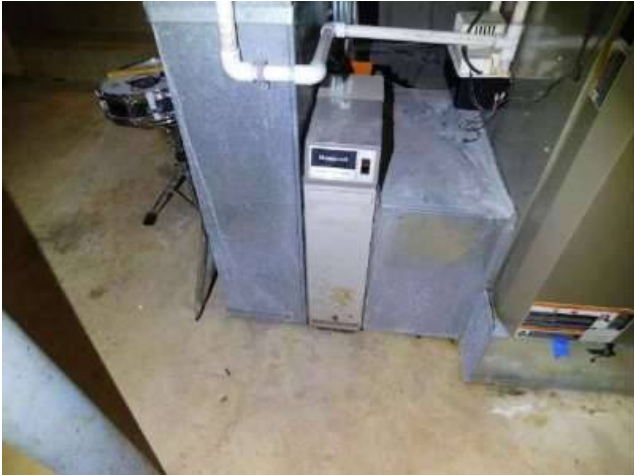
87) Maintain - Recommend replacing or washing HVAC filters upon taking occupancy depending on the type of filters installed (disposable or reusable). Regardless of the type, recommend checking filters monthly in the future and replacing or washing them as necessary and in accordance with the filter manufacturer's instructions. How frequently they need replacing or washing depends on the type and quality of the filter, how the system is configured (e.g. always on vs. "Auto"), and on environmental factors (e.g. pets, smoking, frequency of house cleaning, number of occupants, the season).

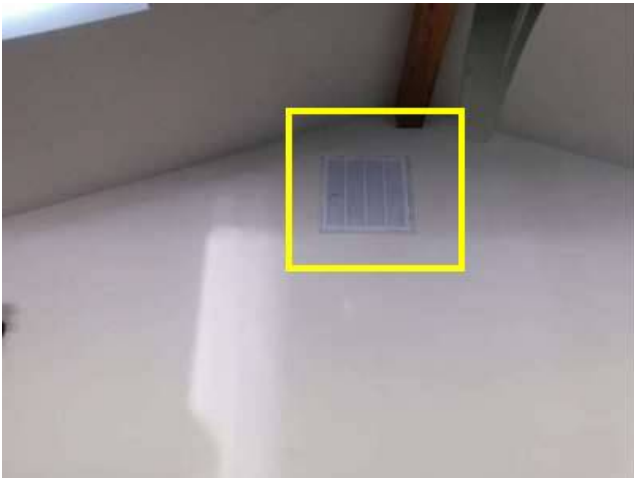
Photo 87-3 This high return for the smaller AC is efficient in that it draws the warmest air in the room back to the AC's evaporator coil for cooling.

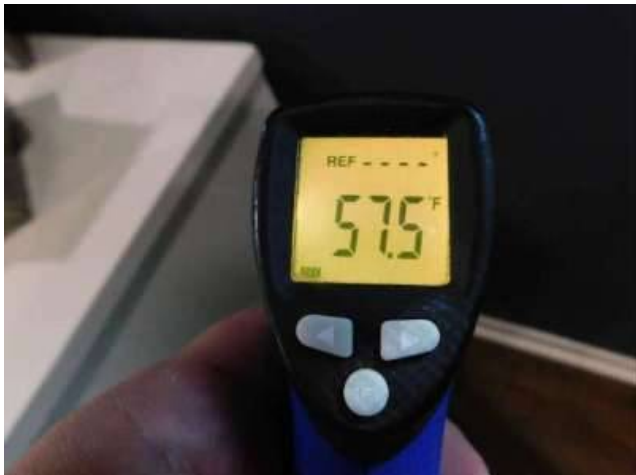
91) Comment/FYI - Sample AC temperatures. All accessible air supply registers were measured. A few examples are shown.

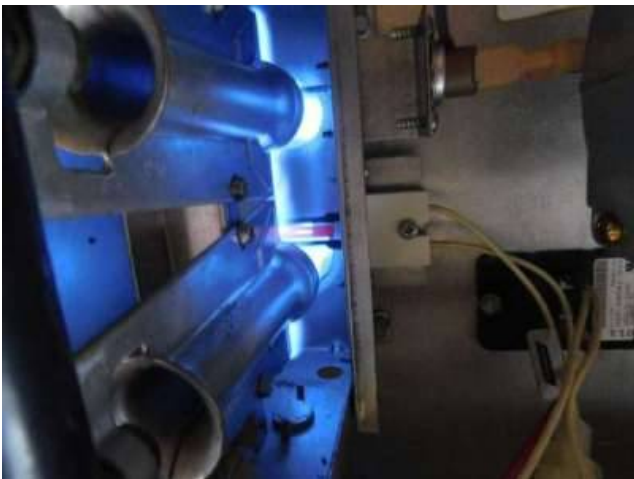
Photo 92-1 Garage furnace's burner.

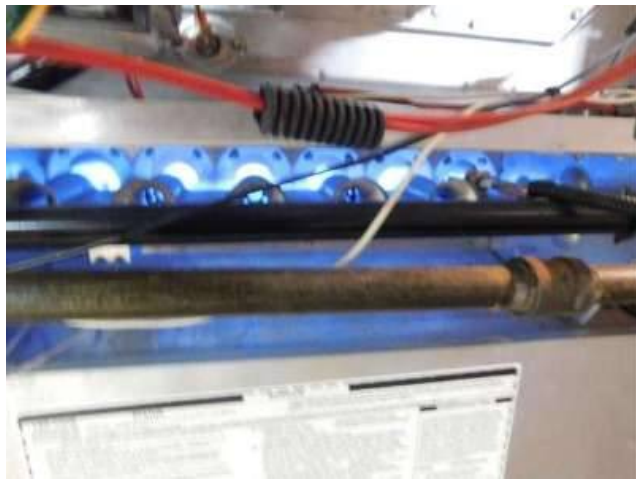
Photo 92-2 Basement.

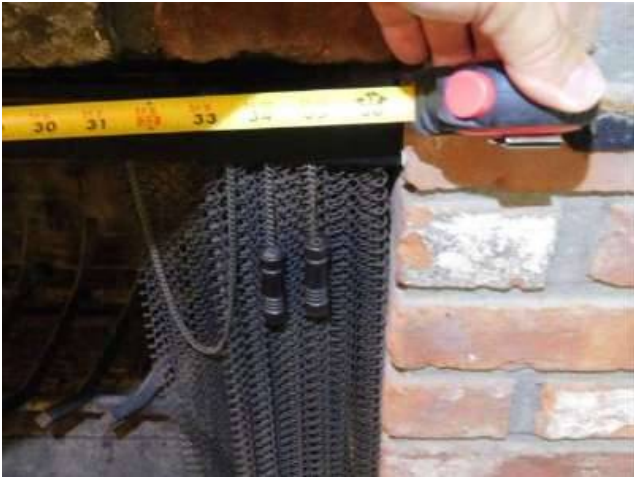
The fireplace roughly measures at 3 feet by 2 & 1/2 feet, being slightly over six square feet in area therefore requiring greater hearth clearance as noted above.

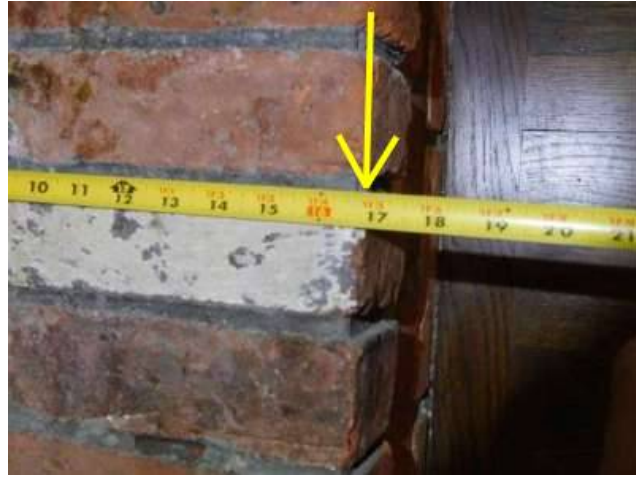
Photo 93-4 This photo is looking down on the hearth. The floor can be seen on the right side of the photo. The hearth is less than 20 inches from the fireplace.

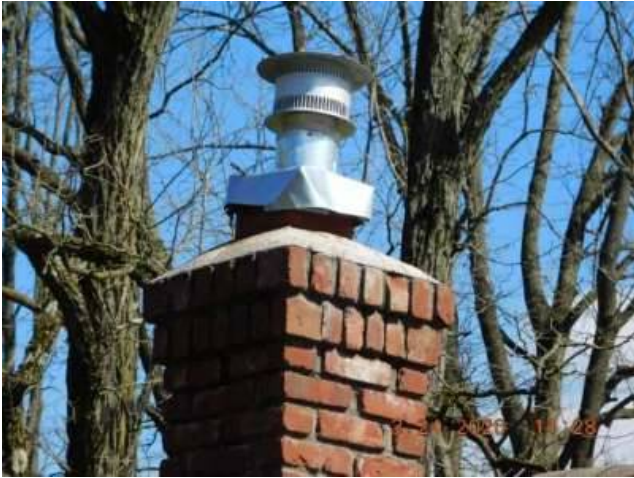
Photo 95-1 This is an example of a metal flue from a DIFFERENT property. No metal flue was seen for THIS property.

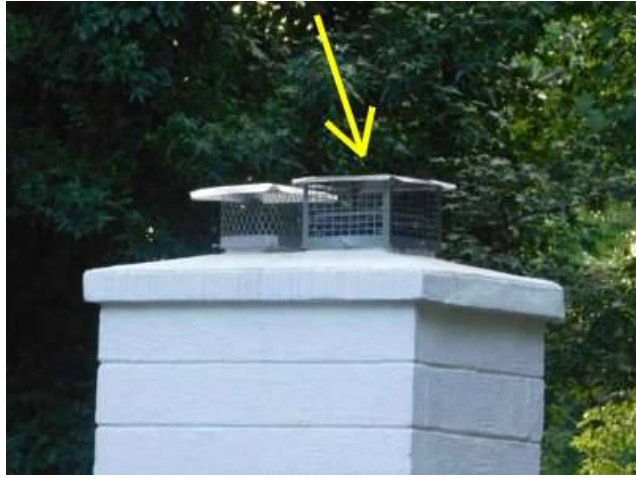
Photo 95-2 The masonry chimney at this location has a rain cap which is appropriate for a wood burning fireplace but not for venting gas appliances as we have here.

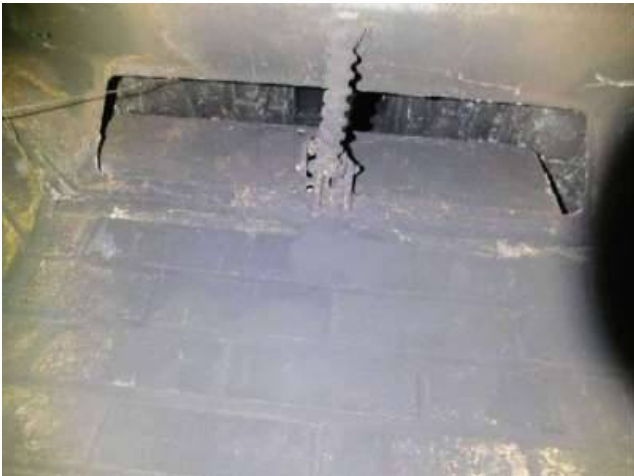
Some general, public information on this subject can be found at: <https://magicbroom.net/services/masonry/smoke-chamber-parging/>

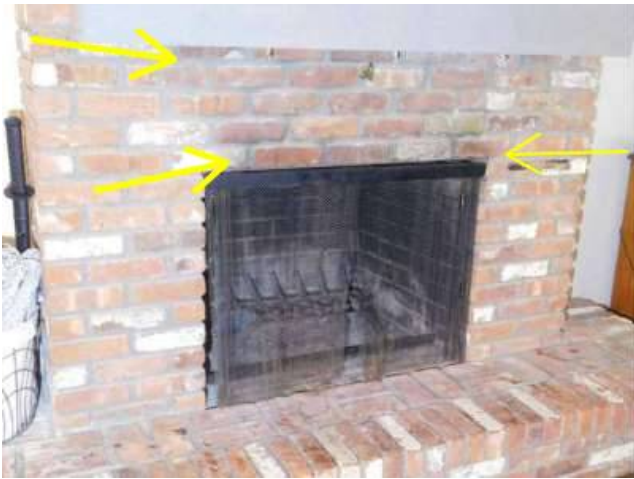
Photo 97-1 Note the darker shade of brick directly above the fireplace.

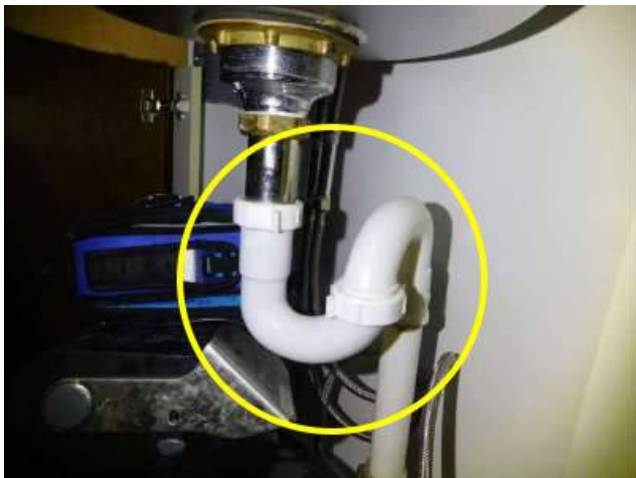
Seen at the prep sink.

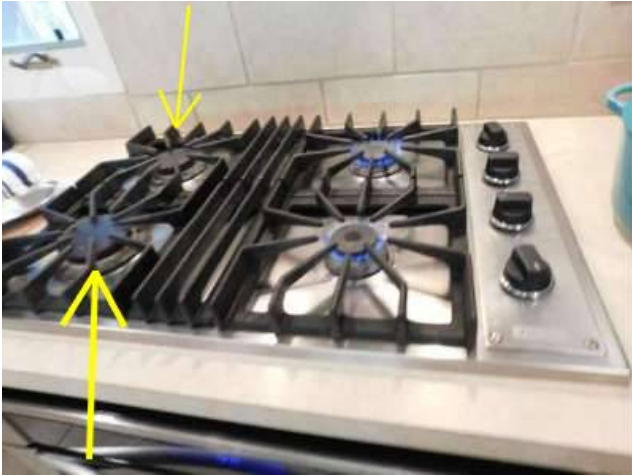
Photo 100-1 There was no response from these two burners.

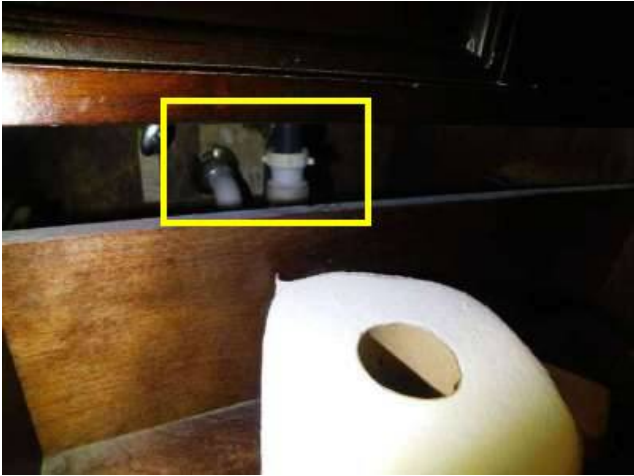
Photo 101-1 Close up of this area in the next photo.

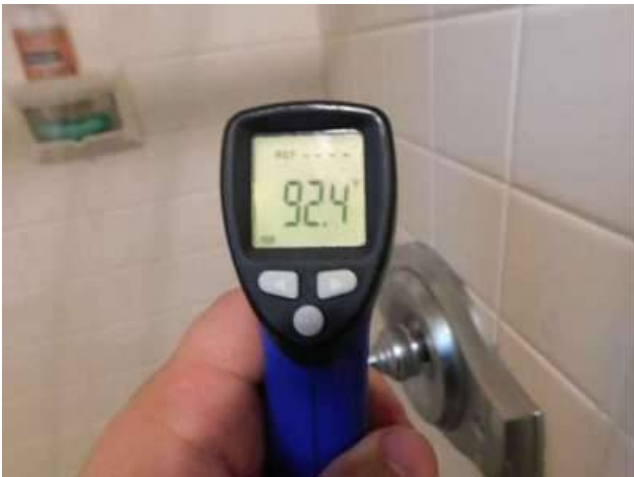
102) Repair/Maintain/Service, Evaluate - The shower blender valves in Baths A & C did not appear to provide enough hot water. This is often caused by a hot water valve or stop limit for the hot water not allowing enough hot water in to overcome the cold water supply. Recommend that a licensed plumber evaluate and repair.

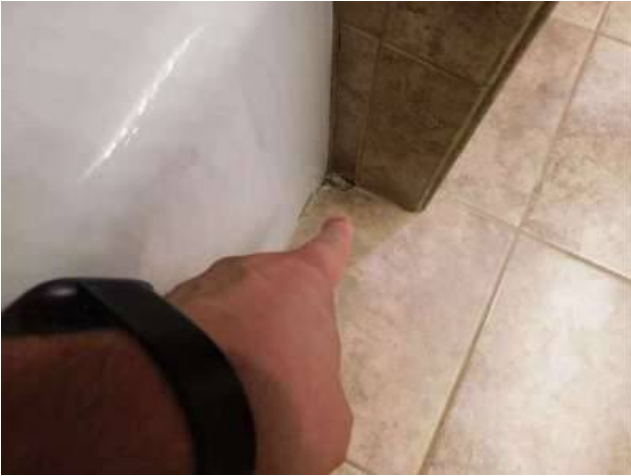
103) Repair/Maintain/Service - Tile, stone and/or grout in the flooring at location(s) B was deteriorated (e.g. loose or cracked tiles, missing grout) or substandard. Water can damage the sub-floor as a result. Required that a qualified contractor repair as necessary.

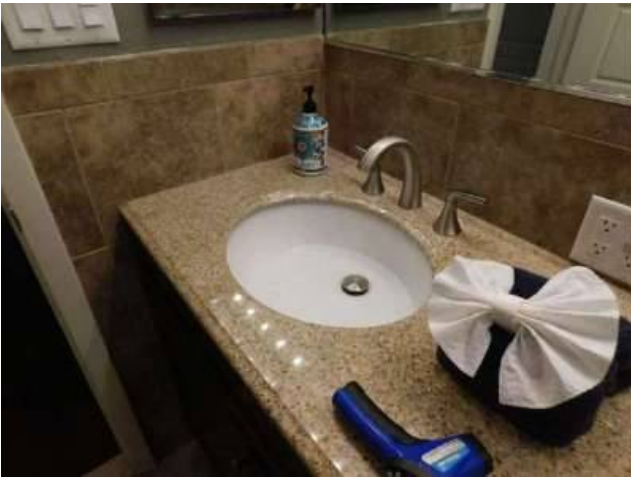
104) Repair/Maintain/Service - The sink at location(s) B drained slowly. Recommend clearing drain and/or having a qualified plumber repair if necessary.

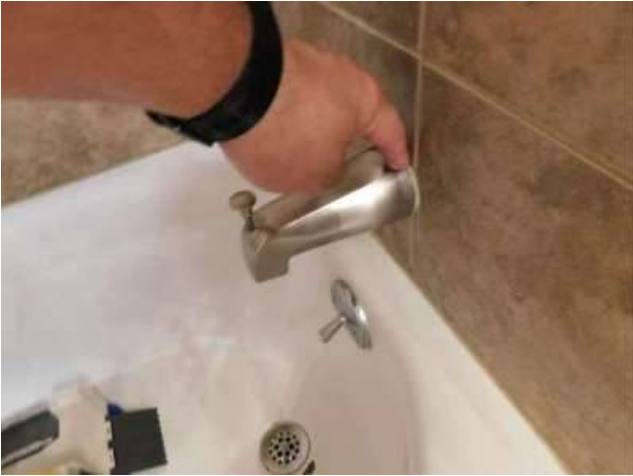
105) Repair/Maintain/Service - Caulk was missing around the base of the bathtub spout, or there was a gap behind it, at location(s) B. Water may enter the wall structure behind the bathtub. Recommend that a qualified person repair as necessary to eliminate the gap. For example, by installing or replacing caulk if the gap is small enough. For larger gaps, a shorter spout nipple or an escutcheon plate can be installed.

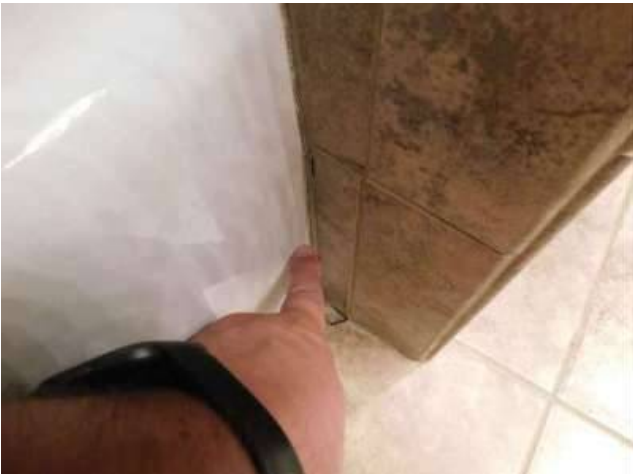
106) Repair/Maintain/Service - Gaps, no caulk, or substandard caulking were found between the bathtub and the walls at location(s) B. Water may penetrate these areas and cause damage. Recommend that a qualified person re-caulk or install caulking as necessary.

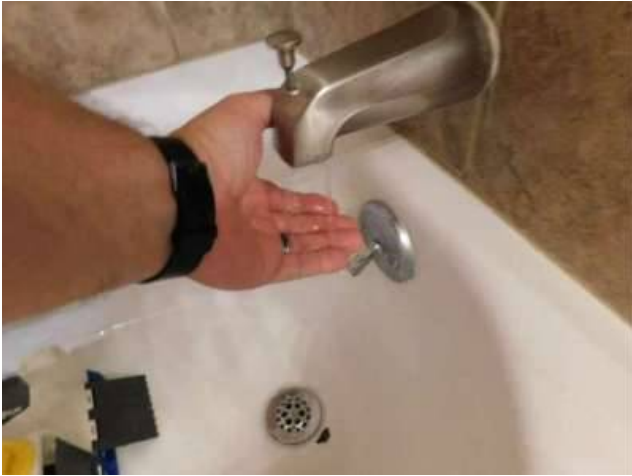
107) Repair/Maintain/Service - The diverter for the tub at location B does not fully divert water to the showerhead. This can increase water or utility usage and energy costs and also decrease water pressure. Requires that it be repaired or replaced as necessary by a qualified contractor.

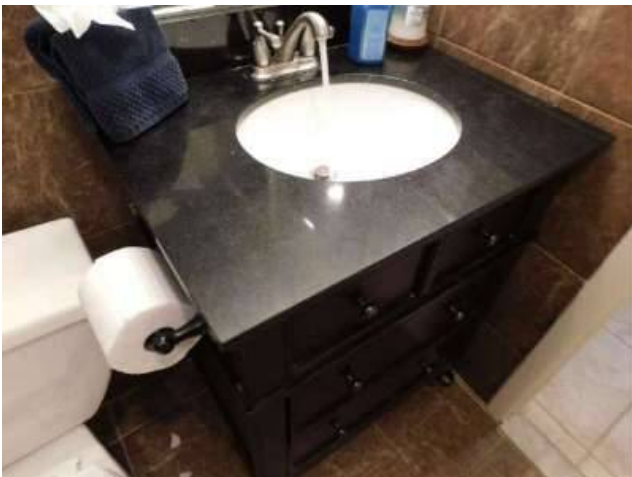
108) Exclusion - One or more under sink areas were obscured by cabinet drawers or hardware. Portions of the sinks that are not available for visual inspection are therefore excluded from the inspection. It is always possible that latent (aka hidden) material defects exist behind these obscured areas. In accordance with the NJ home inspection administrative code, the inspector conducts a visual inspection, "...without requiring the moving of personal property...destructive measures...". When furnishings, stored items, or other obstructions are present, all areas or items that are obscured, concealed or not readily accessible are excluded from the inspection.

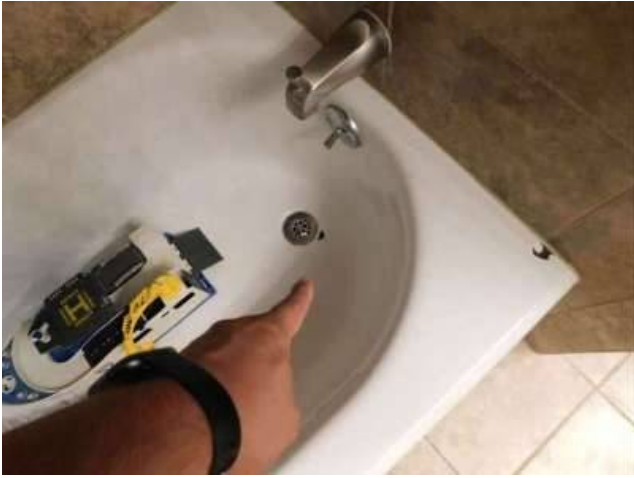
109) Comment/FYI - The bathtub at location(s) B was worn, blemished or deteriorated.

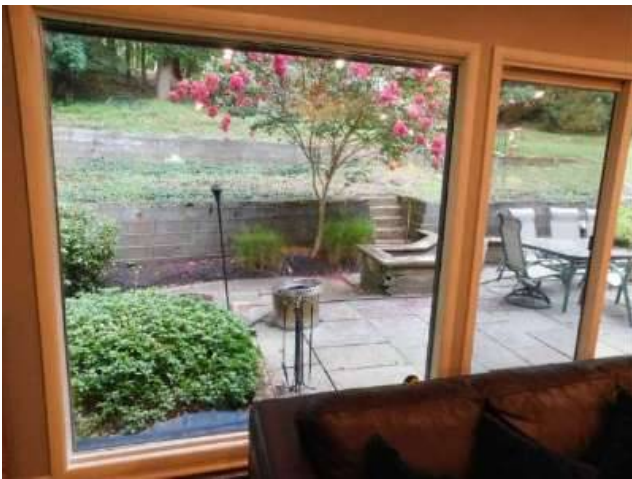
Note that "art glass" (leaded, faceted, carved or decorative) may be an acceptable alternative for safety glass due to its visibility. Also, a 1 1/2-inch-wide protective bar on the accessible side of the glass, placed 34-38 inches above the floor, can serve as an acceptable substitute for safety glass. Required that a qualified contractor evaluate further to determine if glazing is approved safety glass, and replace glass if necessary, and per standard building practices.

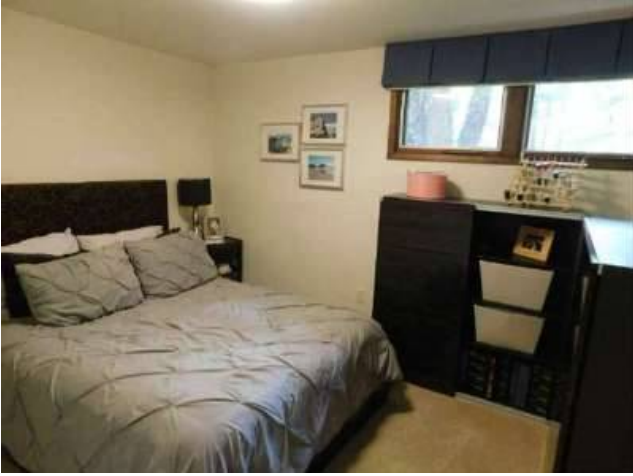
112) Material Defect/Safety, Replace - One or more bedrooms had windows that were too high off the floor. At least one window requires adequate egress in the event of a fire or emergency to allow escape or to allow access by emergency personnel. Such windows should have a maximum sill height of 44 inches off the floor. At a minimum, keep a chair or something that serves as a ladder below the window at all times. Required to have a qualified contractor repair or make modifications per standard building practices.

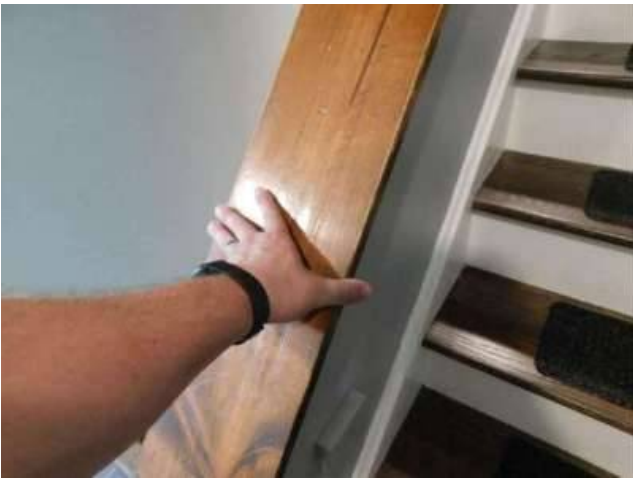
113) Material Defect/Safety, Replace - Handrails at one or more flights of stairs were not graspable and posed a fall hazard. Handrails should be 1 1/4 - 2 inches in diameter if round, or 2 5/8 inches or less in width if flat with recesses for fingers. Required that a qualified person install graspable handrails or modify existing handrails per standard building practices.

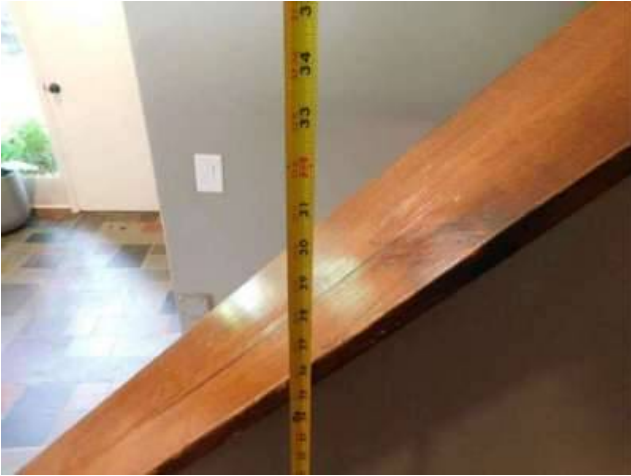
114) Material Defect/Safety, Replace - Handrails at one or more flights of stairs were too low or too high and pose a fall hazard. Handrails should be located at least 34 inches and at most 38 inches above the nose of each tread/riser. Required that a qualified person repair per standard building practices.

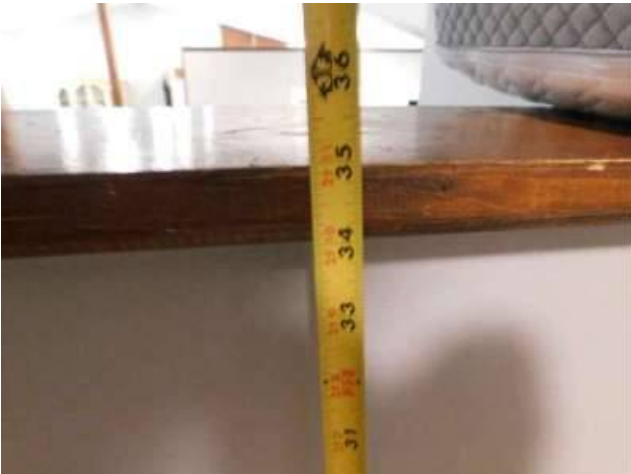
115) Material Defect/Safety, Replace - Guardrails at one or more locations with drop-offs higher than 30 inches were too low. This poses a fall hazard. Guardrails should be at least 36 inches in height. Required that a qualified contractor replace or repair guardrails per standard building practices.

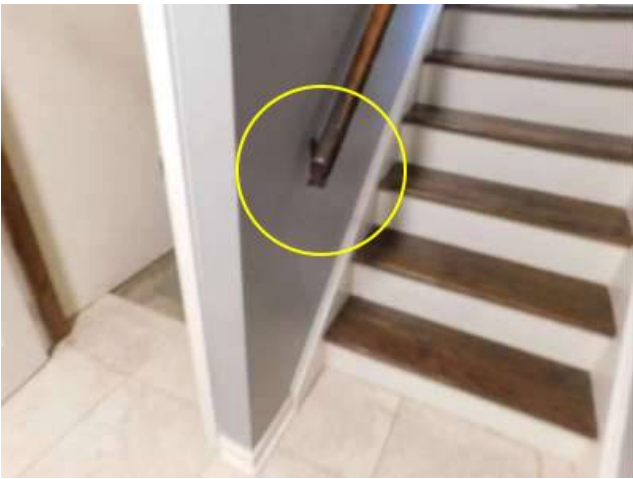
Photo 116-1 Close up of this area in the following photo.

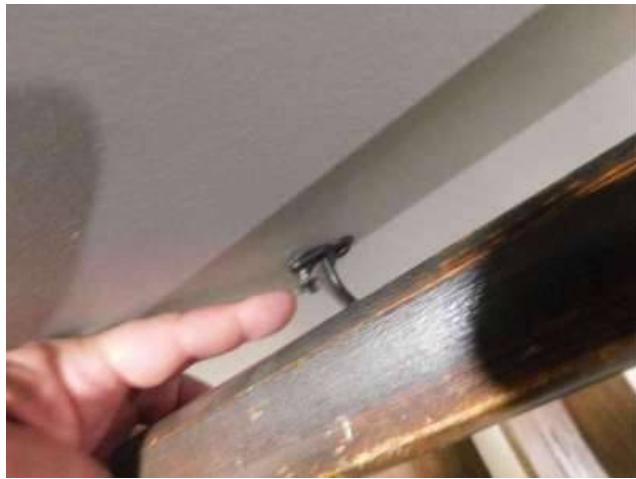
Photo 116-2 One of the screws holding the handrail in place has begun to come out.

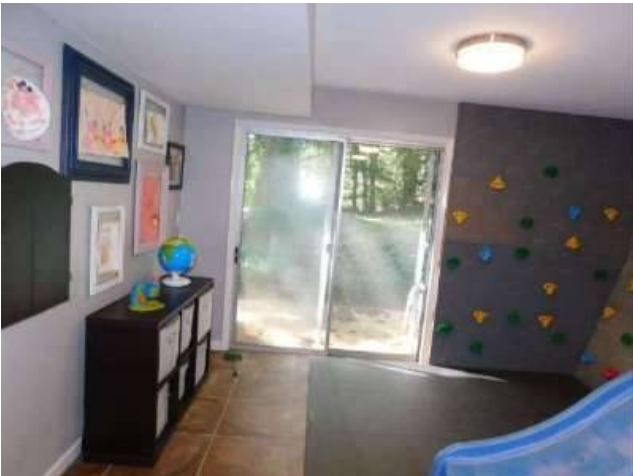
Be aware that evidence of broken seals may be more or less visible from one day to the next depending on the temperature, humidity, sunlight, etc. Glass doors or windows other than those that the inspector identified may also have failed seals and need glass replaced too.

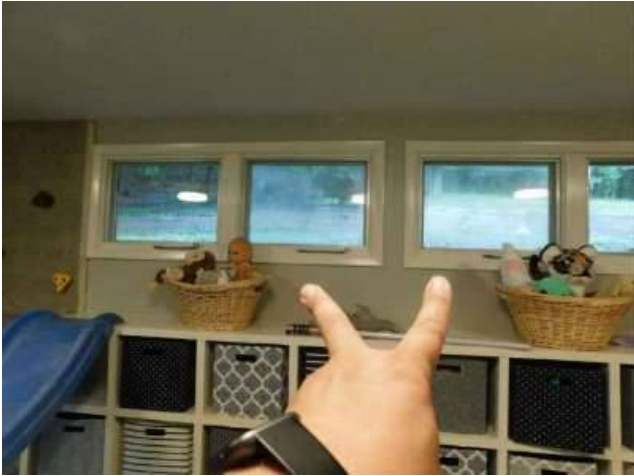
Be aware that evidence of failed seals or desiccant may be more or less visible depending on the temperature, humidity, sunlight, etc. Windows or glass-paneled doors other than those that the inspector identified may also have failed seals and need glass replaced. It is beyond the scope of this inspection to identify every window with failed seals or desiccant.

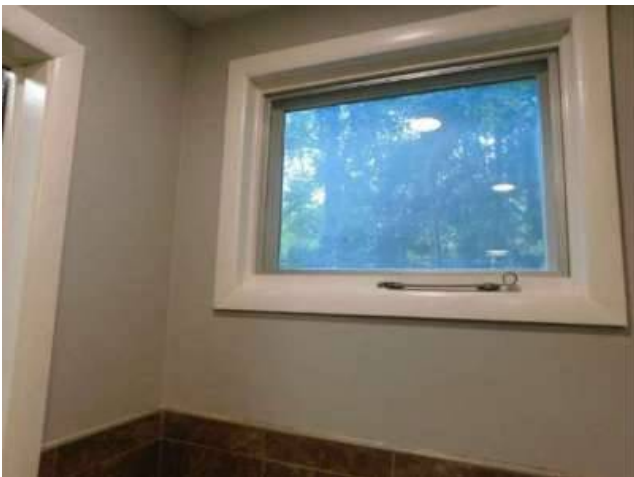
119) Replace - One or more windows that were designed to open and close were stuck shut and/or difficult to open and close. Required that a qualified person repair windows as necessary so they open and close easily.

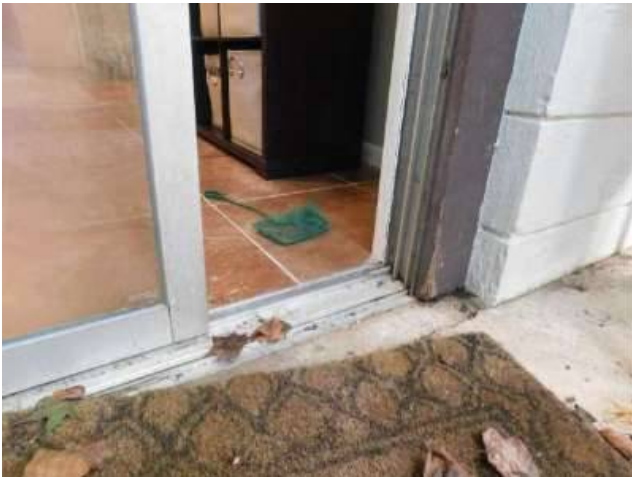
120) Repair/Maintain/Service, Evaluate, Monitor - The height of the area outside the sliding door is situated above the height of the interior floor or there is no step up going into it. The elevation of the outside area above the interior floor can create a path for rainwater, melting snow, or other moisture to flow into the home when the exterior door is opened. This can result in water damage to the interior flooring and potentially promote mold or rot. Requires that the entryway be evaluated by a qualified contractor and that contractor make any necessary repairs. At a minimum the area outside of the door should be kept free of snow.

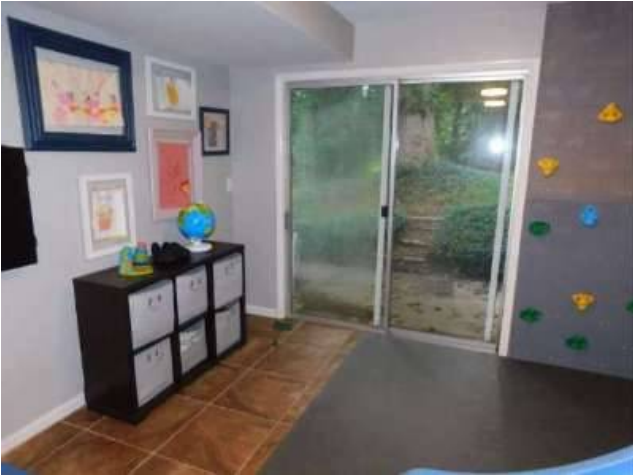
121) Repair/Maintain/Service - One or more sliding glass doors were difficult to open or close. Required that a qualified person maintain, repair or replace door(s) as necessary. Often, cleaning the track and applying a lubricant will help.

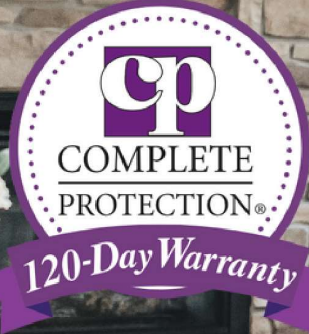
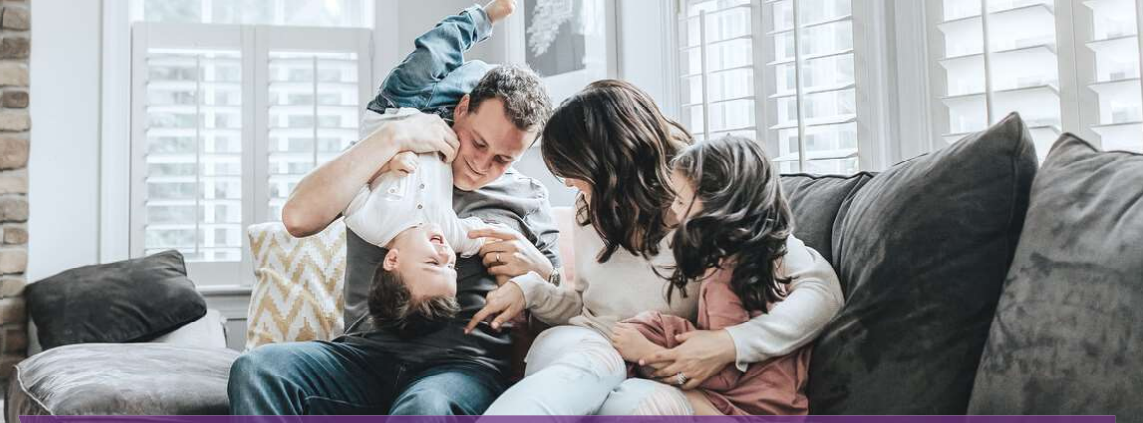
**PROTECTED
ITEMS INCLUDE:**

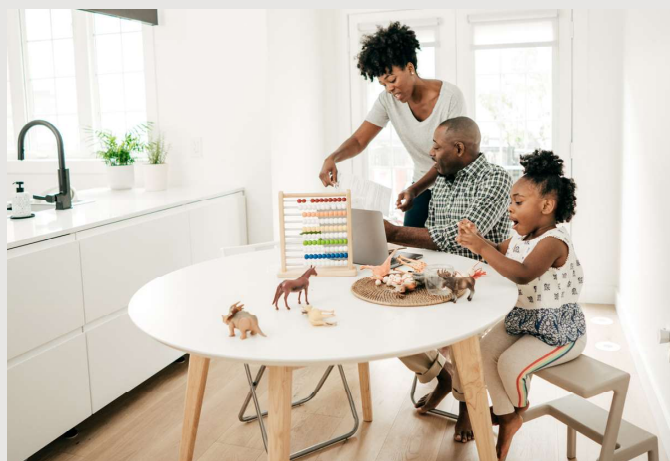
NEED TO INITIATE A CLAIM?
