Regal Home Inspections, LLC

37 Ridge Road
Colts Neck NJ 07722

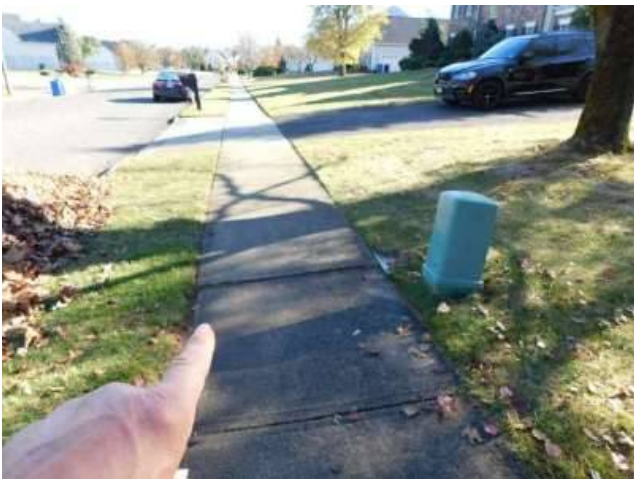
Photo 9-1 Close up of this area in the next photo.

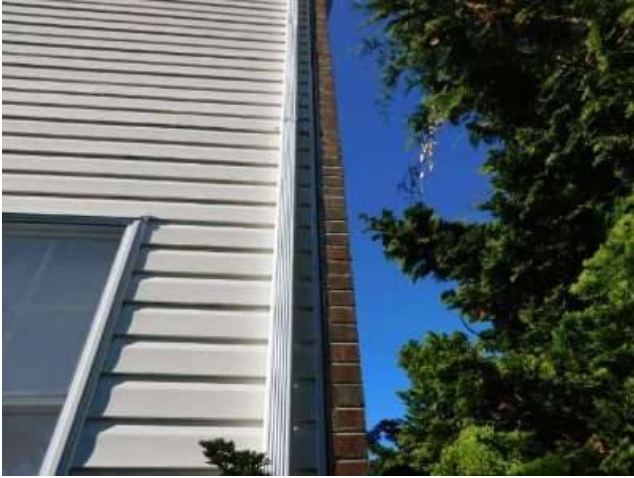
11) Repair/Maintain/Service - One or more gaps were found in siding or trim. Water may enter the structure. Required that a qualified siding contractor repair as necessary. For example, by sealing the gap between the bricks and vinyl siding.

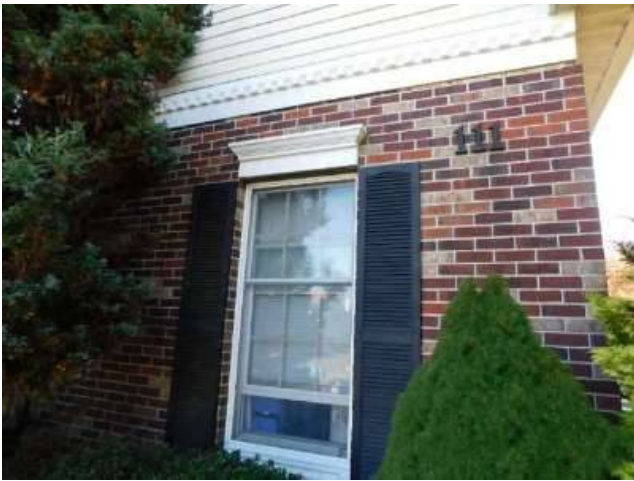
14) Maintain, Comment/FYI - Lintels are structural elements that support the weight of the brick over openings like windows and doors. Lintels are made of iron and often rust. Lintels are also embedded approximately 6 inches past the openings on either side to anchor them structurally. Over time lintels will rust. The rust can increase the size of the lintel and often applies upward force to the bricks causing cracks. No cracks seen. Requires maintaining the lintels by using a rust inhibiting paint and maintaining seals at the seams between the lintels and the brick.

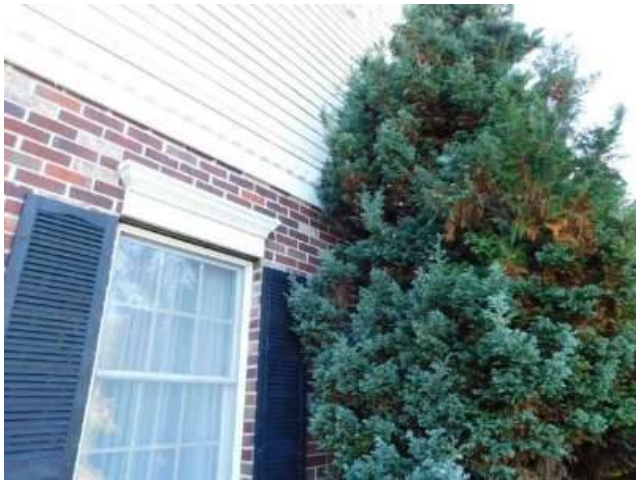
15) Maintain - Vegetation such as trees, shrubs and/or vines was in contact with or close to the building exterior. Vegetation can serve as a pathway for wood-destroying insects and can retain moisture against the exterior after it rains. This is a conducive condition for wood-destroying organisms. Required pruning, moving or removing vegetation as necessary to maintain at least 6 inches of space between it and the building exterior. A 1-foot clearance is better.

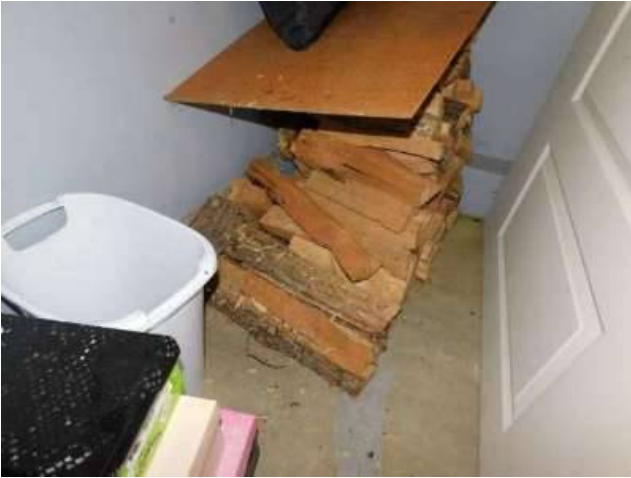
16) Comment/FYI - Firewood was stored so that it was in contact with or close to the building as seen inside the garage. This is a conducive condition for wood-destroying organisms. Requires storing firewood outdoors in an open area, and as far away from buildings as practical to keep insects away from buildings.

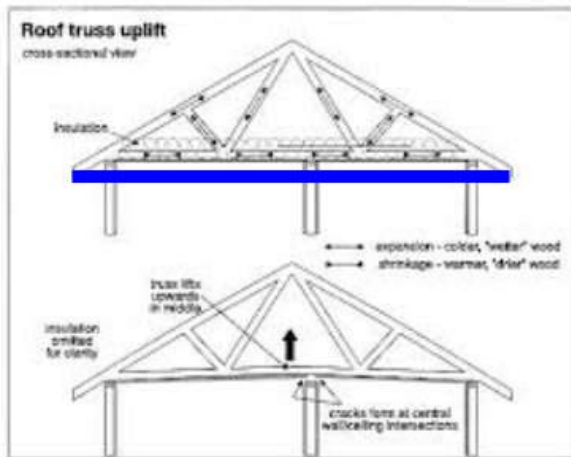
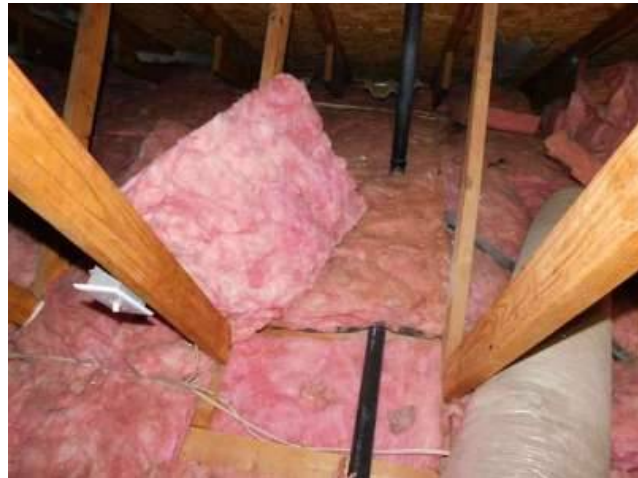
22) Monitor - The roof structure of this home has trusses. There is a phenomenon called truss uplift. It's explained at the link below. In essence, due to the fact that the bottom parts of the truss are embedded in insulation, in the winter, the upper parts of the trusses expand or contract differently than the truss cords embedded in the insulation. Consequently, the trusses flex. This can result in the appearance of cracks in ceilings or walls at specific times of the year due to the temperature differences between the parts of the trusses.

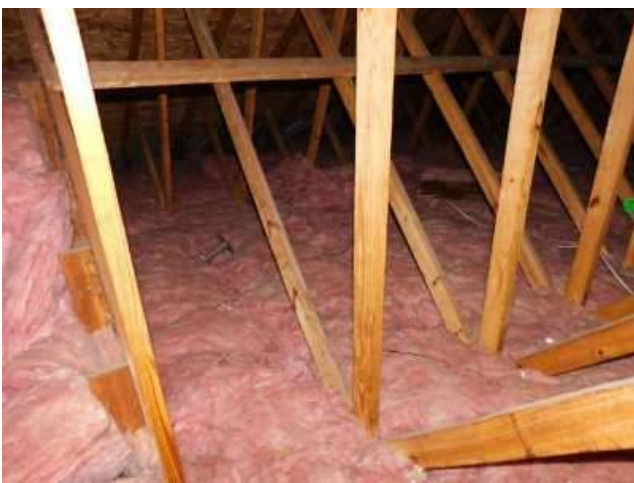
Photo 22-1 This illustration shows how temperature changes can cause the trusses to move and flex. Sometimes this results in cracks, nail pops and blemishes in the drywall ceiling and adjacent walls.

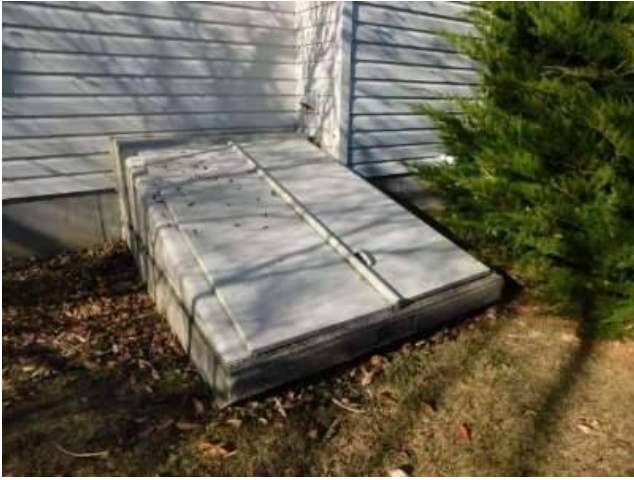
While our official requirement is to have all deficiencies repaired, some repairs may not be possible.

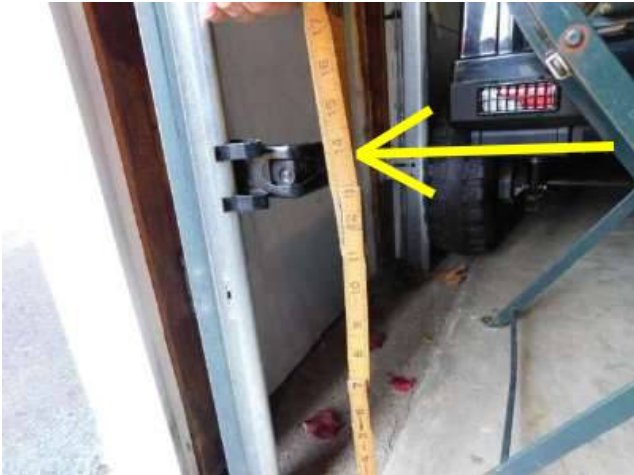
29) Material Defect/Safety, Repair/Maintain/Service - The photoelectric sensors that trigger the auto-reverse feature on both of the garage vehicle doors' automatic openers were located higher than 4-6 inches from the floor. This is a potential safety hazard. A qualified garage door contractor must relocate sensors so they are 4-6 inches from the floor per standard building practices.

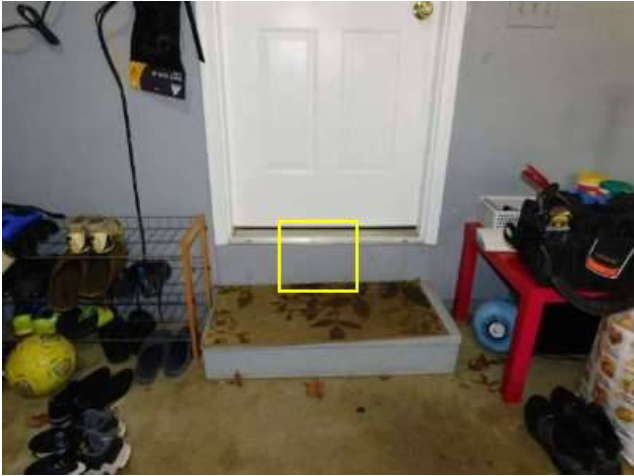
Photo 30-1 Close up of this area in the next photo.

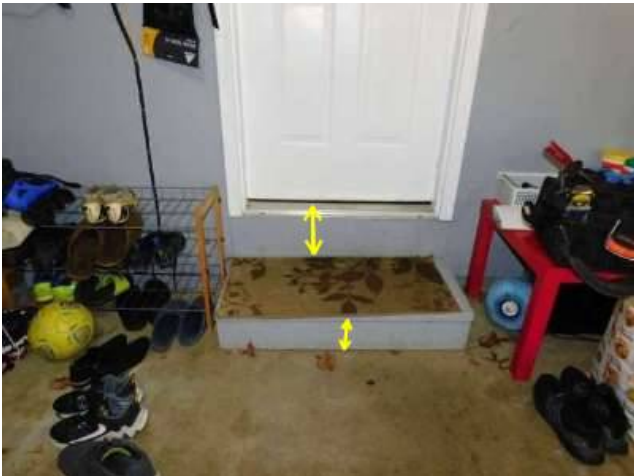
31) Material Defect/Safety, Repair/Maintain/Service - The risers for stairs at one or more locations varied in height and pose a fall or trip hazard. Risers within the same flight of stairs should vary by no more than 3/8 inch. At a minimum, be aware of this hazard, especially when guests who are not familiar with the stairs are present. Required that a qualified contractor repair per standard building practices.

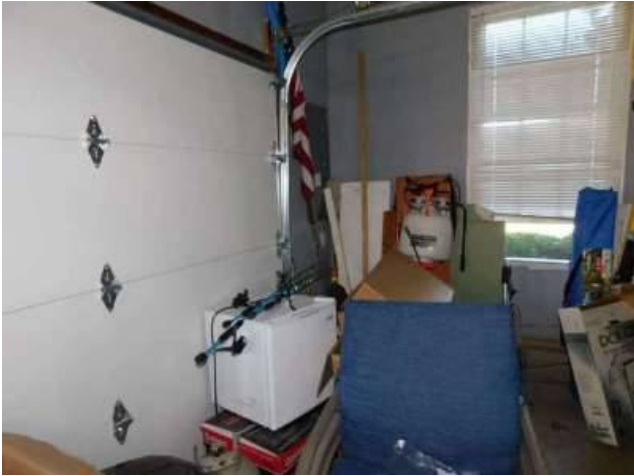
In accordance with the NJ home inspection administrative code, the inspector conducts a visual inspection, "...without requiring the moving of personal property...destructive measures..." . When furnishings, stored items, debris or other obstructions are present, all areas or items that are obscured, concealed or not readily accessible are excluded from the inspection.

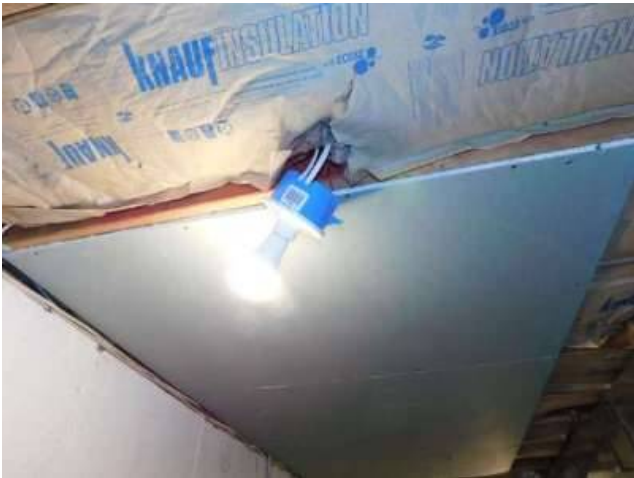
36) Material Defect/Safety, Replace, Repair/Maintain/Service - One or more light fixtures were loose. Required that a licensed electrician repair or replace light fixtures as necessary. Seen in the basement.

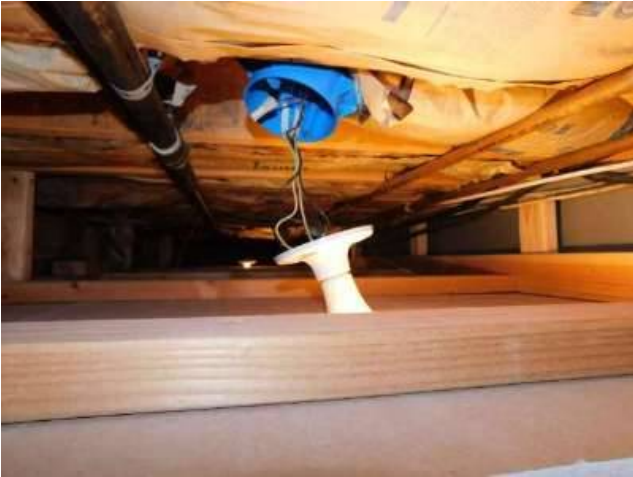
Photo 36-4 Close up of this area in the next photo.

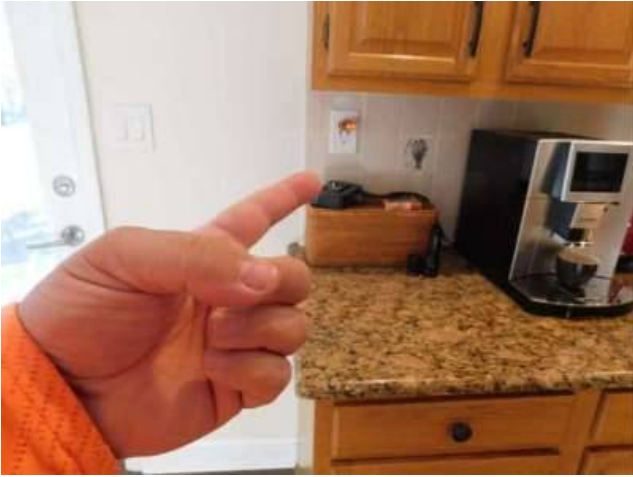
licensed electrician install GFCI protection as an upgrade to any circuits where there is a higher potential for electrical shock and GFCI protection does not currently exist. National electrical standards currently require that all outlets that serve the kitchen countertop surfaces be GFCI protected regardless of their proximity to a sink. Lack of GFCI protection where currently required is a safety issue for the occupant.

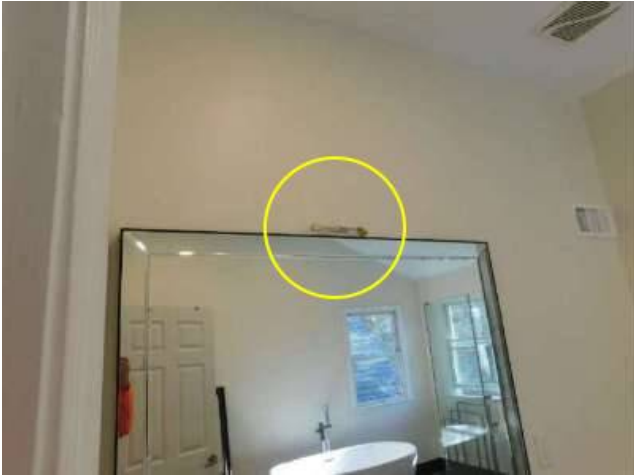
Photo 38-1 Close up of this area in the following photo.

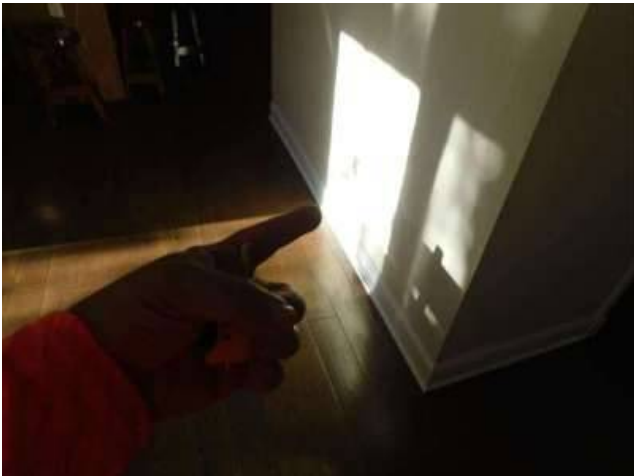
39) Material Defect/Safety, Replace - One or more electric receptacles (outlets) and/or the boxes in which they were installed were loose and/or not securely anchored. Wire conductors can be damaged due to repeated movement and/or tension on wires, or insulation can be damaged. This is a shock and fire hazard. Required that a licensed electrician repair as necessary.

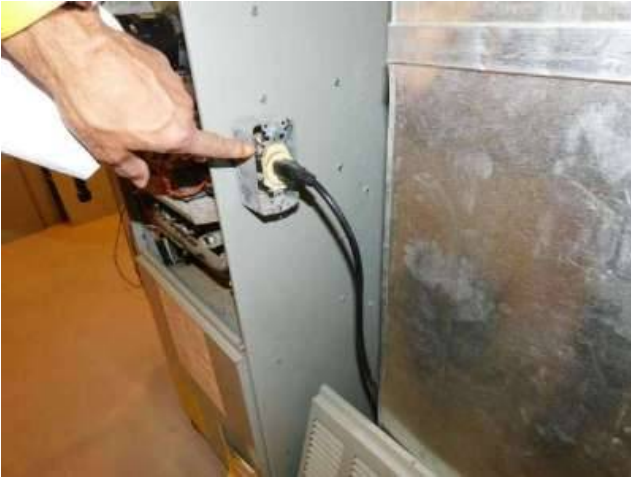
40) Material Defect/Safety, Repair/Maintain/Service - One or more cover plates for switches, receptacles (outlets) or junction boxes were missing or broken. These plates are intended to contain fire and prevent electric shock from occurring due to exposed wires. Required that a licensed electrician install cover plates where necessary.

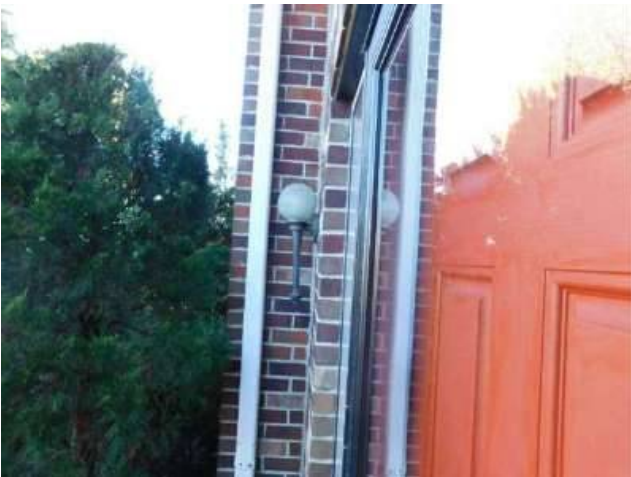
43) Evaluate - One or more light fixtures were inoperable (didn't turn on when nearby switches were operated). Recommend further evaluation by replacing bulbs and/or consulting with the property owner. If replacing bulbs doesn't work and/or no other switch(es) can be found, then recommend that a licensed electrician evaluate and repair or replace light fixtures as necessary.

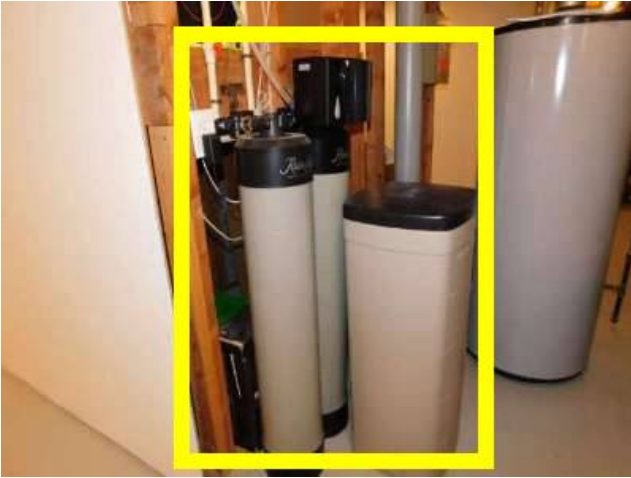
46) Repair/Maintain/Service, Exclusion, Evaluate - A water softener system was installed on the premises. These are specialty systems and are excluded from this inspection. Comments in this report related to this system are made as a courtesy only and are not meant to be a substitute for a full evaluation by a qualified specialist. Water softeners typically work by removing unwanted minerals (e.g. calcium, magnesium) from the water supply. They prevent build-up of scale inside water supply pipes, improve lathering while washing, and prevent spots on dishes.

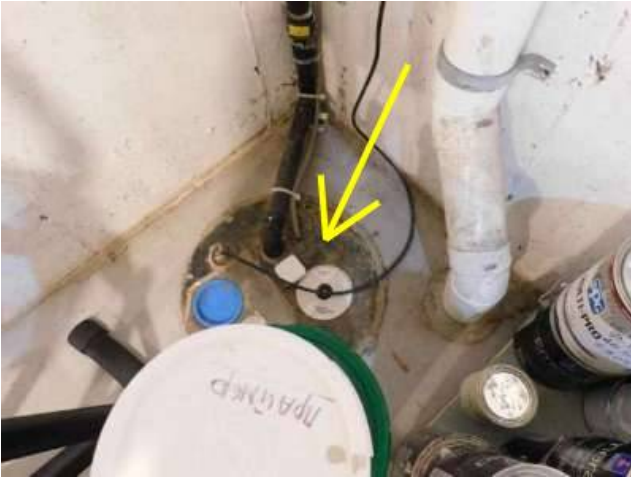
Please note that the sump pit is sealed as part of the radon mitigation system. The pump was therefore, inaccessible to attempt to operate it manually.

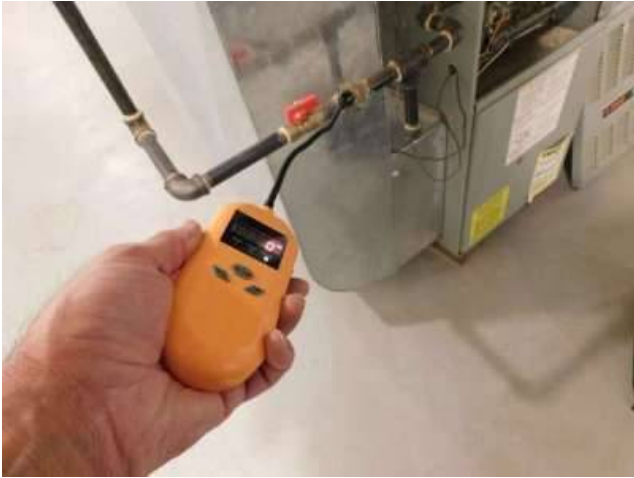
The meter can be seen in the photos. The probe extends to the gas piping for testing for leaks. None were detected. Few examples shown below.

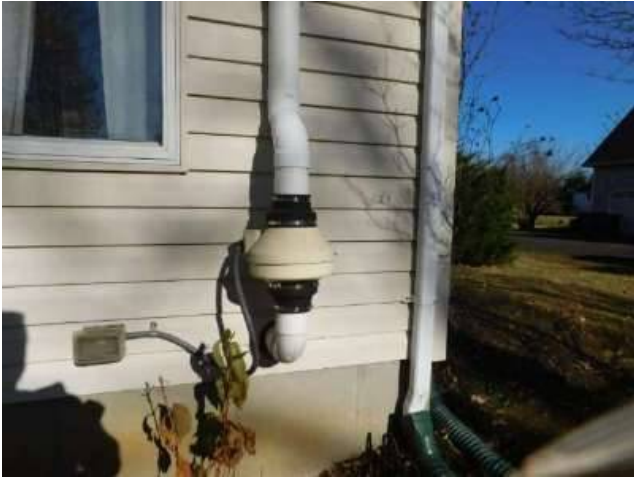
It is recommended by the NJ DEP and national Radon standards (ASTM E2121) that houses with radon mitigation systems be retested every 2 years.

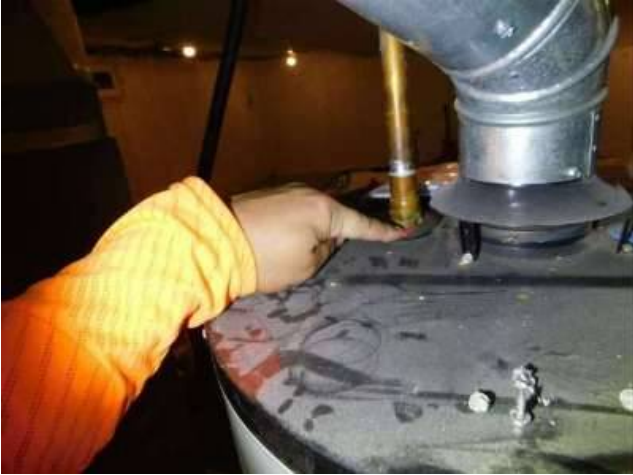
Plastic components at the top of the water heater have melted which is indicative of hot exhaust gases leaking out of the natural draft hood.

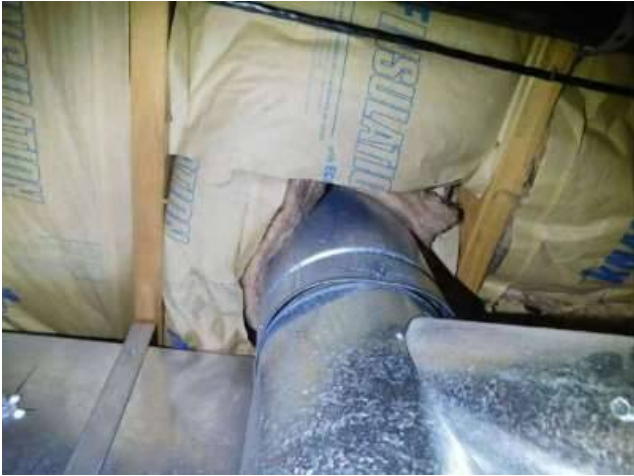
55) Material Defect/Safety, Repair/Maintain/Service - One or more sections of B-vent or L-vent metal flue pipe were too close to combustible materials and/or insulation. This type of vent requires a minimum of 1 inch clearance to such materials. This is a fire hazard. Requires that a qualified person repair as necessary. For example, by moving insulation, moving the flue pipe, installing a shield or making modifications to surrounding structures and combustibles.

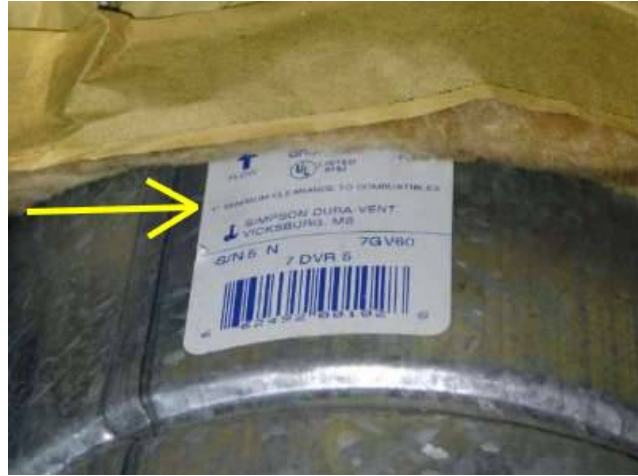
Photo 55-2 Label seen on the vent. "1" minimum clearance to combustibles." The insulation is not combustible but the paper around it is.

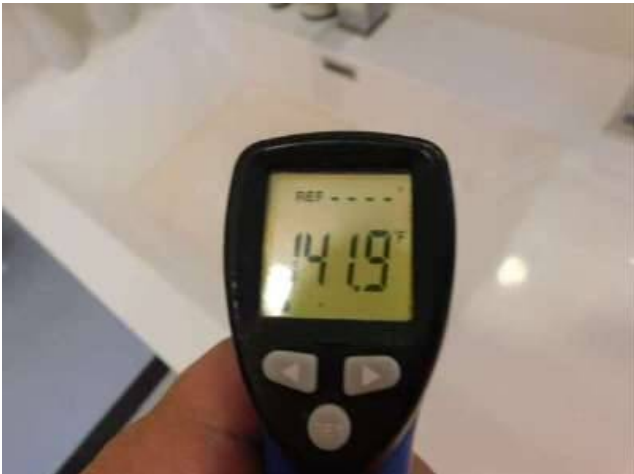
This is specific to children but applies to adults as well.

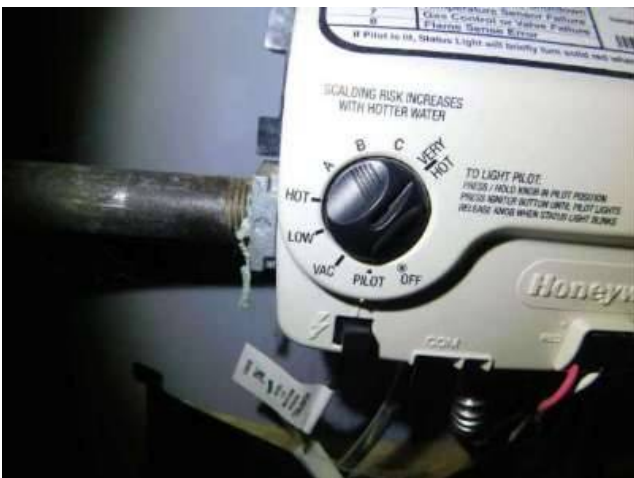
Photo 56-7 Upon arrival, the water heater was set to the manufacturer's "VERY HOT" setting. As noted on the thermostat, "SCALDING RISK INCREASES WITH HOTTER WATER".

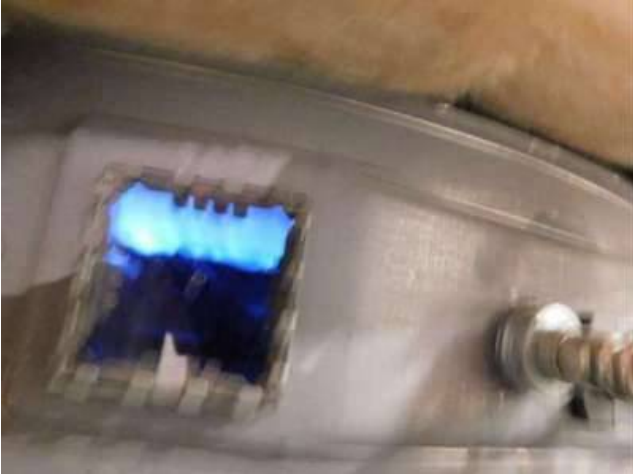
59) Comment/FYI - The water heater's burner flame was blue in color indicating proper combustion. As seen through the water heater's sight glass.

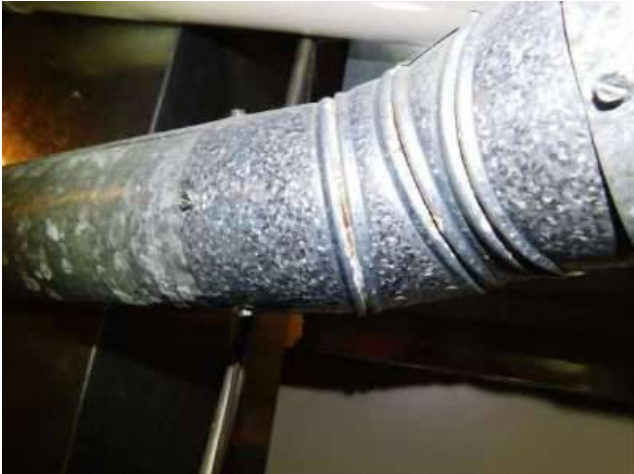
60) Material Defect/Safety, Replace, Repair/Maintain/Service - Rust is accumulating on furnace exhaust flues. If the metal rusts completely through the flue then by-products of combustion can leak out into the house. A licensed HVAC technician must evaluate the flues for proper function and condition and make repairs or replace as necessary.

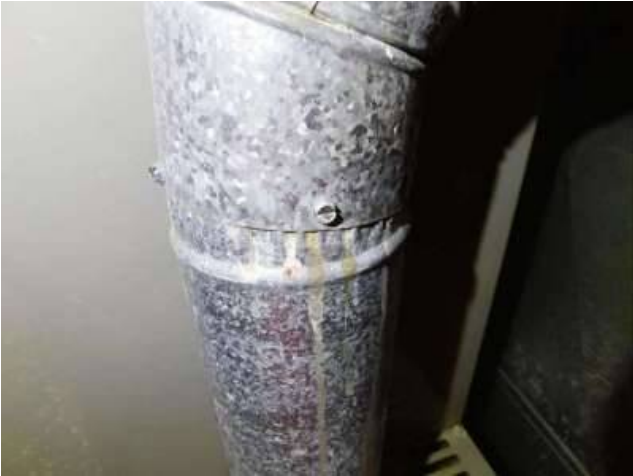
63) Repair/Maintain/Service, Evaluate - A white, powdery residue was found on or below the B-vent or L-vent exhaust flue. Typically this is a result of condensation in the flue and may indicate that the flue has a substandard draw. The flue may be incorrectly configured, blocked (e.g. debris, bird nest), or the appliance may be incorrectly configured. Required that a HVAC qualified contractor evaluate and repair as necessary.

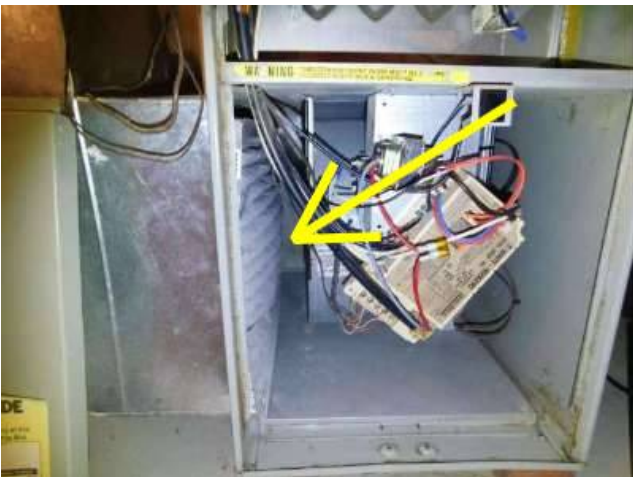
64) Maintain - Recommend replacing or washing HVAC filters upon taking occupancy depending on the type of filters installed (disposable or reusable). Regardless of the type, recommend checking filters monthly in the future and replacing or washing them as necessary and in accordance with the filter manufacturer's instructions. How frequently they need replacing or washing depends on the type and quality of the filter, how the system is configured (e.g. always on vs. "Auto"), and on environmental factors (e.g. pets, smoking, frequency of house cleaning, number of occupants, the season).

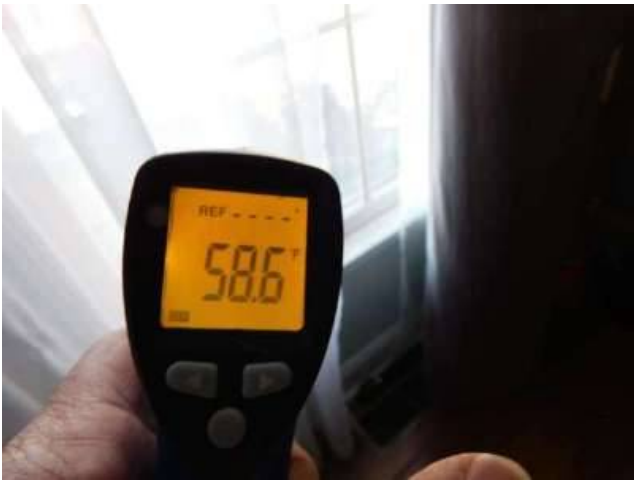
68) Comment/FYI - Sample AC temperatures. All accessible air supply registers were measured. A few examples are shown.

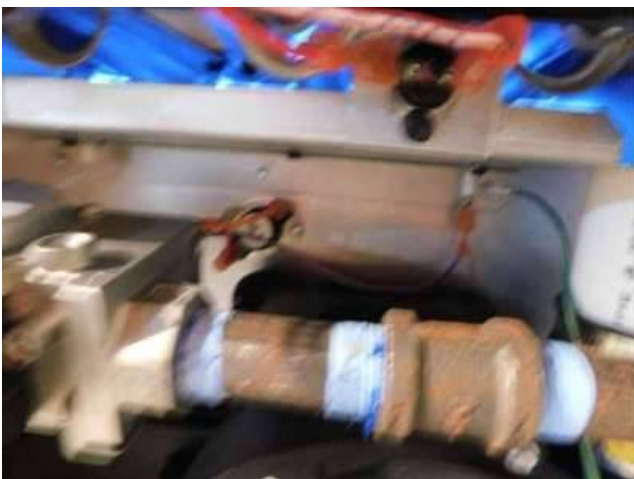
69) **Comment/FYI** - The furnace's burners were blue in color indicating proper fuel combustion.

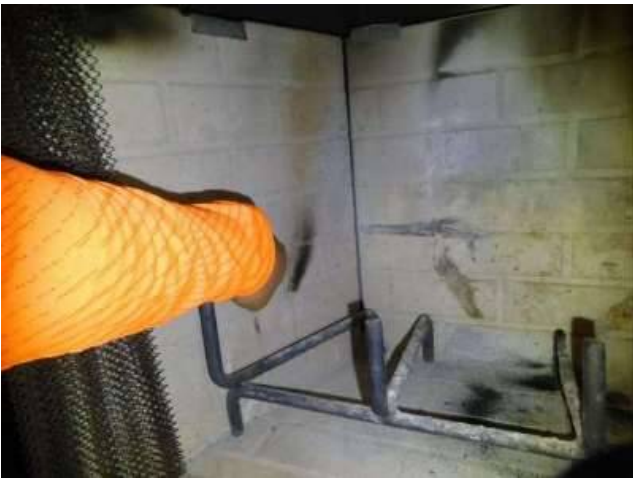
70) Material Defect/Safety, Replace, Repair/Maintain/Service - One or more refractory panels (the 1-inch thick fireproof, ceramic panels lining the fireplace) had cracks or was deteriorated. Damage to the refractory panels could allow heat from the fire to get past the panels and could be a fire hazard. Required that a qualified, chimney contractor repair or replace refractory panels.

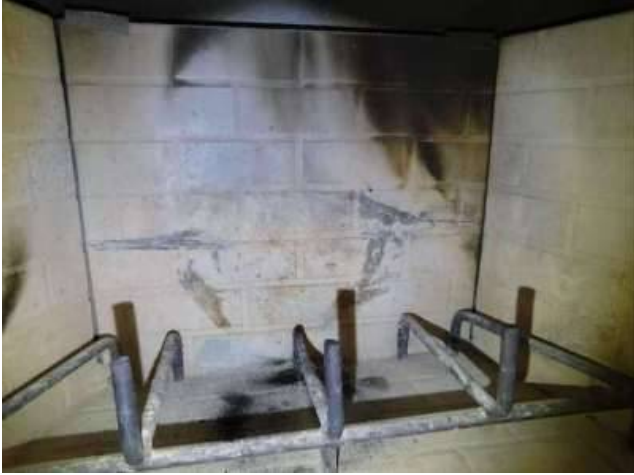
The pile of soot fell out when the damper was opened. Compare the difference seen between both photos.

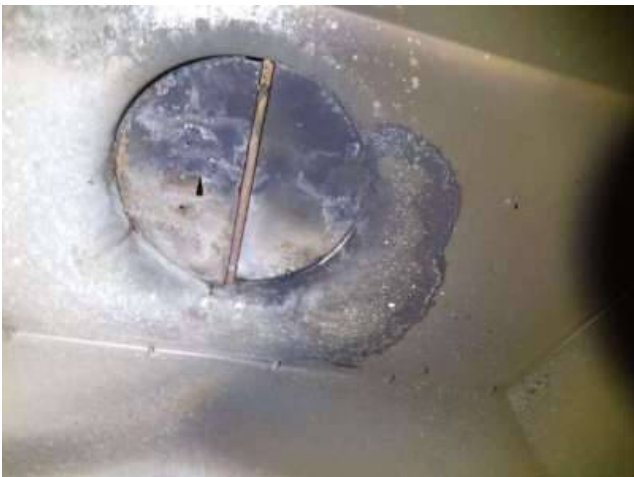
72) Replace, Repair/Maintain/Service, Evaluate - One or more fireplace dampers were corroded. Required that a qualified contractor evaluate and repair or replace dampers as necessary.

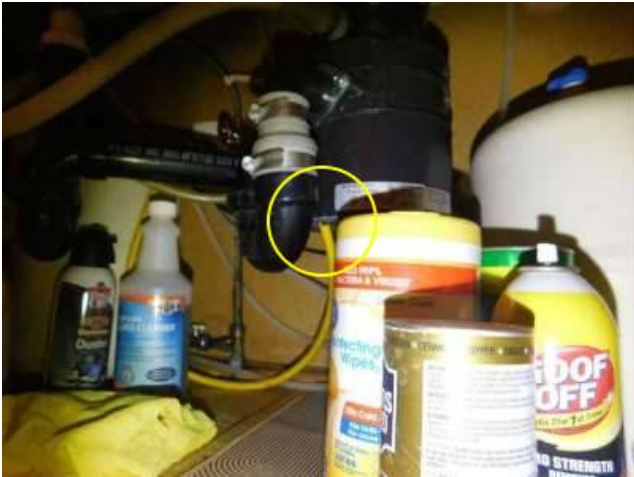
Photo 73-1 Close up of this area in the following photo.

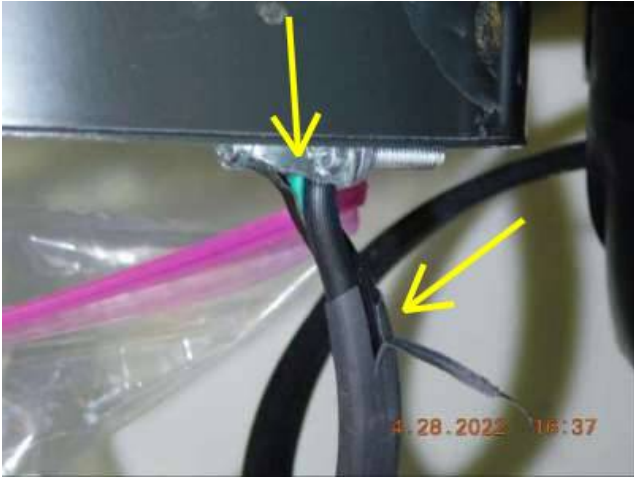
Photo 73-3 This is an example from a DIFFERENT property of how wiring for a disposal can become damaged or frayed.

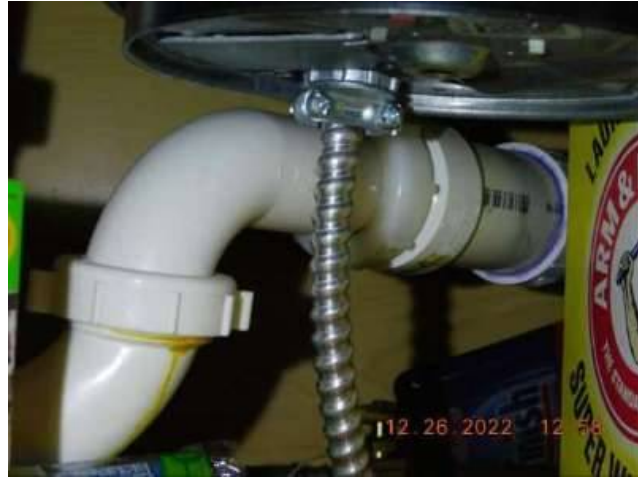
Photo 73-4 This is an example of armor clad wiring from a DIFFERENT property.

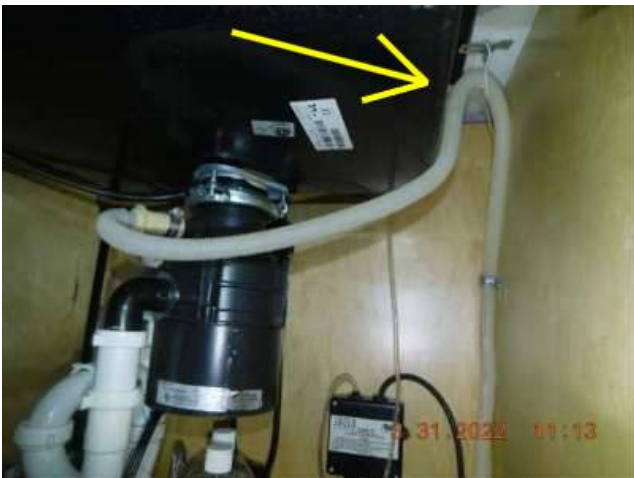
Photo 74-1 This is an example of a high loop from a DIFFERENT property. No high loop was seen for THIS property.

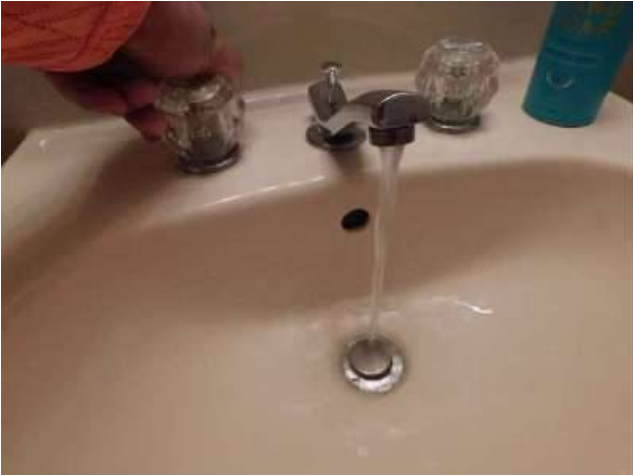
Compare the flow of the hot and cold supplies here.

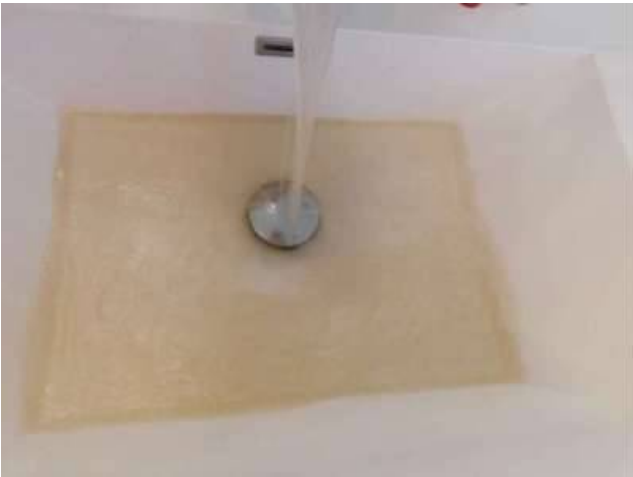
Seen in the master bathroom sink.

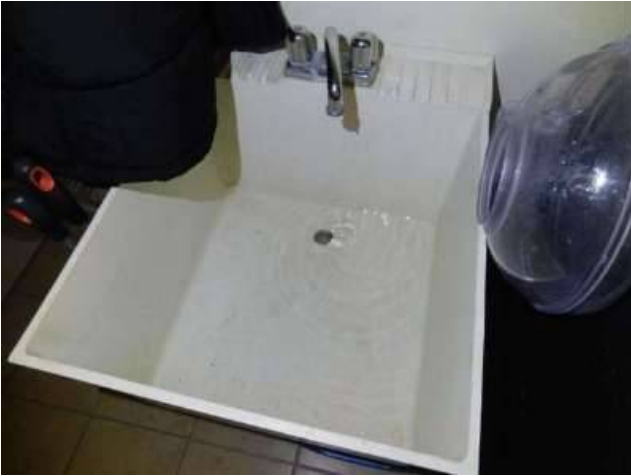
78) Repair/Maintain/Service - The sink at location(s) D drained slowly. Recommend clearing drain and/or having a qualified plumber repair if necessary.

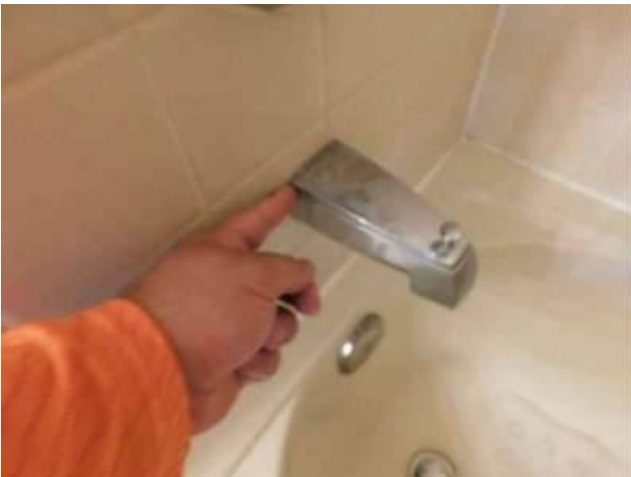
79) Repair/Maintain/Service - Caulk was missing around the base of the bathtub spout, or there was a gap behind it, at location(s) B. Water may enter the wall structure behind the bathtub. Recommend that a qualified person repair as necessary to eliminate the gap. For example, by installing or replacing caulk if the gap is small enough. For larger gaps, a shorter spout nipple or an escutcheon plate can be installed.

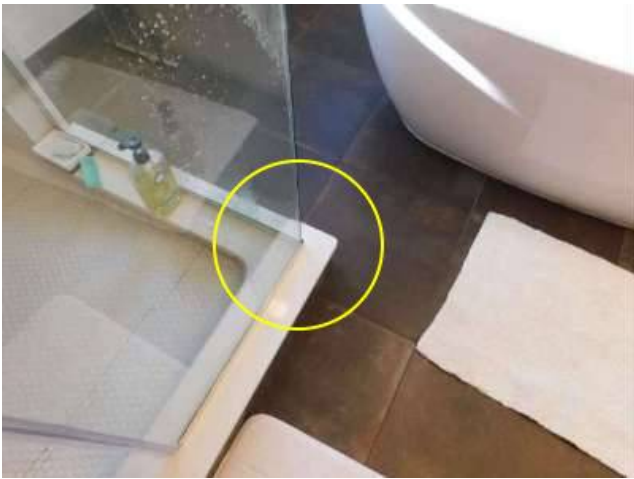
Photo 80-1 Close up of this area in the following photo.

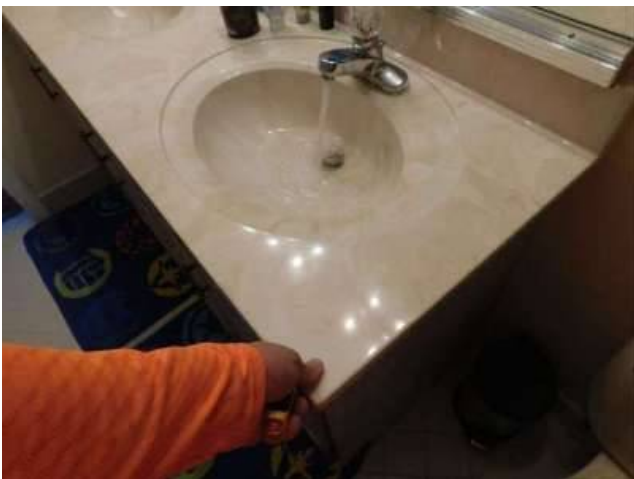
81) Repair/Maintain/Service - The countertop at location B is loose. Required it be secured or fastened by a qualified contractor.

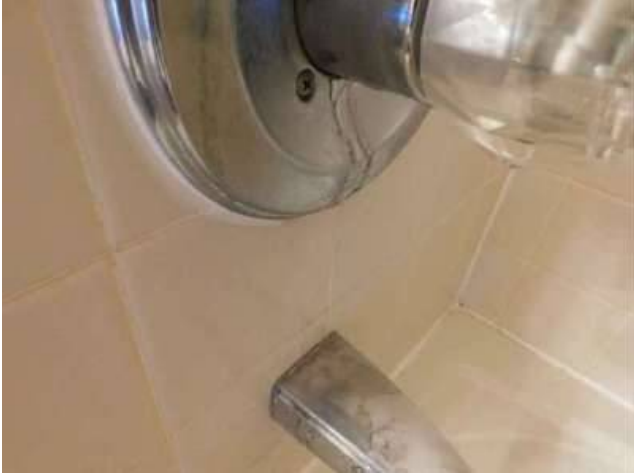
utility costs. Requires that it be repaired or replaced as necessary by a qualified contractor.

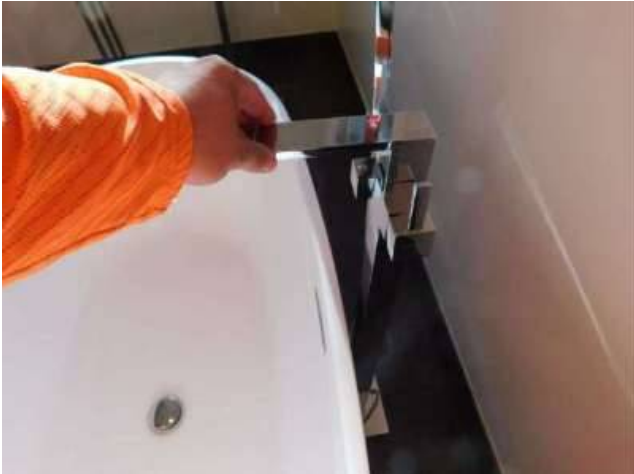
83) Repair/Maintain/Service - The tub assembly at location C is loose. Leaks may occur as a result. Requires it be secured or fastened by a qualified contractor.

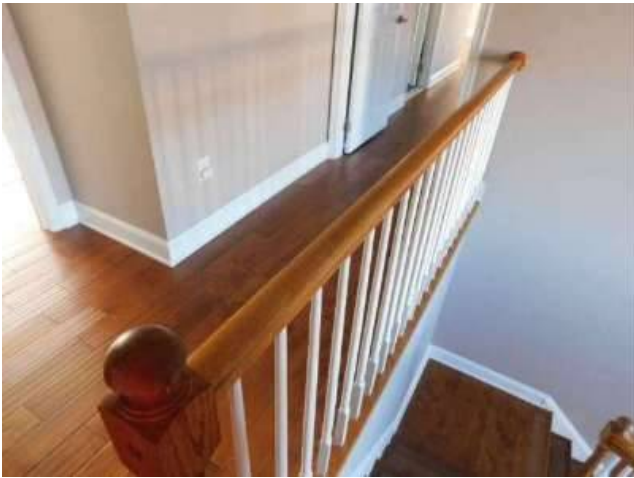
85) Material Defect/Safety, Repair/Maintain/Service - Guardrails at one or more locations with drop-offs higher than 30 inches were wobbly, and pose a fall hazard. Required that a qualified person repair guardrails as necessary.

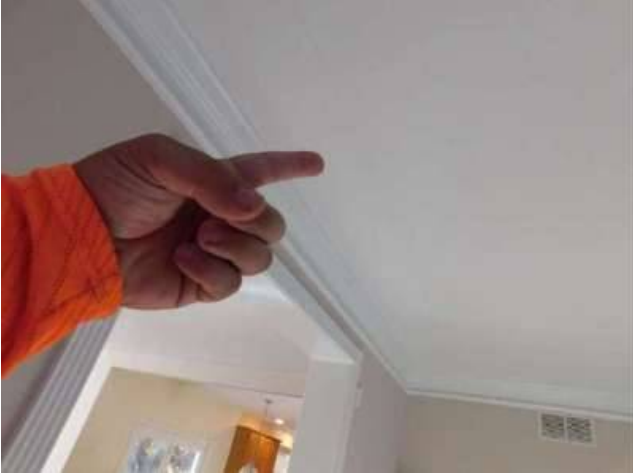
86) Repair/Maintain/Service - Cracks, nail pops and/or blemishes were found in walls and/or ceilings in one or more areas. Cracks and nail pops are common, are often caused by lumber shrinkage or minor settlement, and can be more or less noticeable depending on changes in humidity. Required that the client have a qualified contractor, such as a painting contractor, repair for aesthetic reasons.

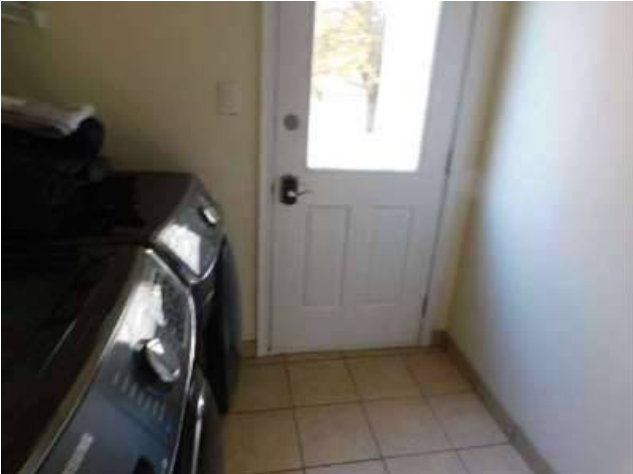
88) Comment/FYI - One or more hinged exterior doors had no deadbolt lock installed and relied solely on the entry lockset for security. Required installing locksets on exterior doors where missing for added security.

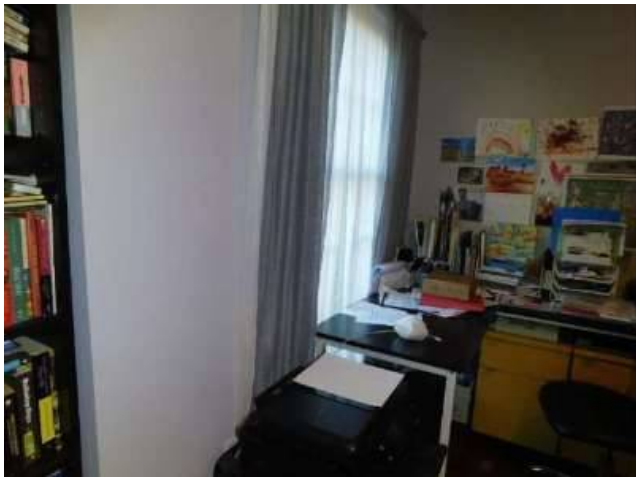
One or more windows such as the ones shown below were not operated because of items blocking access.
