Regal Home Inspections, LLC

37 Ridge Road

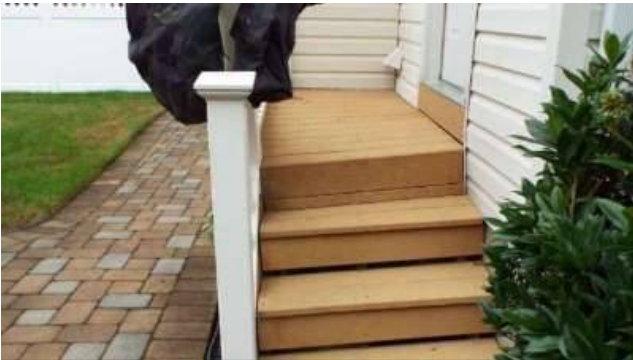
4) Material Defect/Safety, Repair/Replace - One or more sets of stairs were unstable and the structure appears to have shifted. A qualified contractor should repair as necessary. For example, by installing additional bracing or supports.

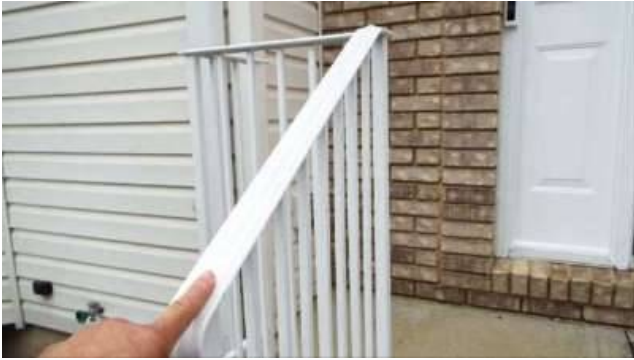
5) Material Defect/Safety, Repair/Maintain/Service - Guardrails and handrails at one or more locations were loose and/or wobbly and pose a fall hazard. Recommend that a qualified person repair handrails and guardrails as necessary.

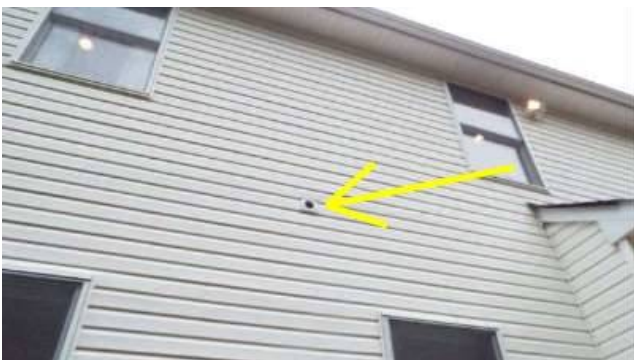
7) Repair/Replace - One or more exhaust duct end caps were damaged. Their purpose is to prevent unconditioned air from entering the building, and keep out birds, rodents and bugs. Blocked ducts can cause fan motors and/or clothes dryers to overheat and can pose a fire hazard. Recommend that a qualified person repair or replace caps as necessary.

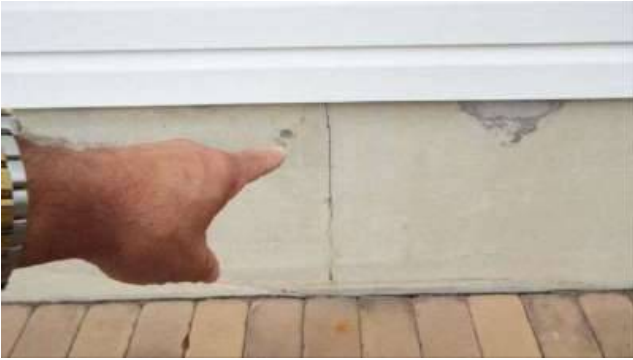
8) Repair/Maintain/Service - One or more minor cracks (1/8 inch or less) were found in the foundation. These didn't appear to be a structural concern, but recommend sealing them to prevent water infiltration and monitor them in the future. Numerous products exist to seal such cracks including hydraulic cement, non-shrinking grout, resilient caulks and epoxy sealants.

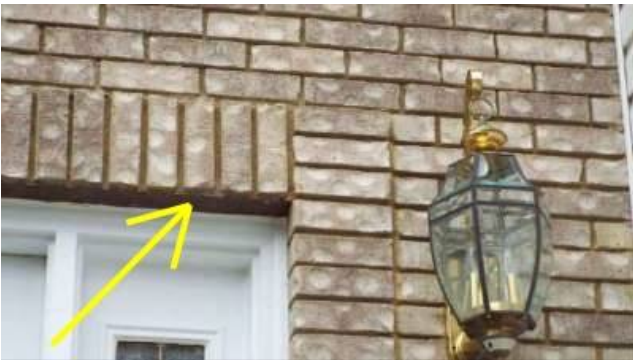
9) Maintain, Comment/FYI - Lintels are structural elements that support the weight of the brick over openings like windows and doors. Lintels are made of iron and often rust. Lintels are also embedded approximately 6 inches past the openings on either side to anchor them structurally. Over time lintels will rust. The rust can increase the size of the lintel and often applies upward force to the bricks causing cracks. No cracks were seen here. Recommend maintaining the lintels by using a rust inhibiting paint and maintaining seals at the seams between the lintels and the brick.

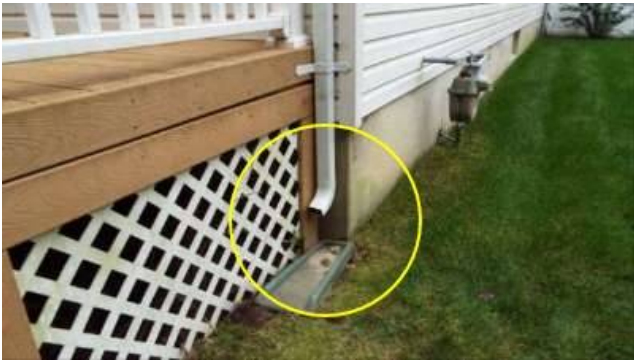
Photo 10-1 Water is deposited too close to the foundation wall.

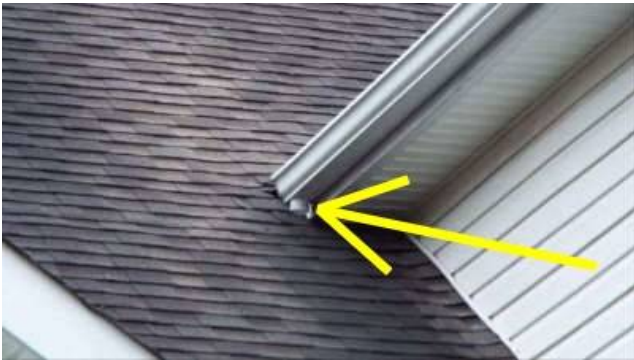
11) Repair/Maintain/Service - Ideally the downspout should not deposit water on the roof as seen in the photos below. The roof is designed to shed water that is flowing down. When the water emerges from the downspout it is going side-ways into the shingle. This will also cause accelerated shingle wear and gravel loss at this location. The illustration, courtesy of the National Association of Home inspectors shows improper ways that gutters deposit water on a roof as we have here. Recommend that a roofing/gutter contractor install a downspout or leader be added to carry the water to the lower gutter.

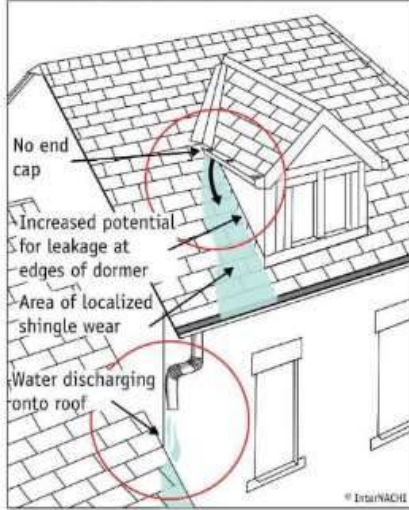
Gutter Improperly Discharging onto Roof

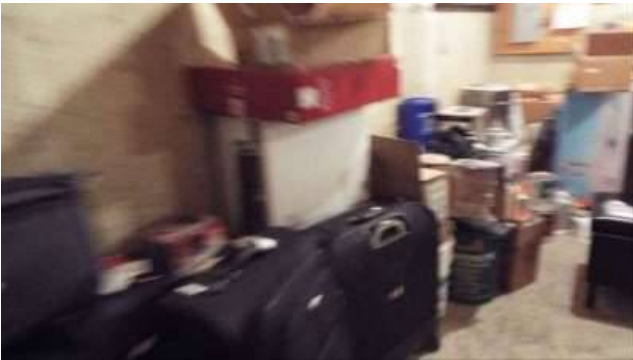
14) Comment/FYI - Areas of the basement were obscured due to stored items. This significantly limits the visual inspection of the foundation and structure behind these obscured areas. Please note that portions of the house and structure that are behind these boxes, stored items, etc. are not available for visual inspection and therefore excluded from the inspection.

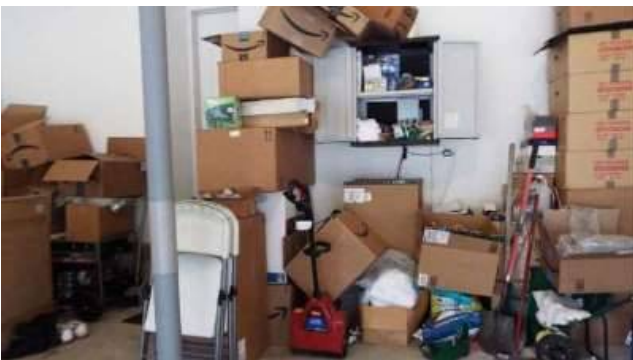
15) Comment/FYI - Areas of the garage were obscured by possessions and a vehicle. Areas that were not readily accessible for visual inspection are excluded from the inspection in accordance with New Jersey home inspection standards of practice. Please note that after the seller's possessions are removed damage, cracks, or deterioration may then be exposed including indications of wood destroying insects.

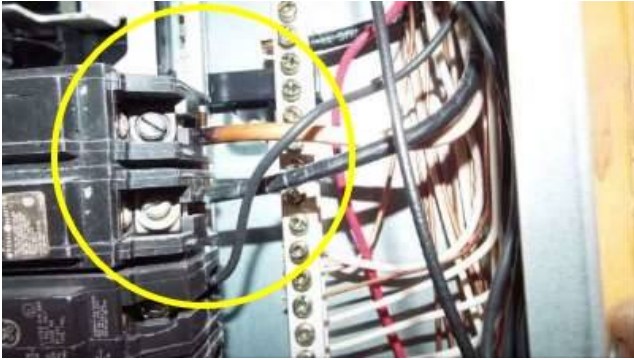
Photo 17-1 Close up of this area in the next photo. The same area is seen in the 3rd photo with a thermal image.

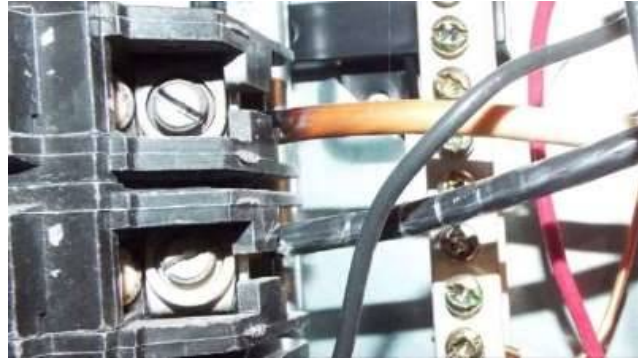
Photo 17-2 Clearly the white conductor shows signs of heat. The white wire insulation has burnt.

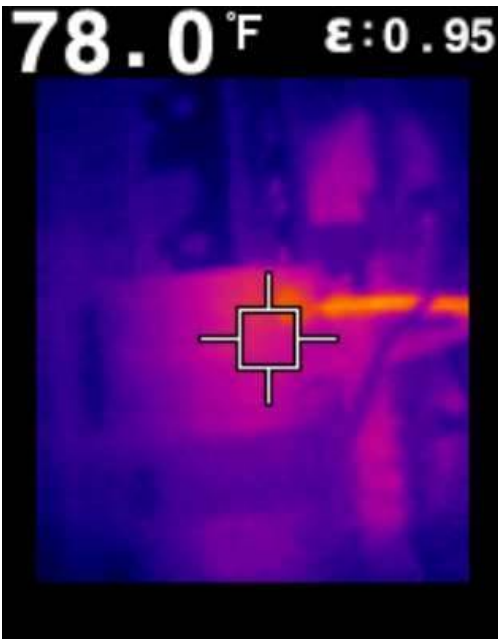
Photo 17-3 A thermal image (photograph) of the same area highlighted in the 1st photo confirms that by comparison, the circuit breaker and the wire (burned in the previous photo), is unusually hot as compared to the surrounding area.

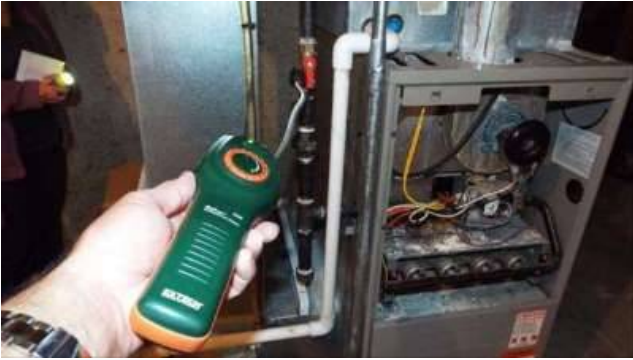
Green meter with orange dial can be seen in the photos. The probe extends to the gas piping for testing for leaks. None were detected. Few examples shown below.

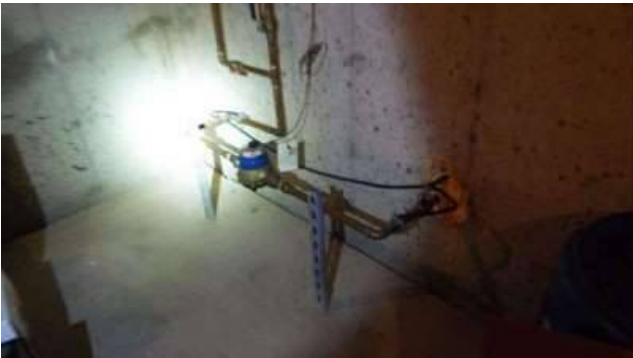
25) Comment/FYI - Water meter and main water shut off valves are in the basement.

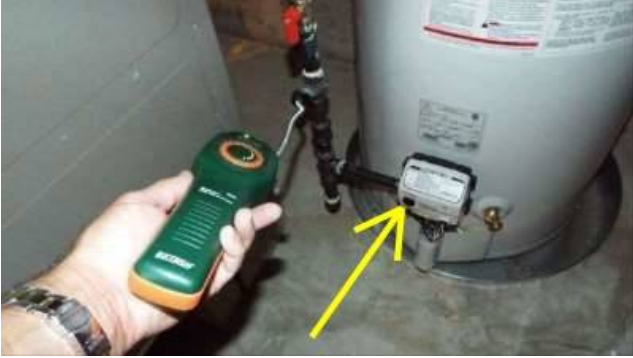
Photo 26-1 This dial should be adjusted. It's currently set, by the occupant, to higher than the labeled, "HOT" setting. Recommend adjusting it downward to the HOT setting at your day-of-closing walk through.

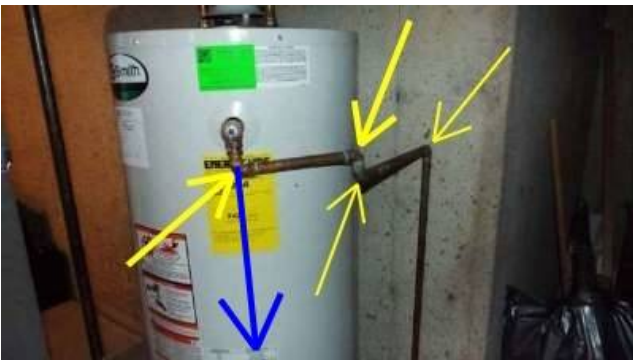
Photo 27-1 The Monroe Twp, "Final" inspection sticker is on the water heater. Typically the drain goes straight to the floor as indicated by the blue arrow.

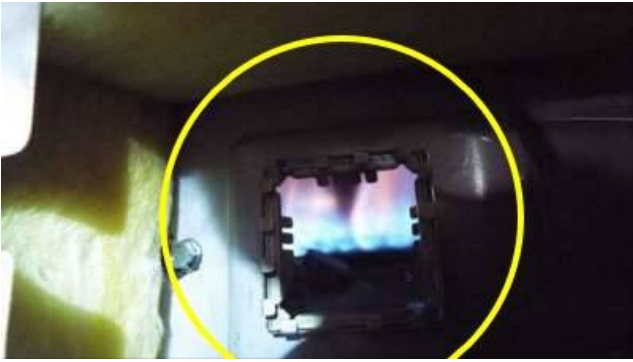
29) Comment/FYI - The water heater's burner flame was blue in color indicating proper combustion. As seen through the water heater's sight glass.

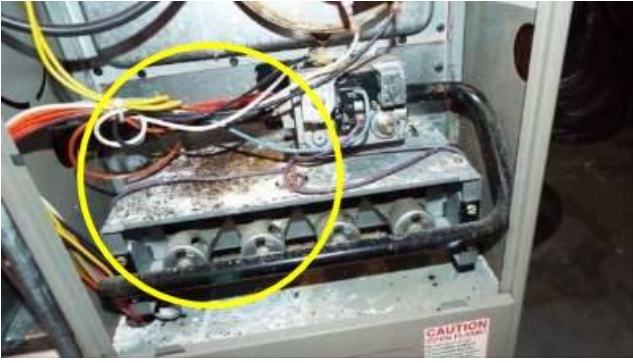
Photo 30-1 There's an abundance of rust particles and debris in the furnace which suggests that it hasn't been professionally serviced for years.

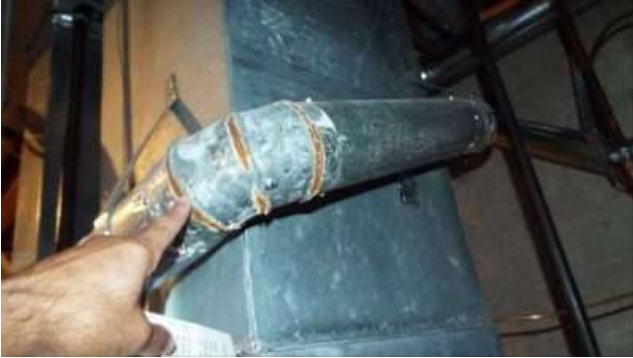
31) Repair/Maintain/Service, Evaluate - There is rust on the furnace's exhaust flue. This is usually carbonic corrosion caused by the caustic condensation that's a byproduct of the furnace's operation. Recommend that a qualified HVAC contractor evaluate and repair. There is also an abundance of rust and other corrosive by product materials inside the furnace indicating that it hasn't been professionally serviced.

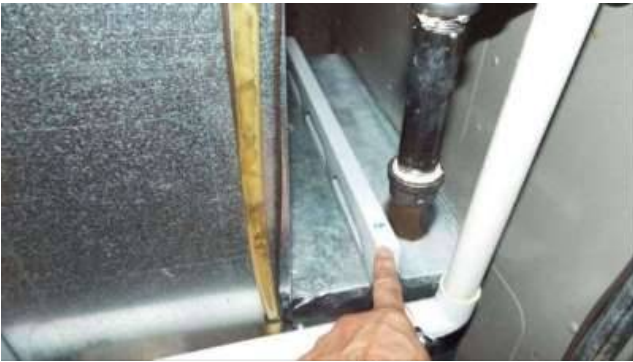
One option for a cover is <https://www.allergyzone.com/collections/clean-air-accessories/products/filterlock-furnace-filter-slot-seal>. Recommend that this cover, or something similar, be used to seal the opening over the air filter.

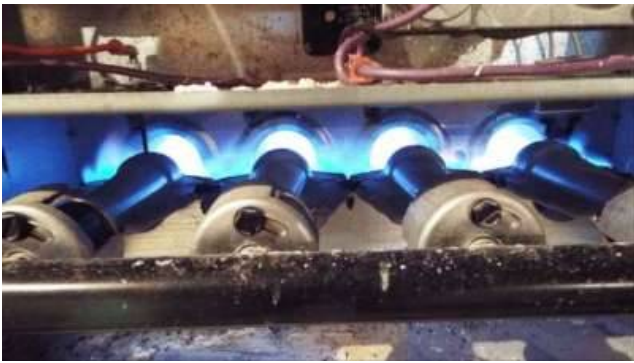
37) Comment/FYI - The furnace's burners were blue in color indicating proper fuel combustion.

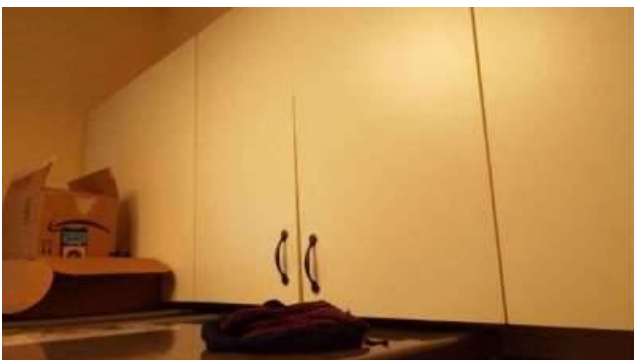
Photo 38-1 The right side of this set of cabinets in the Laundry room appears to be falling off the wall and should be properly secured.
