Regal Home Inspections, LLC

Find of the Week 2/23/2019

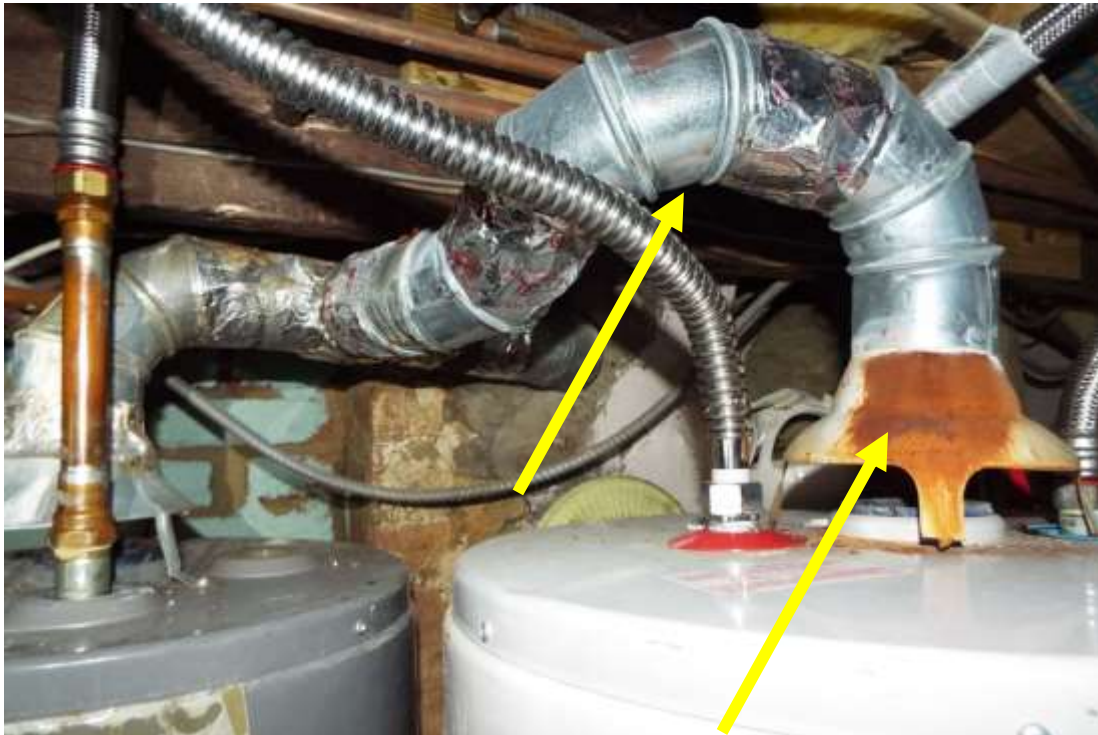
Figure 1 Are you kidding me?

This week's find of the week is, to some degree, related to last weeks. In another home, the water heater's flue pipe was poorly sloped. Based on the burn marks on the draft hood, there was a large amount of exhaust gasses that were likely venting into the basement and NOT up the flue. Additionally, the basement was being used as (Possibly illegal) living unit.

This was, of course, a material defect in accordance with NJ home inspection laws and standards of practice.

There were actually two water heaters at this location. They both shared part of the same, metal flue. There were other issues with the water heaters as well. Such as a temperature pressure relief valve (TPRV) drain line that was reduced from $\frac{3}{4}$ inch diameter pipe to a $\frac{1}{2}$ inch diameter pipe. The TPRV drain can't be reduced. There were also various leaks and a scorch mark at the bottom of one of the water heaters that may be due to poor drafting (exhaust) due to the aforementioned flue pipe issues.
