## Regal Home Inspections, LLC

### Find of the Week 7/6/2019

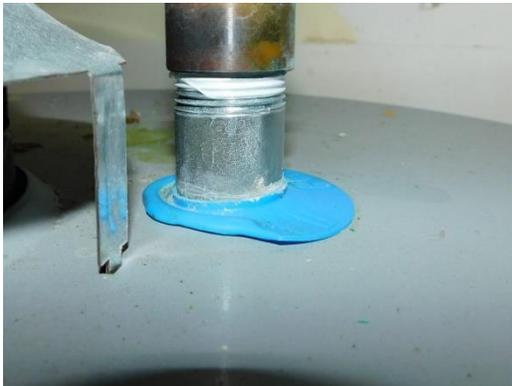
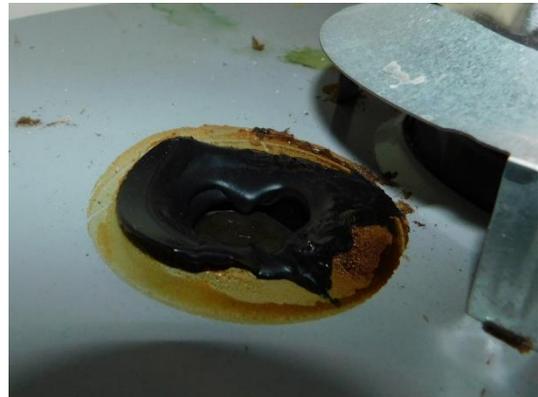
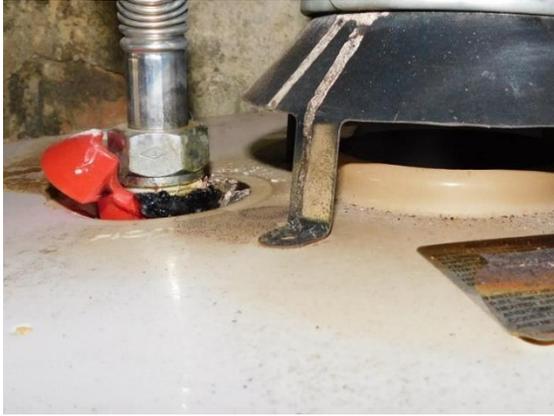
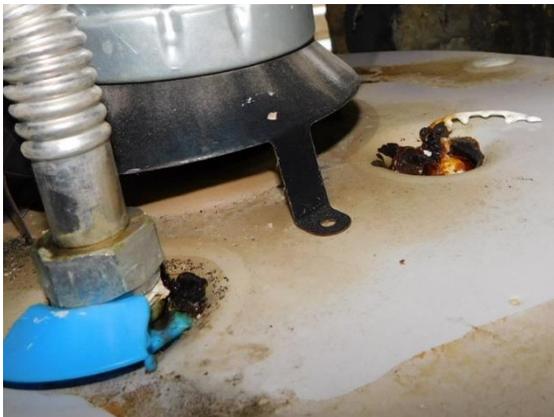
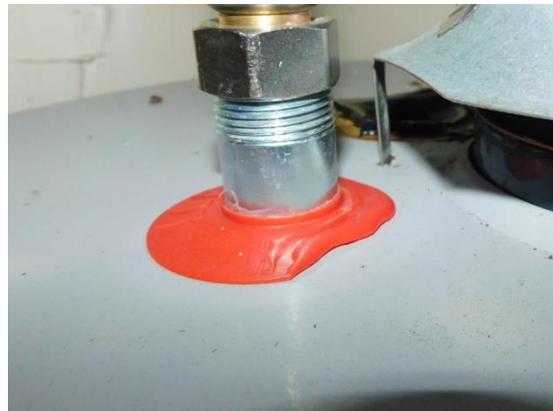
This, and many water heaters, have what's called a, "Natural draft hood". The hot exhaust naturally rises and draws in air at the opening on top of the water heater. **Heat and combustion gasses should not (MUST NOT) exit at this location.** The partially melted plastic components around the draft hood indicates that heat and combustion gasses, INCLUDING carbon monoxide, ARE leaking into the living space around the water heater. In this week's instance, the water heater was in a closet adjacent to a bedroom.

Anyway, the problem was identified. It was classified as a material defect in accordance with NJ home inspection standards of practice. To the definition of a, "Material defect", this effected the "safety" of the occupants. The first three photos are from this week's home. The last 2 are from a home inspected in early June.

Melted blue, red and black plastic elements at the top of two different water heaters due to poor exhaust drafting.

If you see this atop your water heater, you should call a licensed plumber immediately. You may also have carbon monoxide leaking into your home too.
