Regal Home Inspections, LLC

Finds of the Week 9/7/2019

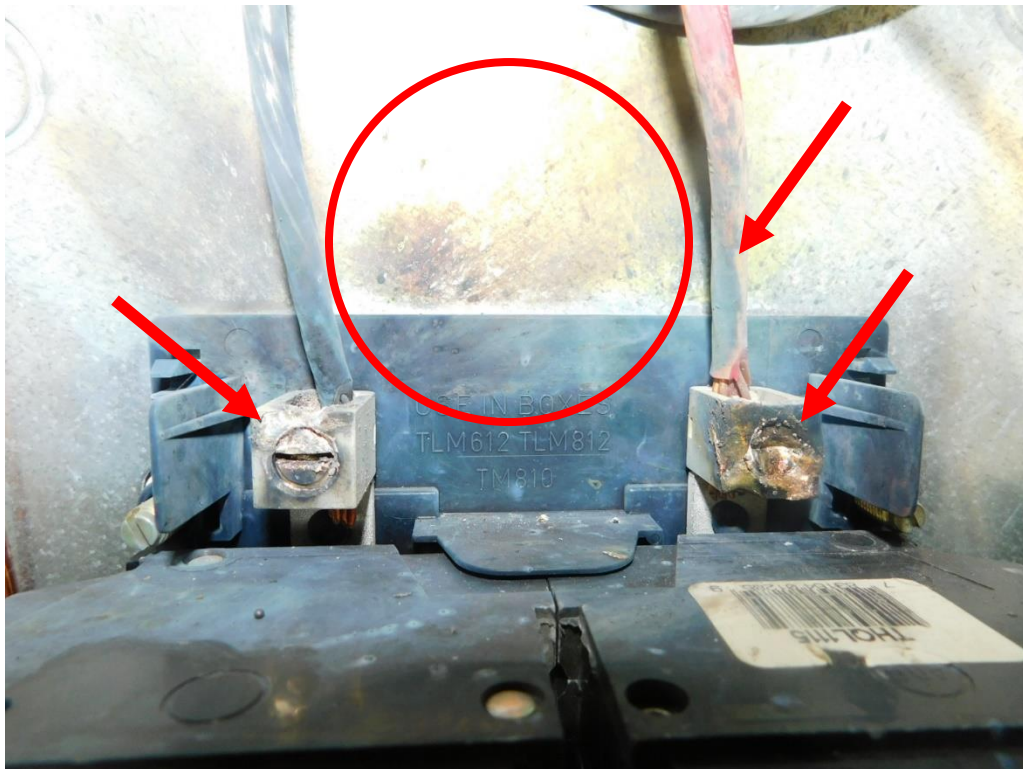
During an inspection on Thursday, September 5, an interesting finding was made inside a sub panel. It appears that there was sparking and/or arcing and possibly fire. The lugs on both incoming electric wires to the panel were charred and partially melted. There are scorch marks on the panel and the wire’s insulation is partially melted.

Of course, this was classified as a, “Material Defect” in the report indicating that the finding was safety related and required evaluation and repair by a licensed electrician.
