Regal Home Inspections, LLC

Find of the Week 2/16/2019

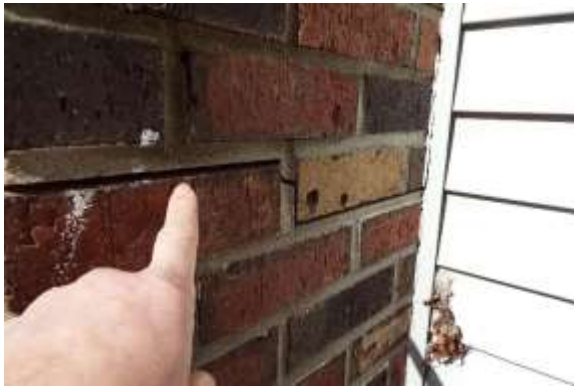
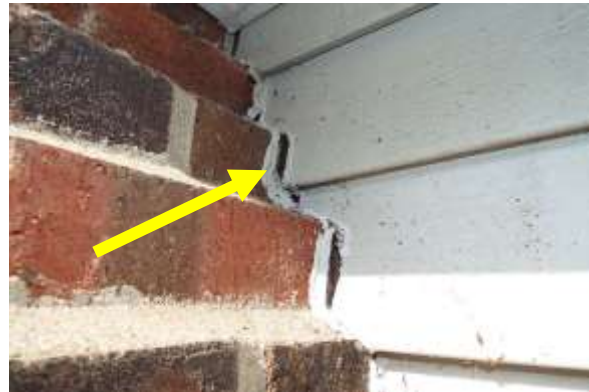
This week's find of the week is a combination of a finding outside and how it may be affecting a problem inside. While conducting an inspection yesterday I noticed some unusual cracks on a brick chimney. The cracks are horizontal and there are some fairly large (for cracks of this sort). There's also a gap along the chimney edge where it meets

the vinyl siding. Noted & photographed for including in the report.

The report did not make, in a concrete manner, the link between the chimney and the moisture found inside but recommended that a qualified contractor consider that as a possible source. Again, because it's a slab I can't see below. The report suggests that it could be a water pipe embedded in the slab. It could be a copper pipe for the heating system (this house has a boiler and hot water baseboards) or something else. The problem was found, identified as a, "Material Defect" in accordance with the NJ home inspection standards of practice and hopefully the source will be identified and fixed without too much trouble.

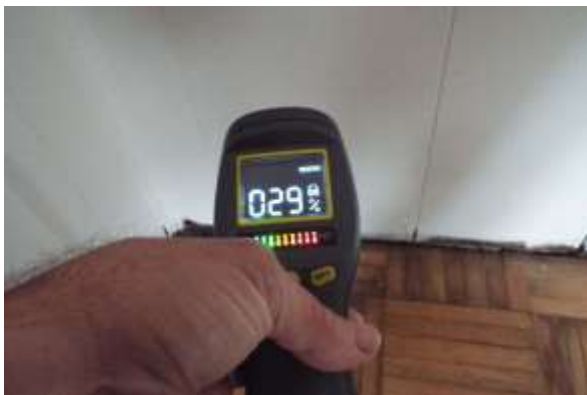
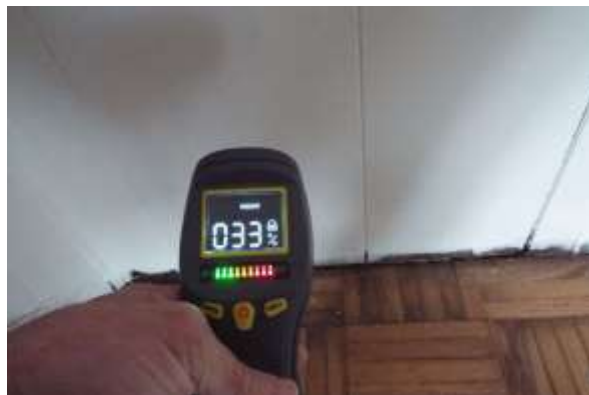
The interesting thing though is that inside, on the floor next to the fireplace, was some discoloration. It's a slab foundation here so there wasn't a basement to check out. Localized discoloration of wood can mean staining but the cause, degree of any damage and the timing can't be determined simply by seeing the discoloration. So, the invaluable moisture meter was used.

The moisture meter confirmed that the hardwood floor was indeed very wet.
