Regal Home Inspections, LLC

Find of the Week 2/9/2019

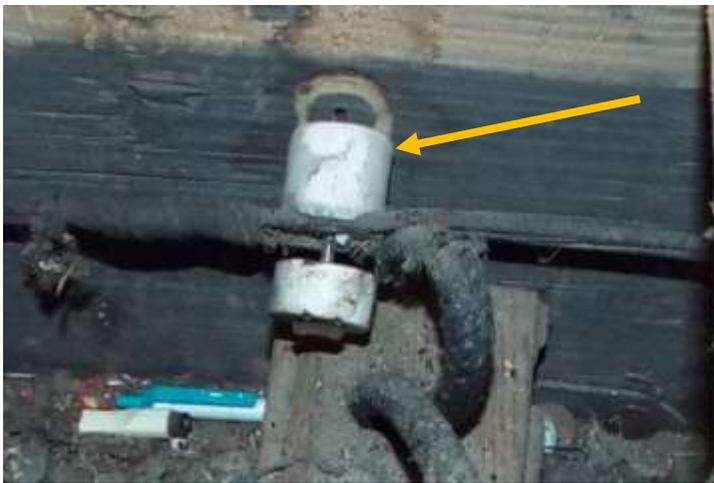
Figure 1 - Knob

This week's find of the week is a wiring relic from nearly 100 years ago. The first version of residential electrical wiring was called, "Knob and Tube". It was individual conductors that were run through a home. The "Knob" part (Figure 1) was the porcelain device (About the size of a shot glass) that held wires when the wires were run along side of a joist. The, "Tube" part (Figure 2) was a porcelain tube that was slid into a hole cut into a joist or rafter when the wires were running perpendicular to structural elements like a joist.

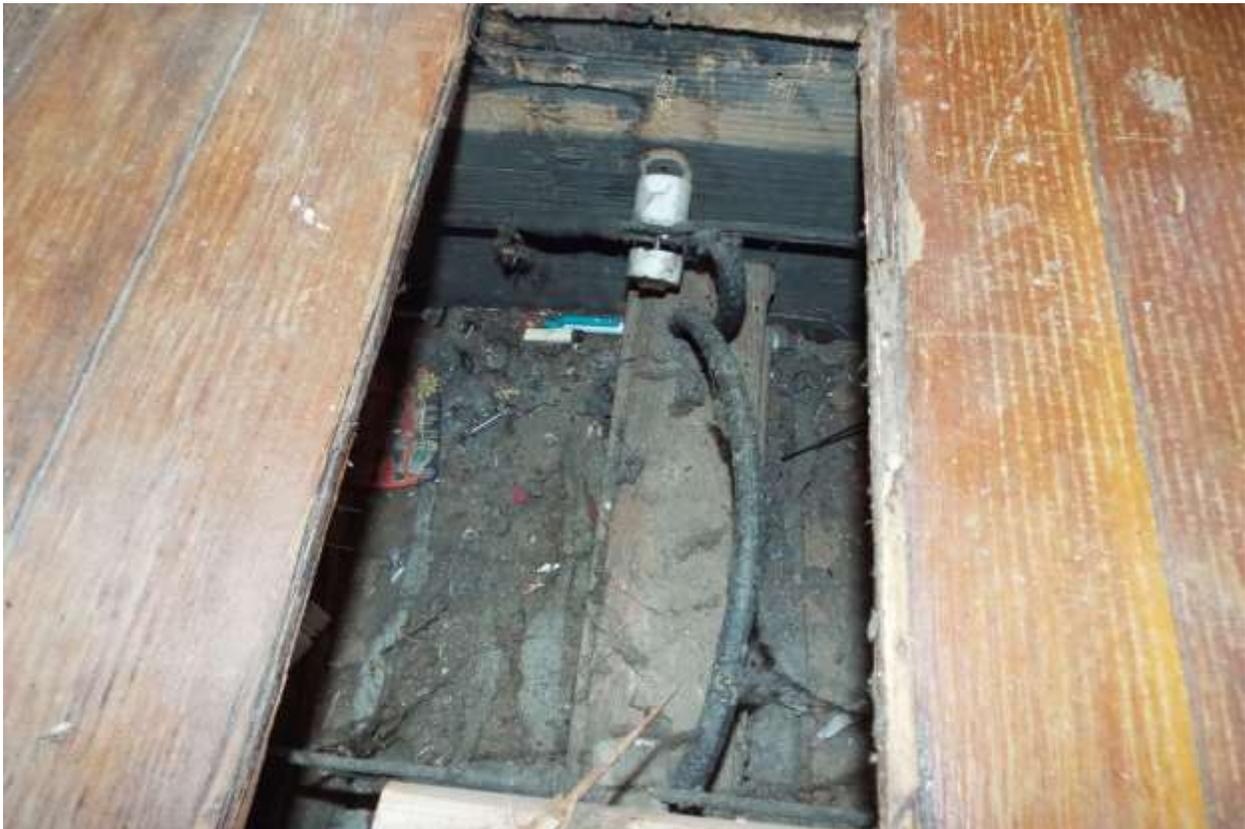
Some of the issues of KnT wiring is that the wire's insulation is often very brittle and cracks or gaps may exist exposing energized wires. Additionally, some knob and tube wiring was installed with lights and fixtures wired, "In series" as it's called. The best way to explain what, "in series" means is the example of the old Christmas lights. When one bulb went out, all of the lights went out. As compared to lights being wired in parallel where one light can go out but all the others stay on.

The photo above is the knob and tube wiring seen below the floor of the 2nd floor of this home and above the ceiling of the 1st floor below. This particular house had active knob and tube in the basement, in the living areas (1st and 2nd floor areas) and in the attic. From a home inspection report writing perspective, the client (buyer) was notified of the presence of the knob and tube, told of some of the issues as mentioned in this piece and urged to have a licensed electrician replace all knob and tube wiring and upgrade to 21st century wiring.
