## Regal Home Inspections, LLC

Find of the Week 1/19/2019

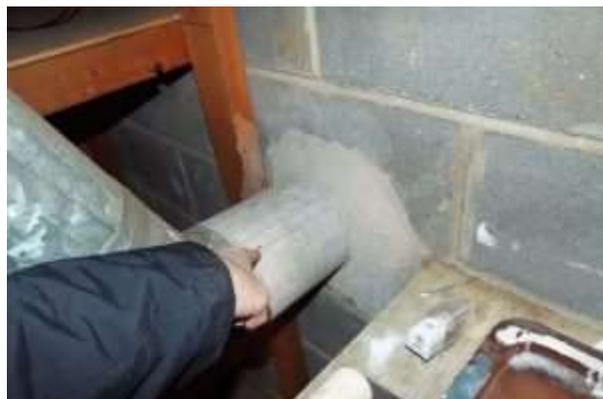
I've seen transite in flue pipe applications in the past as well as in waste piping. However, at a recent inspection of a house built in the 1960s, transite was used in the ducts for the forced air heating system. The air circulating through the house in the heating system was, in part, being distributed through transite pipes.

From a home inspection perspective, once the transite was visually identified\* as shown in the adjacent photo, it was reported as a, "Material Defect" in accordance with NJ Home Inspection Administrative Code standards of practice and the client was given a recommendation for next steps and a reference to an asbestos expert.

*\*Please note that the material appeared to be transite and based on the age of the house it likely is. However, this inspector does not carry a microscope and is not technically trained to identify asbestos fibers under a microscope. However, based on general, home inspection training, experience and considering all the facts (such as the*

*age of the house) the findings and manner of reporting are believed to be accurate and appropriate.*

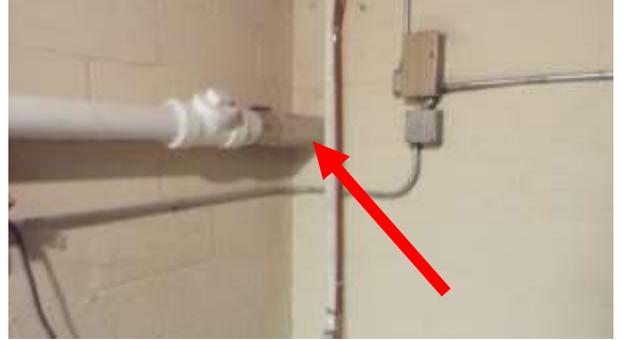
Here's a section of transite pipe used on the waste (Sewer) pipe leaving a house seen on an inspection in 2018. Not as important as when it's used for air supply ducts. Only the section near the wall is transite. There is also modern PVC waste pipe seen in the adjacent photo.
