Regal Home Inspections, LLC

Find of the Week 6/8/2019

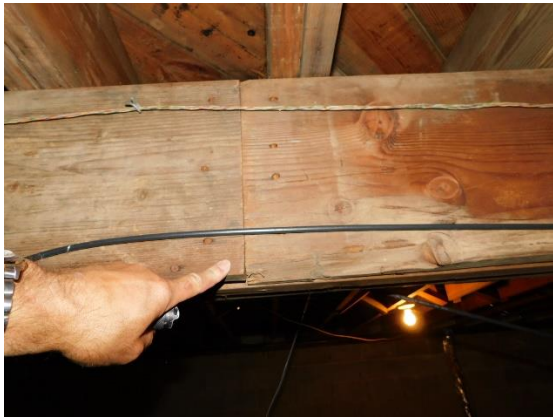
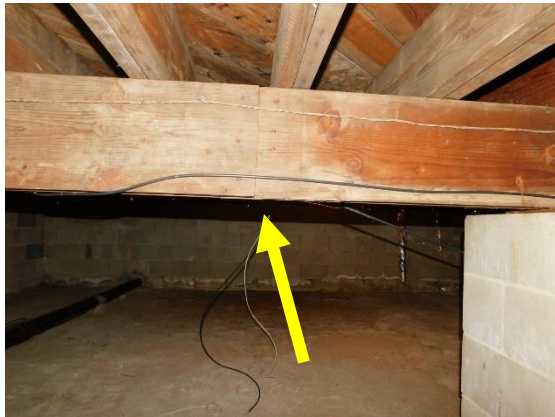
In this case, two sections of a three piece built up beam have seams that are not over a column. Essentially, one of the three parts to the built up beam is holding the whole thing up.

Of course this is a material defect in accordance with the NJ home inspection standards of practice.
