Microbial Growths and Leaking Water

June 28, 2019

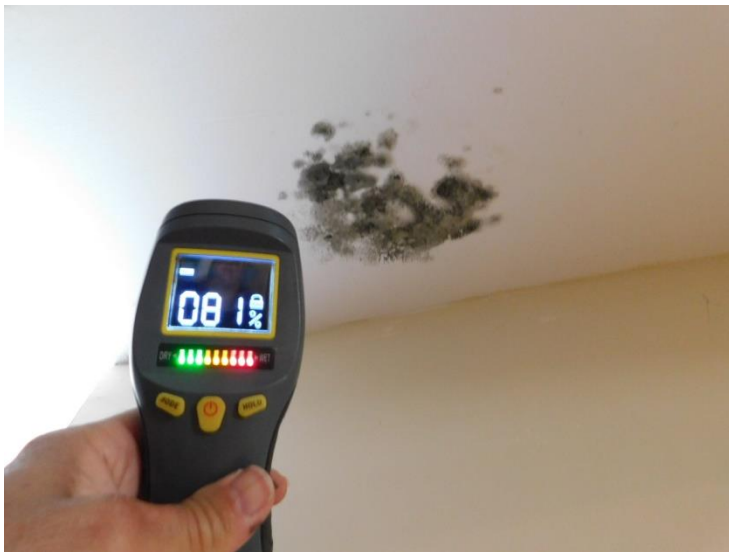
This week's find of the week almost jumped out and bit me. There was a black stain on a basement ceiling about 10 inches in diameter and it was quickly identified as a, "Microbial growth". I can't positively identify mold in the field and the home inspection standards of practice specifically exclude looking for or identifying mold (and other toxins or carcinogens for that matter) in the course of a home inspection. But I do tell clients when they ask that I am looking for leaks. The leaks may be from the roof or plumbing and plumbing leaks can come from supply pipes, fixtures and faucets or drain and waste. In this first case, the leak likely comes from a very loose toilet bowl directly above. I had not been in the upper floor as of yet but the real estate agent confirmed that there was a bathroom above and a leak

from one of the fixtures or pipes in that bathroom was a safe prediction. Using a moisture meter it was confirmed that there were high levels of moisture in the drywall. Later in the inspection it was confirmed that the toilet bowl above was very loose. This was reported both in my General Information section of the report (Stating that a "microbial growth" had been found) and in the Bathroom section as well.

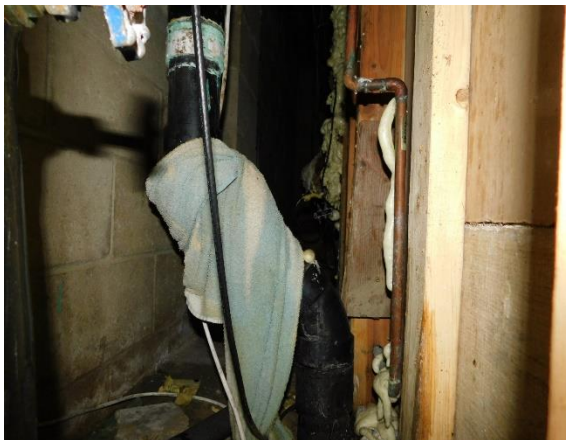
While inspecting another area of the basement there was a small hatch. It was opened and behind the finished

basement wall (actually a shower in a bathroom) there was water all over the place! Wet pipes, a wet floor and an old soaking wet towel that had been left inside the wall! This too was appropriately reported.
