Regal Home Inspections, LLC

Finds of the Week 9/28/2019

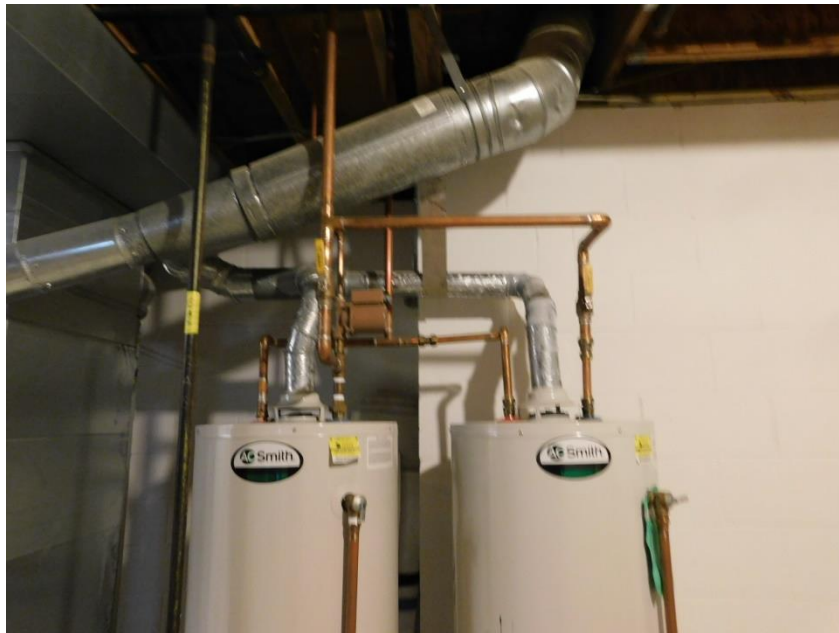
This was a fairly large house and there were two, 50 gallon water heaters in the basement for a 100 gallon total. The two exhausts merge together making a number of 90 degree bends and smaller bends and then, the combined exhaust flue makes a 180 degree bend and merges with the exhaust flue from a furnace. The water heater with the longest run showed signs of back-drafting. As seen in earlier FOTWs the plastic at the top of the water heater was melting due to the exhaust gasses exiting the natural draft hood and not properly venting to the exterior.

Here are the two water heaters and the vent pipes.

Of course this was written up as a safety issue and therefore a, "Material Defect" in accordance with the NJ home inspection standards of practice.

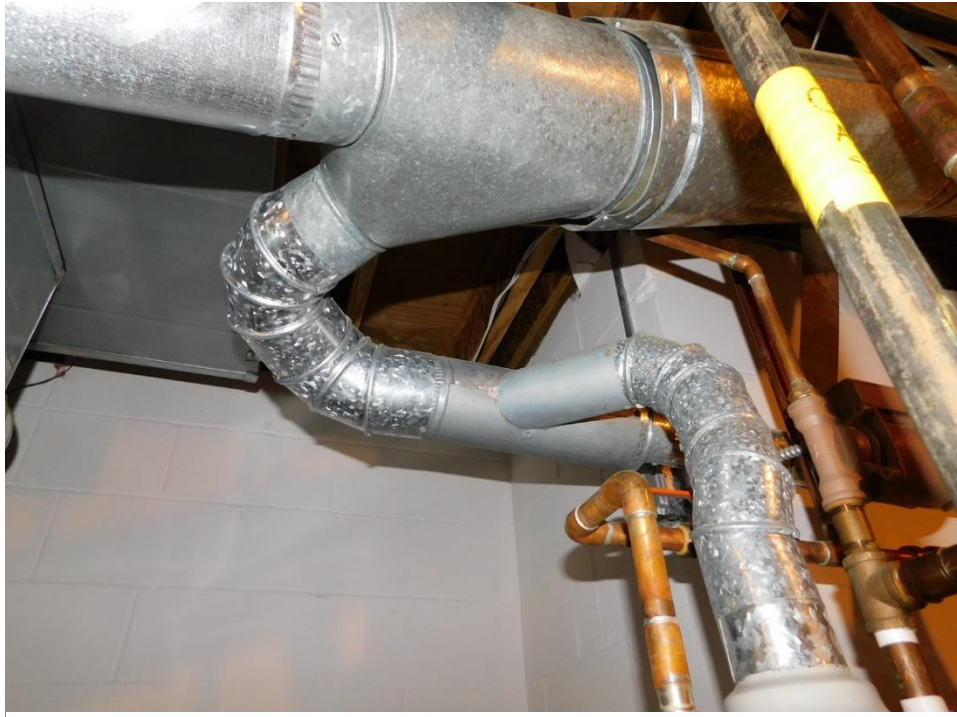
Above is the 180 degree bend that the natural draft exhaust is suppose to follow. All the bends create resistance which makes it very difficult for the gasses to rise efficiently.

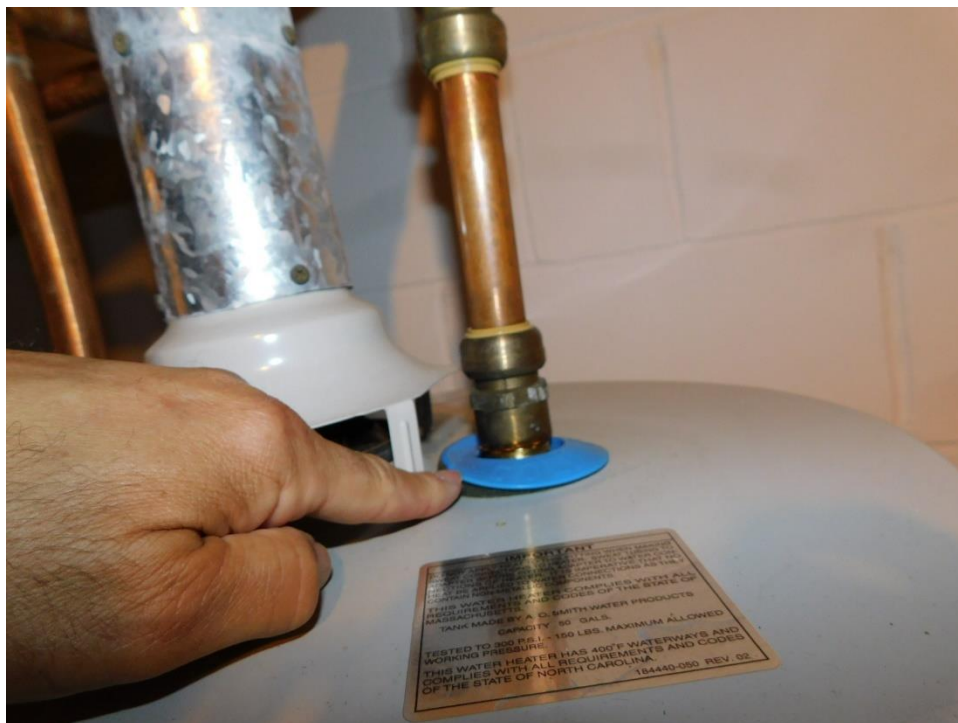
Below is the sign of the back drafting in the form of melted plastic.
