# Regal Home Inspections, LLC

## Property Inspection Report

Client(s): **Sample Report**  
Property address: **New Jersey**  
Inspection date: **Saturday, April 04, 2015**

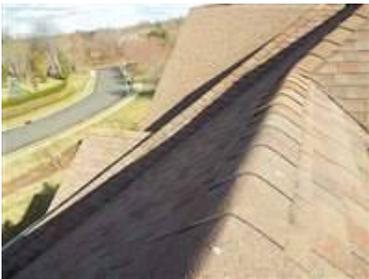
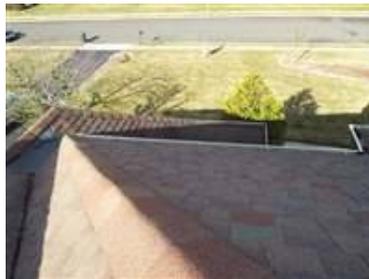
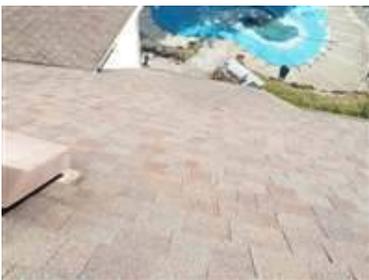
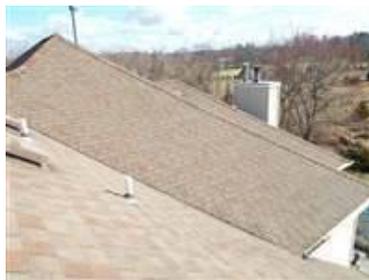
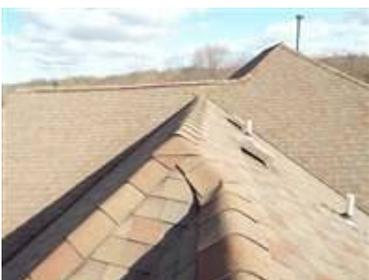
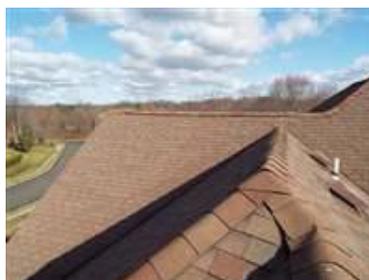
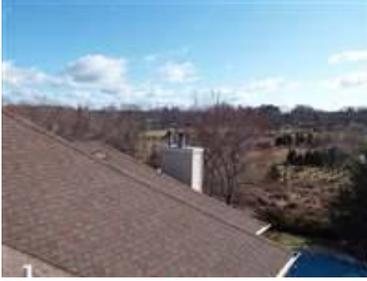
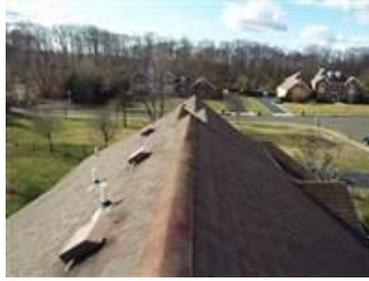
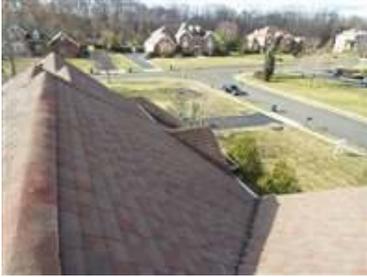
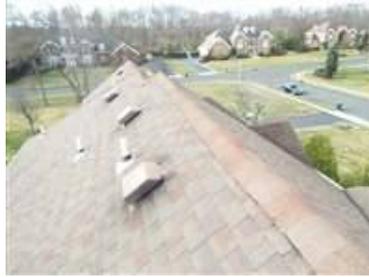
14) **Comment** - General roof photos.

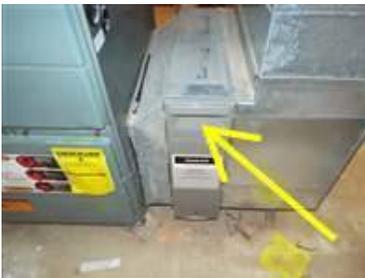
**Photo 26-1**

**26) Maintain, Comment** - The furnace filter should be changed upon occupancy and then in accordance with the filter manufacturer's instructions thereafter.

Filter is behind this panel as seen in the next photo.
