Regal Home Inspections, LLC

SAMPLE Property Inspection Report

Property address: **New Jersey**

Inspection date: **Thursday, September 10, 2015**

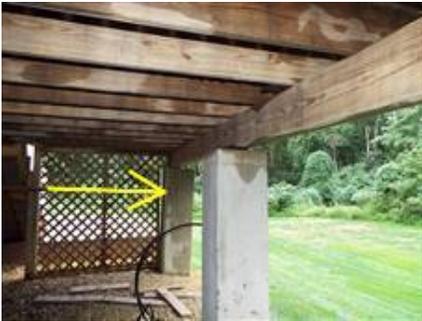
Photo 3-1

3) Repair/Replace, Evaluate - One concrete support post appears to be tilted. In association with the other, structural recommendation in this section, highly recommend that the client retain the services of a structural engineer to evaluate this and the associated deck beam findings also in this report section.

This post is leaning. Photo taken to compare the post in the foreground with the one in question.

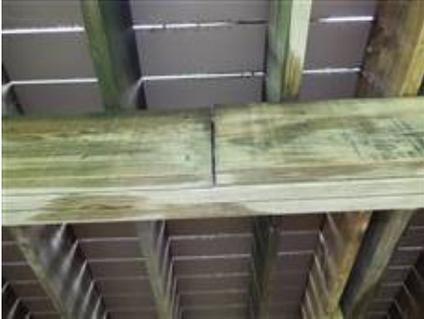
Photo 4-3

4) Repair/Replace, Evaluate - The deck beams, (built up, 3 timber beams), had beam splices (butt ends) that were not over a vertical support column. All points where two beam members are butted together must be over a vertical support. There are a number of spans with at least one beam splice and at least one where there are two or more.

Highly recommend that a professional engineer inspect this and evaluate. Resource options include:

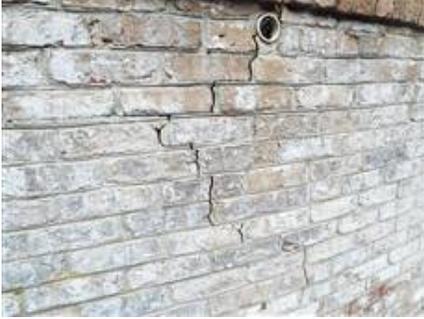
Photo 6-4

6) Repair/Maintain, Evaluate - The brick retaining wall is cracked next to the driveway. The inspector was not able to inspect the structural components of the wall behind the brick veneer. There should be a solid concrete or concrete block wall and the bricks are merely a finished surface.

At a minimum the wall should be repaired and all cracks sealed. If the client retains the recommended services of the professional engineer for evaluation of the deck items noted in this section, I suggest that the P.E. look at this as well and advise the client accordingly.

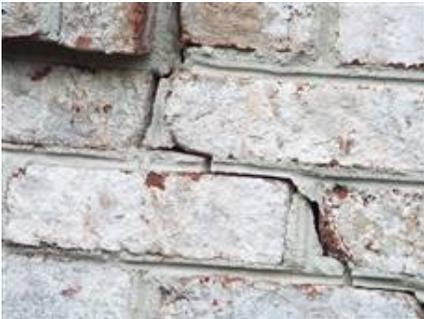
Photo 7-3

7) Repair/Maintain - The masonry, brick veneer was cracked or damaged in some areas. Where cracks or openings are exposed, water can enter the wall structure causing mold, fungal growth and structural damage. This is a conducive condition for wood-destroying organisms. Two areas noted. One is above the guest quarter on the right side of the house. The other is the chimney as seen from the

Recommend that a qualified contractor repair as necessary. For example, by repointing mortar or replacing broken or missing masonry.

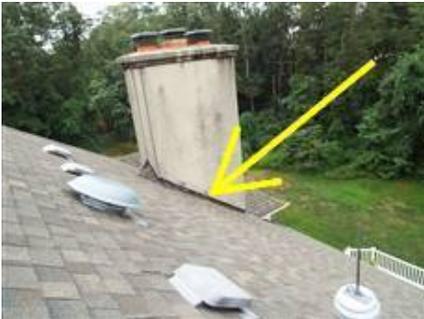
Photo 7-5
Area of close up in the next photo.

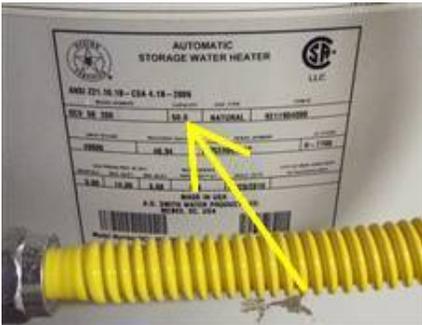
Photo 30-1

30) Comment - The manufacturer's data plate has the capacity (50 gallons) for one water heater. The data plate for the larger one does not indicate a capacity.

The capacity in gallons is printed here on the data plate for the smaller unit.

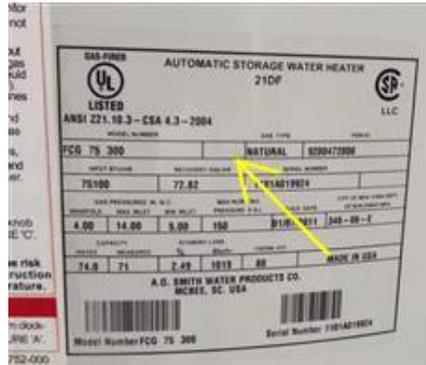
Photo 30-2

The same field in the larger unit's data plate is blank.

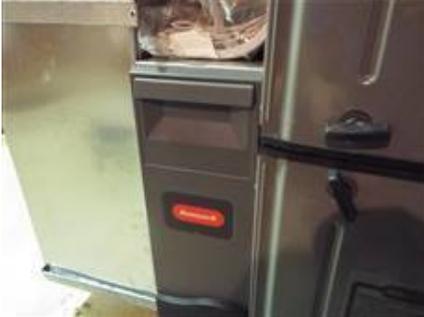
Photo 31-1
Basement.

31) *Maintain* - Recommend replacing or washing HVAC filters upon taking occupancy depending on the type of filters installed (disposable or reusable). Regardless of the type, recommend checking filters monthly in the future and replacing or washing them as necessary. How frequently they need replacing or washing depends on the type and quality of the filter, how the system is configured (e.g. always on vs. "Auto"), and on environmental factors (e.g. pets, smoking, frequency of house cleaning, number of occupants, the season).

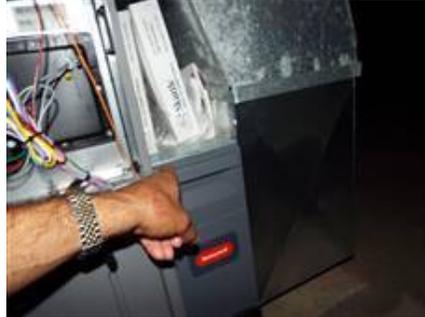
Photo 31-2
Basement.

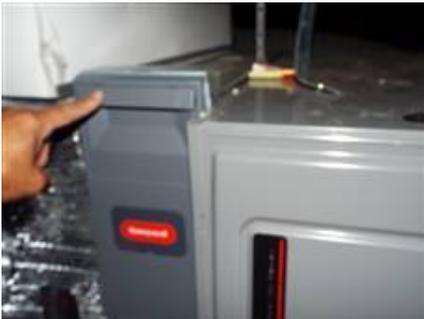
Photo 31-3
Attic.

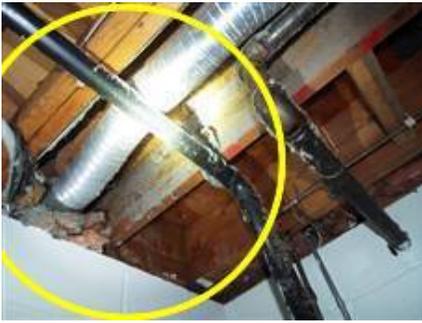
Photo 39-1

39) Safety, Repair/Maintain - The clothes dryer exhaust duct appeared to have, "leaked" as there is an excessive amount of lint around the duct on the joists and the general area in the basement. Combined with the excessive lint's proximity to the electrical service to the house this is being classified as a Safety item.

Recommend:

A) The duct be cleaned and inspected by a dryer duct cleaning service. They are readily available in the area.

B) The lint in and around the area should be vacuumed.

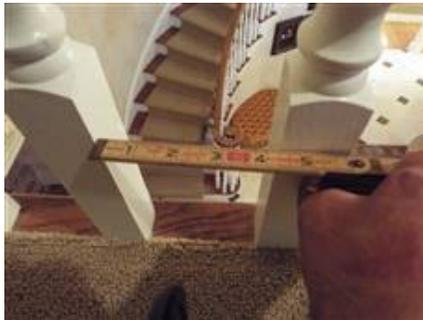
Photo 43-2

Ruler indicates the gap between spindles on the second floor are greater than 4 inches. Here and next photo.

4.25 inches.

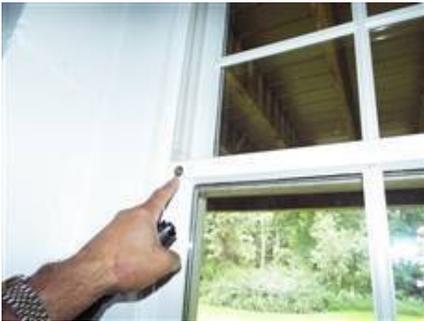
Photo 48-1

48) Comment - All accessible windows were checked for operation. They were unlocked, opened, closed and re-locked. Windows blocked by furniture, possessions or multiple layers of window treatments were not opened. All of those tested, operated with noted exception. See above.

Please note that numerous windows had keyed locks. These were not operated.
