Regal Home Inspections, LLC

SAMPLE Property Inspection Report

Property address: **Buccaneer Way**

Inspection date: **Wednesday, May 22, 2024**

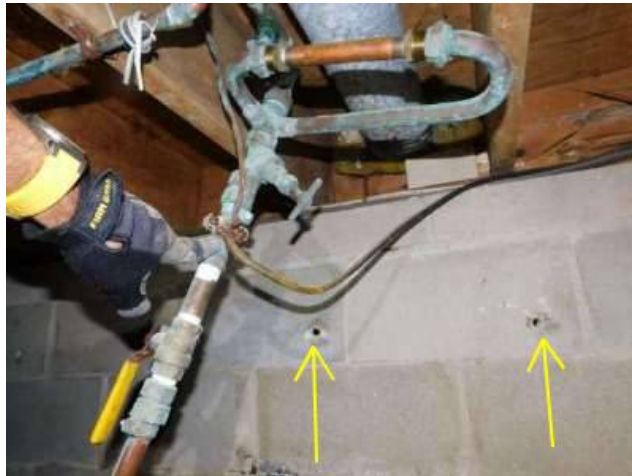
Photo 2-2 Drill marks seen in the foundation wall. Highlighted with the arrows.

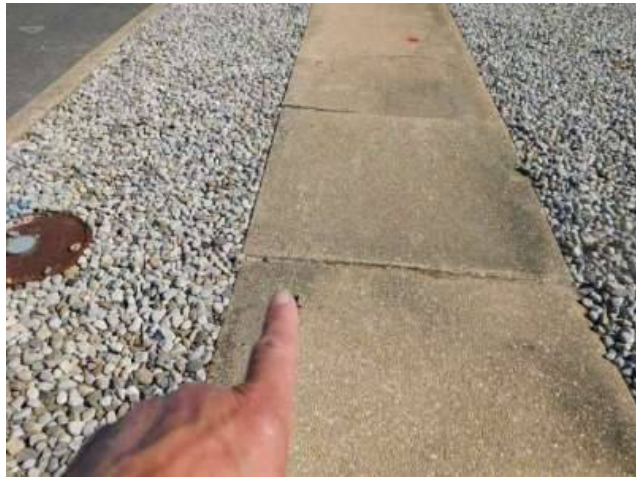
Photo 10-2

10) Material Defect/Safety, Repair/Maintain/Service - Cracks, holes, settlement, heaving and/or deterioration resulting in trip hazards were found in the sidewalks or patios. For safety reasons, required that a qualified contractor repair as necessary to eliminate trip hazards. Check with the Brick Township (Building Department or Code Enforcement Officer) to see if the homeowner is responsible for maintenance of the sidewalk at the curb in front of your house. If the homeowner is responsible and liable, Regal Home Inspections, LLC requires that all sidewalk repairs be made prior to taking ownership of the house.

Please note: A trip hazard is a 3/4 of an inch surface differential where one is not expecting a change in the surface elevation for paved areas like sidewalks and patios.

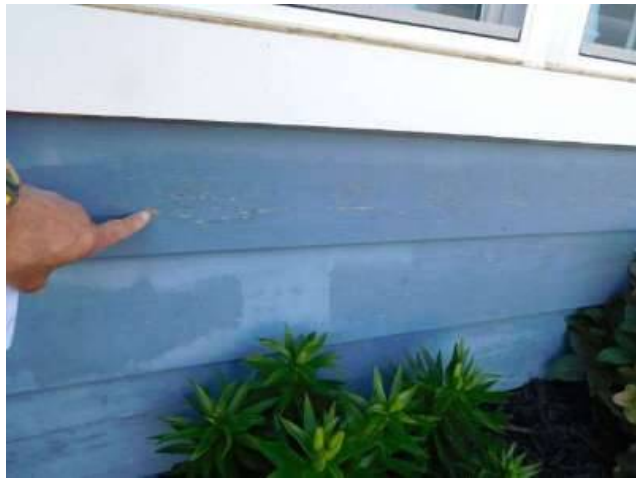
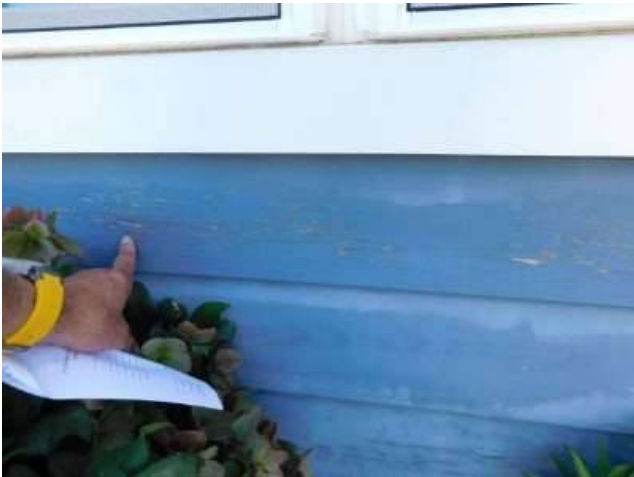
15) Repair/Maintain/Service, Maintain - The paint or stain finish in some areas was failing (e.g. peeling, faded, worn, thinning). Window frames or trim with a failing finish can be damaged by moisture. Required that a qualified contractor prep (e.g. clean, scrape, sand, prime, caulk) and repaint or re-stain the building exterior where necessary and per standard building practices. Any repairs needed to the siding or trim should be made prior to this.

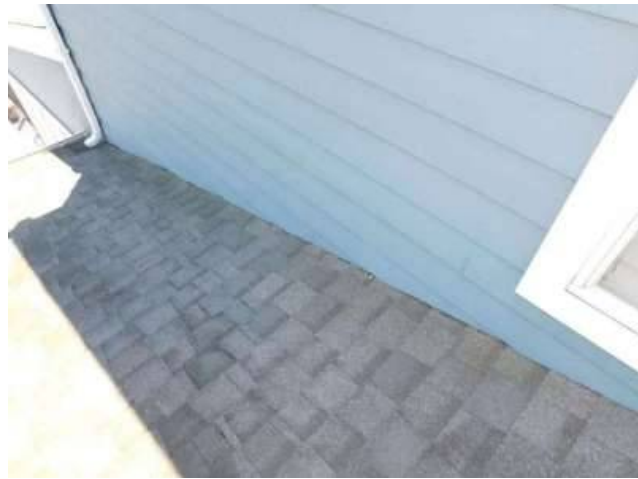
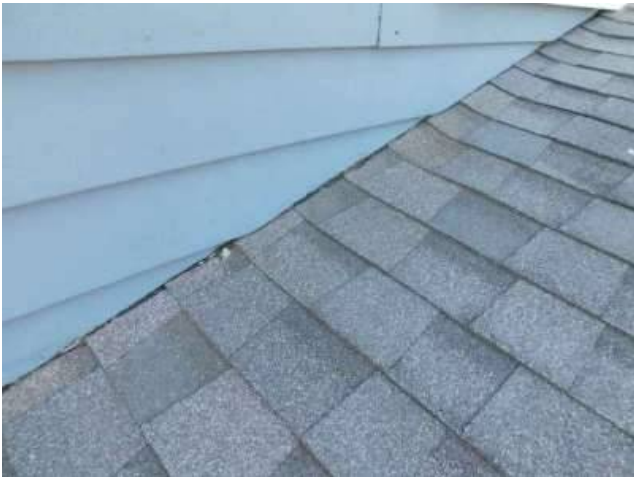
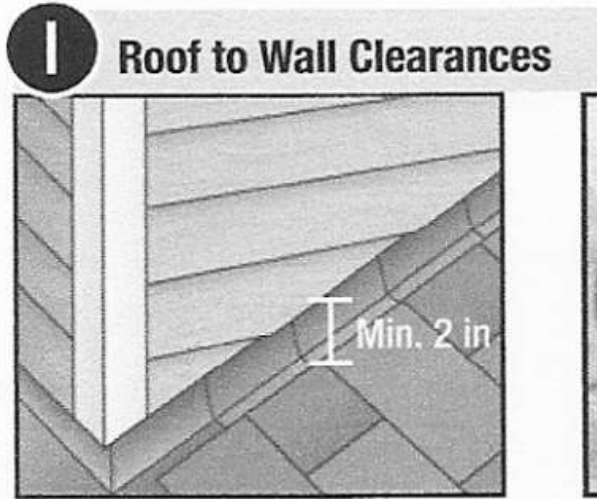
16) Repair/Maintain/Service, Evaluate - Areas of siding goes all the way to the roof surface material. As diagram I at the following link shows, there should be a 2 inch gap with proper flashing below. This 2 inch gap will prevent fungal rot of the siding material over time. Although the link is for a specific siding manufacturer, the gap recommended is a recommended best practice. <https://www.jameshardie.com/d2w/best-practices/quick-start-hz5-us-en.pdf>

Requires repair by a siding contractor.

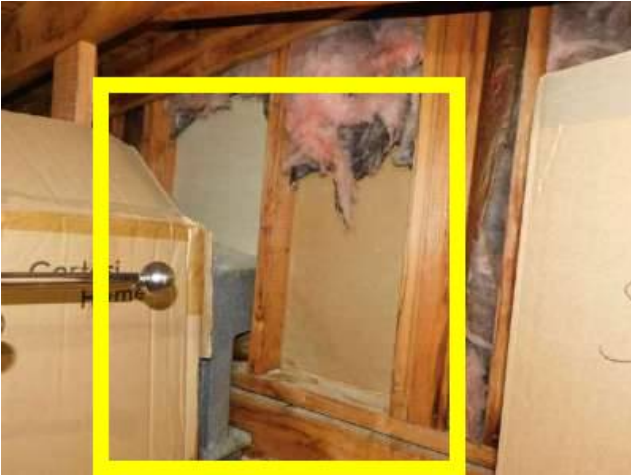
Photo 22-1

22) Repair/Maintain/Service - Attic insulation at one or more skylight chases or attic walls was missing and/or as seen from the attic over the garage. Heating and cooling costs will likely be higher due to reduced energy efficiency. Required that a qualified person repair, replace or install insulation as necessary and per standard building practices. One option is <https://masterattic.com/>

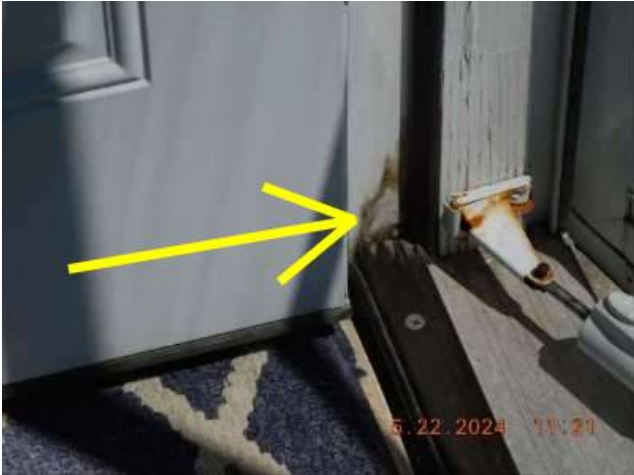
Please refer to the Crawl Space section. There were high levels of moisture seen in the crawl space in the area shown below. Additionally, there was some sub-floor wood rot that may be related to the staining seen at the back door (Seen in this photo) at the right side door jamb.

Photo 25-3 The previous photo's damage may be associated with the staining seen here.

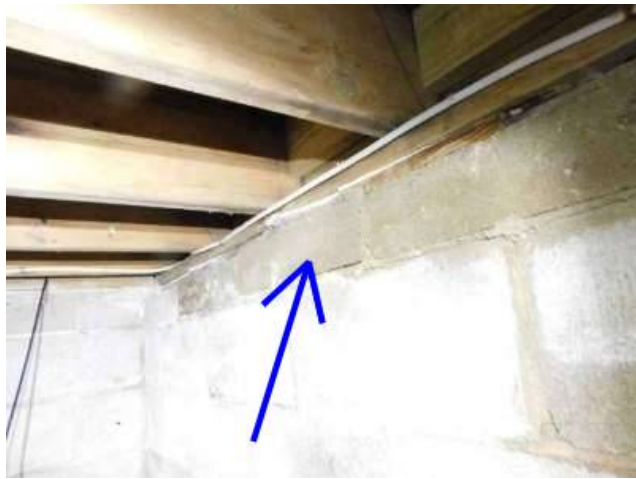
26) Material Defect/Major, Repair/Maintain/Service, Evaluate, Monitor - Evidence of water intrusion or accumulation was found in one or more sections of the crawl space. For example, high moisture meter readings at the foundation wall and sill plate. Accumulated water is a conducive condition for wood-destroying organisms and should not be present in the crawl space. It appears that pavement may be sloped toward the house as shown below (And mentioned in the Grounds section).

Photo 26-2 The concrete block is wet.

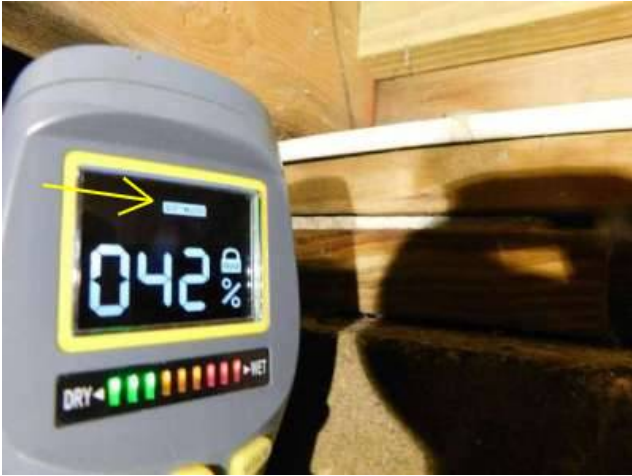
Photo 26-5 The meter is set to, "Softwood" as indicated by the yellow arrow. For wood, moisture is excessive when it reaches the mid 20% range. 42% is excessive as confirmed by the light bar again: Lit to the red.

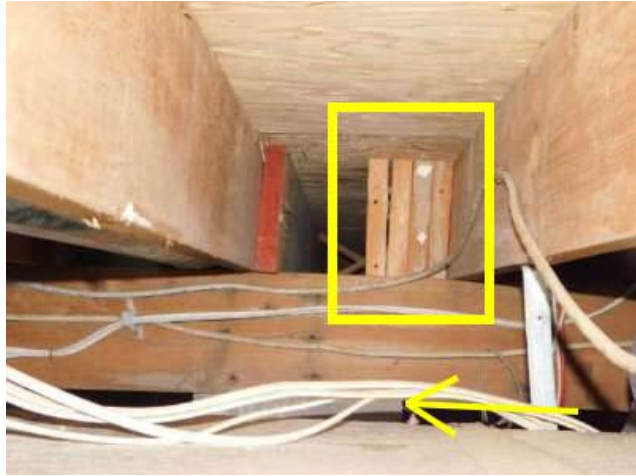
Photo 27-2 The edge of the concrete block column is highlighted with the arrow. One can see that 2 of the 4 blocks above are not over the column.

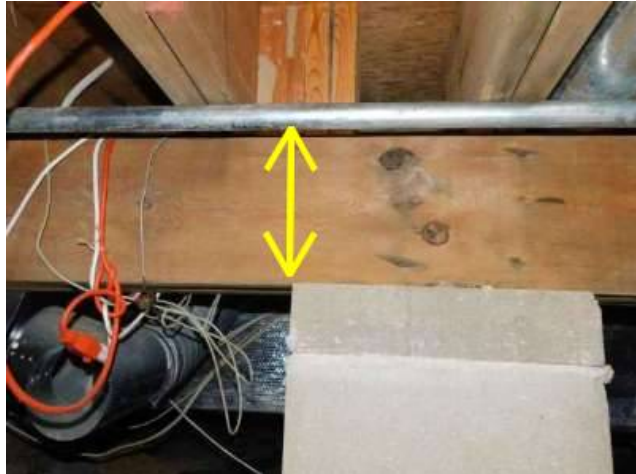
Photo 27-4 One can see that the load is not centered above the column. This is the same as seen in Photo27-2 but from the opposite direction.

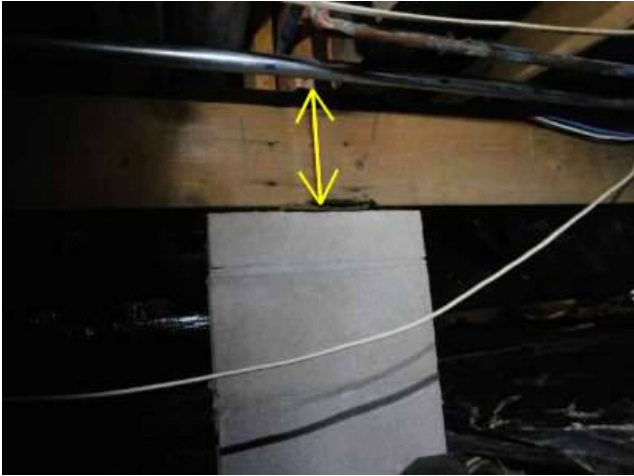
Photo 27-5 This is the right-side load. One can see that the added blocking is, at least, centered above the column.

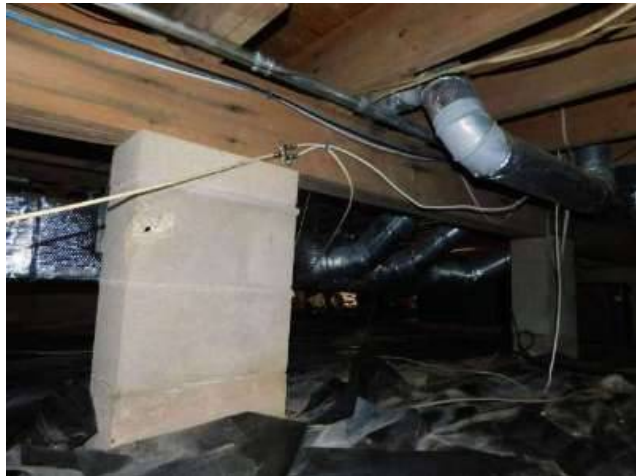
Photo 28-2 No such post and beam ties seen at this location.

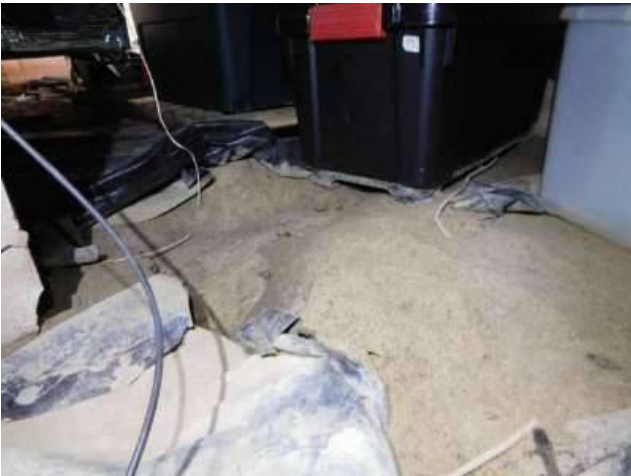
Photo 30-1

30) Repair/Maintain/Service - The vapor barrier in few areas of the crawl space was loose or askew. Soil was exposed as a result and will allow water from the soil to evaporate up into the structure. This is a conducive condition for wood-destroying organisms. A 6 mil black plastic sheet should be placed over all exposed soil with seams overlapped to 24 inches, and not in contact with any wood structural components. The sheeting should be held in place with bricks or stones, not wood. Required that a qualified contractor replace or repair the vapor barrier where necessary and per standard building practices.

Options include:

- 1) Hale Built Group - www.halebuilt.com
- 2) www.quality1stbasementsystems.com

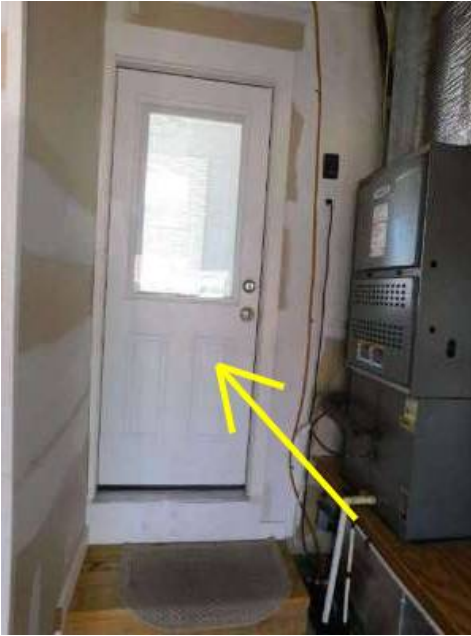
33) Material Defect/Safety, Replace, Evaluate - The door between the garage and the house did not appear to be fire resistant, or the inspector was unable to verify that it was via a label. This is a potential safety hazard. House to garage doors, to prevent fire and fumes from spreading from the garage into interior living space, must be constructed of fire-resistant materials or constructed so that it retards the spread of a fire (Purpose built fire retardant). Doors, generally considered to be suitable for the purpose, are solid core wood, steel, honeycomb steel or a door that has been factory labeled as fire rated. Required that a qualified contractor replace or repair the door and, at that time, make any other corrections that might be required to provide suitable fire resistance between the garage and the dwelling per standard building practices.

Photo 33-1 The glass may disqualify this as being a fire rated door.

There is a NJ House/Garage fire rating document attached at the end of this same PDF. The last paragraph identified the NJ requirement for house/garage doors.

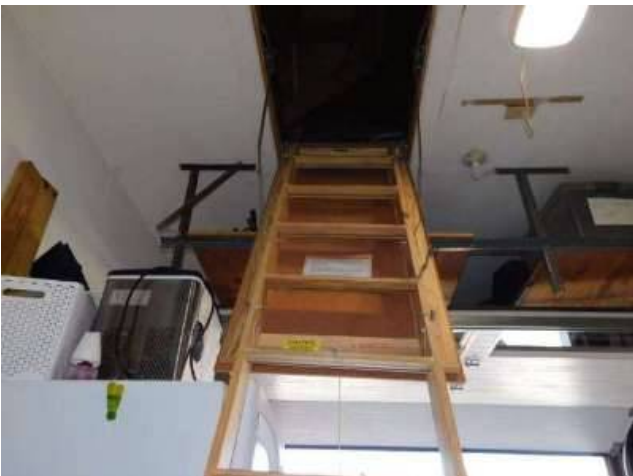
Photo 34-1

34) Material Defect/Safety, Replace - The pull-down attic stairs installed in the attached garage ceiling had no visible fire-resistance rating. Current standard building practices call for wooden-framed ceilings with an attic space that goes from above the garage to above the living space have a fire-resistance rating (Normally a drywall ceiling) including the pull down hatch/stairs. Installing pull-down attic stairs in the garage without a proper fire rating (Usually the pull down stairs are intended for interior spaces) compromises the ceiling's fire resistance and therefore is a safety issue. Required that a licensed contractor repair as necessary to restore the ceiling's fire resistance. For example, by replacing or removing the stairs. Note that commercially made, fire resistance-rated stairs are available. https://roofing4us.com/collections/attic-ladders?_pf&pf_t_fire_rating=Fire%20Rating%3A%20ASTM%20E119

An alternative is to have a qualified contractor install a framed wall inside the attic that divides the garage and living space which conforms to all fire resistance ratings as required by local jurisdictions.

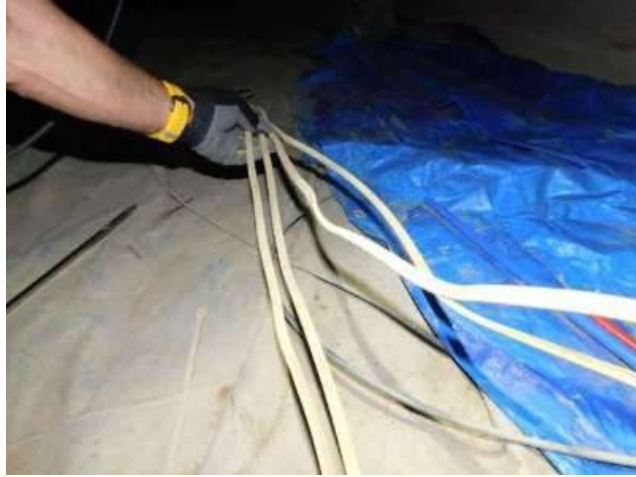
Photo 39-2

39) Material Defect/Safety, Replace - Non-metallic sheathed wiring was loose, unsupported, or inadequately

supported at one or more locations. Such wiring should be trimmed to length if necessary and attached to runners or to solid backing with fasteners at intervals of 4 1/2 feet or less. Fasteners should be installed within 12 inches of all enclosures. Required that a licensed electrician repair per standard building practices.

Photo 39-1 Crawl space here and the next 2 photos.

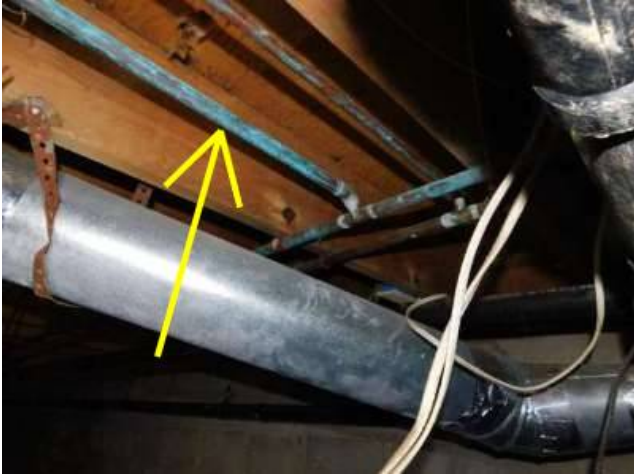
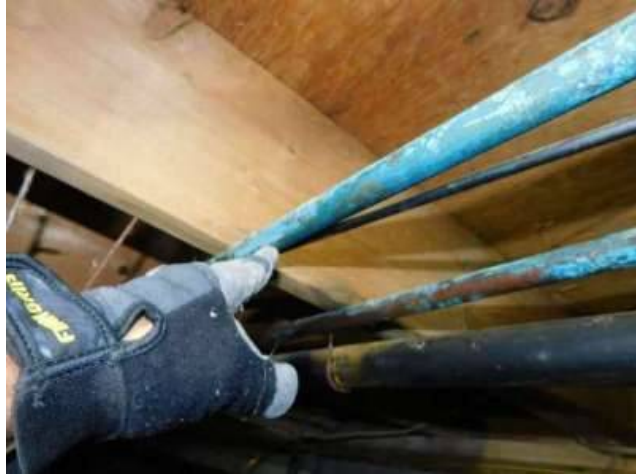
44) Replace, Repair/Maintain/Service, Evaluate - Significant corrosion was found in some water supply pipes or fittings. Leaks can occur as a result. Required that a licensed plumber evaluate and replace components as necessary.

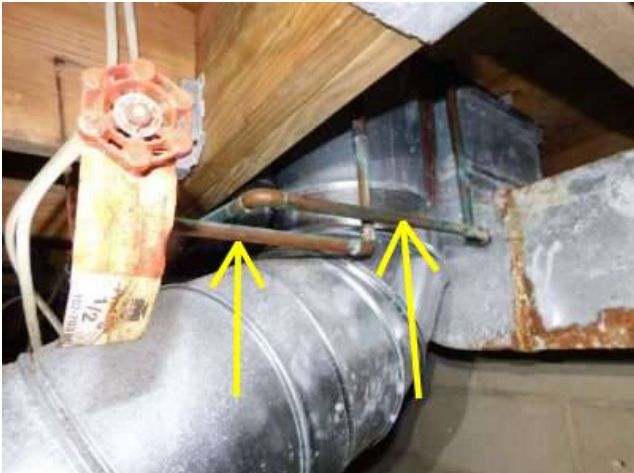
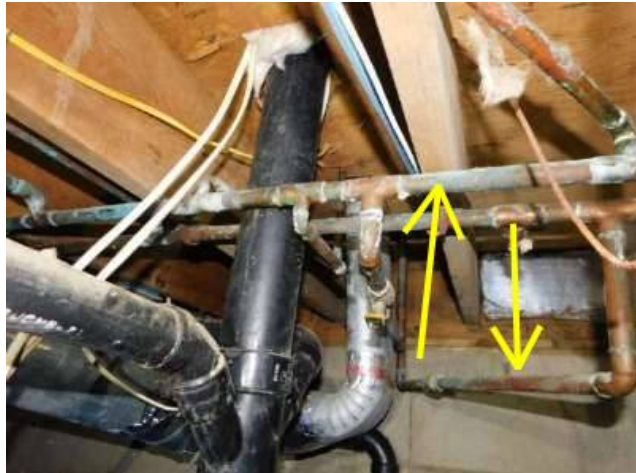
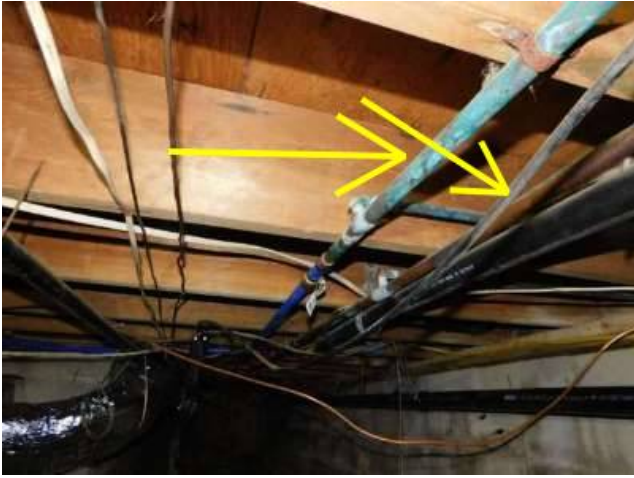
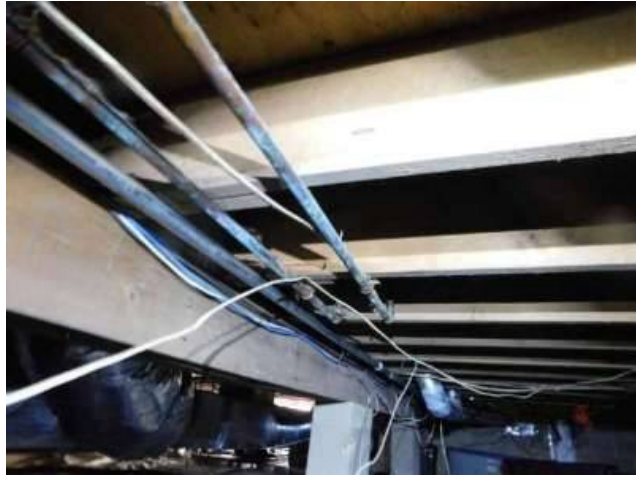
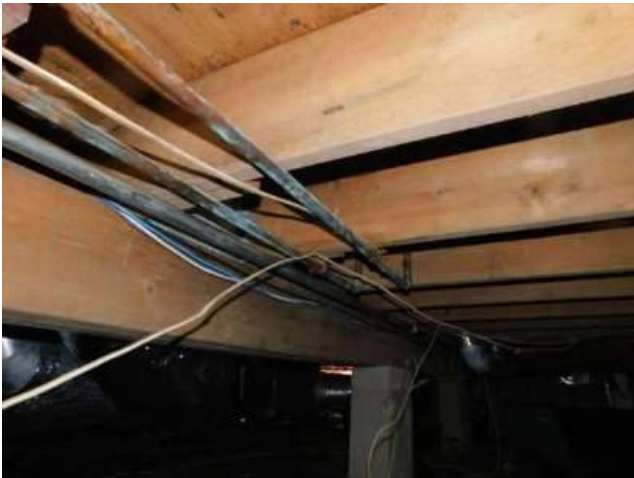
45) Replace - Insulation for one or more water supply pipes in the crawlspace was missing (No insulation was seen). Requires replacing or installing insulation on pipes per standard building practices to prevent them from freezing during cold weather, and for better energy efficiency with hot water supply pipes. A qualified contractor or qualified handyman should add insulation to all water supply pipes.

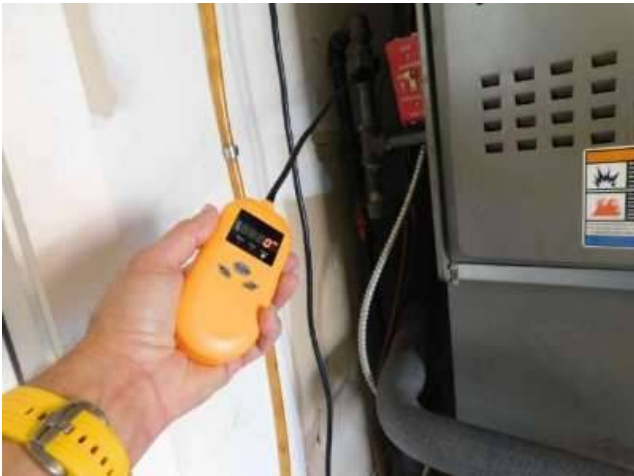
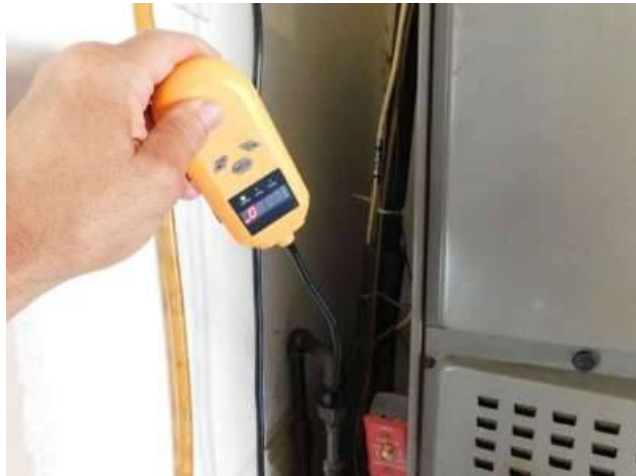
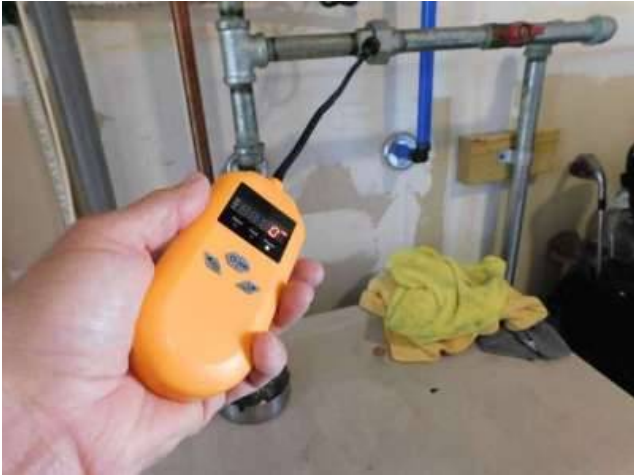
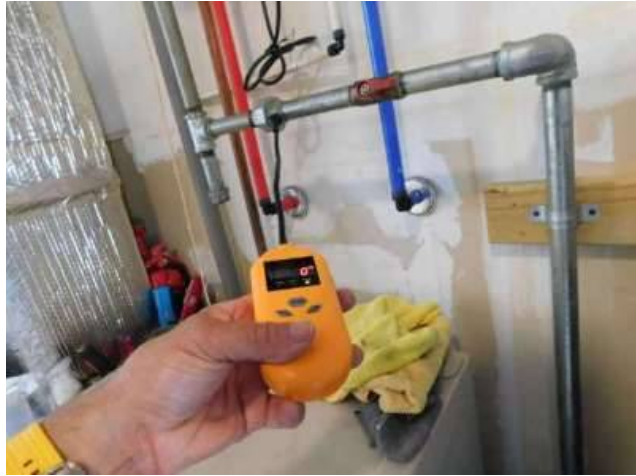
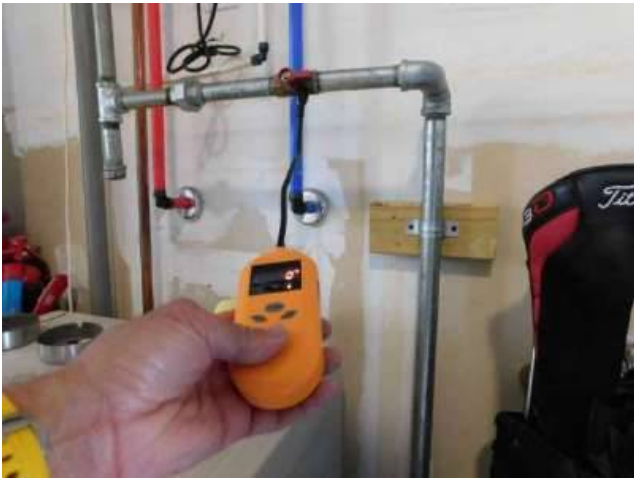
49) Monitor, Comment/FYI - The natural gas lines around the furnace and the water heater were checked with a combustible gas detector for leaks. There was no access behind the clothes dryer or the kitchen stove. None were detected by the instrument. This is absolutely not a substitute for owner diligence, awareness and appropriate response if a natural gas odor is ever detected. Immediately leave the house and call 911.

The meter can be seen in the photos. The probe extends to the gas piping for testing for leaks. None were detected. Few examples shown below.

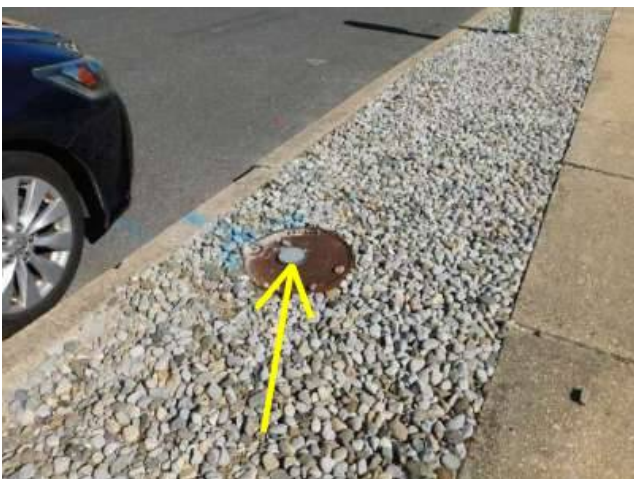
Photo 50-1 Water meter.

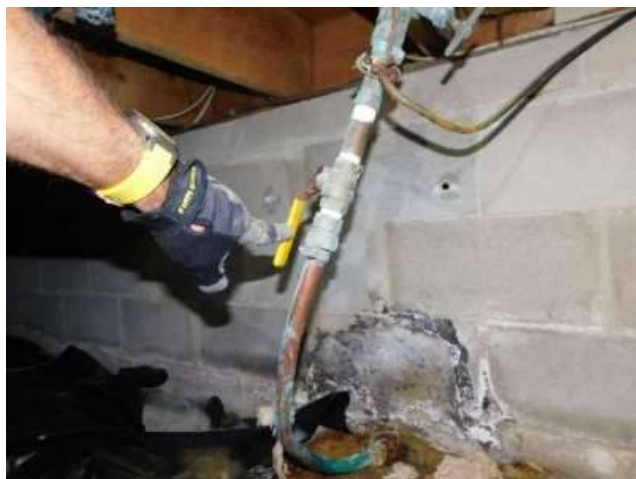
Photo 50-2 Main, water shut off valve.

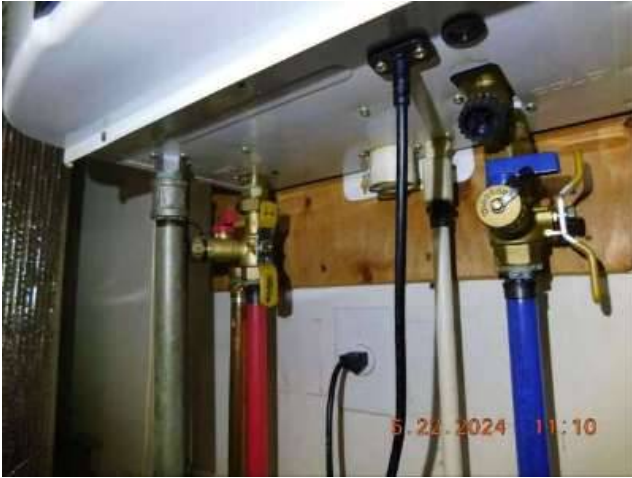
Photo 52-1

The following link provides some insight to the generic process. Not specific to this water heater. There are numerous other instructional videos on YouTube. <https://www.youtube.com/watch?v=T4FaqGod3VU> Recommend that a licensed plumber perform this maintenance periodically. Some tankless water heaters will provide a control panel indication, (some refer to the indication as an "Error Code") to indicate that flushing is necessary. Please refer to your tankless water heater Owner's Manual for the manufacturer's recommendations and instructions.

Required that a licensed plumber perform this maintenance periodically. You should not do this yourself. Here's a link from a major, NJ energy company regarding their tankless maintenance service.

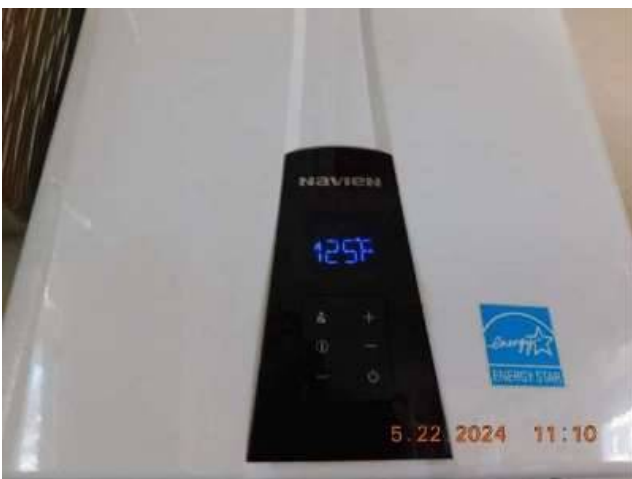
Photo 53-1

53) Evaluate, Monitor - The tankless water heater was set at 125 degrees Fahrenheit, which exceeds the recommended temperature to prevent scalding. However, it's important to consider that there may be some discrepancy between the temperature the water heater is set to and the actual temperature output. Despite this setting, no scalding temperatures were observed during the inspection.

Any calibration or adjustment of the water heater temperature must be performed by a licensed plumber. This ensures that the adjustment is done correctly and safely, in compliance with relevant regulations and standards.

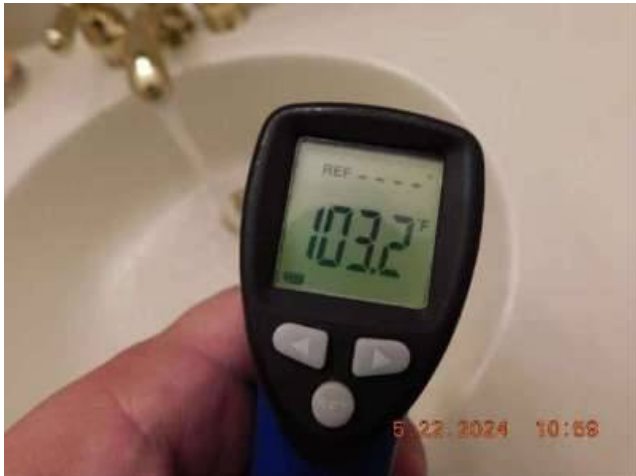
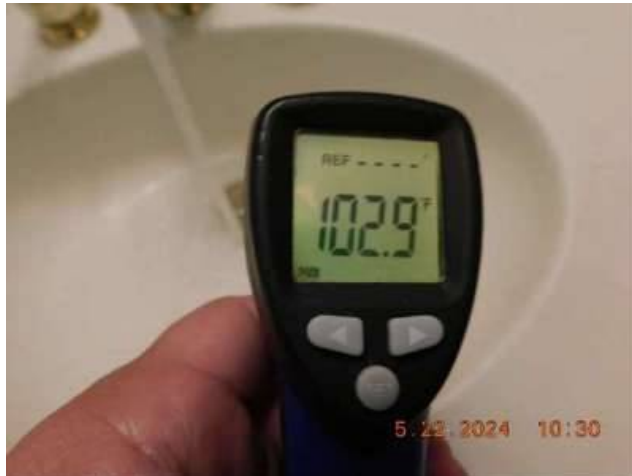
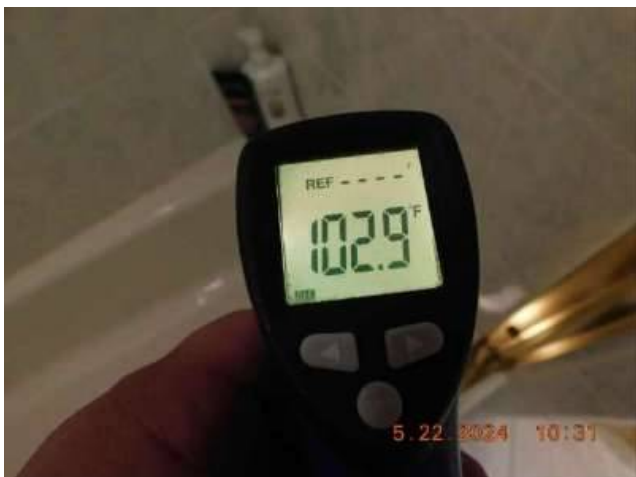
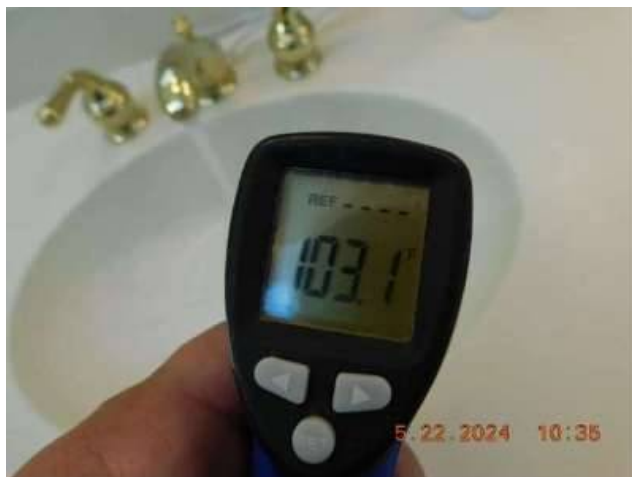
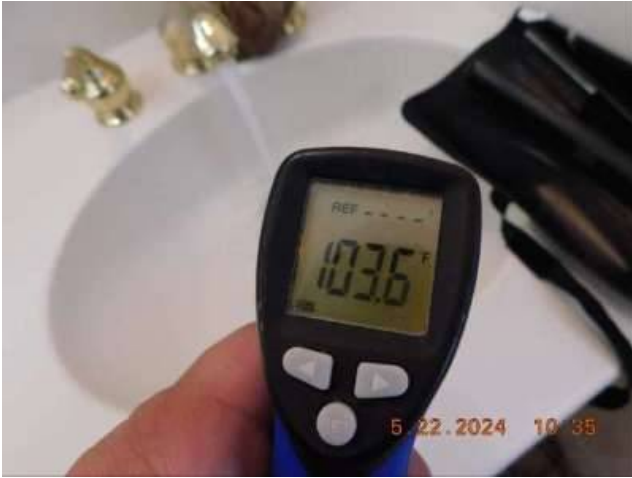
55) Comment/FYI - Sample water temperatures.

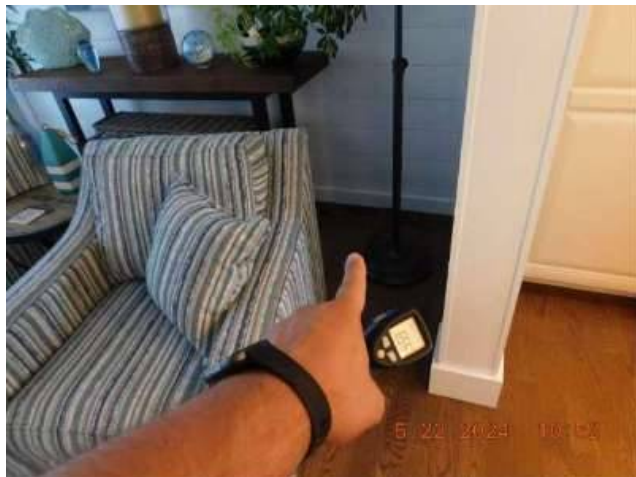
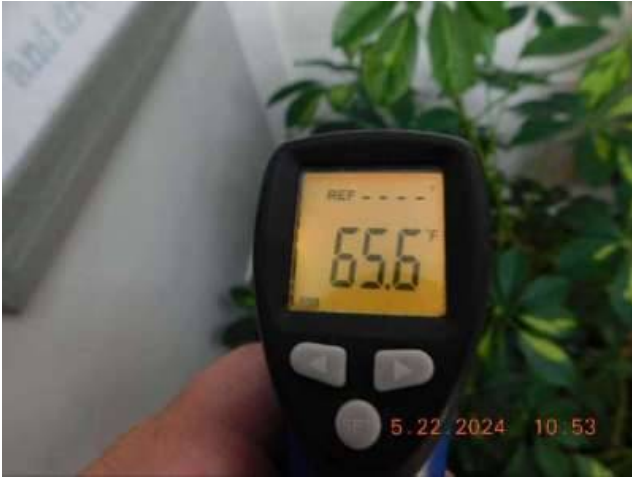
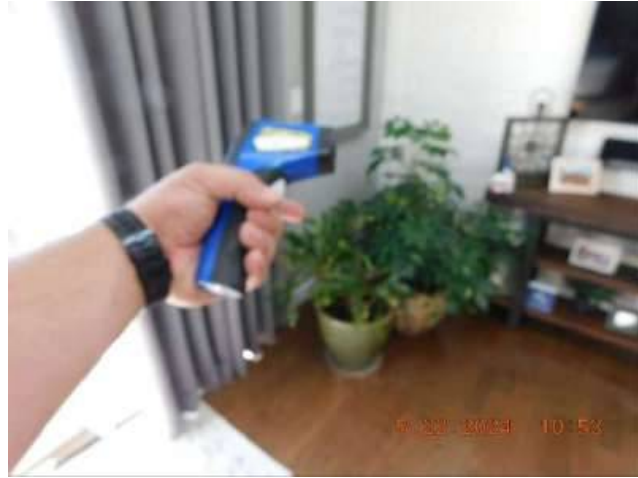
58) Repair/Maintain/Service, Evaluate - One or more heating or cooling air supply registers had a weak air flow, or no apparent flow. This may result in an inadequate air supply. Recommend asking the property owner about this. Adjustable damper(s) in ducts may exist and be reducing the flow. If dampers exist, then they should be opened to attempt to improve the air flow. If the property owner is unaware of such dampers, or if adjusting dampers does not improve the air flow, then required that a licensed and qualified HVAC contractor evaluate and repair or make modifications as necessary.

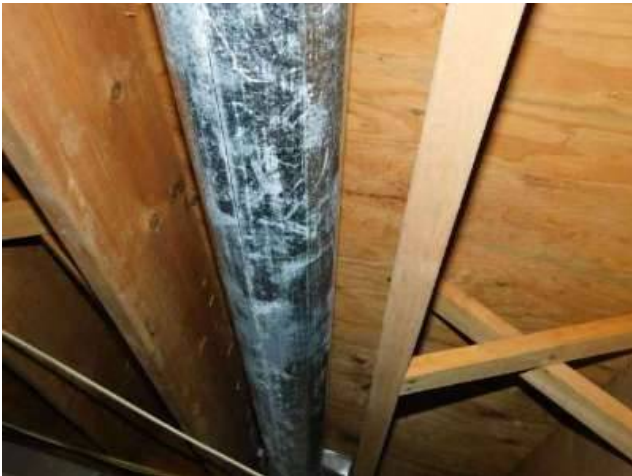
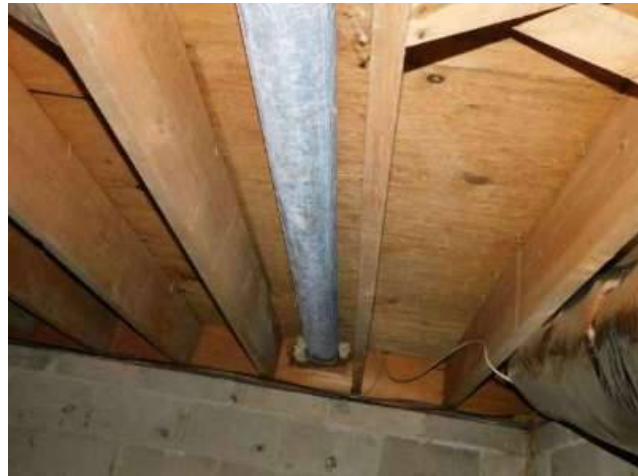
59) Repair/Maintain/Service - One or more heating or cooling ducts in an unconditioned space (crawl space) were not insulated, or the insulation was damaged or deteriorated. This can result in reduced energy efficiency, moisture inside heating ducts, and/or "sweating" on cooling ducts. Required that a licensed and qualified HVAC contractor repair per standard building practices. For example, by wrapping ducts in insulation with an R-value of R-8.

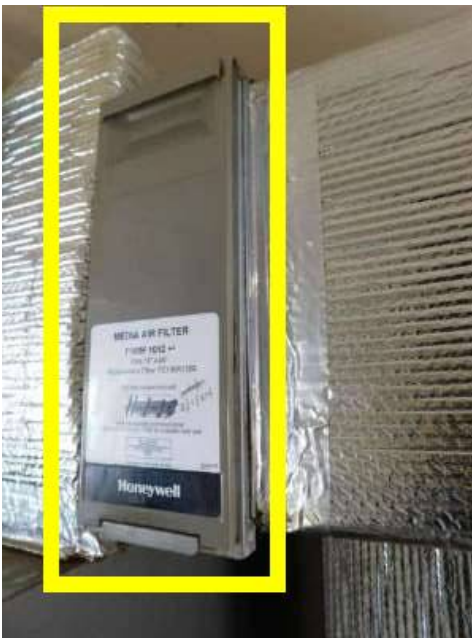
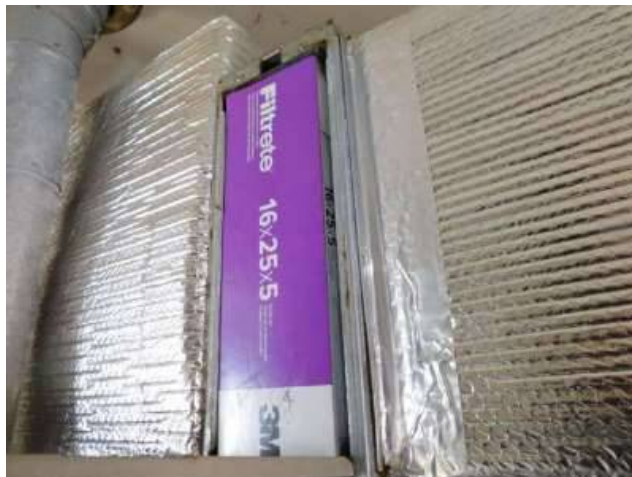
Photo 61-1 First floor HVAC filter seen here and the next photo.

61) Maintain - Recommend replacing or washing HVAC filters upon taking occupancy depending on the type of filters installed (disposable or reusable). Regardless of the type, recommend checking filters monthly in the future and replacing or washing them as necessary and in accordance with the filter manufacturer's instructions. How frequently they need replacing or washing depends on the type and quality of the filter, how the system is configured (e.g. always on vs. "Auto"), and on environmental factors (e.g. pets, smoking, frequency of house cleaning, number of occupants, the season).

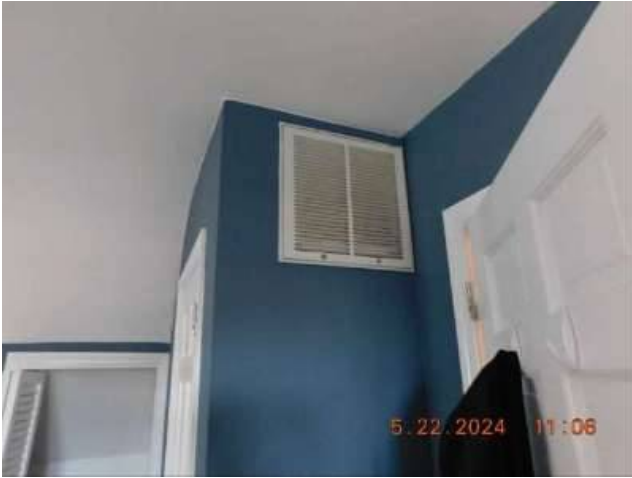
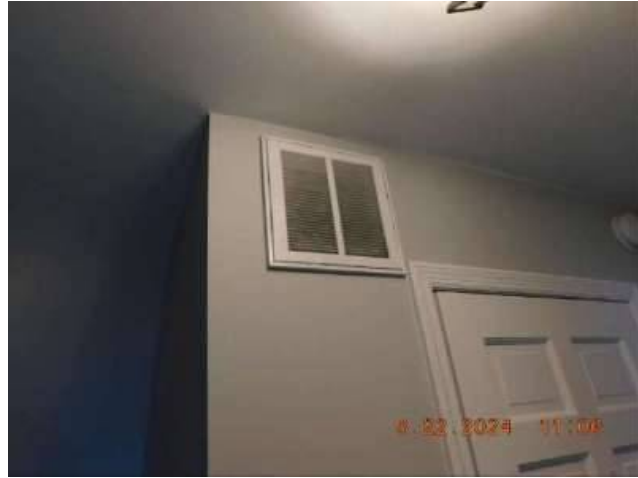
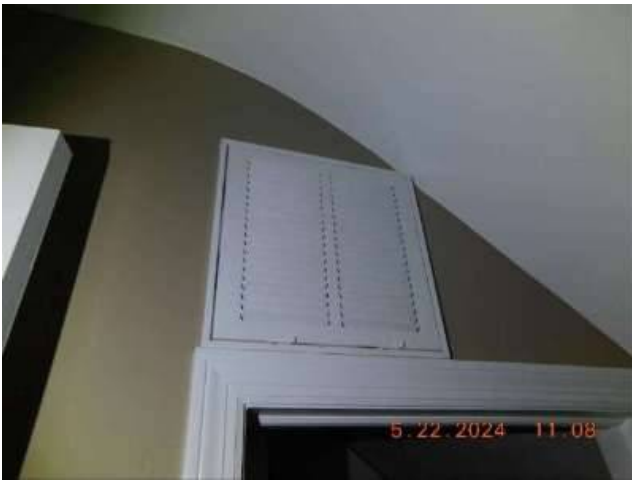
Photo 61-3 Second floor filters for the AC are located behind these return grills. Here and the next 2 photos.

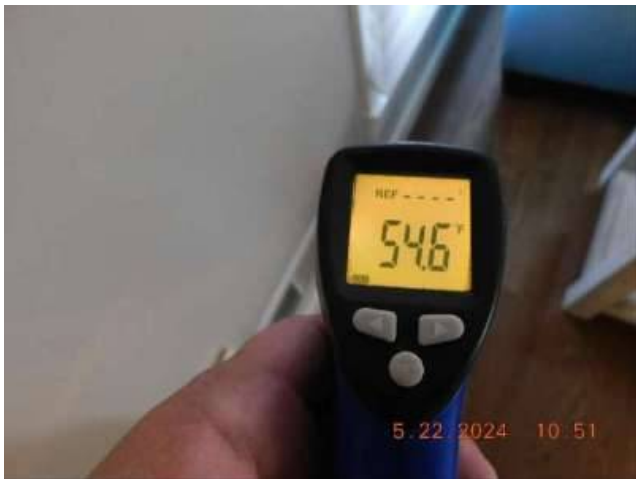
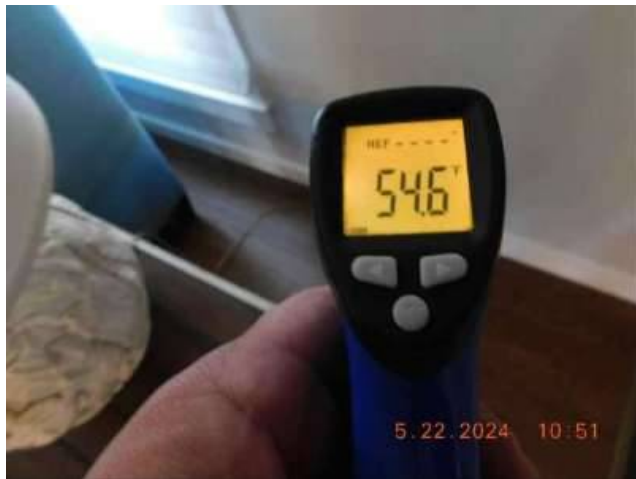
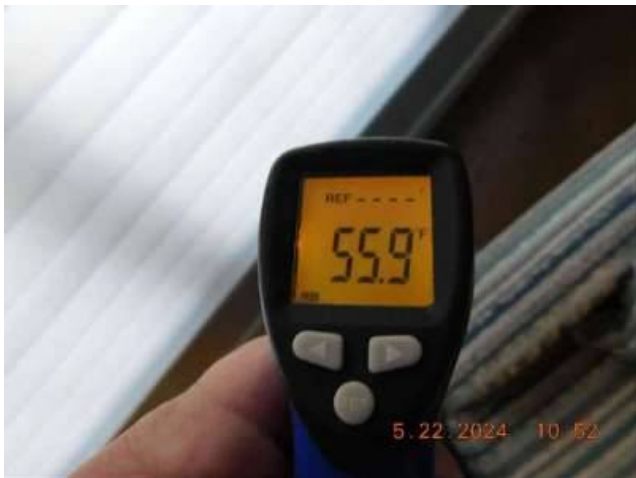
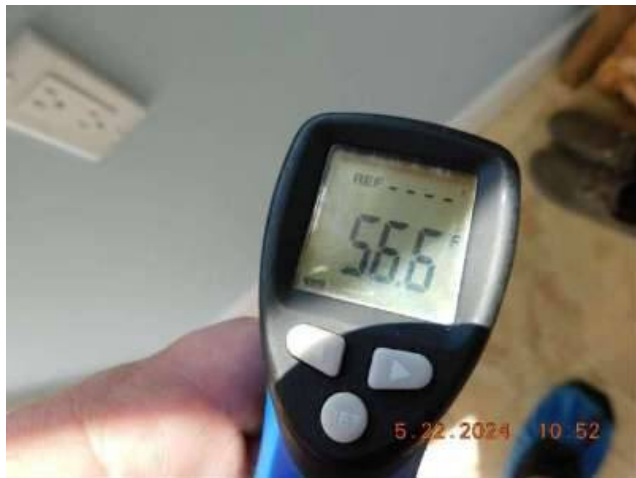
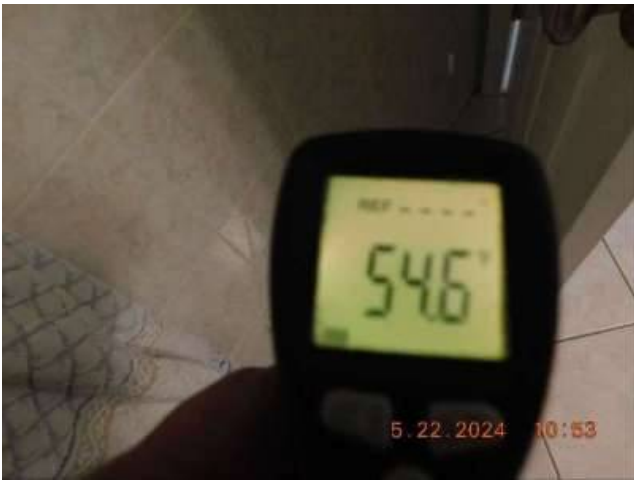
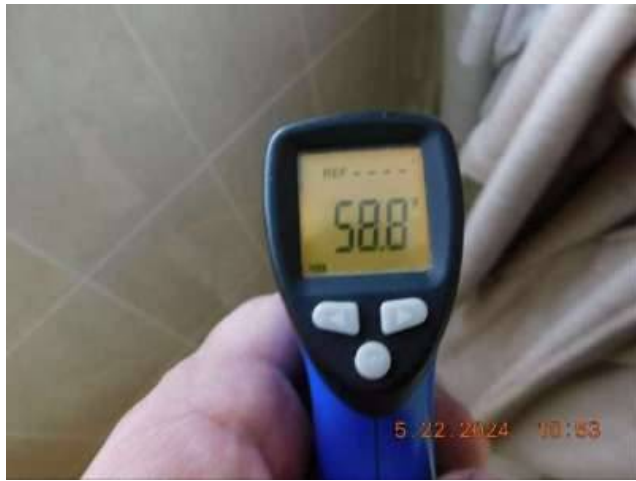
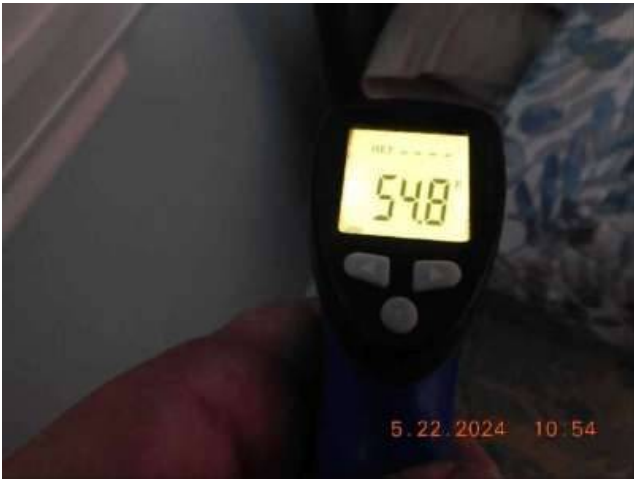
65) Comment/FYI - Sample AC temperatures. All accessible air supply registers were measured. A few examples are shown.

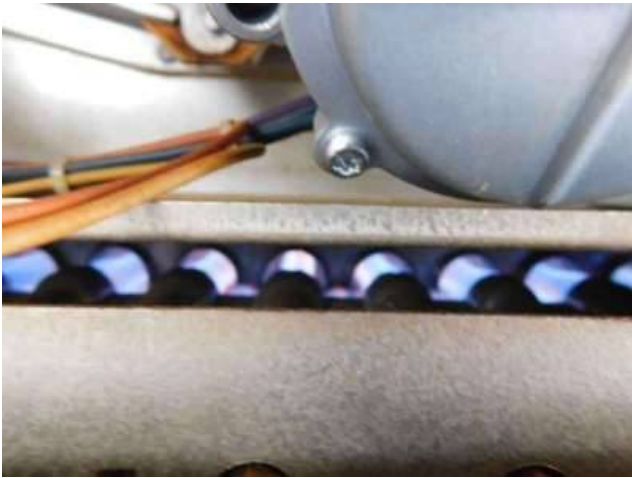
Photo 66-1

66) **Comment/FYI** - The furnace's burners were blue in color indicating proper fuel combustion.

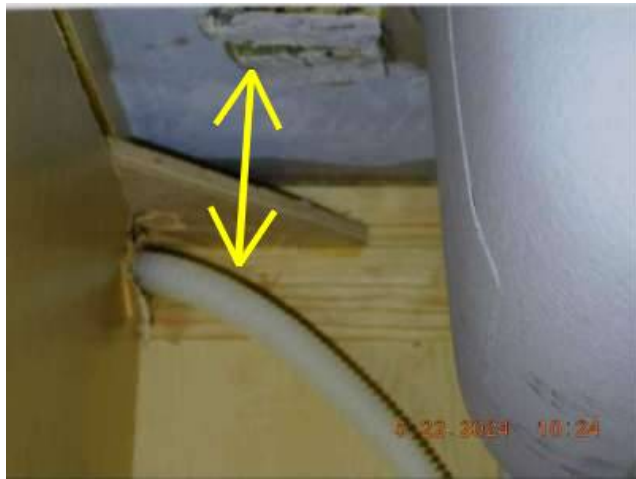
67) Repair/Maintain/Service, Evaluate - The high loop for the dishwasher drain could be slightly higher. A high loop is created by routing the drain line up to the bottom surface of the countertop above and securely fastening it to that surface. An air gap is a device that makes the drain line non-continuous. Both of these prevent waste-water backflow from entering the dishwasher, and possibly flooding out of the dishwasher if/when a siphon occurs. Some newer dishwashers have these devices built in. The client should try to determine if these devices are built into this brand and model of dishwasher (e.g., review installation instructions). If not, or if this cannot be determined, then required that a qualified contractor install a high loop and air gap per standard building practices.

Photo 67-2 Ideally, the dishwasher drain line should be routed to the HIGHEST point underneath the countertop.

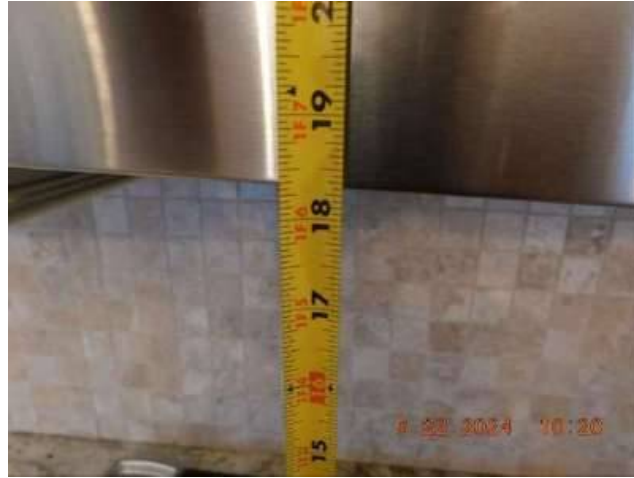
Photo 68-2

68) Repair/Maintain/Service - The clearance between the stove top and the base of the exhaust hood above was too low. While the recommended height varies per the hood manufacturer, standards usually call for a minimum of 24 inches of clearance. A low hood height can restrict visibility of the stove top. Required that a qualified contractor repair per standard building practices.

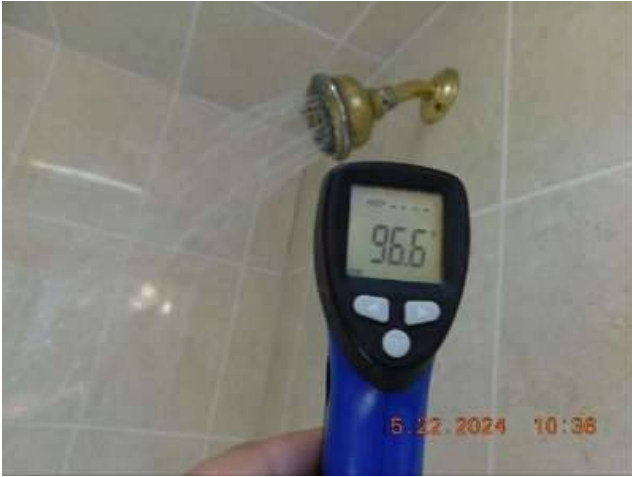
Photo 71-1

71) Repair/Maintain/Service, Evaluate - The shower blender valve in Bath B did not appear to provide enough

hot water. This is often caused by a hot water valve or stop limit for the hot water not allowing enough hot water in to overcome the cold water supply. Recommend that a licensed plumber evaluate and repair.

Compare the temperature shown here with the sample temperatures in the Water Heater section of this report.

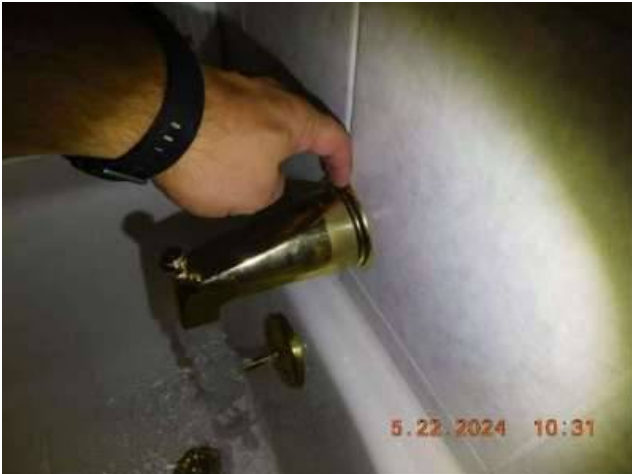
Photo 72-1

72) Repair/Maintain/Service - Caulk was missing around the base of the bathtub spout, or there was a gap behind it, at location(s) A. Water may enter the wall structure behind the bathtub. Recommend that a qualified person repair as necessary to eliminate the gap. For example, by installing or replacing caulk if the gap is small enough. For larger gaps, a shorter spout nipple or an escutcheon plate can be installed.
