Regal Home Inspections, LLC

SAMPLE Property Inspection Report

Property address: **Buccaneer Way**

Inspection date: **Wednesday, May 22, 2024**

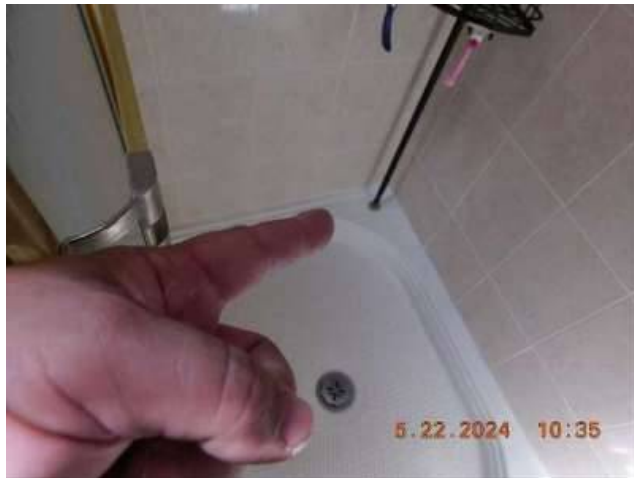
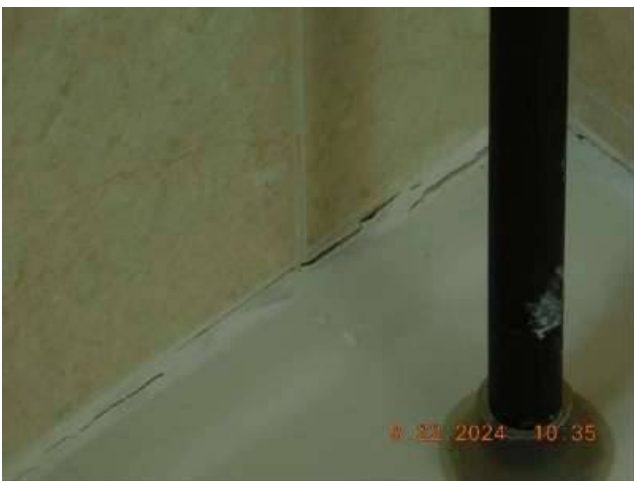
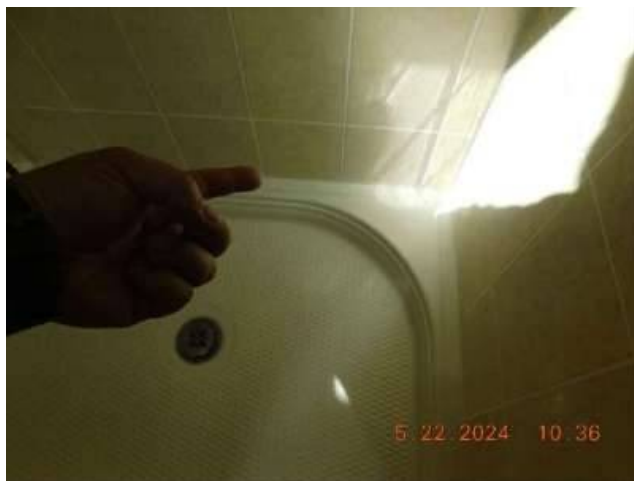
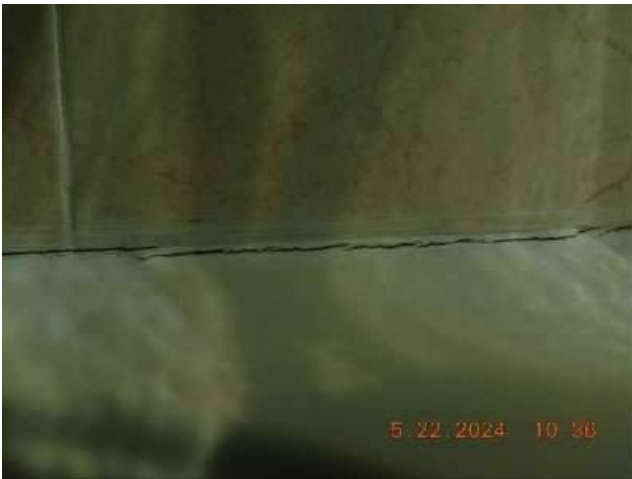
74) Repair/Maintain/Service - Gaps, no caulk, or substandard caulking were found between the shower enclosure and the floor at location(s) B. Water can penetrate these areas and cause damage. Recommend that a qualified person re-caulk or install caulking as necessary.

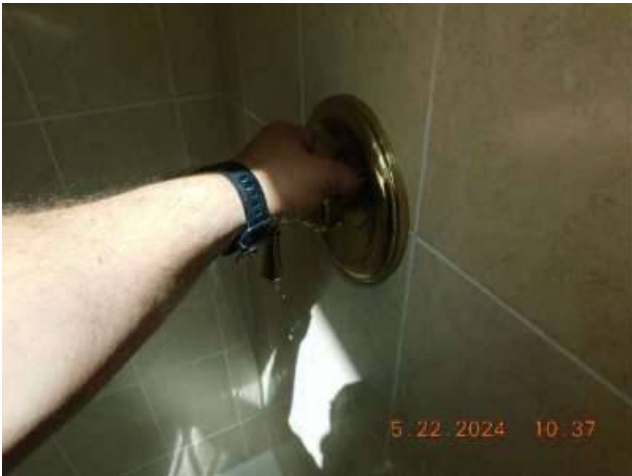
Photo 76-1

76) Repair/Maintain/Service - The valve for the shower at bathroom B is loose. Leaks can occur and if they do, they are inside the wall where unknown damage can occur such as wood rot and potentially mold. A licensed and qualified plumber must repair so that the pipes are well secured in the wall.

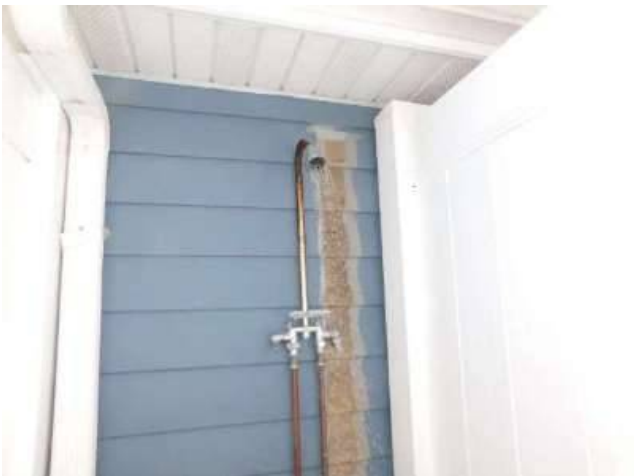
Photo 79-1

79) Comment/FYI - There is an outdoor shower. It will require seasonal winterization.

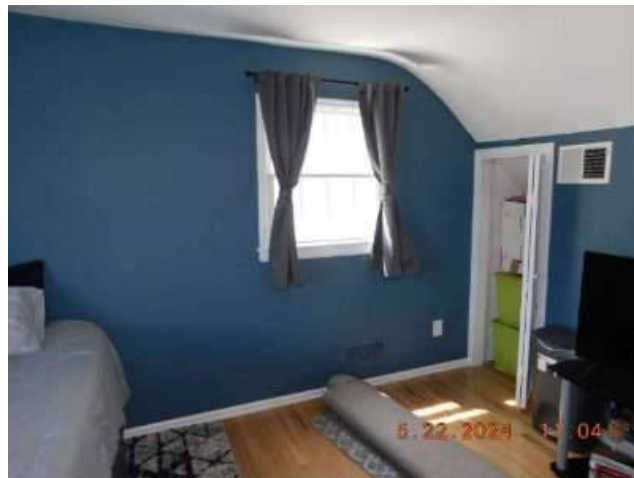
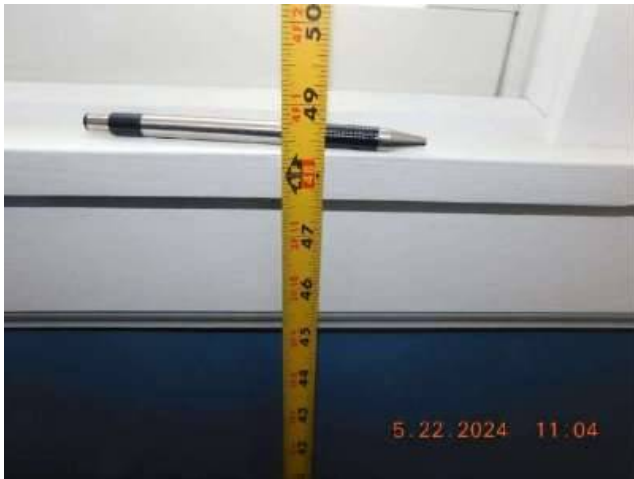
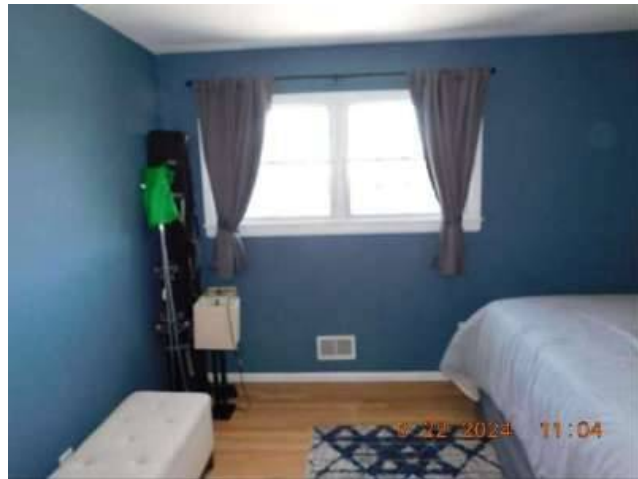
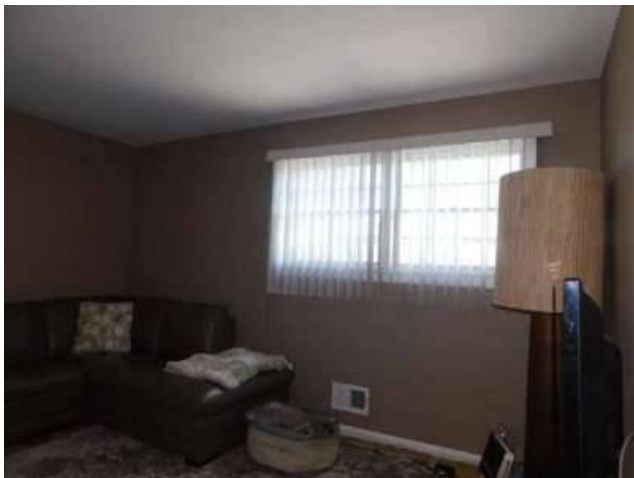
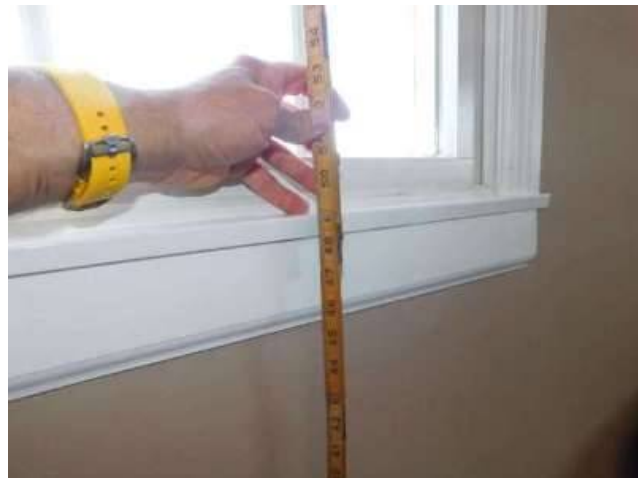
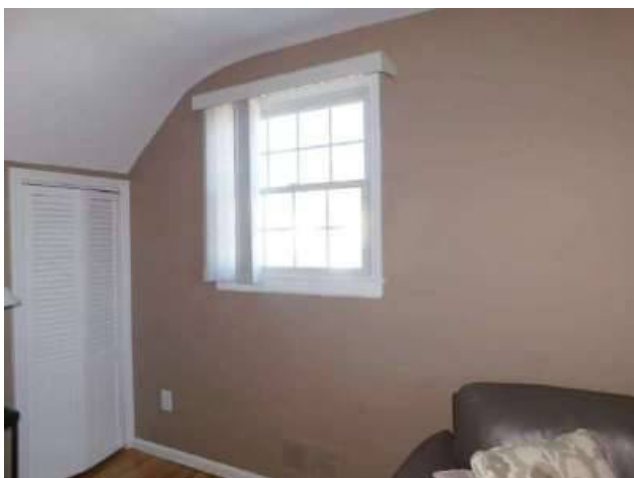
80) Material Defect/Safety, Replace - One or more bedrooms had windows that were too high off the floor. At least one window requires adequate egress in the event of a fire or emergency to allow escape or to allow access by emergency personnel. Such windows should have a maximum sill height of 44 inches off the floor. At a minimum, keep a chair or something that serves as a ladder below the window at all times. Required to have a qualified contractor repair or make modifications per standard building practices.

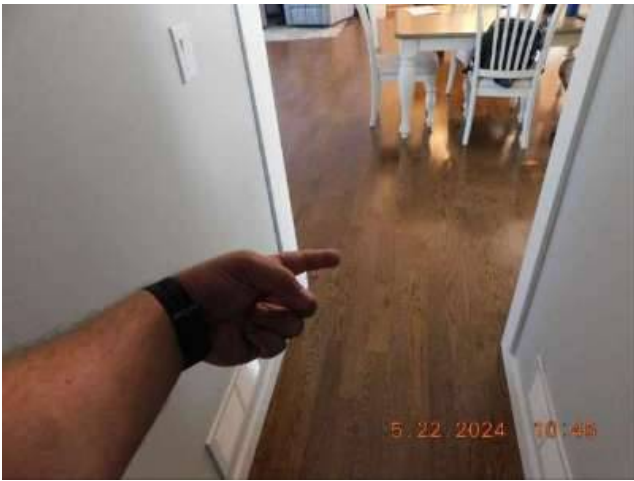
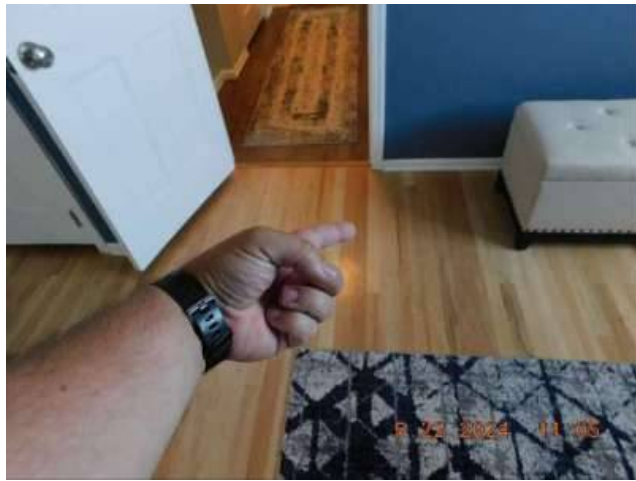
83) Material Defect/Major, Repair/Maintain/Service, Evaluate - Floors in one or more areas were not level. This can be caused by foundation settlement or movement of the foundation, posts and/or beams. Significant repairs may be needed to make floors level. Required that a qualified contractor and/or engineer evaluate further for potential causes and repair needs. Repairs must be performed by a qualified contractor.

Please refer to the Crawl Space section for possible related findings.

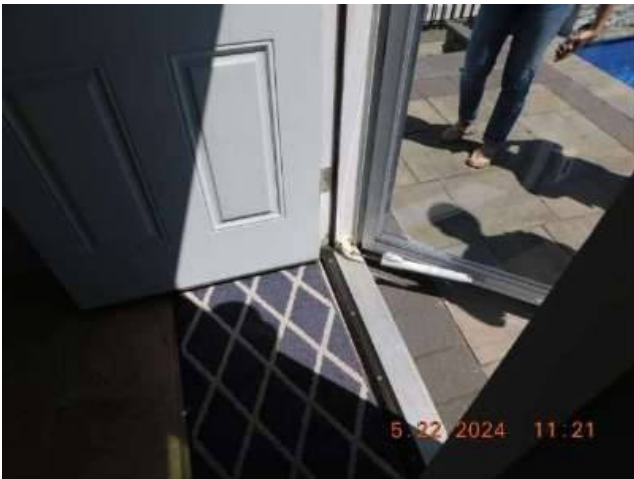
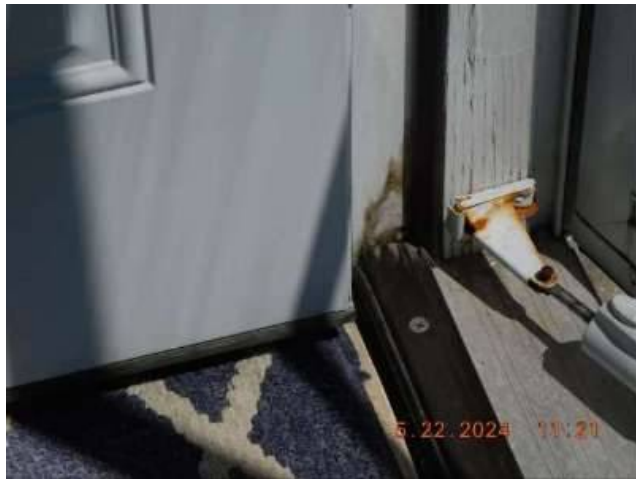
84) Replace - Fungal rot or staining was found at one or more exterior door jambs. Required that a qualified person repair as necessary. All rotten wood should be replaced.

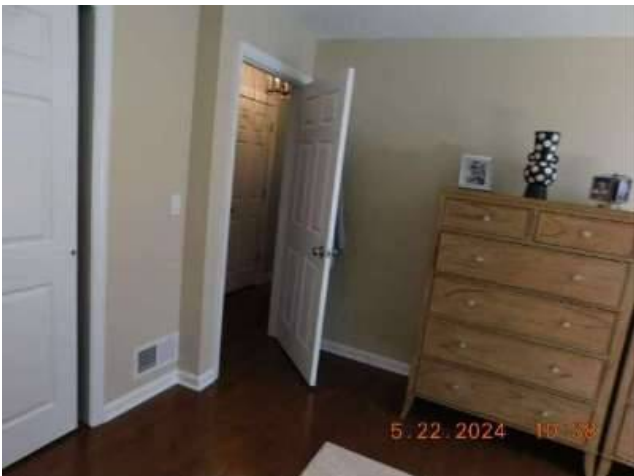
Photo 85-1

85) Repair/Maintain/Service - One or more interior doors wouldn't latch or were difficult to latch. Required that a qualified person repair as necessary. For example, by adjusting latch plates or locksets.
