Regal Home Inspections, LLC

SAMPLE Property Inspection Report

Property address: **Locust Ln.**

Inspection date: **Monday, December 9, 2024**

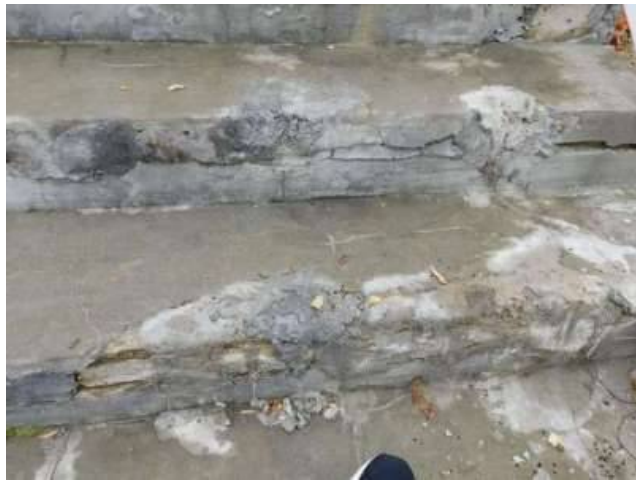
Photo 11-2

11) Material Defect/Safety, Repair/Maintain/Service - The concrete steps are deteriorated and present a fall hazard. Gaps and cracks allow water to penetrate the step/porch structure. Sections of the concrete are breaking away. In the freeze/thaw cycles of winter the ice will cause additional deterioration. Required that a qualified masonry contractor evaluate all and repair as that professional deems necessary.

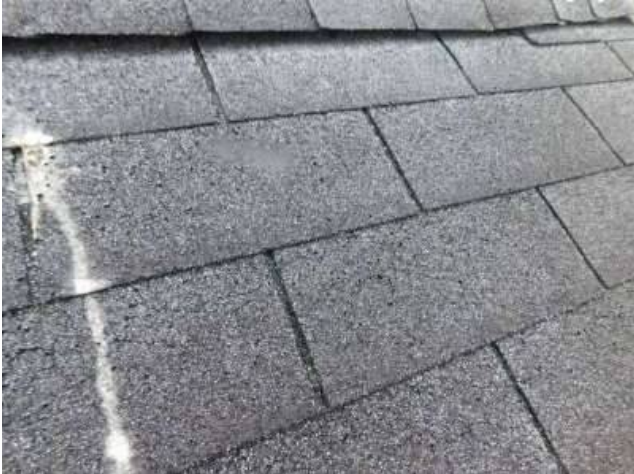
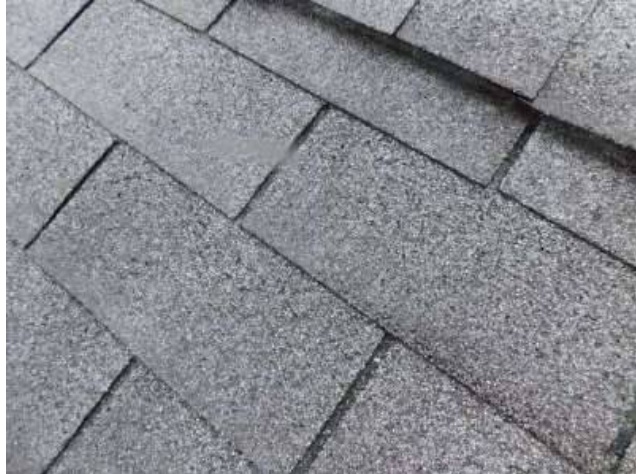
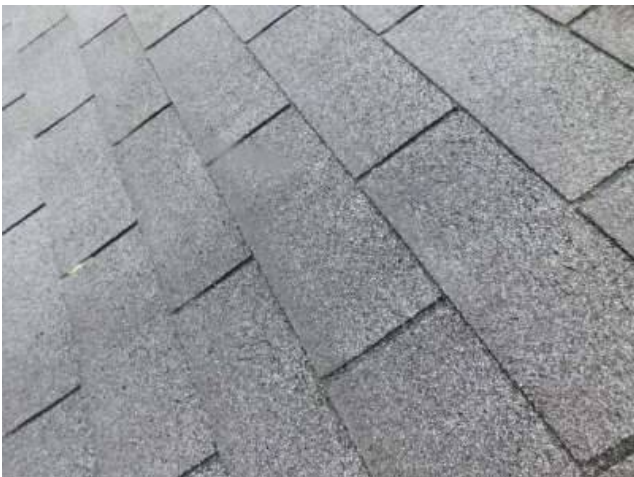
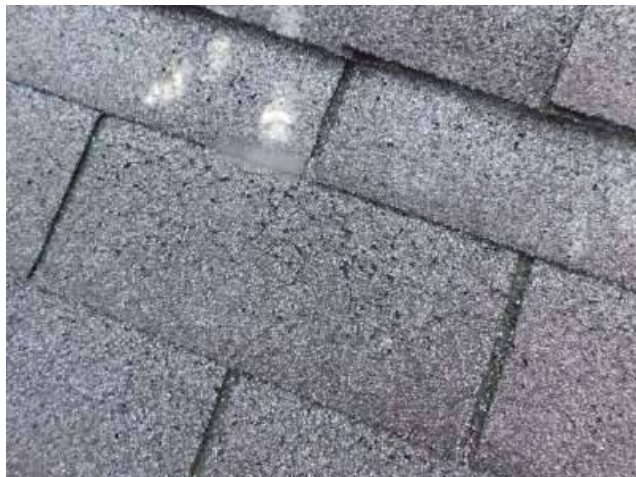
15) Material Defect/Major, Replace, Evaluate - The roof surface was significantly deteriorated and appeared to be at or beyond its service life. It needs replacing now. This is a conducive condition for wood-destroying organisms. Required that you consult with a qualified roofing contractor to determine replacement options. Note that some structural repairs are often needed after old roof surfaces are removed and the structure becomes fully visible. Related roofing components such as flashings and vents should be replaced or installed as needed and per standard building practices.

This is a factor in the inspector's conclusion that the roof surface is at or beyond its service life.

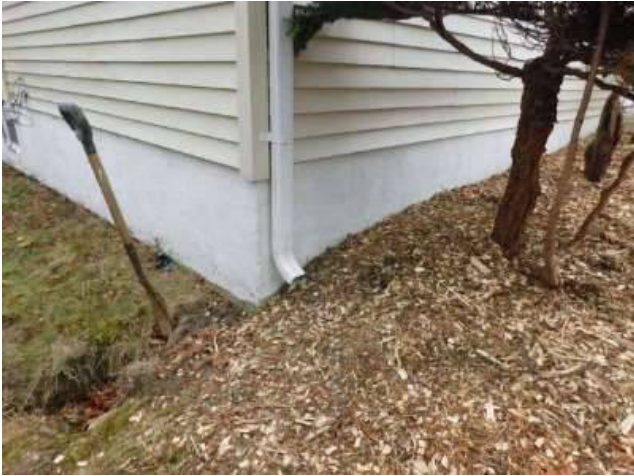
Photo 19-1

19) Replace, Repair/Maintain/Service - Extensions such as splash blocks or drainpipes for one or more downspouts were depositing water too close to the foundation. Water can accumulate around the building foundation or inside crawl spaces or basements as a result. Required that a qualified person install, replace or repair extensions as necessary so rainwater drains away from the structure.

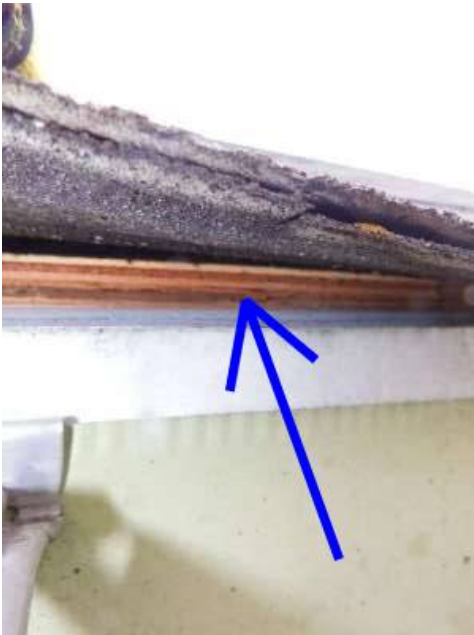
Photo 20-1

20) Repair/Maintain/Service - There is no drip edge flashing. Drip edge flashing is intended to protect the edge of the plywood roof sheathing where the shingles end and help ensure that all rain water goes into the gutter. It's often not installed by roofers so they can save money but is a good practice to ensure a more water repellent roof. Properly installed drip edge flashing should be installed around the entire perimeter of the roof. One edge should go between the plywood sheathing and the roof surface (shingles, etc.) and then bend downward into the back of the gutter or along the outside of the rake board. In this installation, when the shingles are lifted, bare plywood is exposed.

Required that drip edge flashing be added by a qualified roofing contractor.

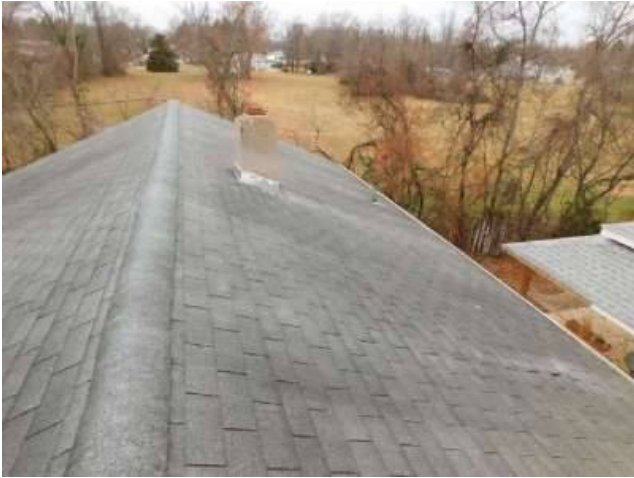
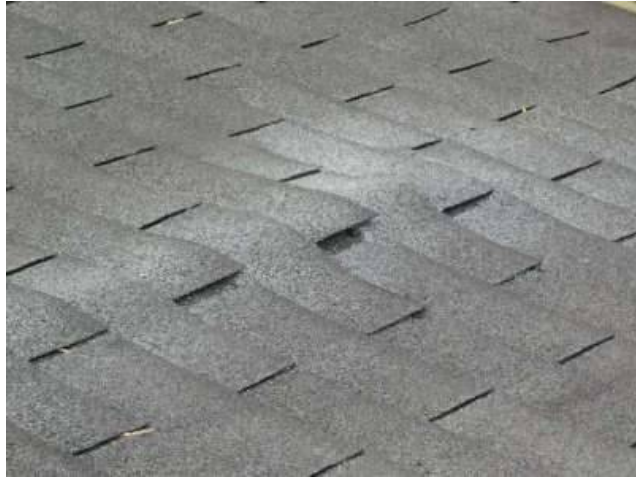
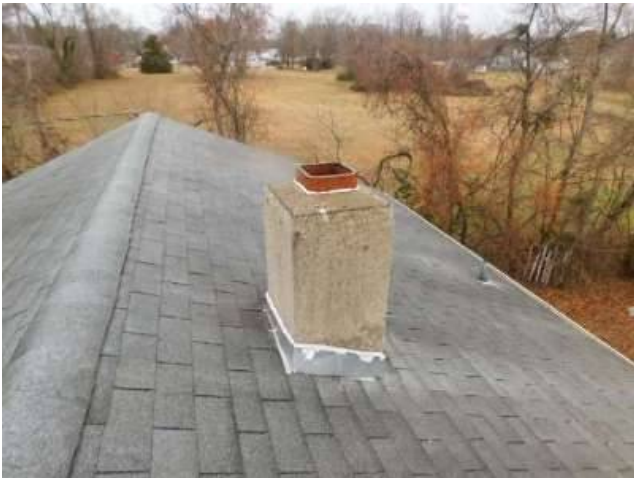
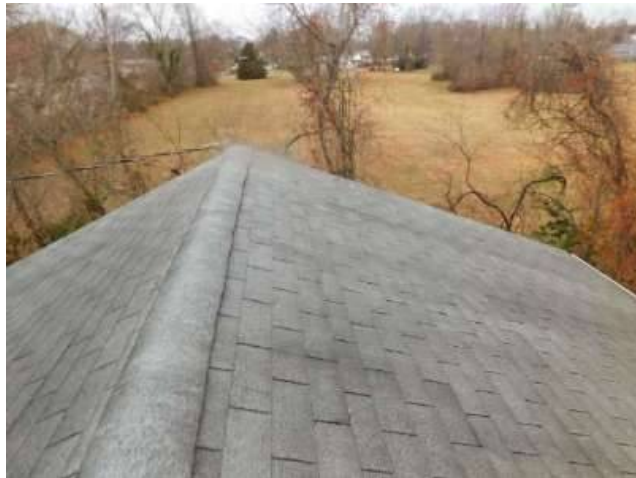
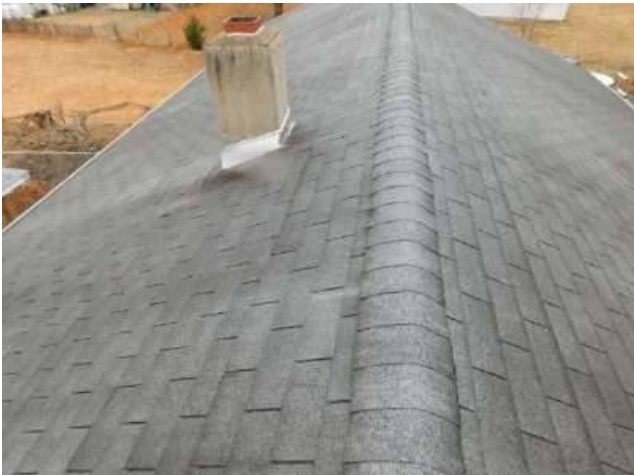
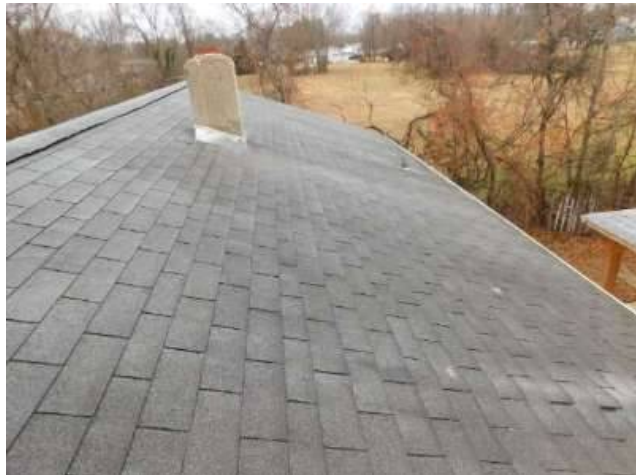
22) Comment/FYI - General roof photos.

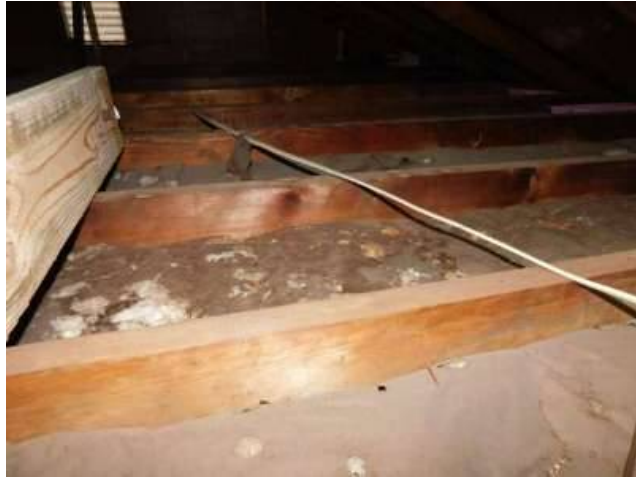
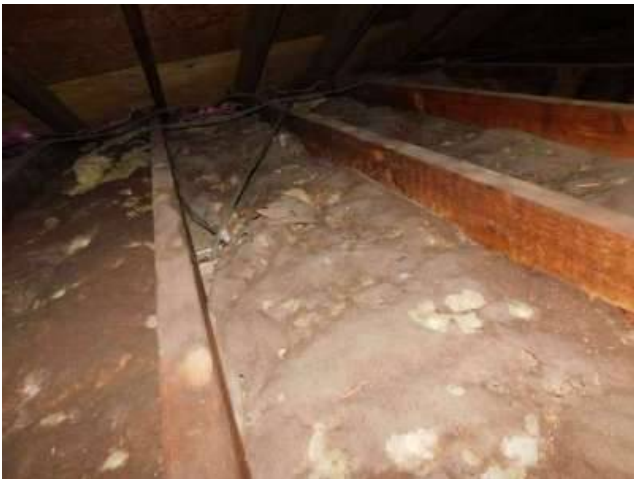
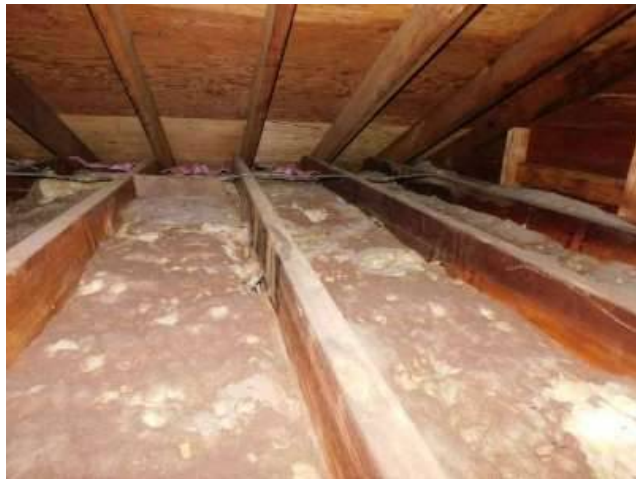
Photo 24-1 Here and the next 3 photos are probably original insulation. Quite compressed, thin and ineffective as an insulating barrier.

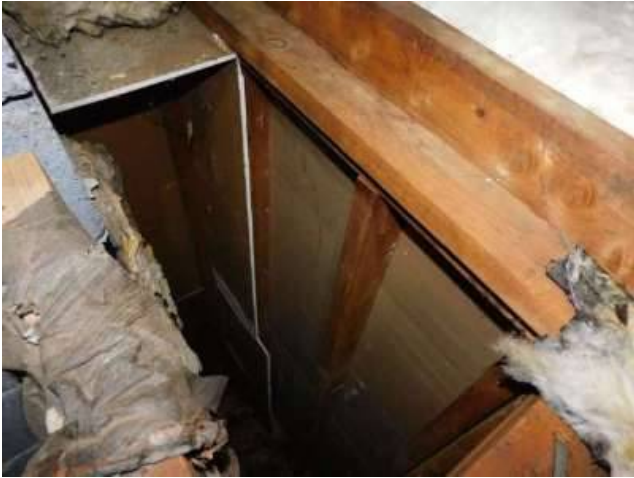
Photo 24-5 Interior, living space walls are not insulated and exposed to the extreme temperatures in the winter and summer. This increases energy costs as cold temperatures easily radiate into the living space in the winter and very hot temperatures radiate into the living space in the summer.

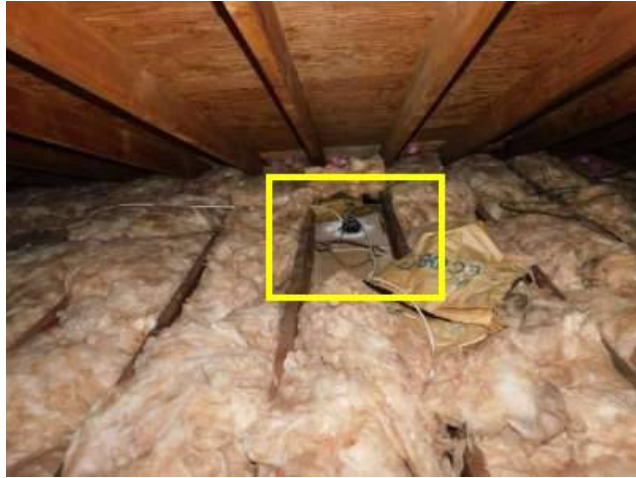
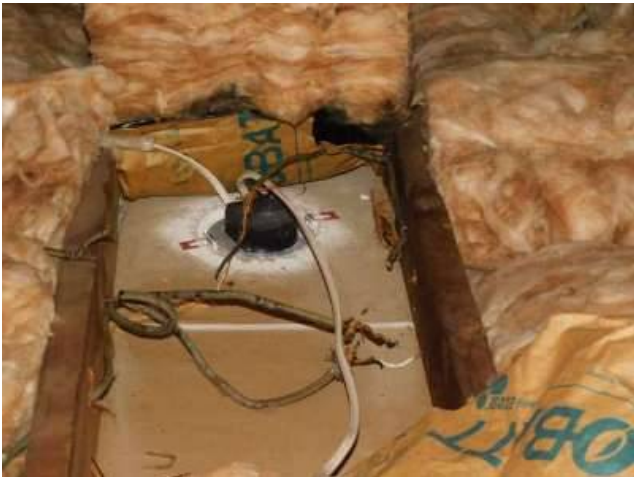
Photo 24-6 Close up of this area in the next photo.

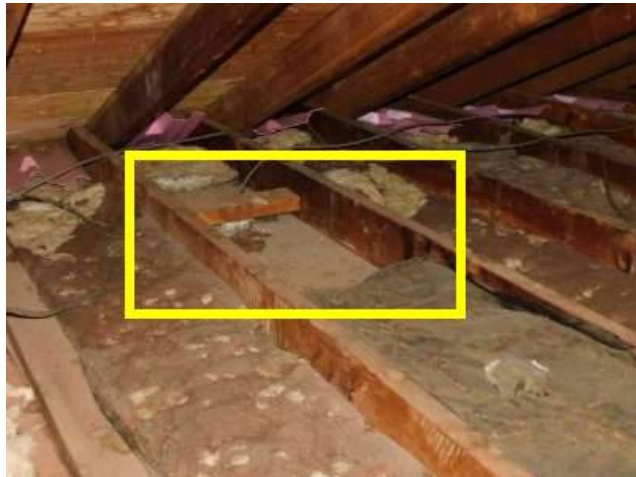
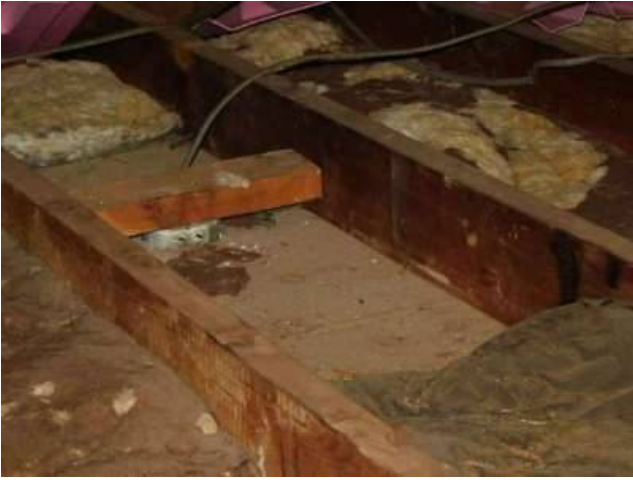
Photo 24-8 Close up of this area in the next photo.

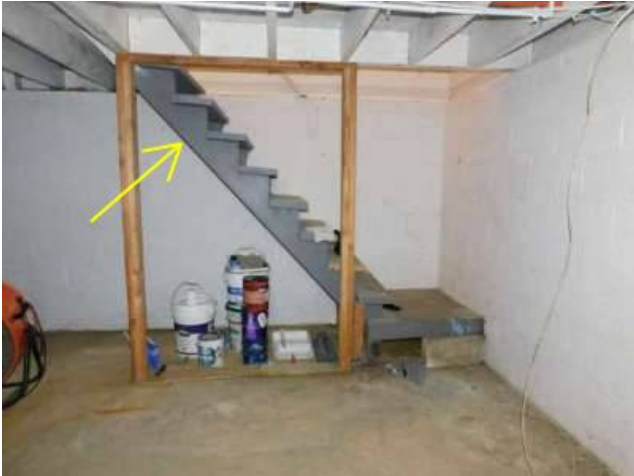
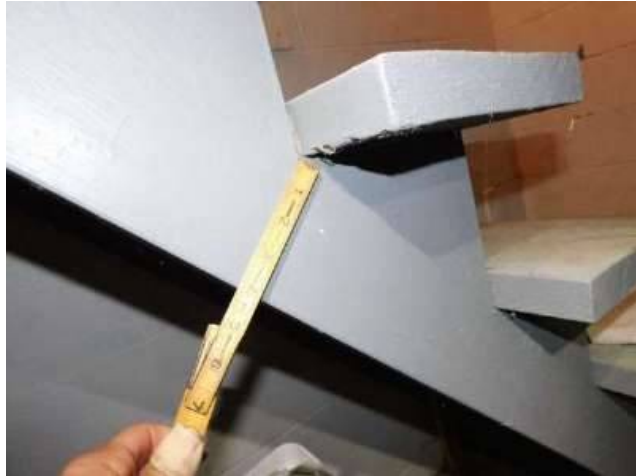
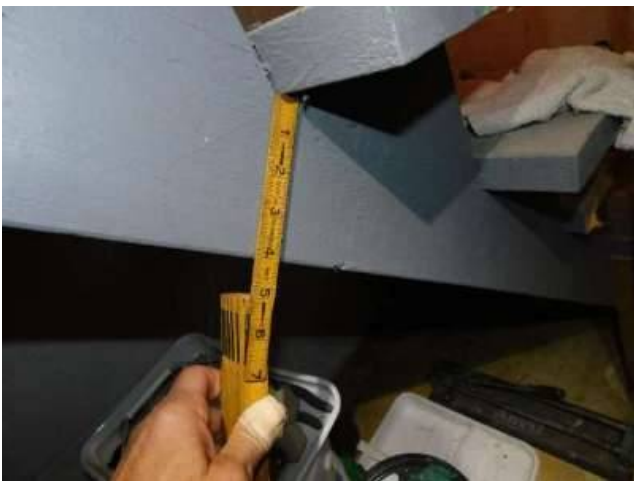
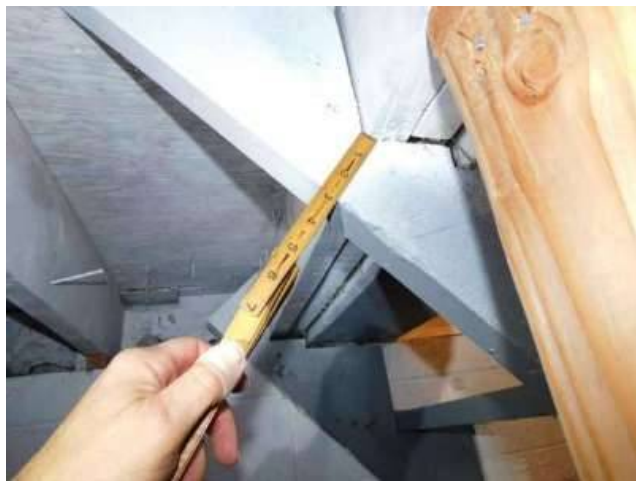
27) Material Defect/Safety, Replace, Repair/Maintain/Service - The shoulder of the step stringers is less than 5 inches. This weakens the stringers and the stringers can break. Requires evaluation and repair by a qualified

contractor.

Photo 27-1 Close up of this area in the next photos.

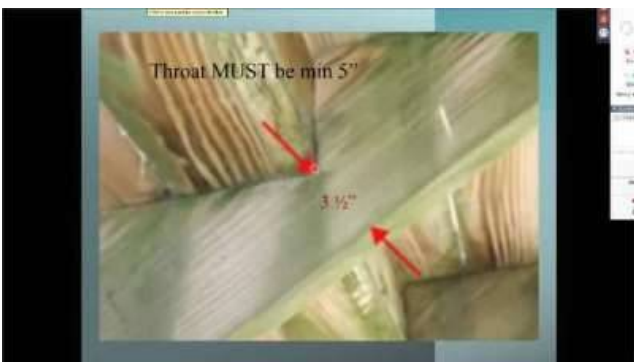
Photo 27-5 This slide is from recent training and shows that the stringer's shoulder must be, "min 5 inches."

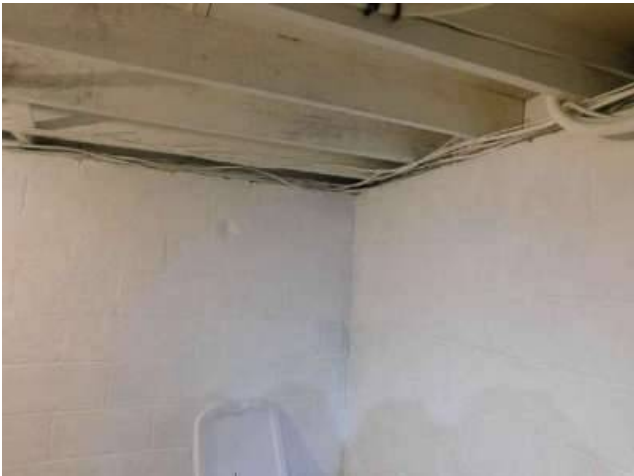
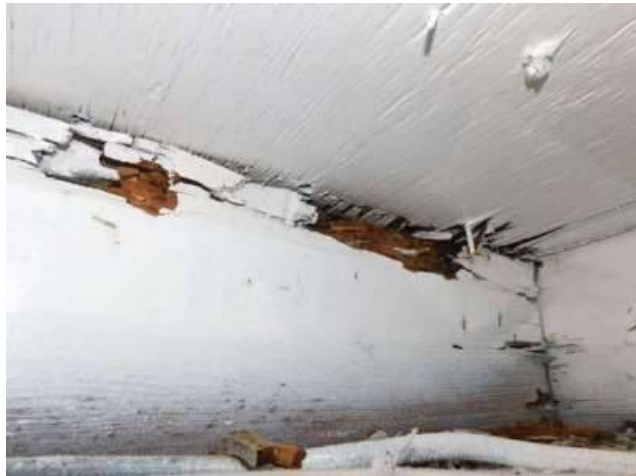
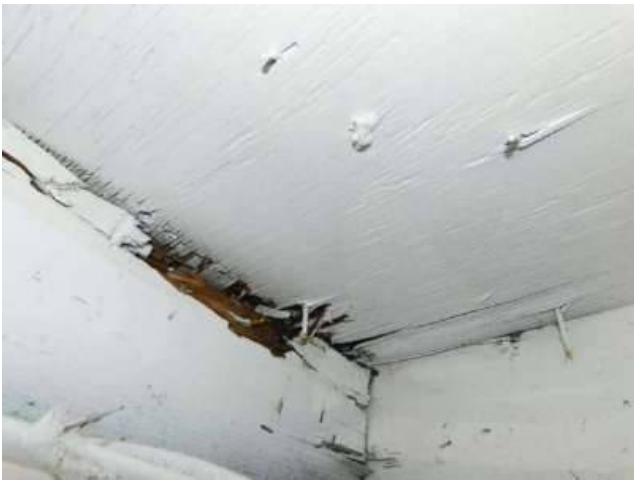
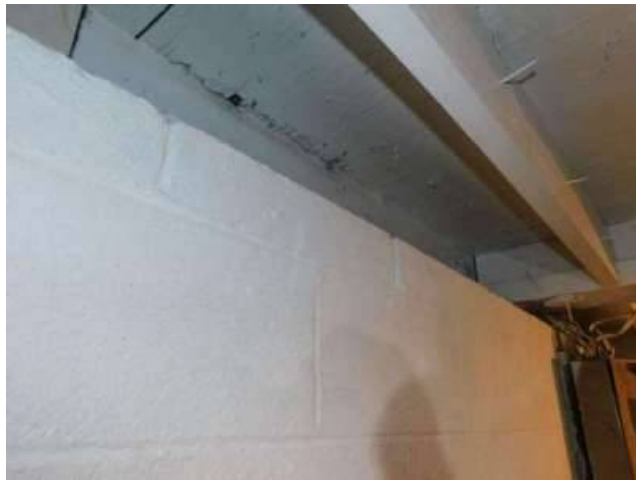
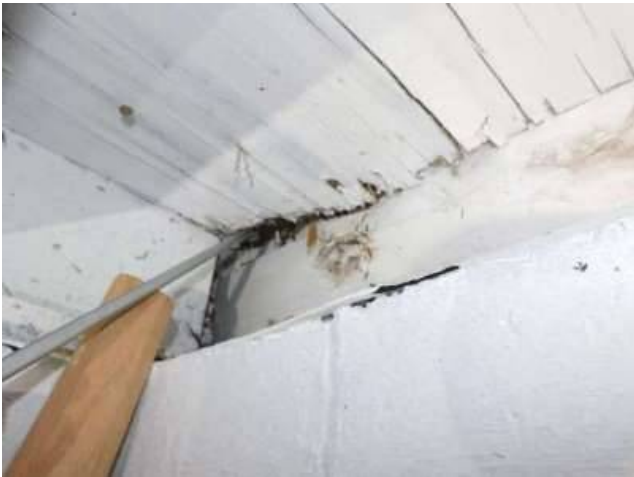
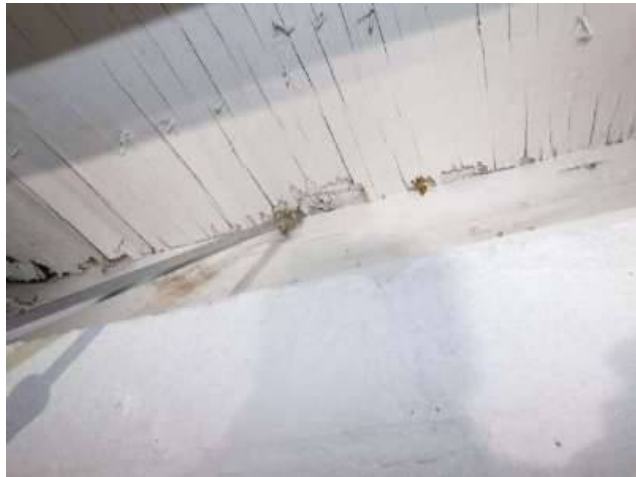
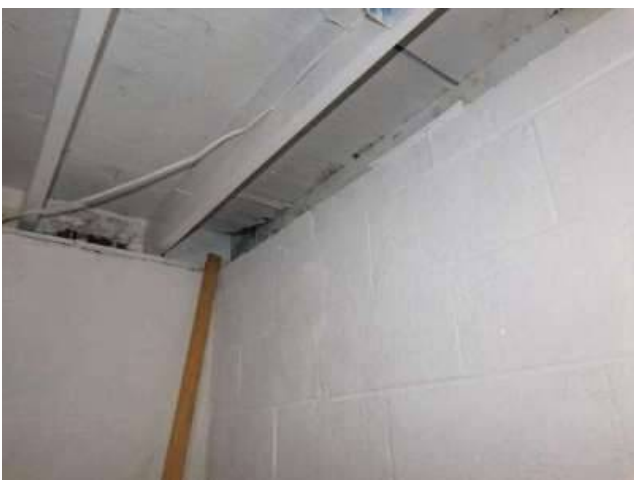
33) Material Defect/Major, Replace, Evaluate - Fungal rot was found at one or more joists and/or sections of floor sheathing. Required that a qualified contractor evaluate and repair as necessary. All rotten wood should be replaced.

Photo 33-1 Close up of this area in the next 2 photos.

Photo 33-4 Here and the next photos are along the wall with the electrical panel.

See Item 1 in the General Information section for resource contact info for repair.

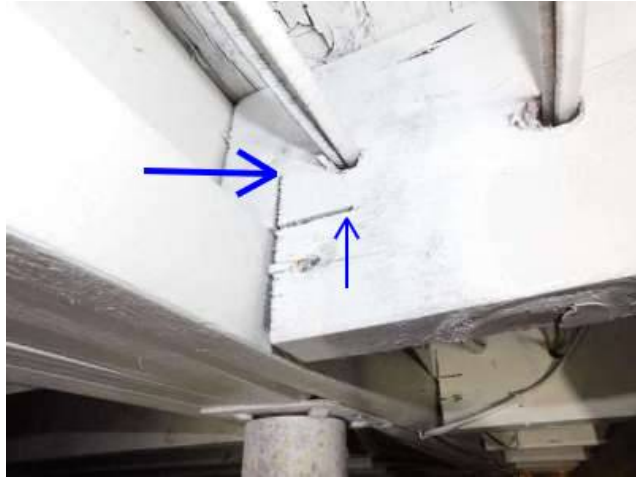
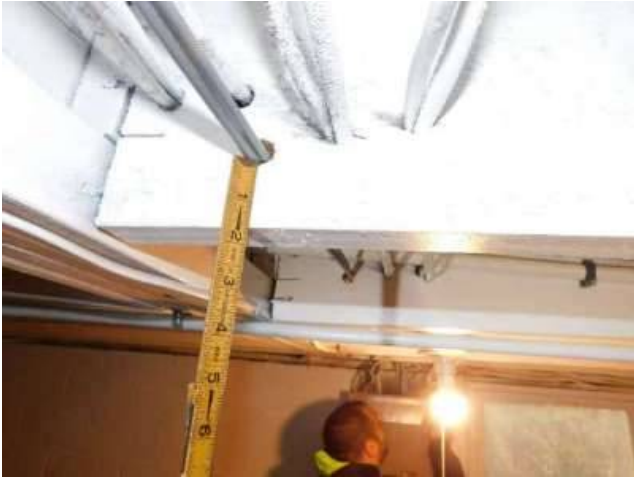
34) Material Defect/Major, Replace - Numerous joists were notched or had holes cut in them in such a way as to significantly weaken the joists. General guidelines for modifying joists made of dimensional lumber include these restrictions:

Photo 34-1 Numerous joists have been cut to create the needed notches to hang from the ledger board. The cuts made are significantly longer than need be. This weakens the joists. Another item in this section shows a number of split joists. The split almost always starts at these poor cuts.

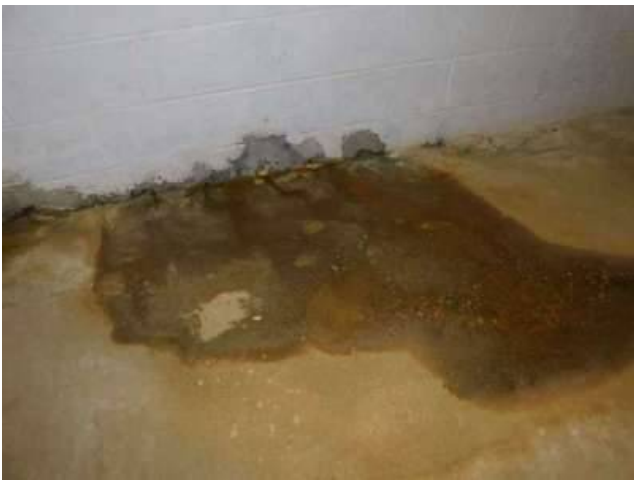
Photo 36-1

36) Material Defect/Major, Repair/Maintain/Service, Evaluate - Standing water was found at one or more locations in the basement. Water from basement can evaporate and enter the structure above causing high levels of moisture in the structure. This is a conducive condition for wood-destroying organisms. Water should

- Repairing, installing or improving underground footing and/or curtain drains
- Applying waterproof coatings to foundation walls
- Digging trenches in the crawl space to collect or divert water
- Installing sump pumps

Options include Hale Built Group www.halebuilt.com
www.quality1stbasementsystems.com

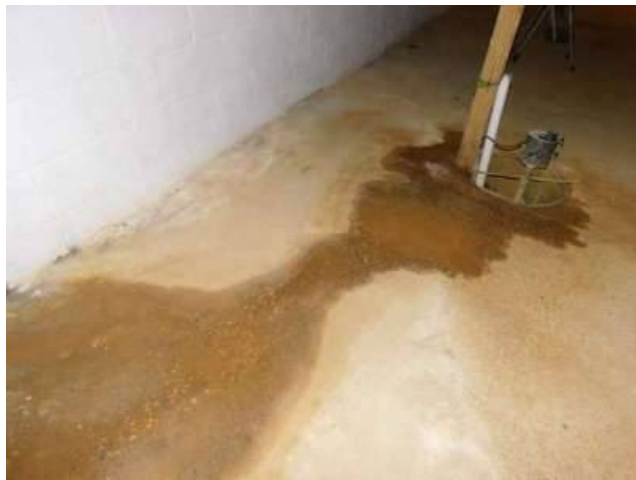
Rain runoff is the most common cause of wet basements, but water can come from other sources such as groundwater or underground springs. Requires that a qualified contractor correct any issues related to outside perimeter grading and/or roof drainage (see any other comments about this in this report). If standing water persists, then recommend that a qualified contractor who specializes in drainage issues evaluate and repair as necessary. Typically, such repairs include:

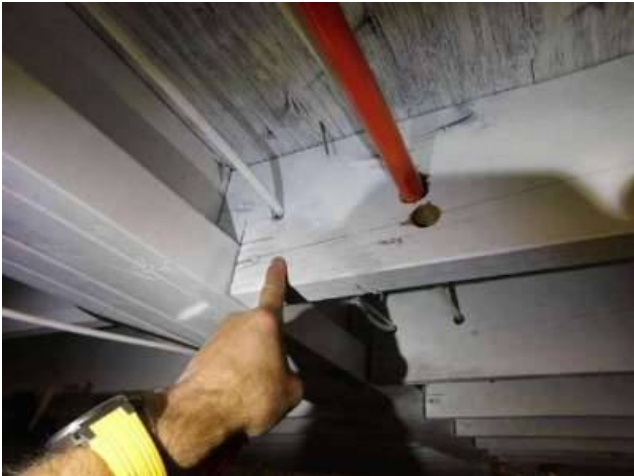
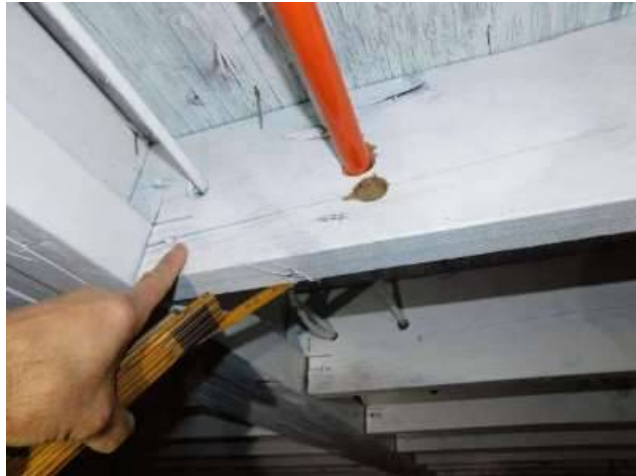
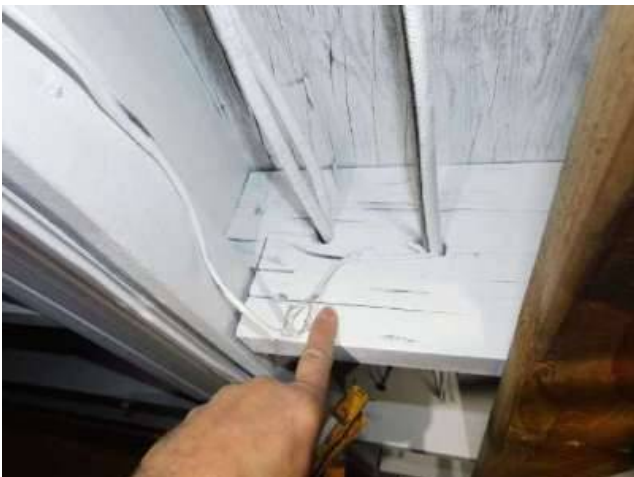
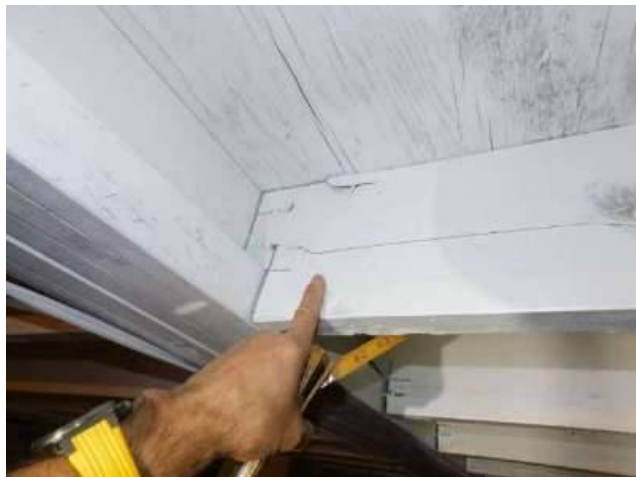
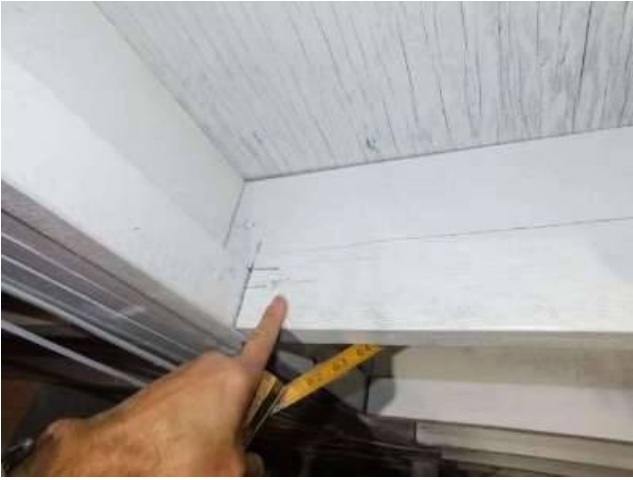
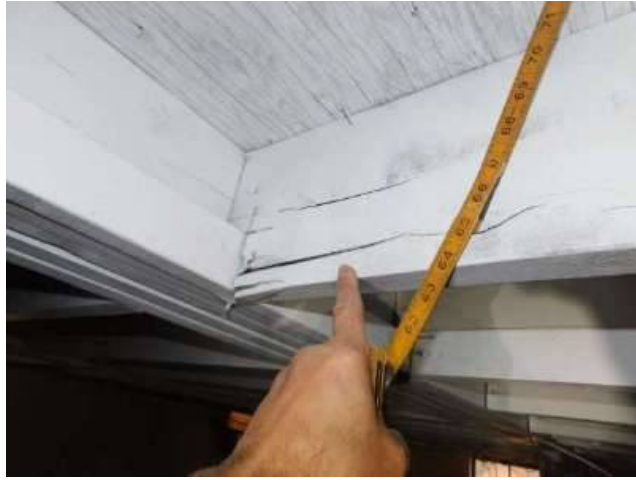
37) Material Defect/Major, Repair/Maintain/Service, Evaluate - One or more floor joists were split. This can reduce the floor's strength and cause sagging or spongy floors. Requires evaluation by a contractor familiar with framing and structures and have this and any other split or damaged joists repaired.

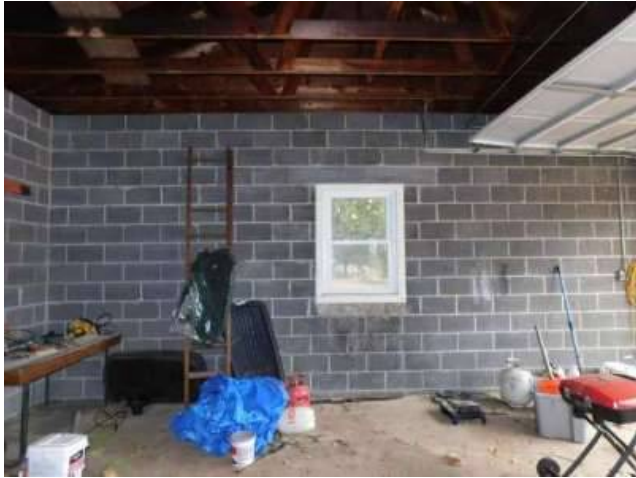
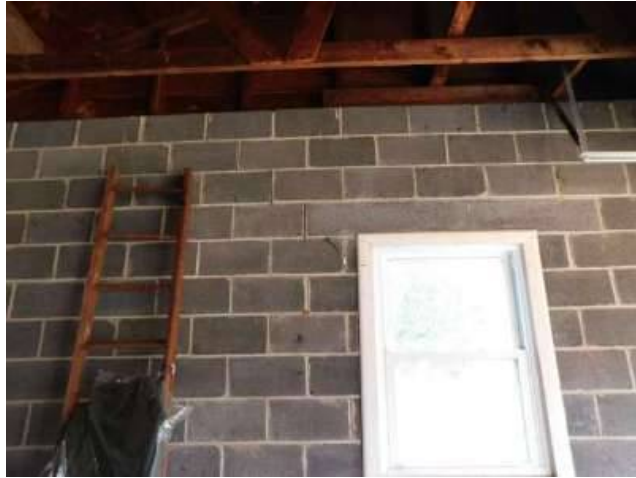
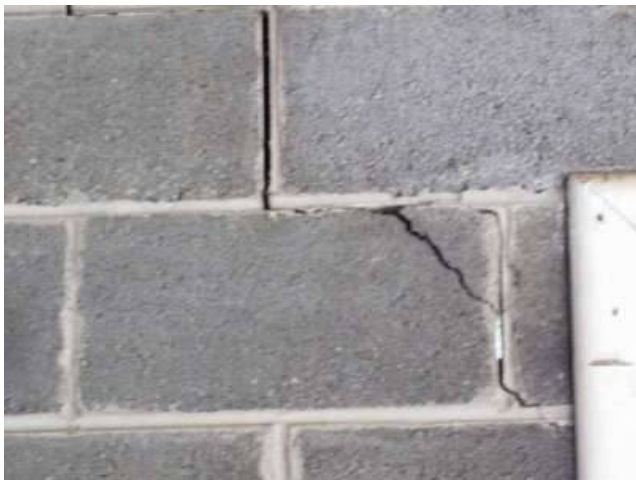
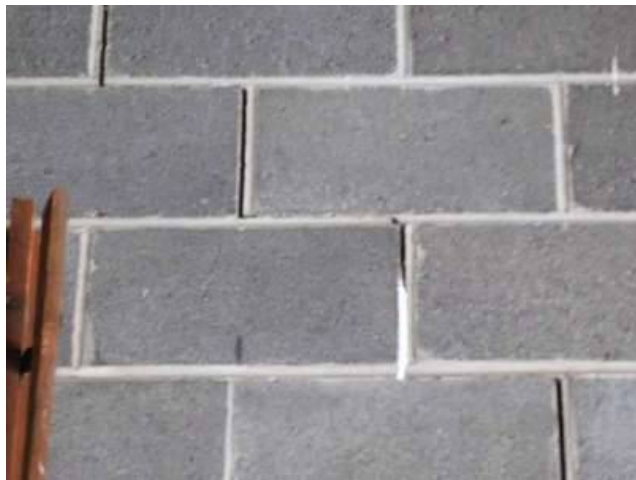
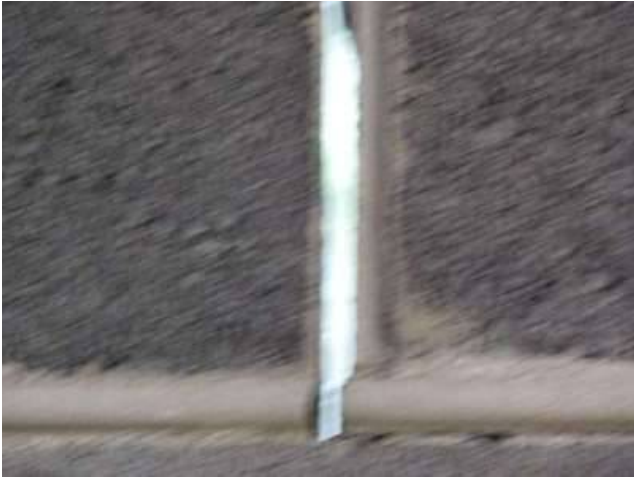
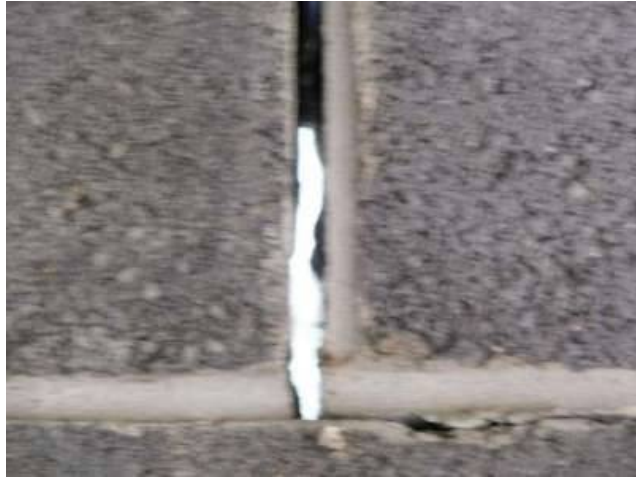
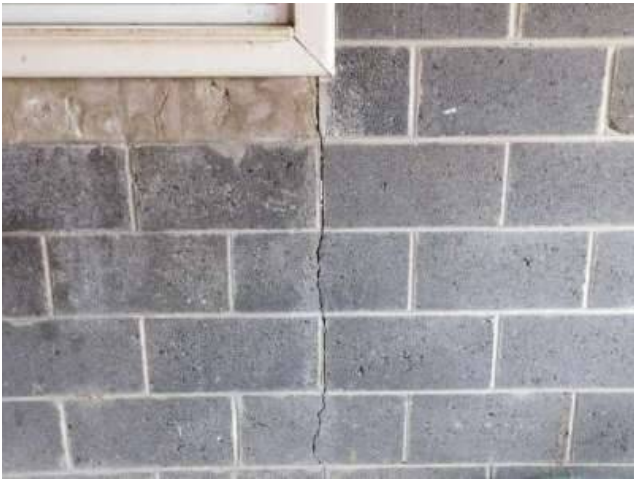
39) Material Defect/Major, Repair/Maintain/Service, Evaluate - Horizontal cracks or vertical cracks indicating concrete block wall movement have been identified. Requires further evaluation by a structural engineer and all repairs must be done by a qualified, foundation repair (Similar concrete blocks) contractor or mason.

Options for structural engineering and/or foundation/structural contractor evaluation include:

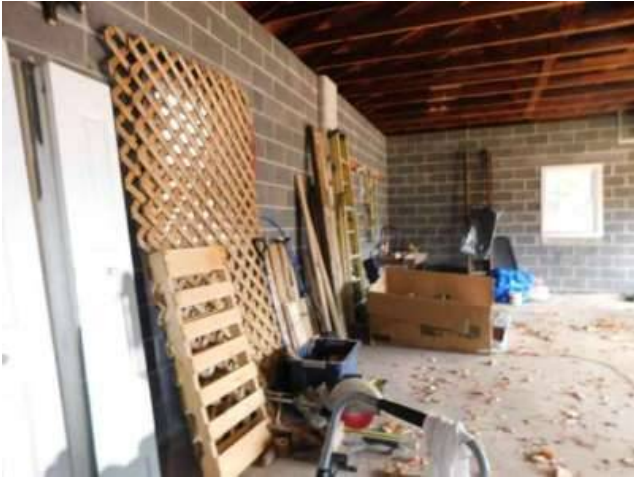
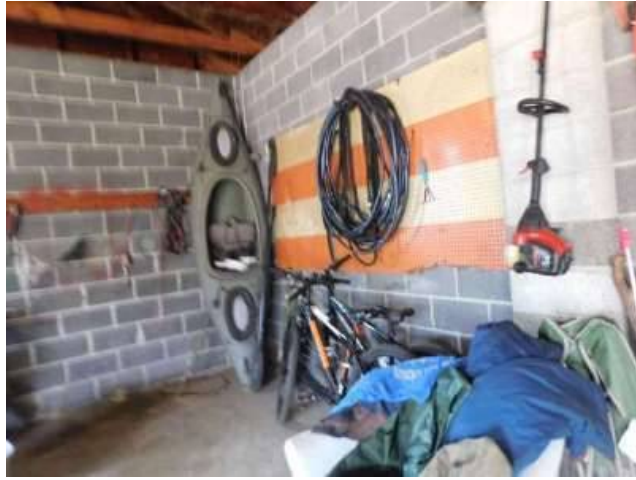
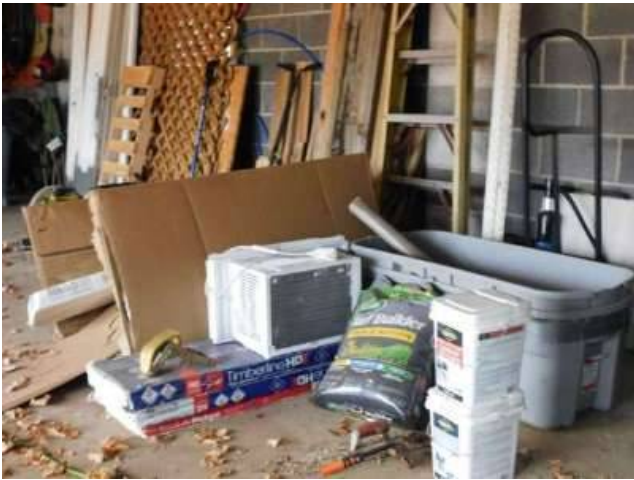
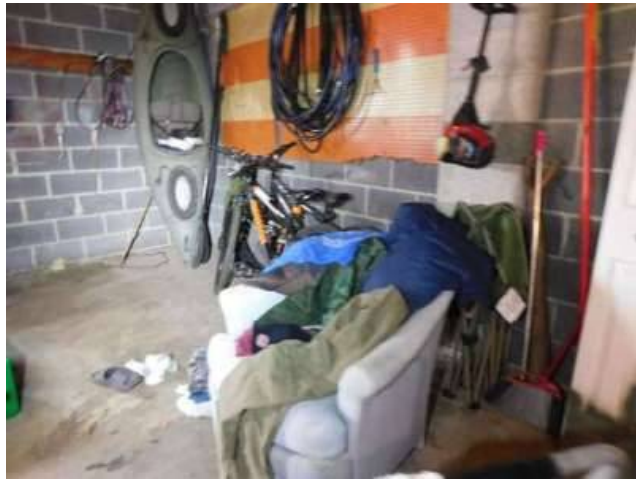
40) Exclusion, Comment/FYI - Areas of the garage were obscured by possessions. Areas that were not readily accessible for visual inspection are excluded from the inspection in accordance with New Jersey home inspection standards of practice. Please note that after the seller's possessions are removed damage, cracks, or deterioration may then be exposed including indications of wood destroying insects. Portions of the garage (house and structure) that are behind these obstructions are not available for visual inspection and therefore excluded from the inspection. It is always possible that latent (aka hidden) material defects exist behind these obscured areas. In accordance with the NJ home inspection administrative code, the inspector conducts a visual inspection, "...without requiring the moving of personal property...destructive measures...". When furnishings, stored items, debris or other obstructions are present, all areas or items that are obscured, concealed or not readily accessible are excluded from the inspection.

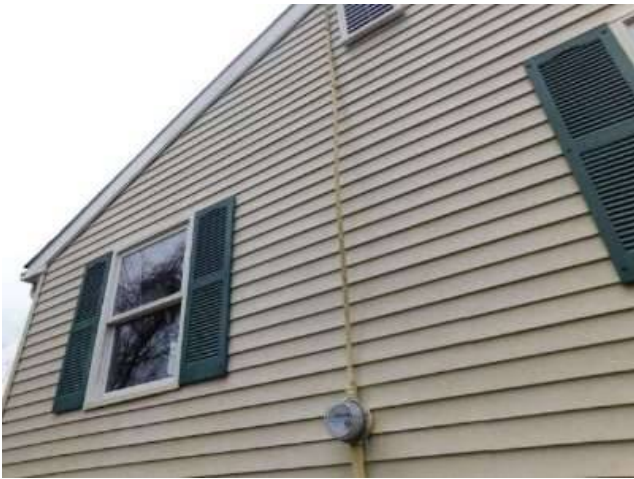
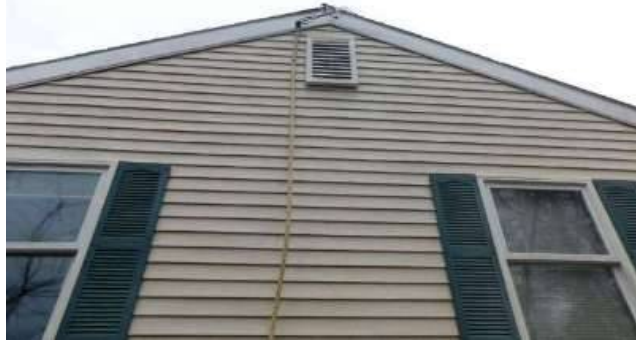
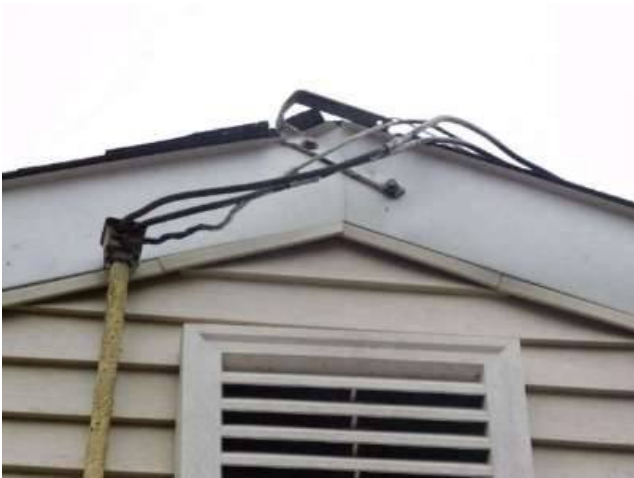
42) Material Defect/Safety, Material Defect/Major, Replace, Evaluate - Requires that a licensed electrician evaluate the service drop from the utility pole and the attachment to the house. Things to have the licensed electrician evaluate, comment on and potential repair or replace:

- 1) Add a service mast to raise the service drop above the roof.
- 2) The service drop must have a drip loop and a weather-head.
- 3) It appears that the service cable, from the splice near the ridge of the roof to the meter is worn and requires replacement.
- 4) Water is entering the electrical panel, Panel A, and the items listed above are the cause or significant contributors. Water inside the electrical panel is a fire and safety hazard. Therefore, the electrical panel must be replaced.

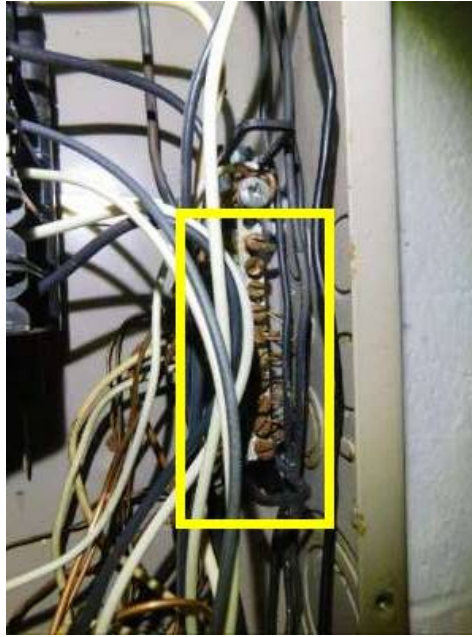
Photo 42-6 Rusted lugs.

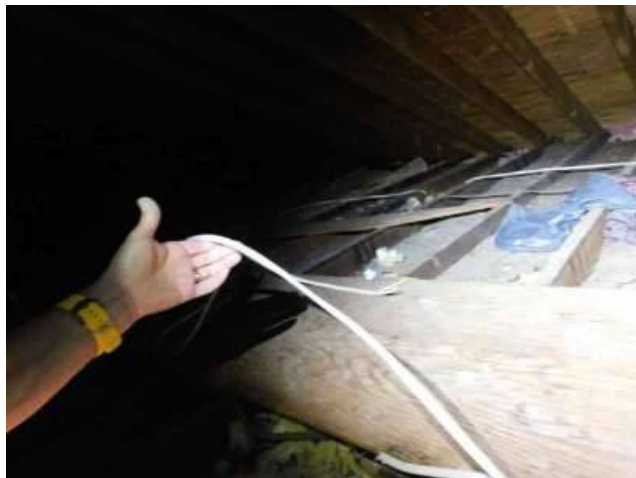
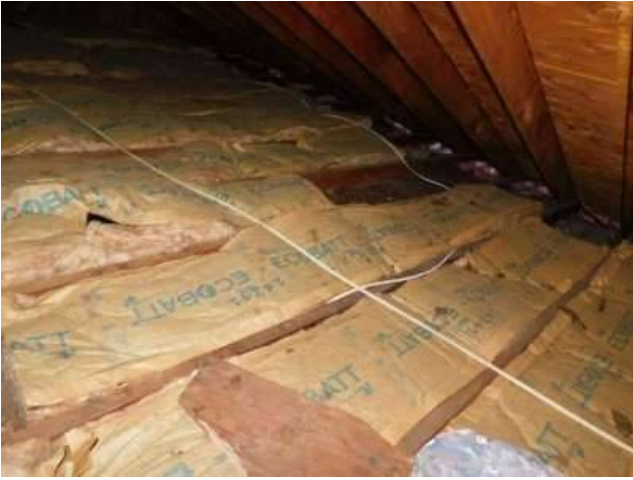
44) Material Defect/Safety, Replace, Repair/Maintain/Service - Non-metallic sheathed wiring was loose, unsupported, or inadequately supported at one or more locations. For example, at numerous locations inside the attic and over Panel A. Such wiring should be trimmed to length if necessary and attached to runners or to solid backing with fasteners at intervals of 4 1/2 feet or less. Fasteners should be installed within 12 inches of all enclosures such as Panel A. Required that a licensed electrician repair per standard building practices.

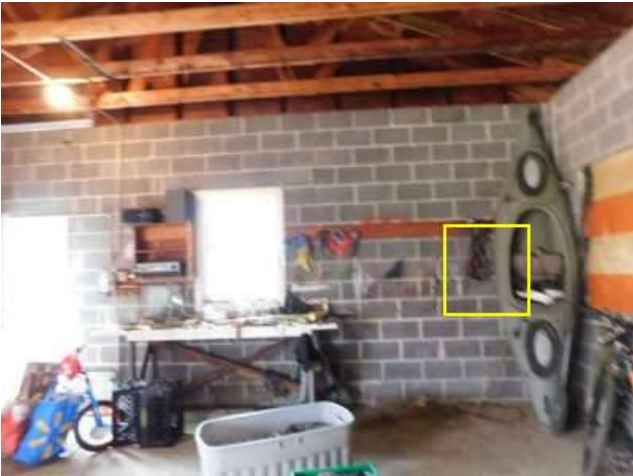
45) Material Defect/Safety, Replace, Evaluate - Substandard wiring was found at the garage. For example, loose wiring. This is a safety hazard. Required that a licensed electrician evaluate and repair as necessary and per standard building practices.

Photo 45-1 Close up of this area in the next photo.

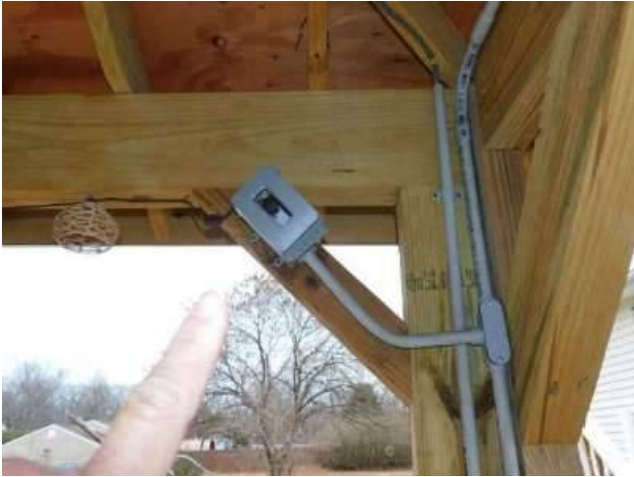
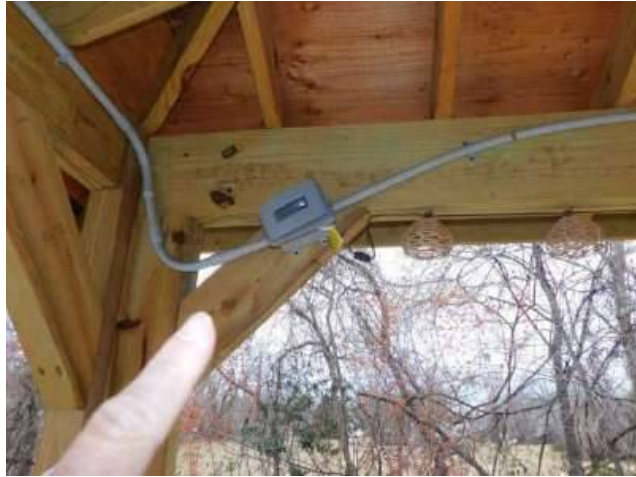
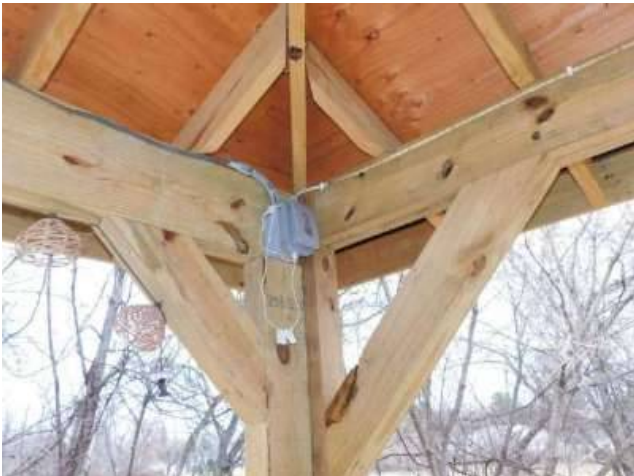
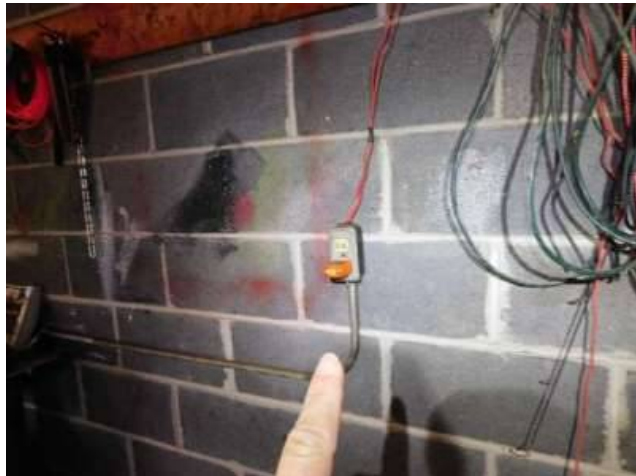
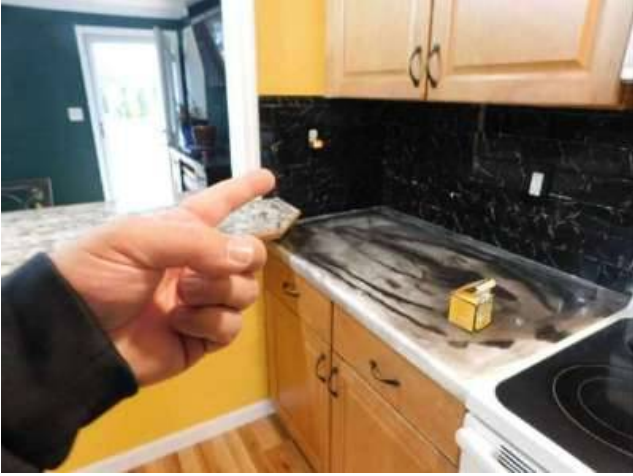
46) Material Defect/Safety, Replace, Evaluate - One or more electric receptacles (outlets) at the kitchen, garage, and exterior had no visible ground fault circuit interrupter (GFCI) protection. If not GFCI-protected, receptacles in wet areas pose a shock hazard. Required that a licensed electrician evaluate and install GFCI protection if necessary and per standard building practices. General guidelines for GFCI-protected receptacles include the following locations:

The age of the structure may predate all or portions of these requirements. The inspector recommends having a licensed electrician install GFCI protection as an upgrade to any circuits where there is a higher potential for electrical shock and GFCI protection does not currently exist. National electrical standards currently require that all outlets that serve the kitchen countertop surfaces be GFCI protected REGARDLESS of their proximity to a sink. Lack of GFCI protection where currently required is a safety issue for the occupant.
