Regal Home Inspections, LLC

SAMPLE Property Inspection Report

Property address: **Locust Ln.**

Inspection date: **Monday, December 9, 2024**

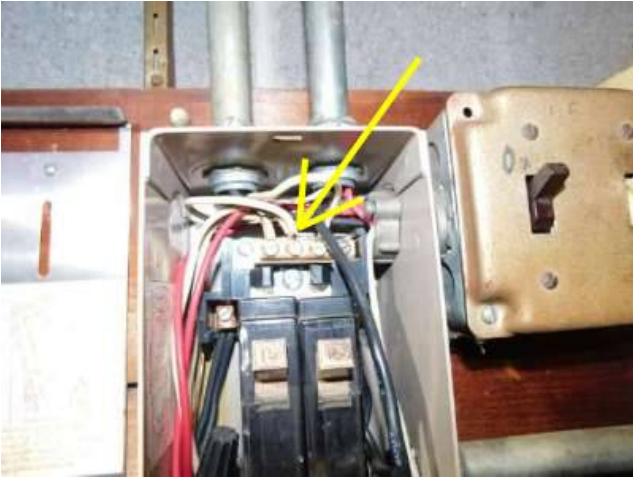
47) Material Defect/Safety, Replace - Neutral wires were doubled or bundled together under the same lug on the neutral bus bar in panel(s) A & B. This is a potential safety hazard in the event that one of the circuits needs to be isolated during servicing. For one neutral to be disconnected, other neutrals from energized circuits sharing the same lug will be loosened. Power surges may result on the energized circuits and result in damage or fire. Also, multiple wires under the same lug may not be secure, resulting in loose wires, arcing, sparks and fire. Required that a licensed electrician repair per standard building practices.

Photo 47-1 Panel B seen here.

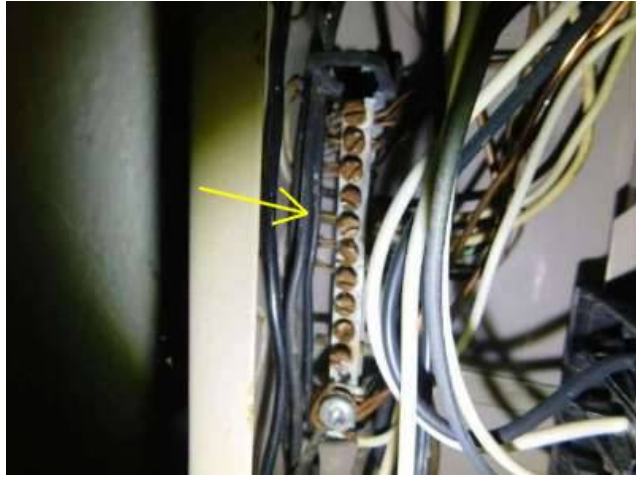
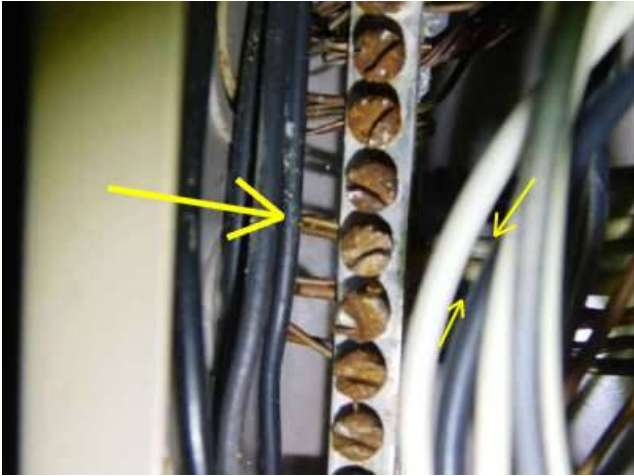
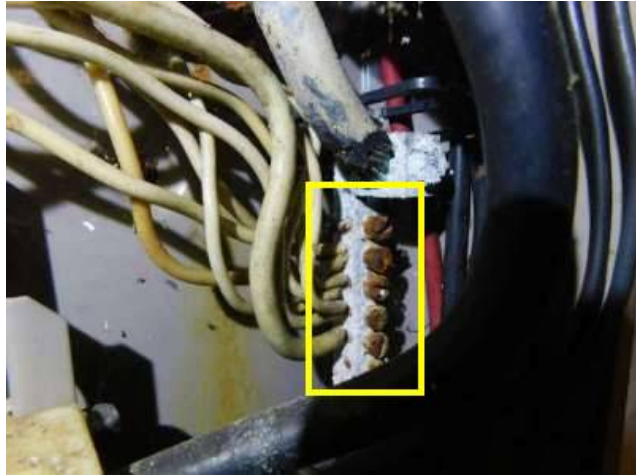
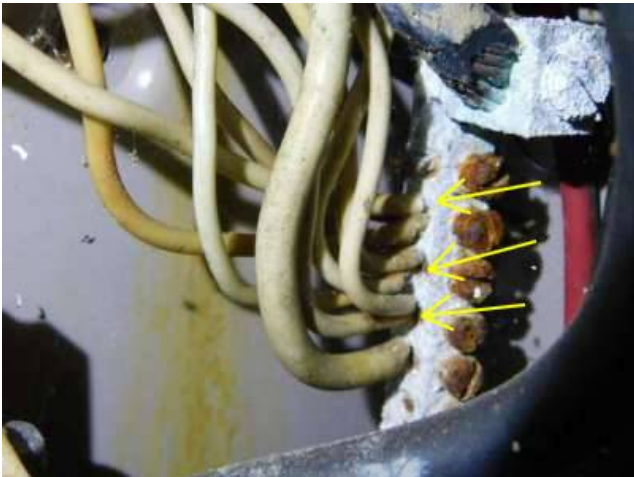
Photo 47-2 Close up of this area in the following photo. Panel A seen here and the following photos.

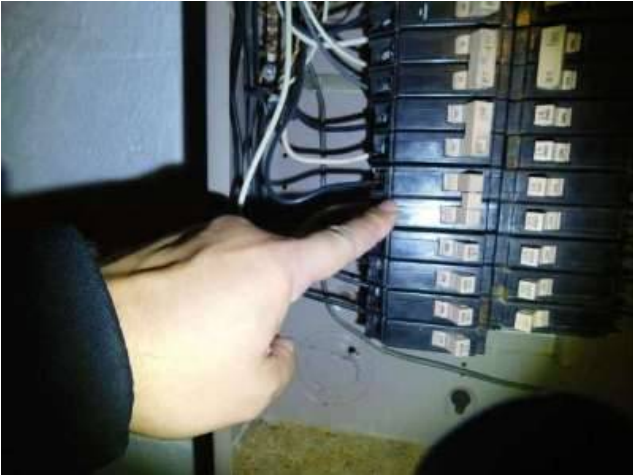
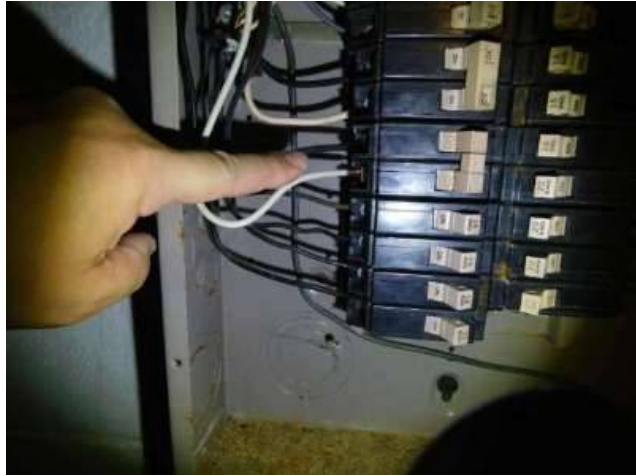
52) Material Defect/Safety, Replace - One or more branch circuit wires in panel(s) A appeared to be undersized for their circuit breaker. This is a potential fire hazard. Required that a licensed electrician repair as necessary.

There is a wire feeding a fifty amp breaker that appears to be the same size as nearby wiring for a thirty amp breaker. The wiring for the fifty amp breaker may be undersized.

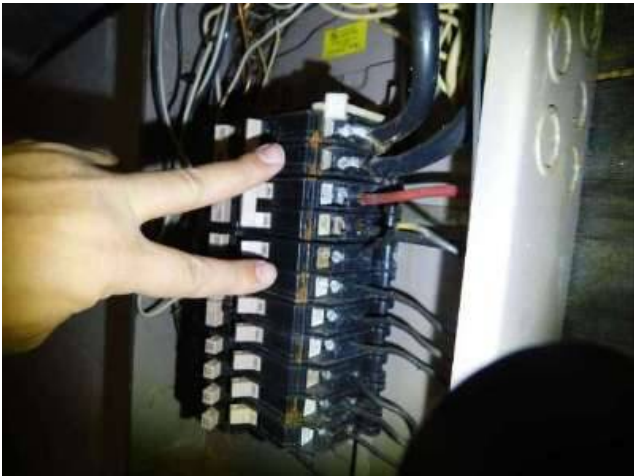
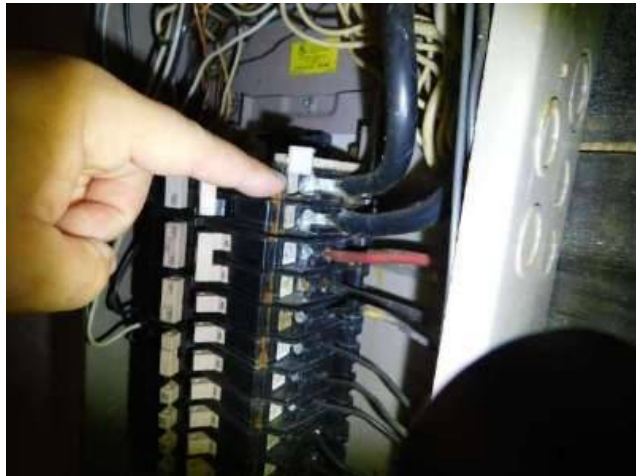
54) Material Defect/Safety, Replace - The electrical panel shows signs of moisture intrusion, as evidenced by rust and corrosion on its components. This is a significant concern because moisture can compromise the integrity of the electrical system, leading to potential failures or even hazardous conditions such as electrical shorts or fires. Corrosion can also degrade connections, reducing the panel's ability to function safely and effectively. Requires that a licensed electrician thoroughly evaluate the panel to determine the extent of the damage and recommend appropriate repairs or replacement. Additionally, steps should be taken to identify and address the source of the moisture to prevent future issues.

Some examples are shown below.

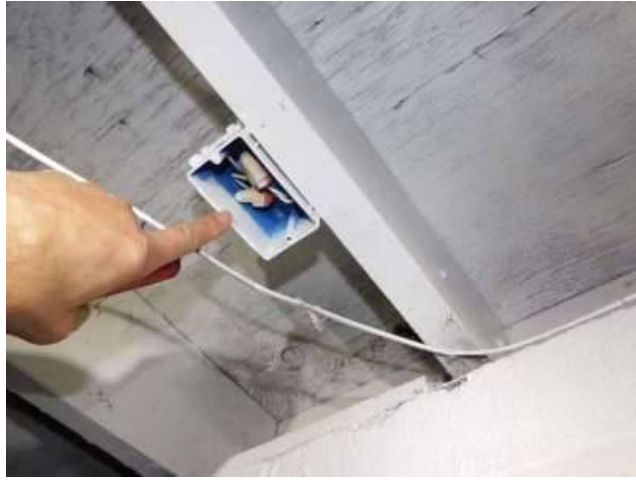
Photo 56-2

56) Material Defect/Safety, Repair/Maintain/Service - Numerous cover plates for switches, receptacles (outlets) or junction boxes were missing or broken. Examples are shown. Potentially other exist but were obscured on this day. These plates are intended to contain fire and prevent electric shock from occurring due to exposed wires. Required that a licensed electrician install cover plates where necessary.

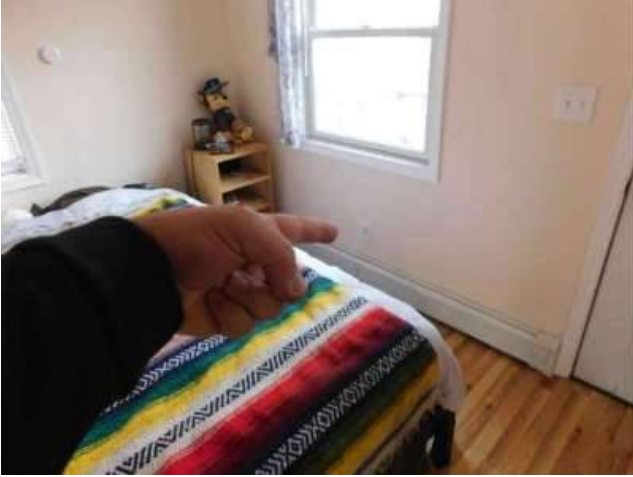
Photo 57-1

57) Material Defect/Safety, Evaluate - 2-slot receptacles (outlets) rather than 3-slot, grounded receptacles were installed in one or more areas. These do not have an equipment ground and are considered unsafe by today's standards. Appliances that require a ground should not be used with 2-slot receptacles. Examples of such appliances include computers and related hardware, refrigerators, freezers, portable air conditioners, clothes washers, aquarium pumps, and electrically operated gardening tools. The client should be aware of this

limitation when planning use for various rooms, such as an office. Upgrading to grounded receptacles typically requires installing new wiring from the main service panel or sub-panel to the receptacle(s), in addition to replacing the receptacle(s). Consult with a qualified electrician about upgrading to 3-wire, grounded circuits.

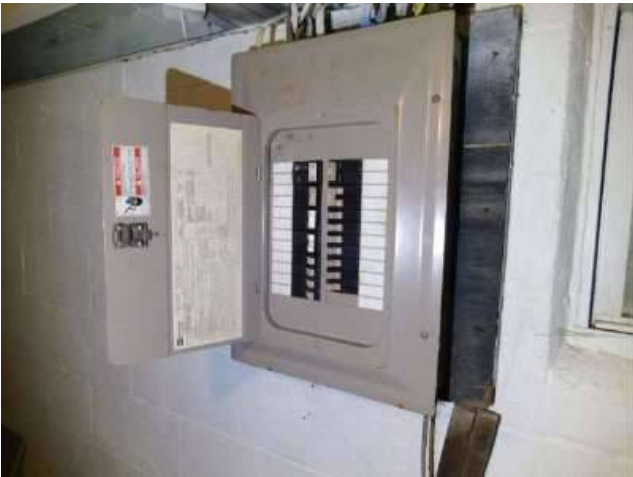
Photo 58-1

58) Repair/Maintain/Service, Evaluate - The legend for circuit breakers in panel(s) A was incomplete. This is a potential shock or fire hazard in the event of an emergency when power needs to be turned off. Recommend correcting the legend so it's accurate, complete and legible. Evaluation by a qualified electrician may be necessary.

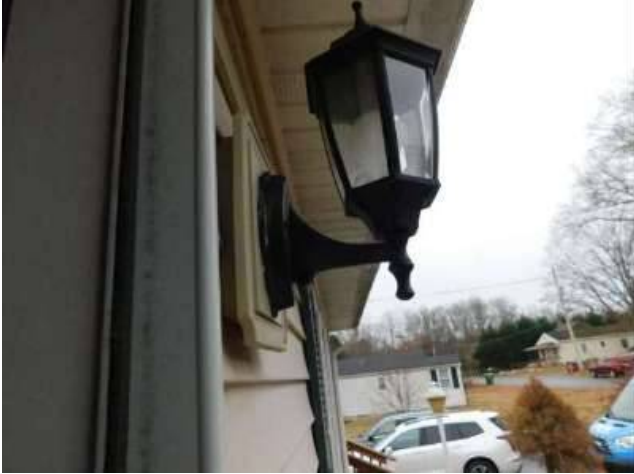
Photo 61-1

61) Evaluate - One or more light fixtures were inoperable (didn't turn on when nearby switches were operated). Recommend further evaluation by replacing bulbs and/or consulting with the property owner. If replacing bulbs doesn't work and/or no other switch(es) can be found, then recommend that a licensed electrician evaluate and

repair or replace light fixtures as necessary.

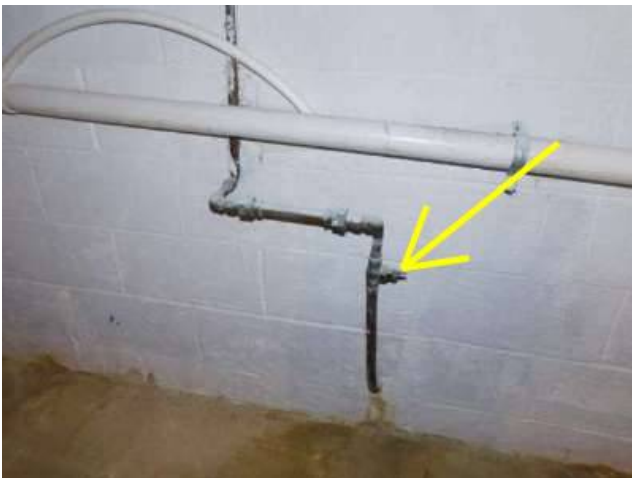
Photo 63-1

63) Replace - The main water shut-off valve handle was missing or damaged. It is especially important to be able to reliably operate the main water shut-off valve in an emergency, such as when a supply pipe bursts. Required that a licensed plumber repair as necessary.

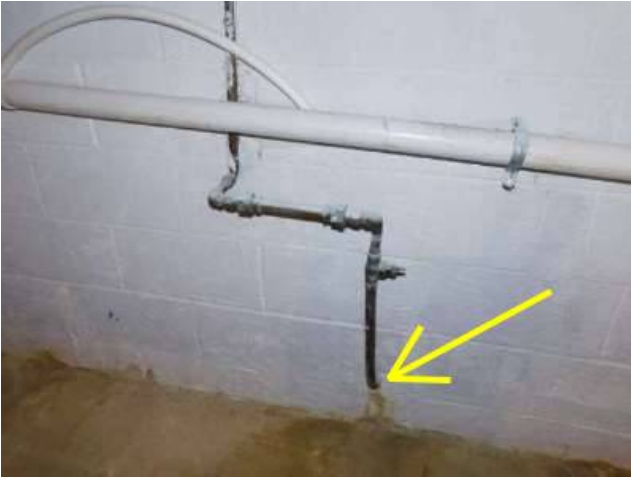
Photo 64-1

64) Repair/Maintain/Service - The copper water service pipe was embedded in concrete or masonry where it was routed through the foundation, and no protection from damage due to thermal expansion was visible. Copper pipes embedded in concrete or masonry should be wrapped with an approved tape or installed through a sleeve for abrasion protection. Required that a licensed plumber evaluate and repair per standard building practices as that professional deems necessary.

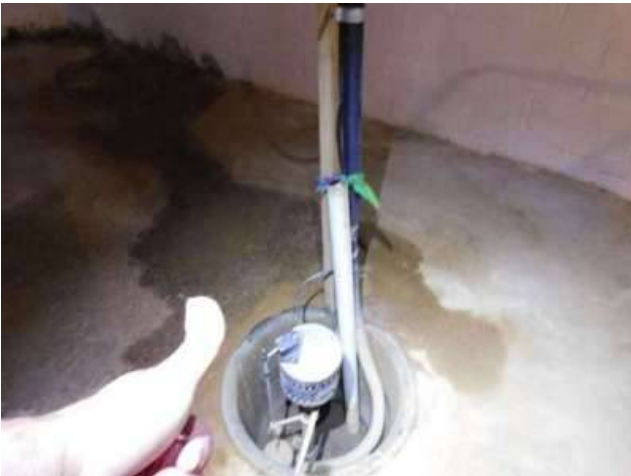
Photo 65-1

65) Evaluate, Comment/FYI - A sump pump was installed in the basement. These are specialty systems and only a limited evaluation was performed as part of this inspection. The inspector does not determine the adequacy of sump pumps and their associated drainage systems. The presence of a sump pump may indicate that water routinely accumulates below or inside the structure. Recommend asking the property owner how often the sump pump operates and for how long at different times of the year. The client should be aware that the service life of most sump pumps is 5-7 years, and that the pump may need replacing soon depending on its age and how often it operates.

Therefore, the client is urged to have a licensed plumber service the sump pump as soon as possible after taking ownership of the house. Failure to do so may result in flooding if the pump isn't in working order.

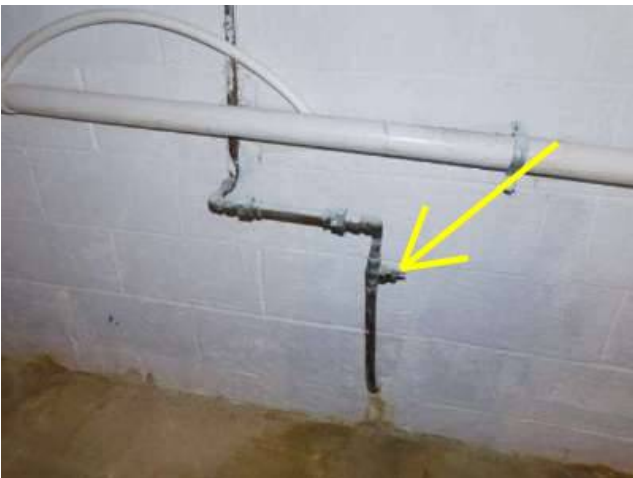
Photo 68-1

68) Comment/FYI - Water meter and main water shut off.

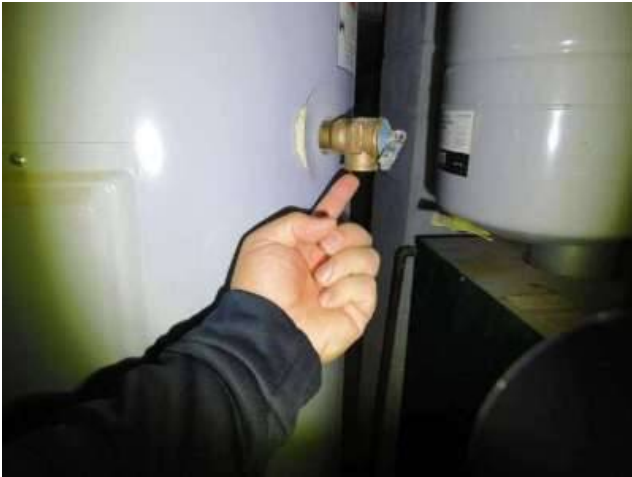
Photo 69-1

69) Material Defect/Safety, Replace - No drain line was installed for the temperature-pressure relief valve. This is a potential safety hazard due to the risk of scalding if someone is standing next to the water heater when the valve opens. Required that a licensed plumber install a drain line per standard building practices.

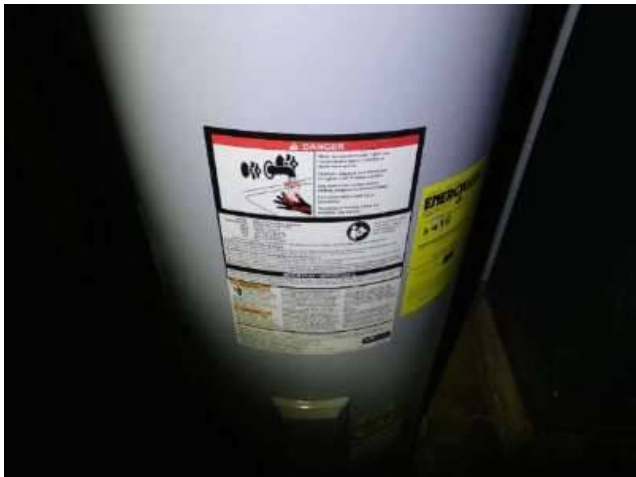
70) Material Defect/Safety, Maintain - The hot water temperature was greater than 120 degrees Fahrenheit. This is a safety hazard due to the risk of scalding. The thermostat **MUST** be adjusted so the water temperature doesn't exceed 120 degrees.

Photo 70-1 Warning label seen on the water heater regarding hot temperatures.

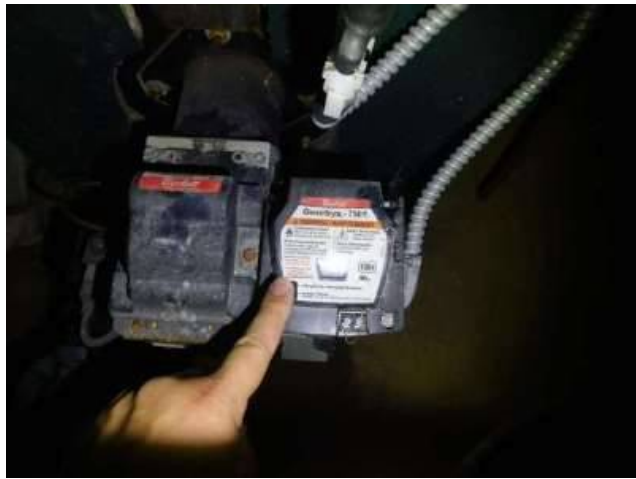
74) Material Defect/Safety, Replace, Evaluate - The boiler did not respond to normal controls (thermostat). It appeared to be inoperable. The inspector was only able to perform a limited evaluation. If possible, consult with the property owner and/or review documentation on this system. Required that a licensed and qualified HVAC contractor evaluate and repair as necessary.

Photo 74-2 The light on this part of the boiler was blinking.

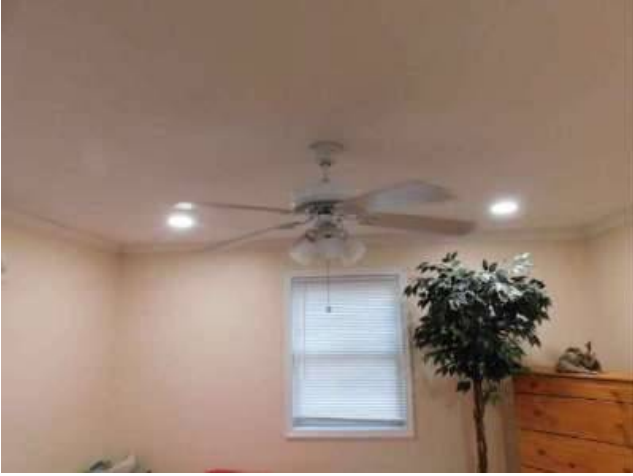
Photo 75-1

75) Material Defect/Safety, Repair/Maintain/Service - One or more ceiling fans were installed so the blades were less than 7 feet from the floor. This is a safety hazard. Required that a qualified contractor repair as necessary so blades are at least 7 feet off the floor (8 feet is better). For optimal air flow, ceiling fans should be installed at least 8-9 feet above the floor. If unable to repair so blades are at this height, then remove the fan(s).

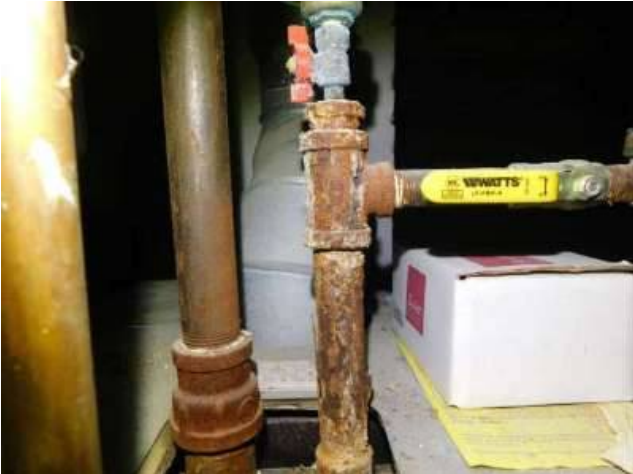
Photo 76-1

76) Replace, Repair/Maintain/Service, Evaluate - Corrosion or rust was found in one or more distribution supply pipes and/or fittings. This can indicate past leaks, or that leaks are likely to occur in the future. Required that a licensed and qualified HVAC contractor or plumber evaluate and repair or replace as necessary.

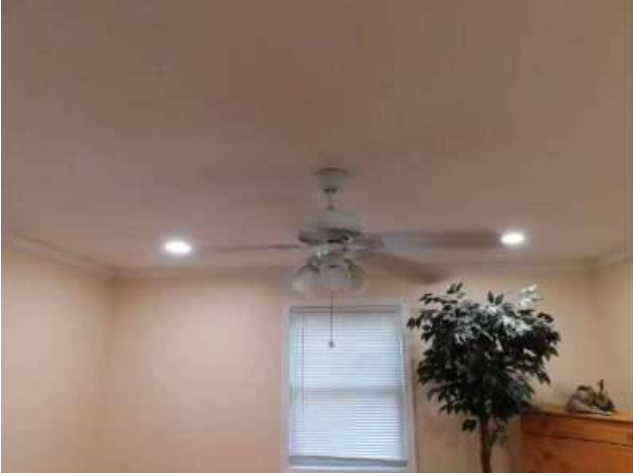
Photo 77-1

77) Replace, Repair/Maintain/Service - One or more ceiling fans wobbled excessively during operation. This is a potential safety hazard and may be caused by loose fasteners, blades, rod-fan body junction, the fan itself being loose, or bent, misaligned or unbalanced blades. Required that a qualified person repair or replace as necessary.

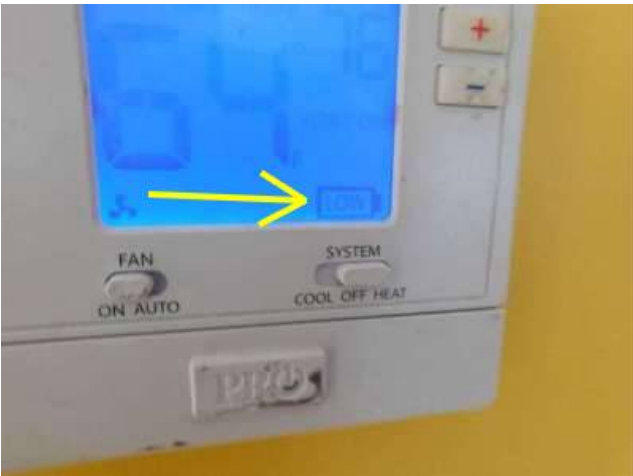
Photo 79-1

79) Repair/Maintain/Service - The digital display on the thermostat was dim or displayed readings in a substandard way. This may be caused by a low or dead battery. The batteries should be replaced. If this condition persists after replacing the batteries, then recommend that a qualified HVAC contractor evaluate and repair or replace as necessary.

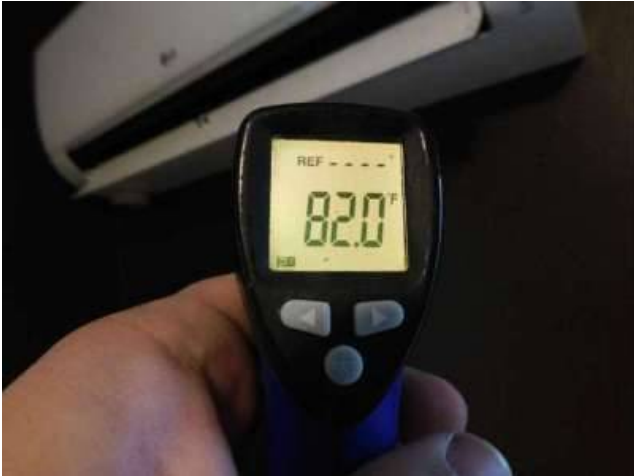
Photo 81-1

81) Comment/FYI - There were no thermostats or remote controls found for the minisplit units. The minisplits were not directly operated or adjusted by the inspector. They both appeared serviceable.

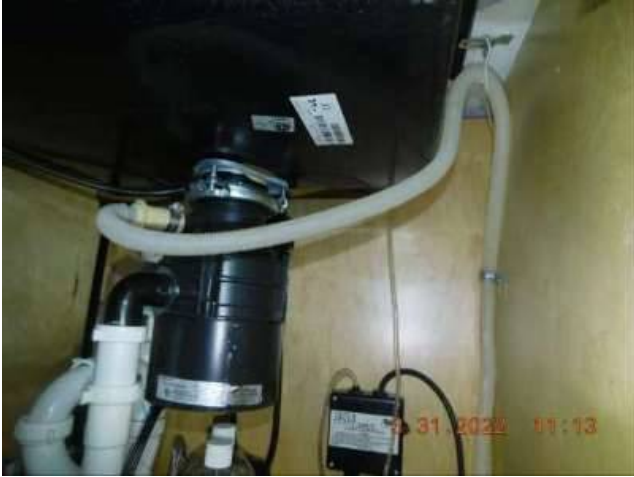
Photo 82-1

82) Repair/Maintain/Service, Evaluate - No high loop or air gap was visible for the dishwasher drain. A high loop is created by routing the drain line up to the bottom surface of the countertop above and securely fastening it to that surface. An air gap is a device that makes the drain line non-continuous. Both of these prevent waste-water backflow from entering the dishwasher, and possibly flooding out of the dishwasher if/when a siphon occurs. Some newer dishwashers have these devices built in. The client should try to determine if these

devices are built into this brand and model of dishwasher (e.g., review installation instructions). If not, or if this cannot be determined, then required that a qualified contractor install a high loop and air gap per standard building practices.

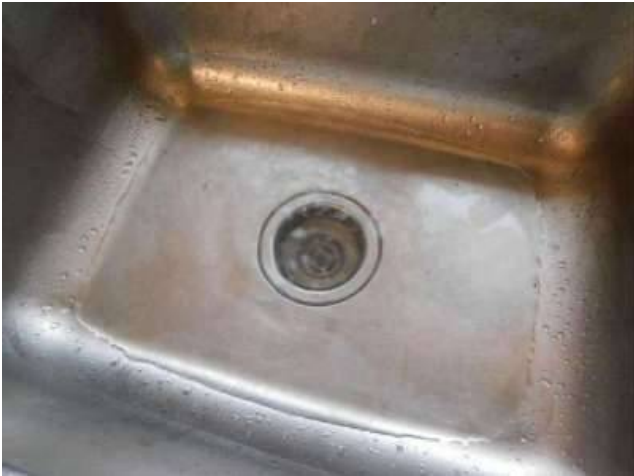
Photo 83-1

83) Repair/Maintain/Service - The sink drained slowly. Required clearing drain and/or having a qualified plumber repair if necessary.

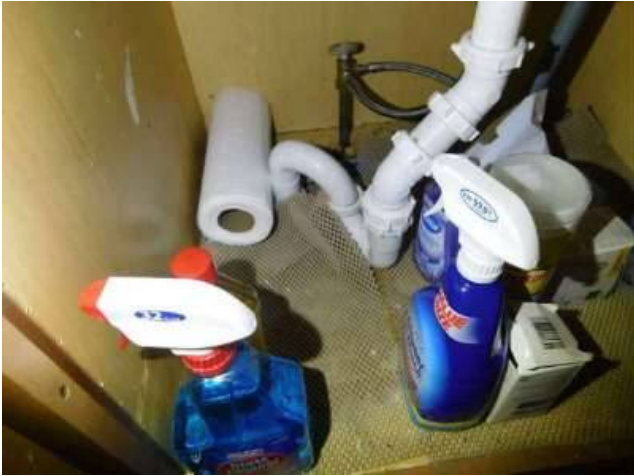
Photo 84-1

84) Repair/Maintain/Service - The kitchen sink drainpipe used an S-trap rather than a P-trap. Siphons and sudden flows of water in S-Traps can drain all the water out of the trap, leaving it dry. Sewer gases can then enter living areas. A solution is an Air Admittance Valve (AAV) installed by a licensed plumber. An AAV (The part itself) is an inexpensive part (\$30 at Home Depot) and can provide the same functionality as an actual plumbing vent when a vent through the roof is not possible. Requires consulting a licensed plumber to have repaired.

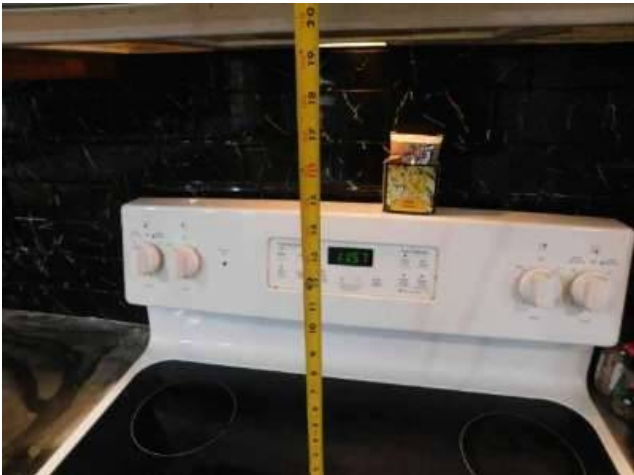
Photo 85-1

85) Repair/Maintain/Service - The clearance between the stove top and the base of the exhaust hood above was too low. While the recommended height varies per the hood manufacturer, standards usually call for a minimum of 24 inches of clearance. A low hood height can restrict visibility of the stove top. Required that a qualified contractor repair per standard building practices.

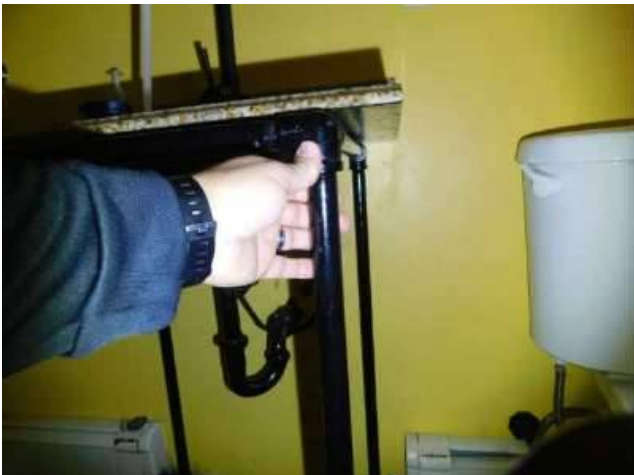
Photo 89-1

89) Repair/Maintain/Service - One or more vanities or cabinets at location(s) A were not securely fastened to the wall. An adequate number of appropriate fasteners should be used. For wall-hung cabinets, inadequate fasteners can pose a safety hazard if cabinets fall. Recommend that a qualified person repair as necessary.

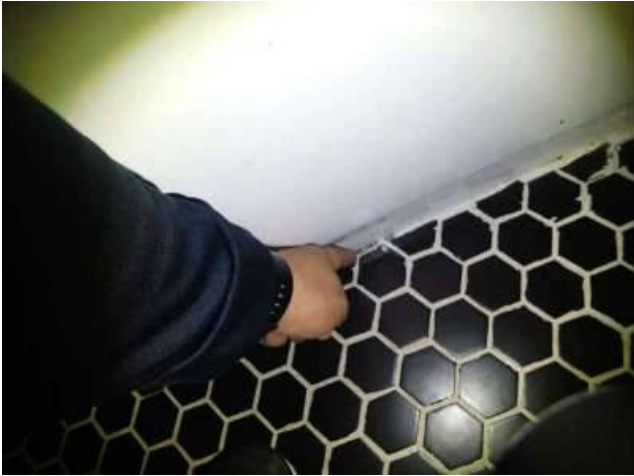
Photo 90-1

90) Repair/Maintain/Service - Gaps, no caulk, or substandard caulking were found between the bathtub and the floor at location(s) A. Water may penetrate these areas and cause damage. Recommend that a qualified person re-caulk or install caulking as necessary.

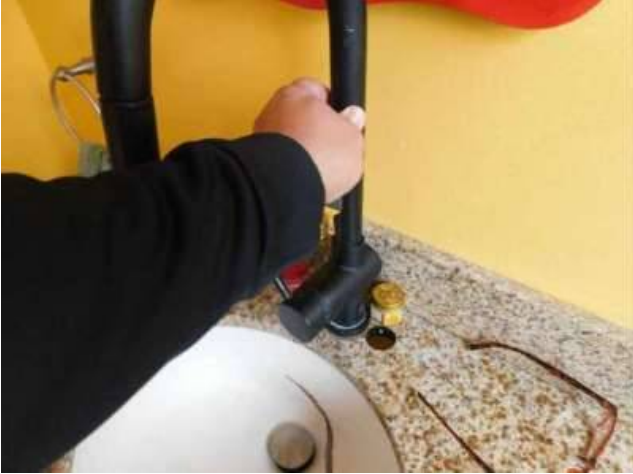
Photo 92-1

92) Repair/Maintain/Service - The faucet at location A is loose. Leaks may occur as a result. Recommend it

be secured or fastened by a licensed and qualified plumber.

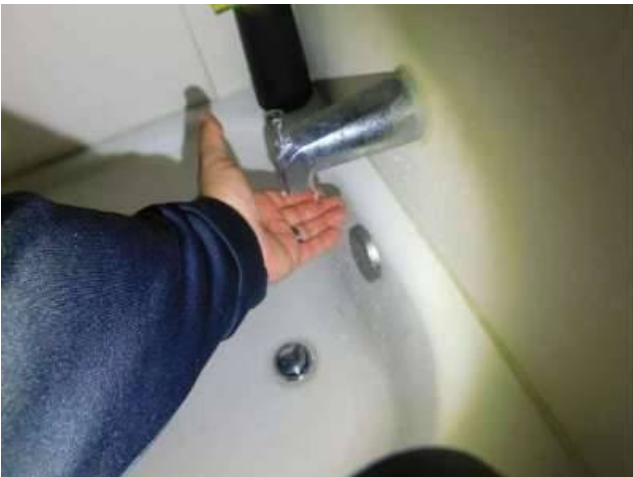
Photo 93-1

93) Repair/Maintain/Service - The diverter for the tub at location A does not fully divert water to the showerhead. This can increase water or utility usage and energy costs and also decrease water pressure. Requires that it be repaired or replaced as necessary by a qualified contractor.

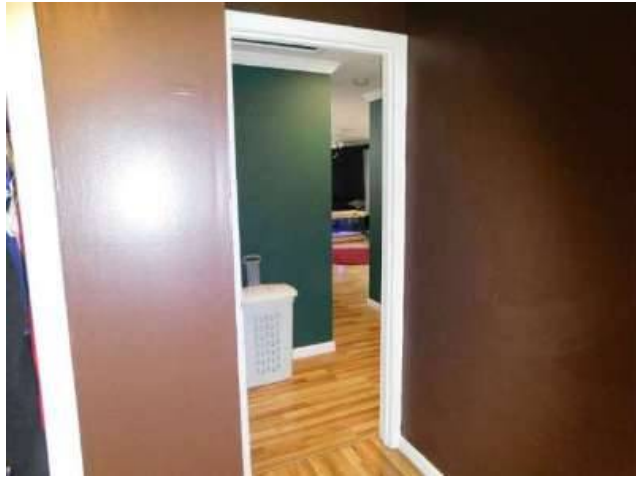
Photo 97-2

97) Replace - One or more interior doors were missing. Required that a qualified person replace or repair doors as necessary.

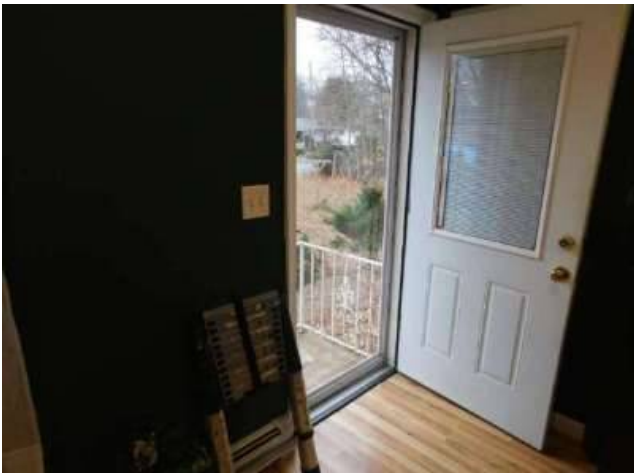
Photo 98-1

98) Repair/Maintain/Service - Some exterior door hardware, including pistons were missing from the storm door. Required that a qualified person repair or replace as necessary. The pistons can be purchased at Home Depot or Lowes and can easily be added by a qualified handyman.

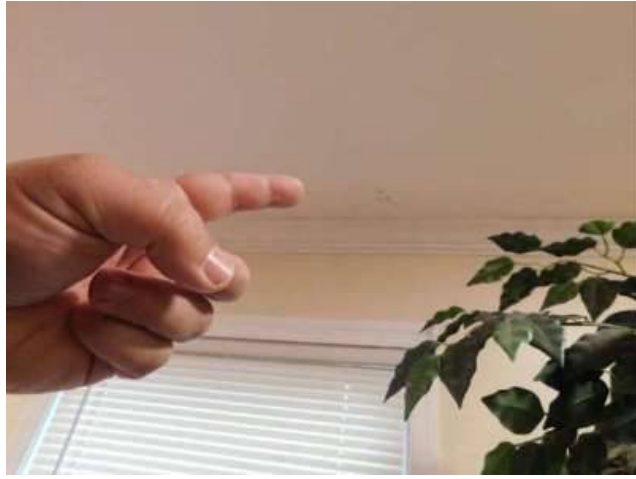
Photo 99-2

99) Repair/Maintain/Service - Cracks, nail pops and/or blemishes were found in walls and/or ceilings in one or more areas. Cracks and nail pops are common, are often caused by lumber shrinkage or minor settlement, and can be more or less noticeable depending on changes in humidity. Required that the client have a qualified contractor, such as a painting contractor, repair for aesthetic reasons.
