Regal Home Inspections, LLC

Property Inspection Report

Property address: **Holmdel, NJ 07733**

Inspection date: **Friday, November 16, 2018**

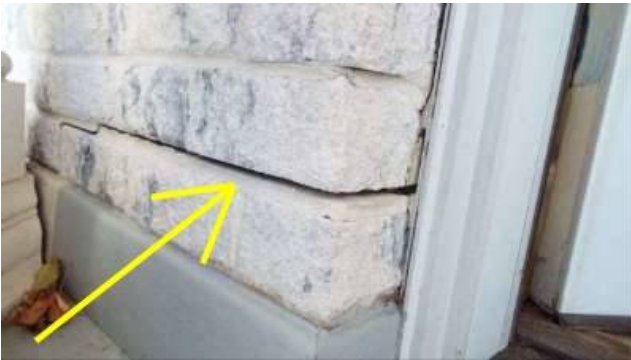
Photo 9-5

The cracks seen at the balcony (Photos 9 - 4, 5, & 6) could indicate that the structural elements (header) spanning the opening may be sagging. This specific area is the reason for the "Material Defect" classification. Recommend evaluation by a structural engineer and repair as that professional deems necessary.

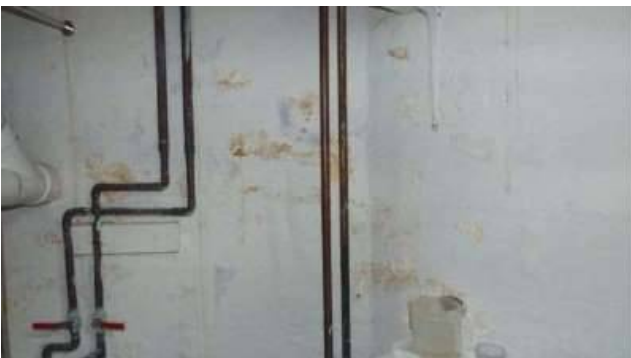
**Photo 12-3**

12) Comment/FYI - Efflorescence was found on the basement wall. Efflorescence are minerals that are drawn from the concrete materials. When there is excessive moisture outside the basement wall, the moisture naturally moves toward areas of lower humidity (on the inside of the basement wall). As the moisture moves through the masonry materials it draws the minerals, calcium and salts, from the masonry materials. As the moisture evaporates on the inside, it leaves behind the calcium and salts.

This is not necessarily a problem but rather a symptom of too much moisture on the outside. This can be due to poor drainage, slope or grading of the soil so that rain water flows toward the house, not away from it. It could be because downspouts and downspout extensions are not routing the rain water far enough from the foundation wall.

Recommend ensuring that the grading slopes water away from the house. Internal foundation wall sealants do not stop efflorescence. In fact the minerals will continue to accumulate below any finished coatings. Controlling the water outside is the best solution.

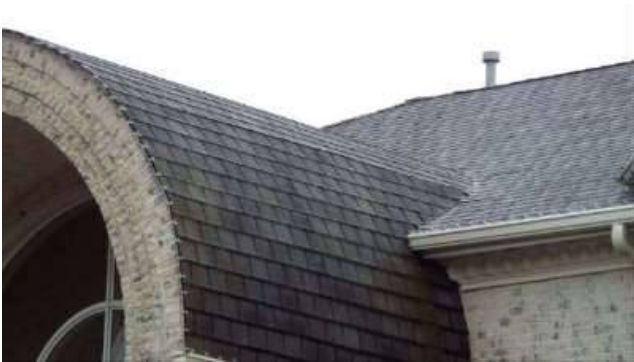
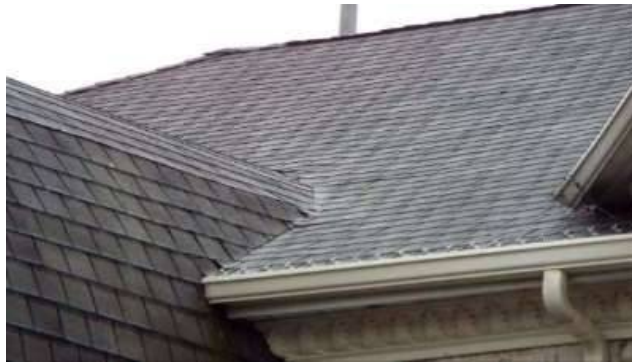
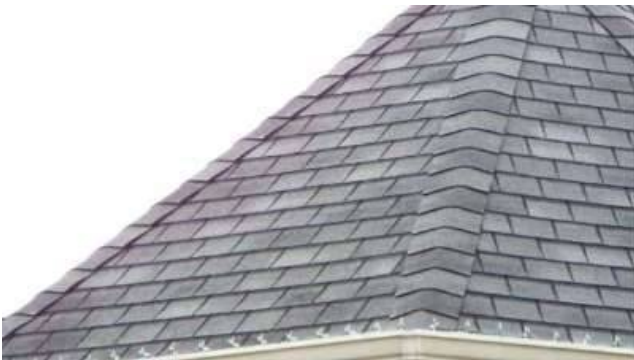
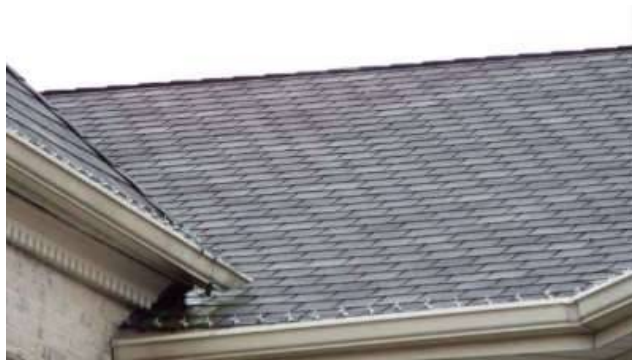
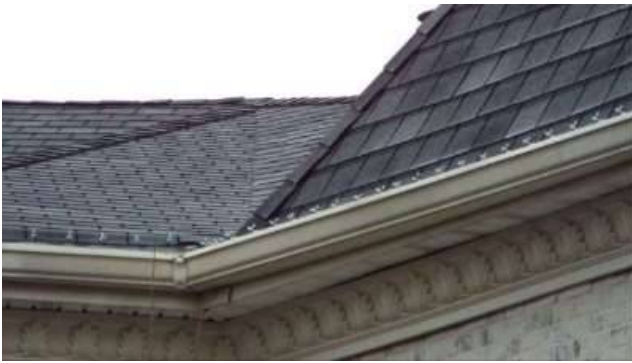
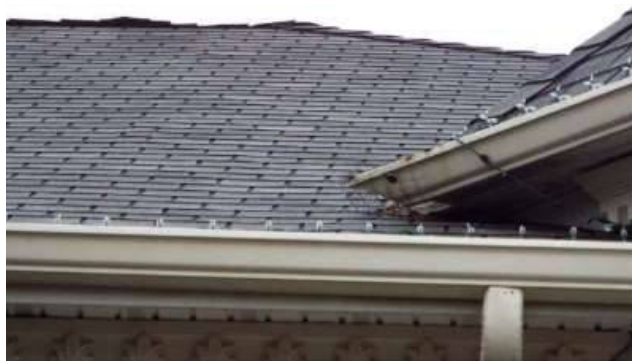
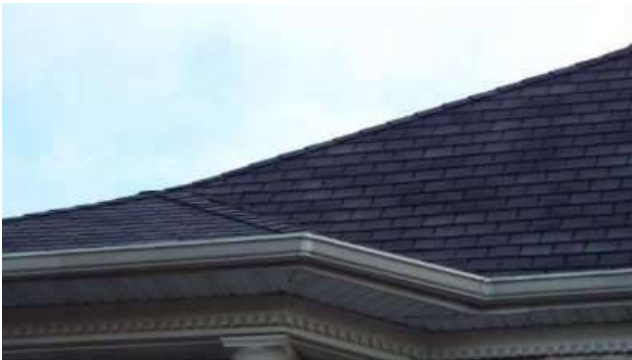
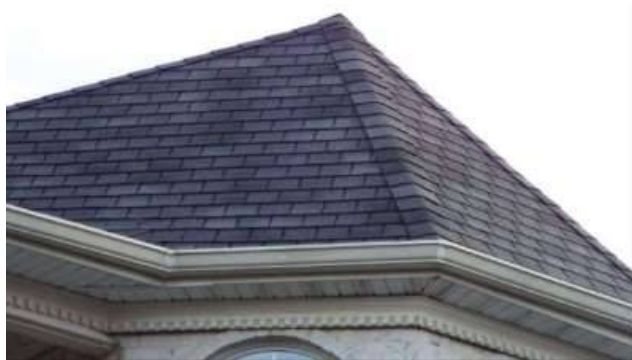
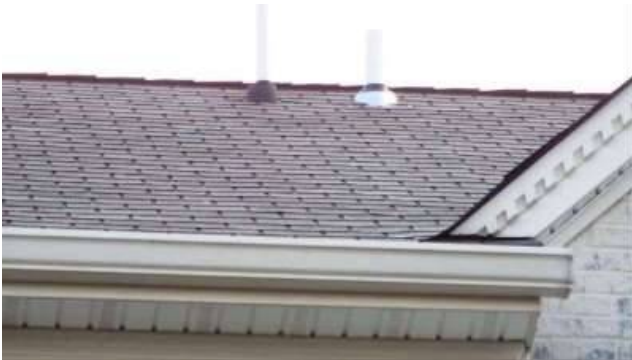
13) Comment/FYI - General roof photos.

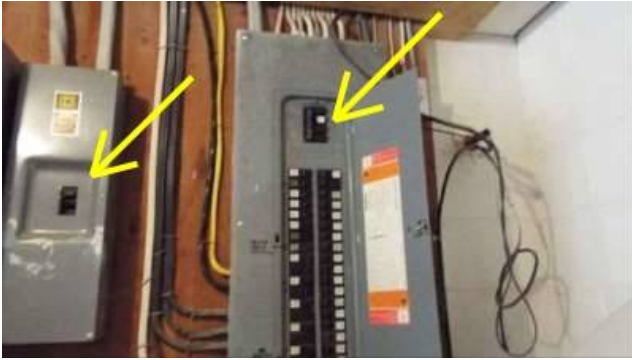
33) Comment/FYI - There were multiple, "main disconnects" seen. All of those shown below are in the garage.

Photo 33-1 There are two, 200 amp disconnects as seen here...

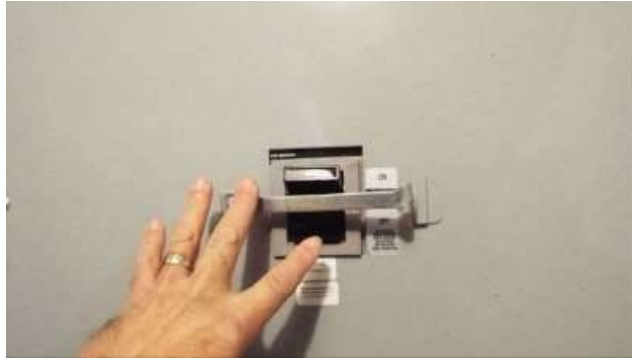
Photo 33-2 ...and a 400 amp disconnect.

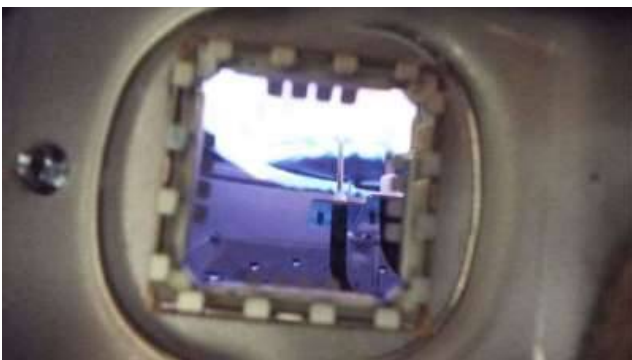
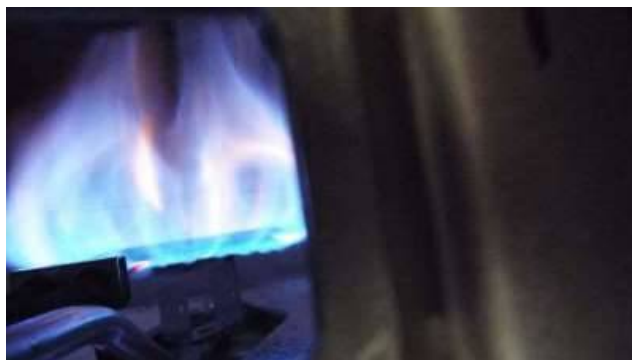
48) Comment/FYI - The water heaters' burner flame were blue in color indicating proper combustion. As seen through the water heaters' sight glasses.

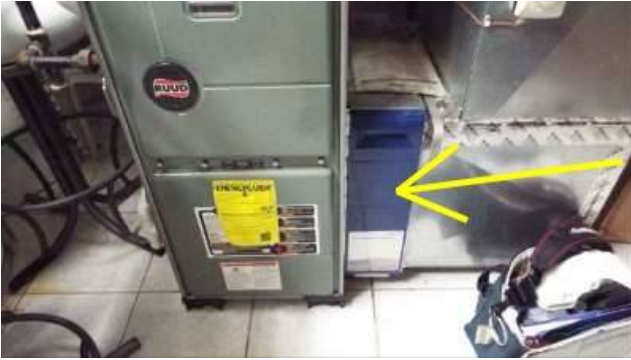
Photo 50-1 All filters are similarly located as seen here. Behind the blue, filter chamber cover.

50) Maintain - Recommend replacing or washing HVAC filters upon taking occupancy depending on the type of filters installed (disposable or reusable). Regardless of the type, recommend checking filters monthly in the future and replacing or washing them as necessary and in accordance with the filter manufacturer's instructions. How frequently they need replacing or washing depends

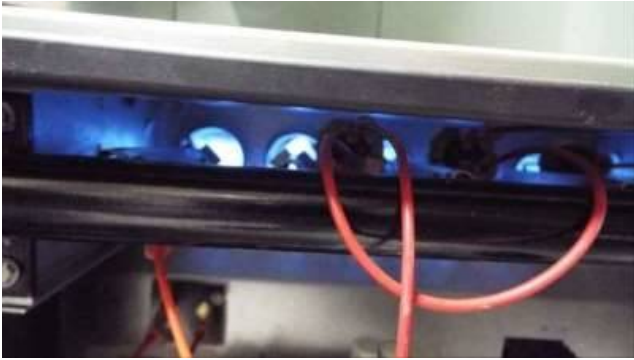
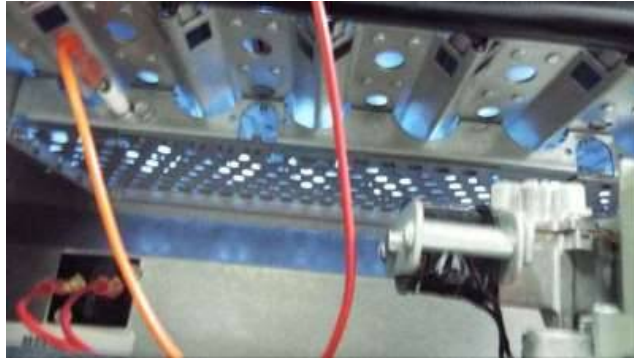
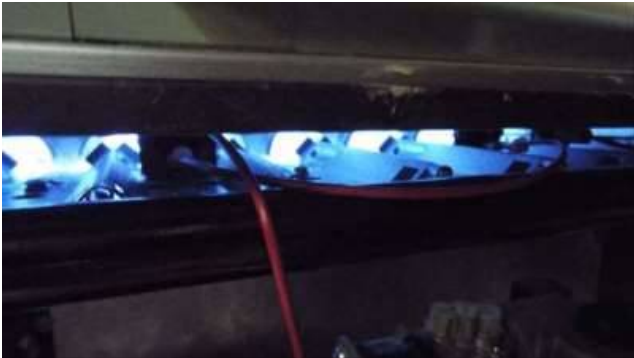
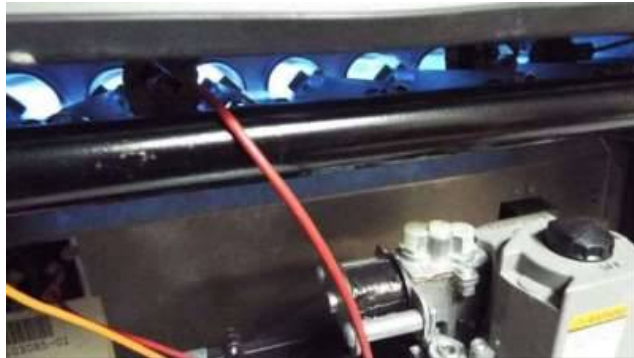
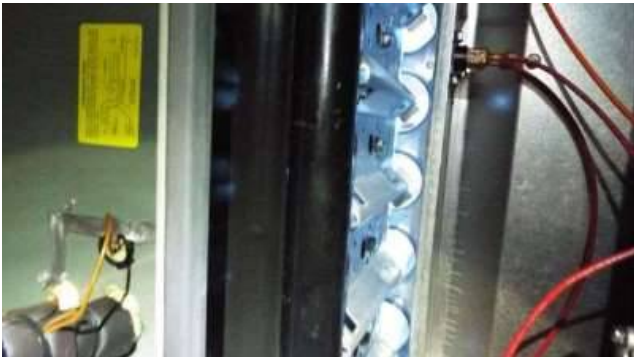
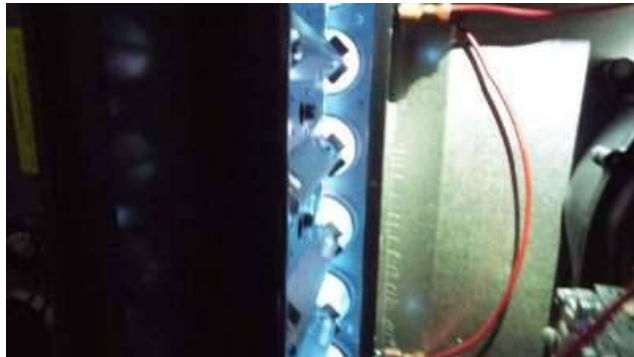
56) Comment/FYI - The furnace burner flames for all six furnaces were observed. They were all blue in color indicating proper combustion.

Photo 56-1 The first 4 are from the basement furnaces. The last 2 from the attic furnaces.

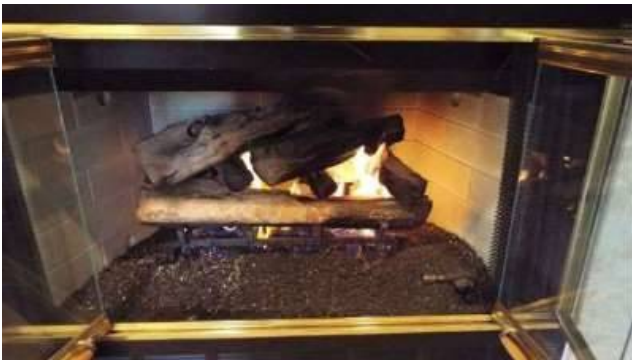
The basement fireplace, the Great Room fireplace and the 2nd floor Master fireplace all did not have a lit pilot light and were not operated. The 1st floor Master fireplace was lit.

Photo 60-1 Fireplace in the 1st floor Master was operated as seen here.

60) Evaluate - Some of the gas fireplaces were not fully evaluated because the pilot lights were off. The inspector only operates normal controls (e.g. on/off switch or thermostat) and does not light pilot lights or, "operate [gas] shut-off valves" or "operate any system or component which is shut down" in accordance with NJ home inspection laws. Recommend that the client review all documentation for such gas appliances and familiarize themselves with the lighting procedure. If necessary, a qualified specialist should assist in lighting such appliances, and make any needed repairs.

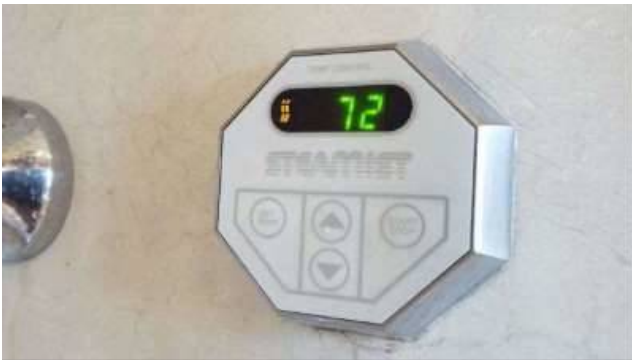
68) Comment/FYI - There's a steam generator in the 2nd floor Master bathroom's shower. Using the controls on the wall the steam generator was turned on. Steam did emerge from the steam port near the bottom of the back wall of the shower.

Photo 68-1 This is the control panel for the steam generator inside the 2nd floor Master bath shower.

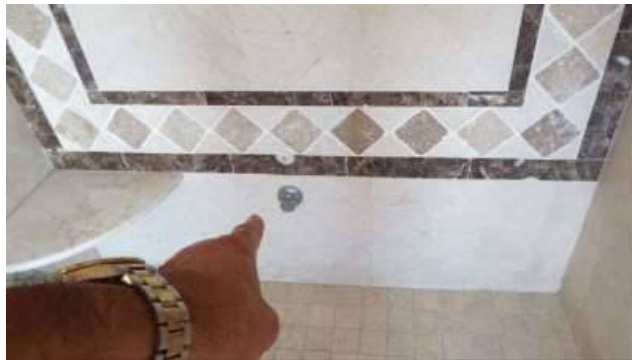
Photo 68-2 The steam emerges from this nozzle.
