## Regal Home Inspections, LLC

## Property Inspection Report

Property address: **Main St  
Anytown USA**

Inspection date: **Saturday, February 27, 2021**

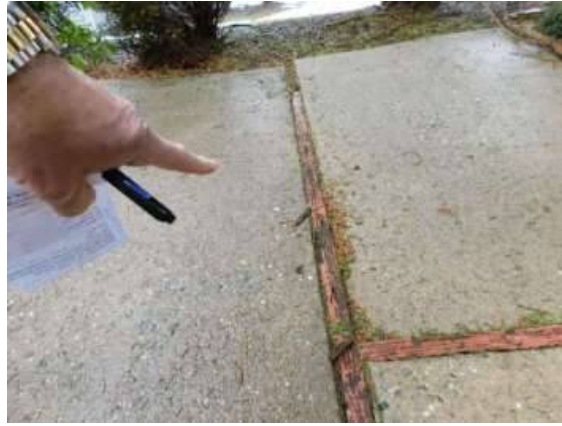
**Photo 2-2**

There were indications of carpenter ant activity and damage to wood on the back patio, some of which are very close to the house. Termite tube scarring seen in the crawl space. There was no damage seen to wood however the floor insulation restricted visibility to most of the floor joists, rim joists and sub floor.

**Photo 2-1** Carpenter ant damage seen in the wood at the patio. Here and the next 2 photos.

Highly recommend that the Termite Report, NPMA-33 provided be read, understood and acted upon with regard to any treatments, repairs or areas that may require attention (such as eliminating conditions conducive to insect activity).

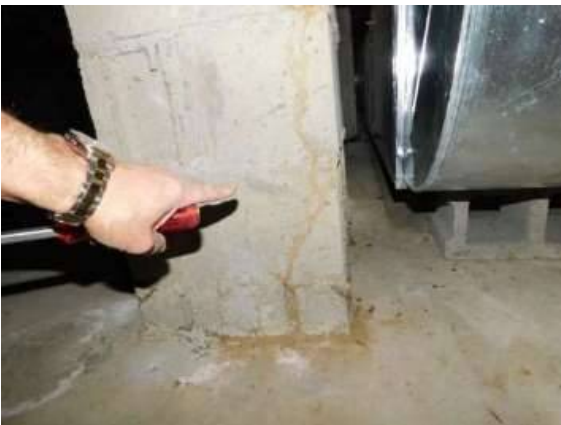
**Photo 2-5**

**Photo 2-4** Examples of termite tube scarring seen inside the crawl space. Here and the next 2 photos.

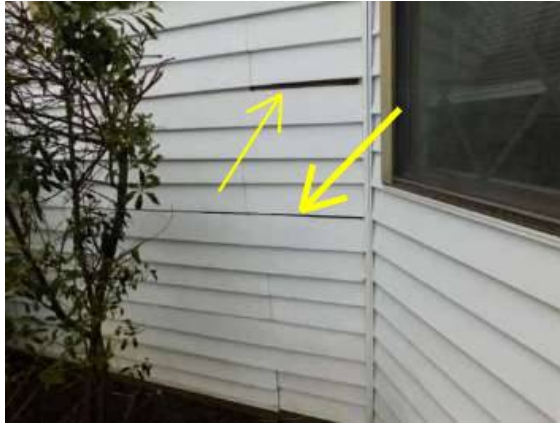
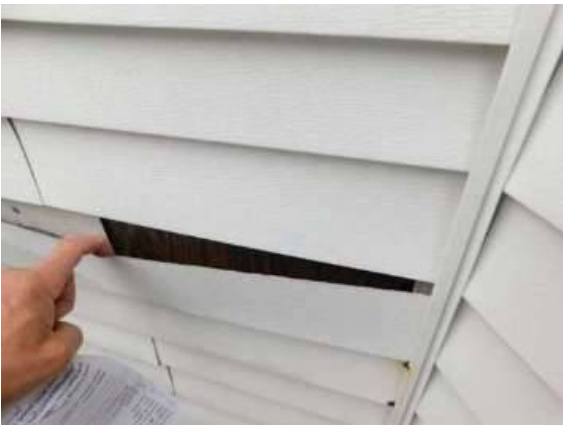
**Photo 11-1** Close up of this area in the next photos.

**Photo 11-2** Areas seen in the next 2 photos.

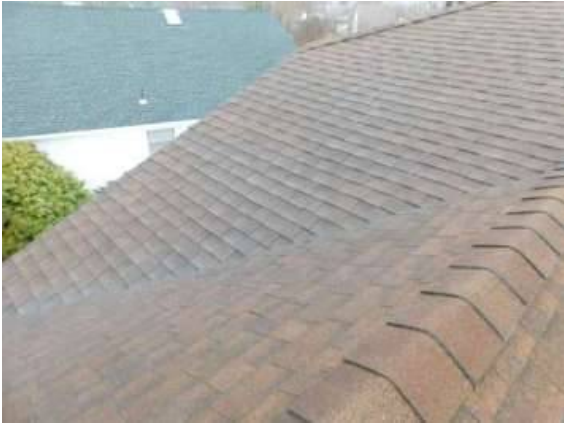
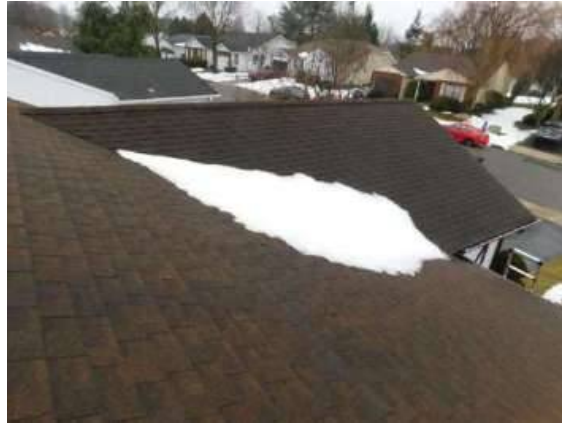
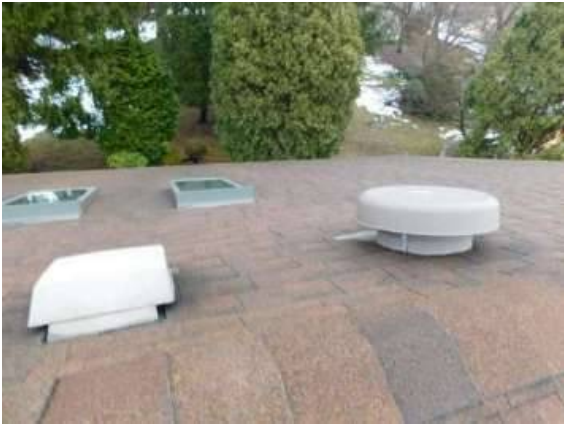
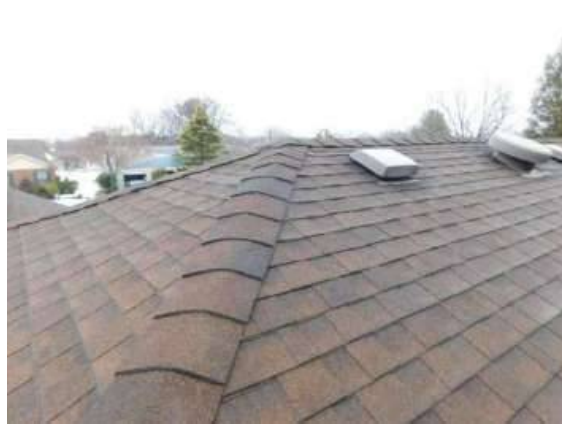
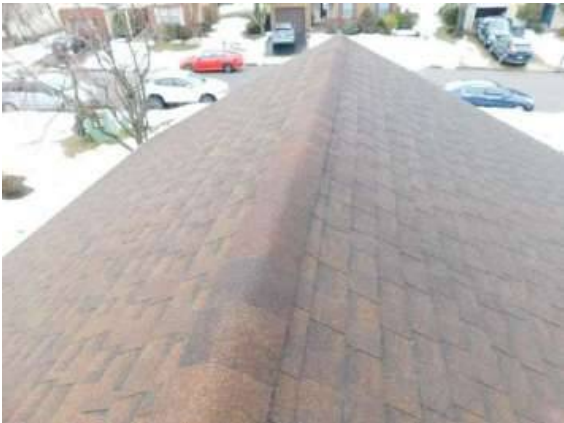
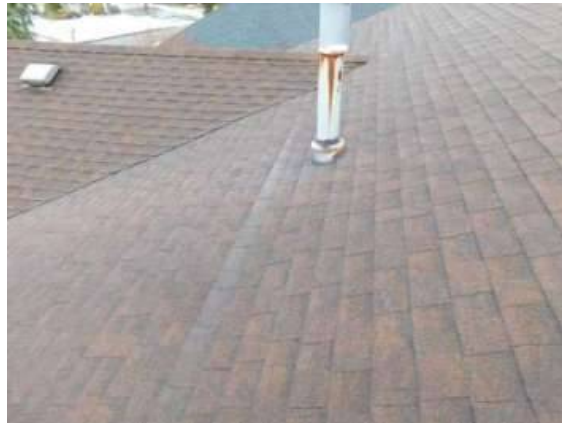
**19) Comment/FYI** - General roof photos.

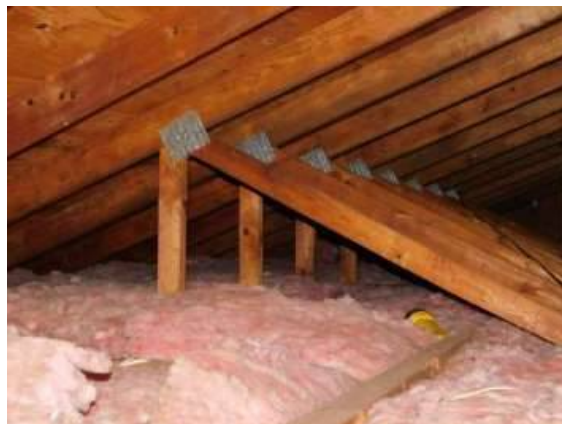
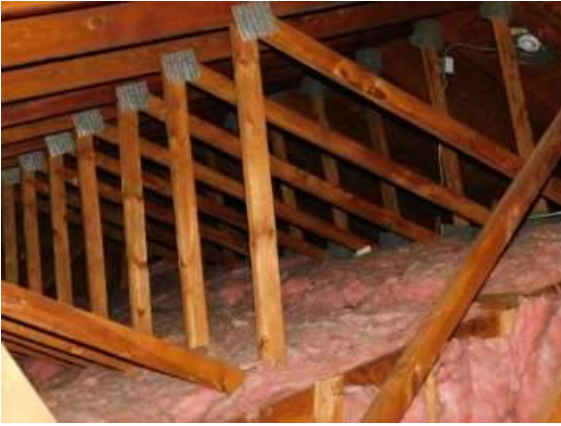
**25) Monitor** - The roof structure of this home has trusses. There is a phenomenon called truss uplift. It's explained at the link below. In essence, due to the fact that the bottom parts of the truss are embedded in insulation, in the winter, the upper parts of the trusses expand or contract differently than the truss cords embedded in the insulation. Consequently, the trusses flex. This can result in the appearance of cracks in ceilings or walls at specific times of the year due to the temperature differences between the parts of the trusses.

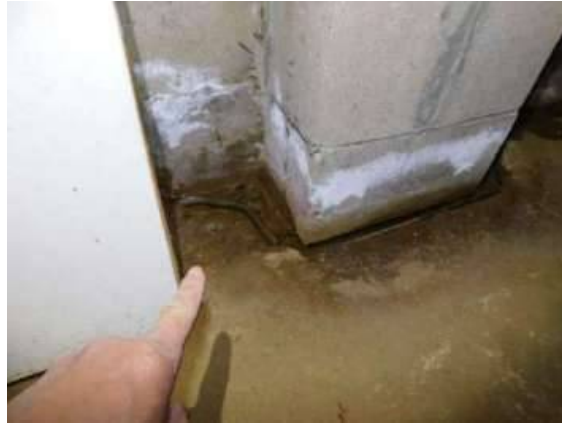
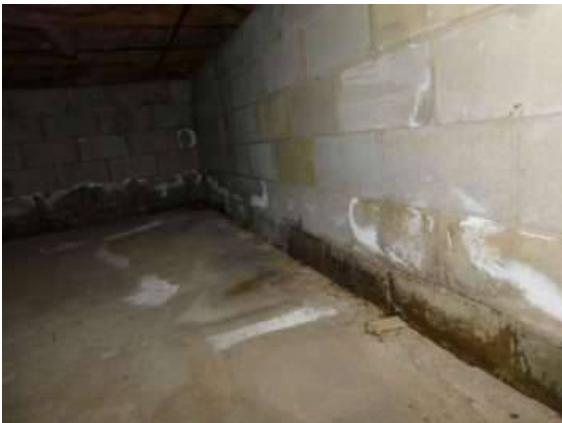
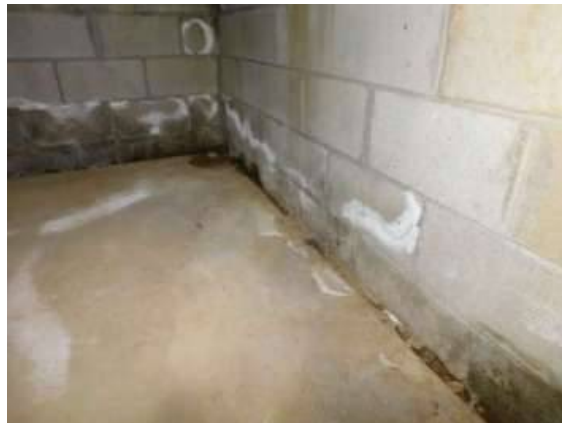
**26) Material Defect/Major, Repair/Maintain/Service, Evaluate** - High levels of moisture were found at one or more locations in the crawl space. Water from crawl spaces can evaporate and enter the structure above causing high levels of moisture in the structure. This is a conducive condition for wood-destroying organisms. While a minor amount of seasonal water is commonly found in crawl spaces, significant amounts should not be present.

Rain runoff is the most common cause of wet crawl spaces, but water can come from other sources such as groundwater or underground springs. Recommend that a qualified person correct any issues related to outside perimeter grading and/or roof drainage (see any other comments about this in this report). If standing water persists, then recommend that a qualified contractor who specializes in drainage issues evaluate and repair as necessary. Typically such repairs include:

- Repairing, installing or improving underground footing and/or curtain drains
- Applying waterproof coatings to foundation walls
- Digging trenches in the crawl space to collect or divert water
- Installing sump pumps

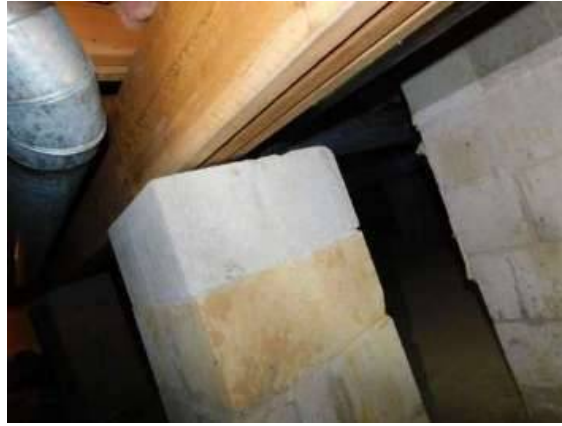
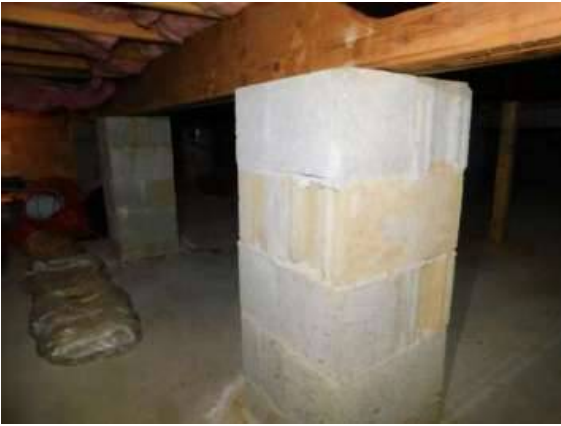
**28) Replace** - One or more support posts were not positively secured to the beam above. While this is common in older homes, current standards require positive connections between support posts and beams above for earthquake reinforcement. Recommend that a qualified contractor repair per standard building practices. For example, by installing metal plates, plywood gussets or dimensional lumber connecting posts and beams.

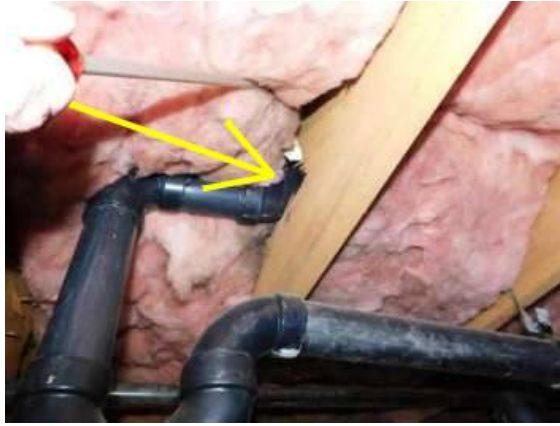
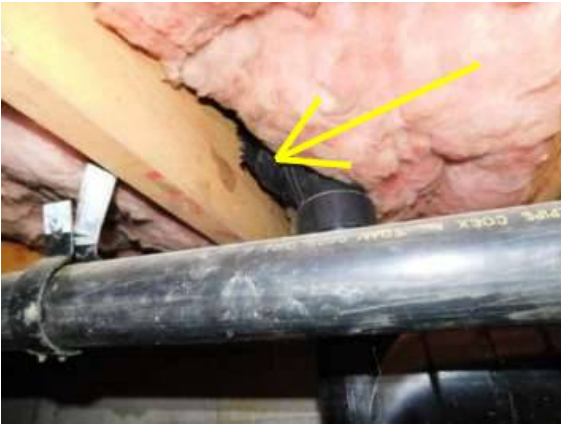
**29) Replace** - At least 3 joists under the bathrooms were notched or had holes cut in them in such a way as to significantly weaken the joist(s). General guidelines for modifying joists made of dimensional lumber include these restrictions:

Recommend that a qualified contractor evaluate and repair as necessary, and per standard building practices.

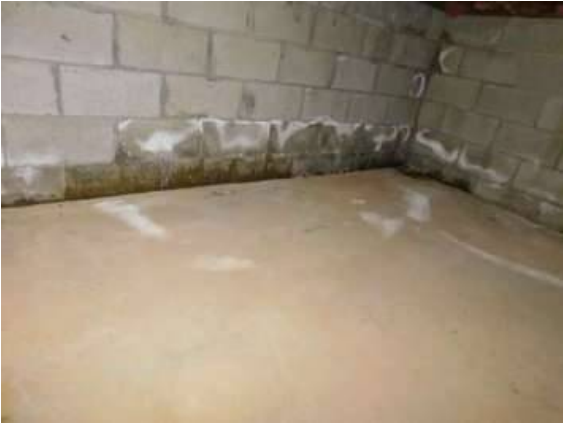
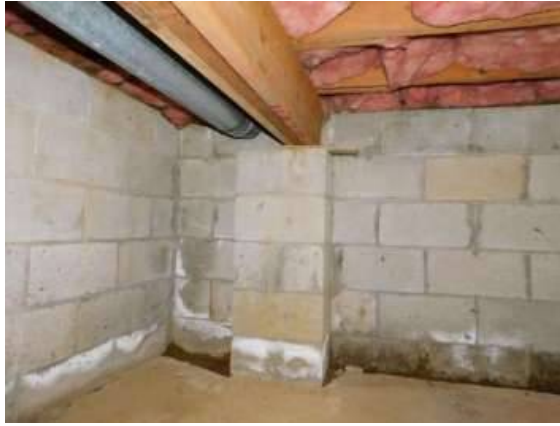
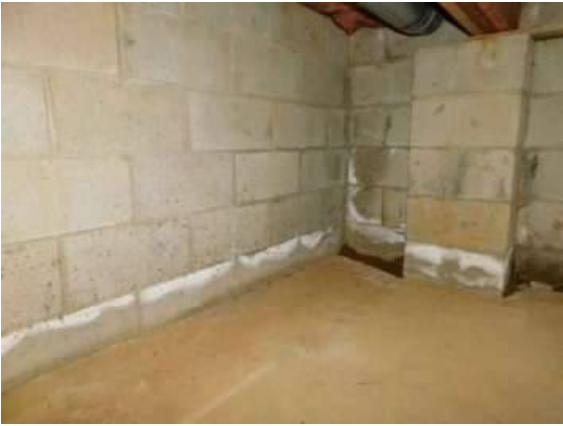
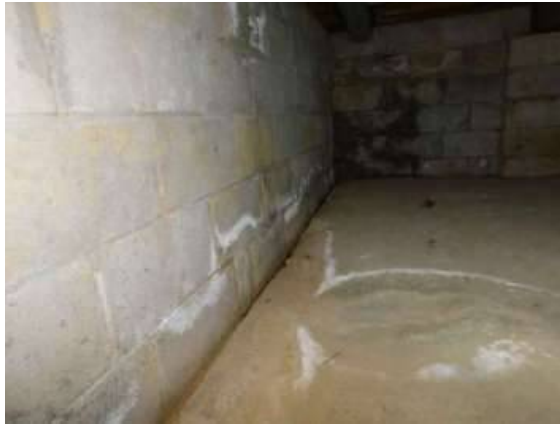
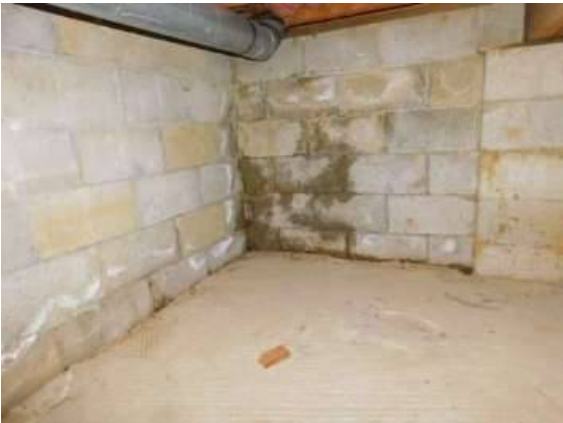
**31) Maintain, Comment/FYI** - Efflorescence was found on the crawl space wall. Efflorescence are minerals that are drawn from the concrete materials. When there is excessive moisture outside the foundation wall, the moisture naturally moves toward areas of lower humidity (on the inside of the foundation wall). As the moisture moves through the masonry materials it draws the minerals, calcium and salts, from the masonry materials. As the moisture evaporates on the inside, it leaves behind the calcium and salts.

This is not necessarily a problem but rather a symptom of too much moisture on the outside. This can be due to poor drainage, slope or grading of the soil so that rain water flows toward the house, not away from it. It could be because downspouts and downspout extensions are not routing the rain water far enough from the foundation wall.

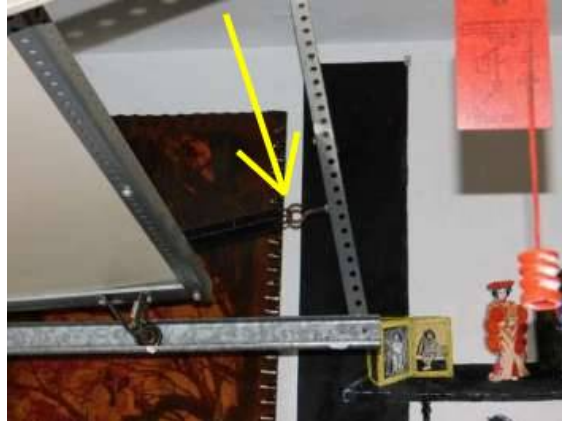
**Photo 35-2** No containment cable seen.

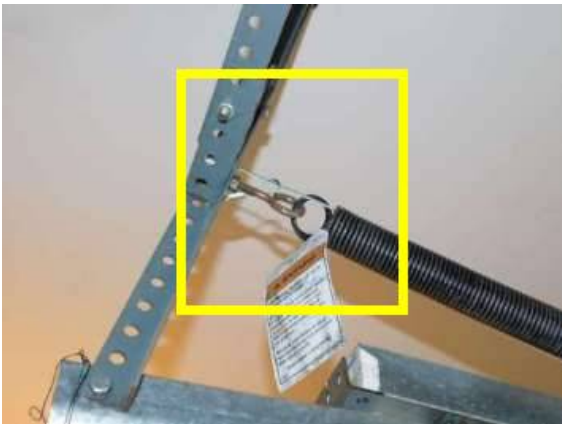
**Photo 35-3** Close up of this area in the next photo. Taken from the other door's spring.

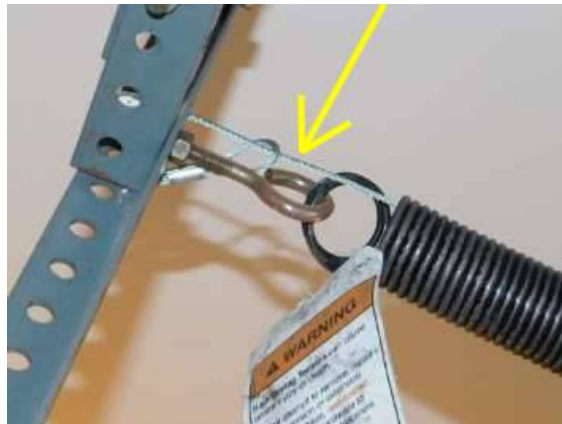
**Photo 35-4** As seen here (and for the same door's other spring) there are containment cables.

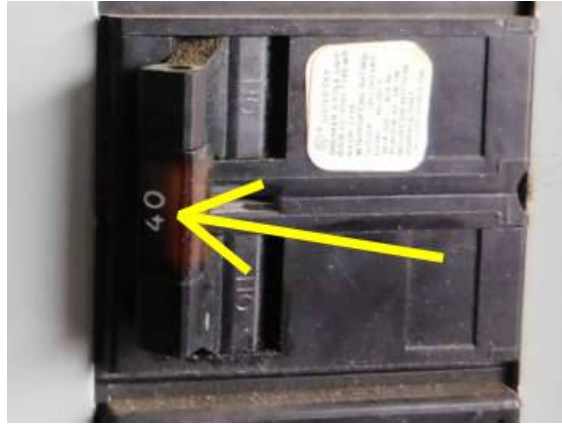
**Photo 39-4** Although this 40 amp breaker is not labeled (Vis a vis the appliance it's serving), it's the only 240vAC breaker in the panel. Therefore, it has to be for the AC.

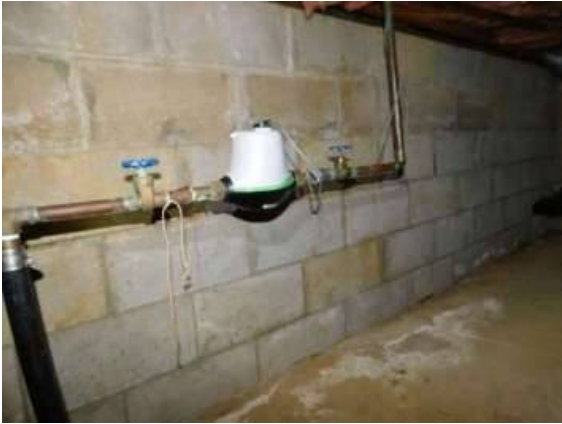
**Photo 51-1**

**51) Comment/FYI** - What appeared to be the main water shut-off valve was located in the crawl space. This is an inconvenient location at best, and may prevent the water from being turned off in a timely manner in the event of a plumbing emergency. Consider having a qualified plumber relocate the shut-off valve to a more convenient location, such as in a closet or a cabinet under a sink.

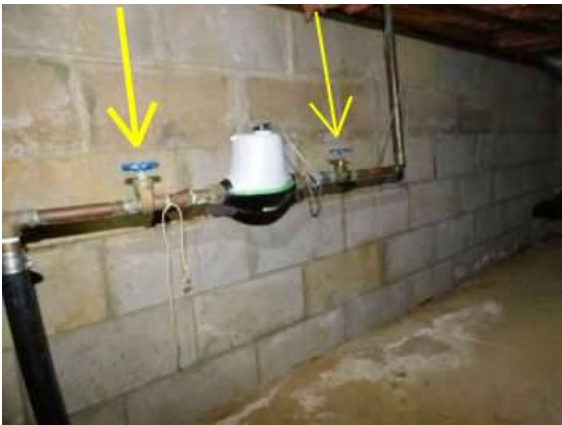
**Photo 52-1** The water meter is the white thing between the two arrows. Each arrow highlights one of the 2 valves that will turn off all the water in the house.

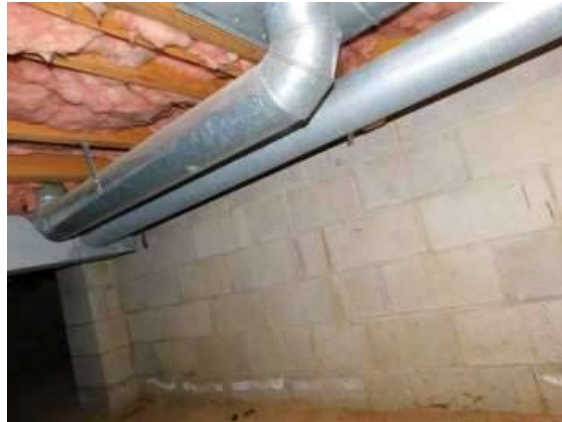
**Photo 57-2**

**57) Replace** - One or more heating or cooling ducts in an unconditioned space (e.g. crawl space) were not insulated, or the insulation was damaged or deteriorated. This can result in reduced energy efficiency, moisture inside heating ducts, and/or "sweating" on cooling ducts. Recommend that a qualified person repair per standard building practices. For example, by wrapping ducts in insulation with an R-value of R-8.

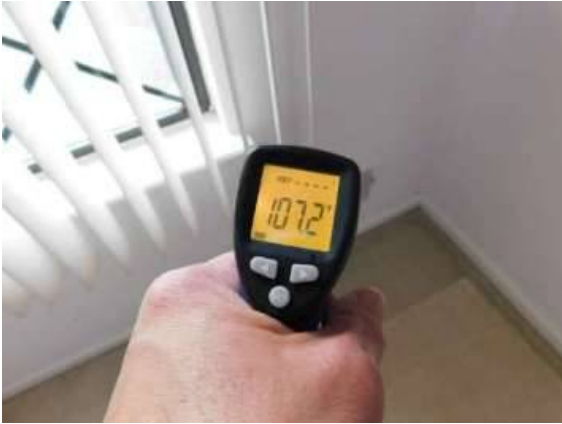
Photo 67-1

**67) Comment/FYI** - Sample heat temperatures. All accessible air supply registers were measured. A few examples are shown.

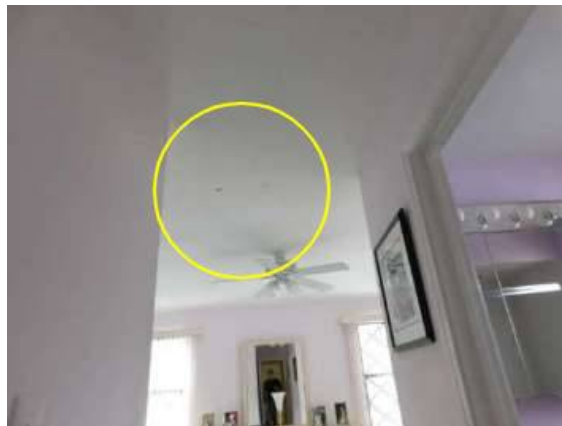
**Photo 79-2** Close up of this area in the next photo.
