Regal Home Inspections, LLC

Property Inspection Report

Property address: **1 Any Street Ct
Anytown, NJ**

Inspection date: **Sunday, February 28, 2021**

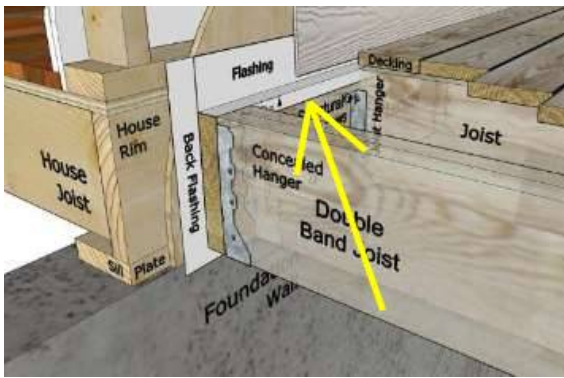
6) Material Defect/Safety, Replace - Flashing appeared to be missing from above one or more deck or porch ledger boards, or could not be verified. Missing flashing at this location can cause moisture to accumulate between the ledger boards and the building. Fungal rot may occur in this area and cause the ledger board fasteners to fail. The deck may separate from the building in this event. This is a potential safety hazard. Recommend that a qualified contractor install flashing above ledger boards per standard building practices. For more information, visit: <https://www.decks.com/how-to/28/flashing-the-ledger-board>

Photo 6-1 The flashing highlighted here is not seen over the deck's ledger board. A few examples are shown in the next photos.

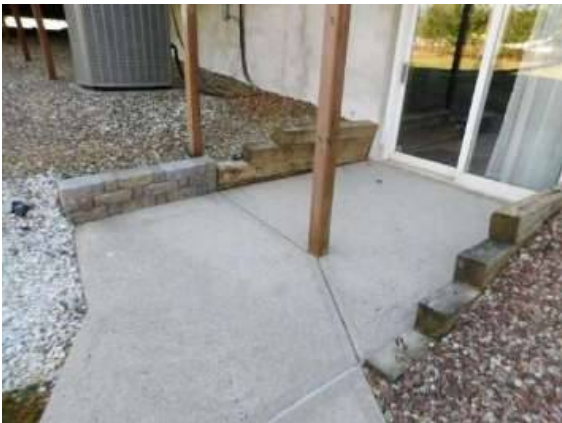
**Photo 8-1**

8) Repair/Maintain/Service - Soil was in contact with or too close to wooden deck or porch substructure components such as the deck posts. This is a conducive condition for wood-destroying organisms. Clearances to soil should be as follows:

Pressure treated wood is typically rated for 25 year contact with soil, but the cut ends hidden below grade may not have been treated and can rot quickly. Support posts should be elevated above grade on concrete piers or footings, and be separated from the concrete by metal brackets or an impermeable membrane such as shingle scraps. For other components, soil should be graded and/or removed to maintain these clearances if possible. Otherwise, replacing non-treated wood with treated wood, or installing borate-based products such as Impel rods may help to prevent infestation and damage.

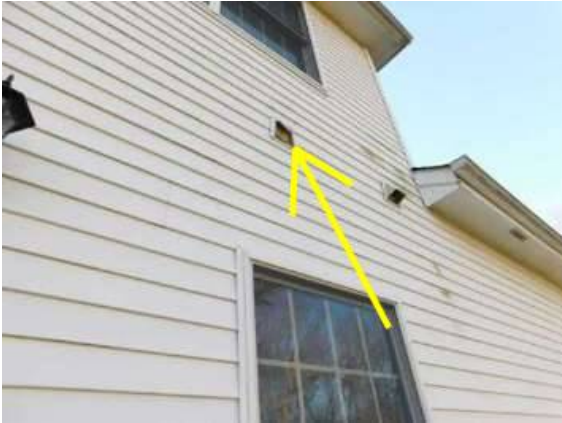
Photo 14-1

14) Replace - One or more exhaust duct end caps were damaged. Their purpose is to prevent unconditioned air from entering the building, and keep out birds, rodents and bugs. Blocked ducts can cause fan motors and/or clothes dryers to overheat and can pose a fire hazard. Recommend that a qualified person repair or replace caps as necessary.

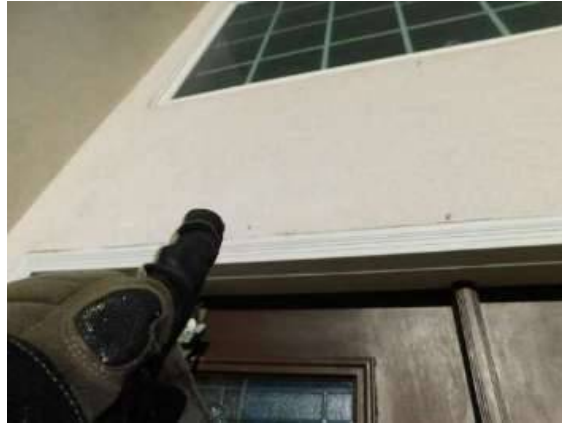
Photo 15-4

15) Repair/Maintain/Service, Maintain, Evaluate - Holes were found in one or more areas of the expanded foam insulation system (EIFS) exterior finish. In damp climates, moisture can enter cracks or damaged areas and further deteriorate the finish. Also, the wall behind the finish can become damaged from moisture intrusion. Note that areas behind the finish are inaccessible and excluded from this inspection. Recommend that a qualified contractor evaluate and make repairs and/or replace the EIFS siding as necessary. For example, seal the holes seen and any others that may exist.

Photo 15-2 Some examples shown of holes in the EIFS and small areas of damage (The damage was smaller than the size of a dime).

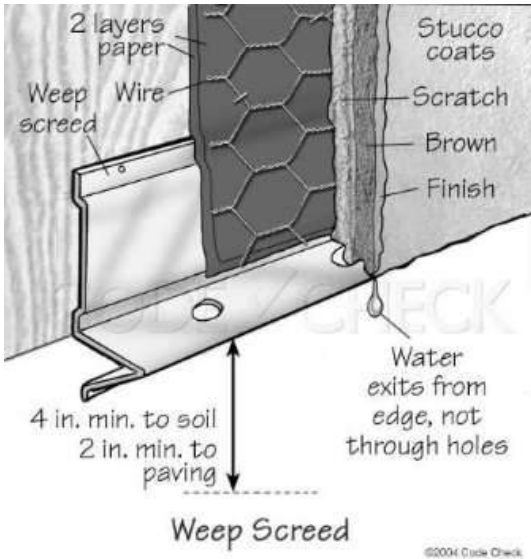
Photo 20-9 There isn't any weep screed seen. This illustration shows a weep screed in a hard coat stucco wall but the illustration is very similar to a weep screed in an EIFS installation.

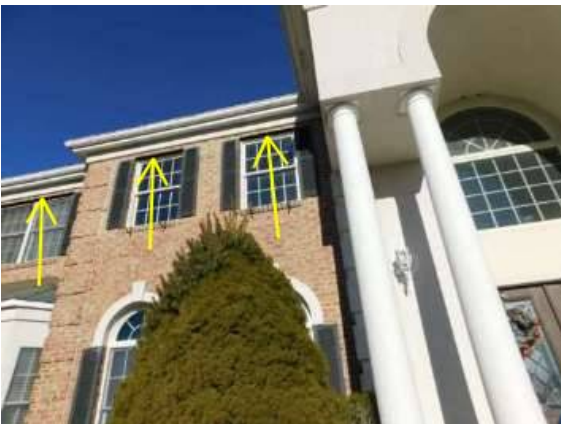
21) Comment/FYI - Lintels are structural elements that support the weight of the brick over openings like windows and doors. Lintels are made of iron and often rust. Lintels are also embedded approximately 6 inches past the openings on either side to anchor them structurally. Over time lintels will rust. The rust can increase the size of the lintel and often applies upward force to the bricks causing cracks. No cracks were seen at this location. Recommend maintaining the lintels by using a rust inhibiting paint and maintaining seals at the seams between the lintels and the brick.

Photo 21-1 Lintels are seen above the 2nd floor windows. The first floor windows, partially obscured by the bush in this photo, use the arch for the structural element.

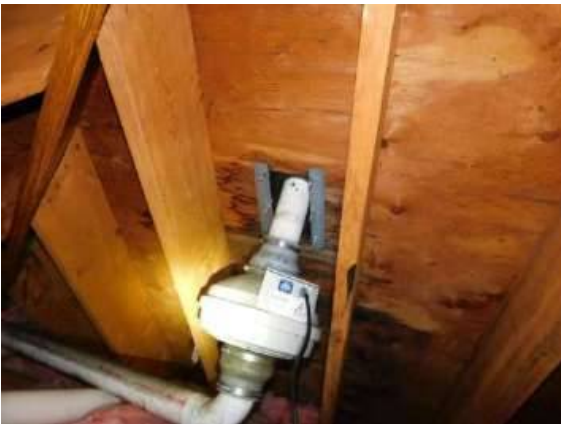
Photo 23-7 Water stains seen inside the attic in this photo are below the substandard flashing seen in the previous photo.

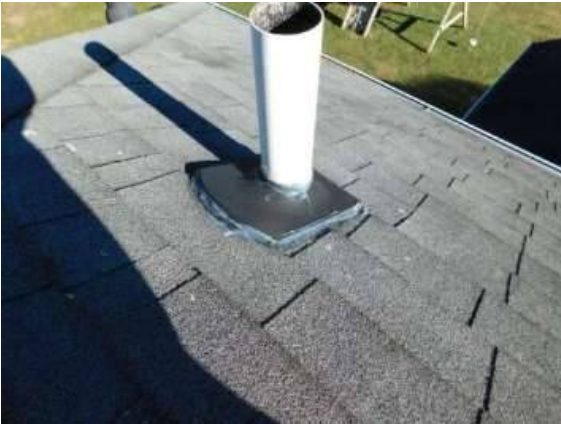
**Photo 25-1**

25) Replace - Flashing at one or more plumbing vent pipes appeared to be improperly installed. For example, the upper/high side of the flashing should be under the upper shingles. That promotes proper water flow over the pipe boot assembly. In this case the pipe boot assembly is placed atop all the shingles. This is a conducive condition for leaks and wood-destroying organisms (Such as mold due to potential leaks). Recommend that a qualified person repair per standard building practices.

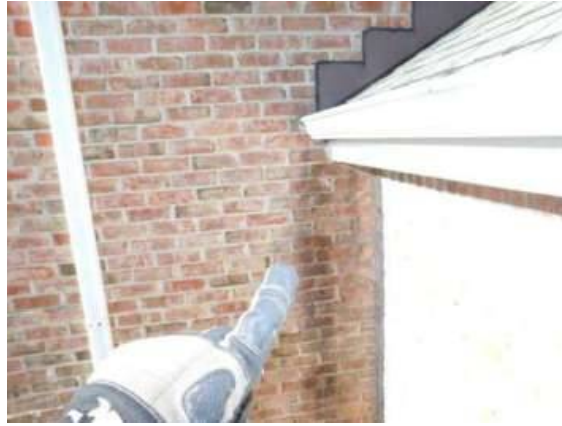
Photo 26-2

26) Repair/Maintain/Service, Evaluate - Recommend having kick out flashing at the end of the gutter to prevent the rain water from over-running the gutter or passing between the gutter end and the wall. That usually results, as seen here, in the staining. Properly installed kick out flashing routes the water coming off the roof into the gutter for proper disposal and prevents the water from getting between the gutter end and the wall. A qualified roofer or siding contractor should evaluate and repair as that professional deem necessary.

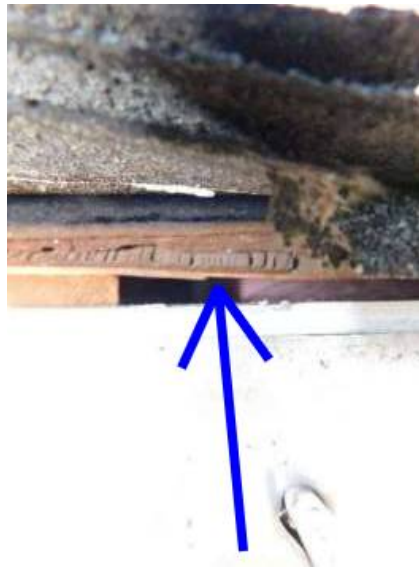
27) Repair/Maintain/Service - There is no drip edge flashing. Drip edge flashing is intended to protect the edge of the plywood roof sheathing where the shingles end and help ensure that all rain water goes into the gutter. It's often not installed by roofers so they can save money but is a good practice to ensure a more water repellent roof. Properly installed drip edge flashing should be installed around the entire perimeter of the roof. One edge should go between the plywood sheathing and the roof surface (shingles, etc.) and then bend downward into the back of the gutter or along the outside of the rake board. In this installation, when the shingles are lifted, bare plywood is exposed.

**Photo 27-2** Lifting the edge of the shingles up right behind the gutter shows that bare wood is exposed.

If the roof is replaced you should request that drip edge flashing be installed.

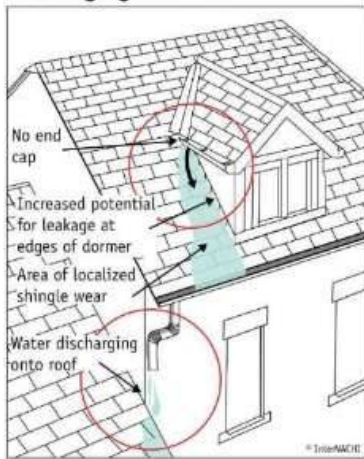
**Photo 28-2****Photo 28-1**

28) Repair/Maintain/Service - Ideally the downspout should not deposit water on the roof as seen in the photo below. The roof is designed to shed water that is flowing down. When the water emerges from the downspout it is going side-ways into the shingle. This will also cause accelerated shingle wear and gravel loss at this location. The illustration, courtesy of the National Association of Home inspectors shows improper ways that gutters deposit water on a roof as we have here. Recommend that a roofing/gutter contractor install a downspout or leader to carry the water to the lower gutter.

Gutter Improperly Discharging onto Roof

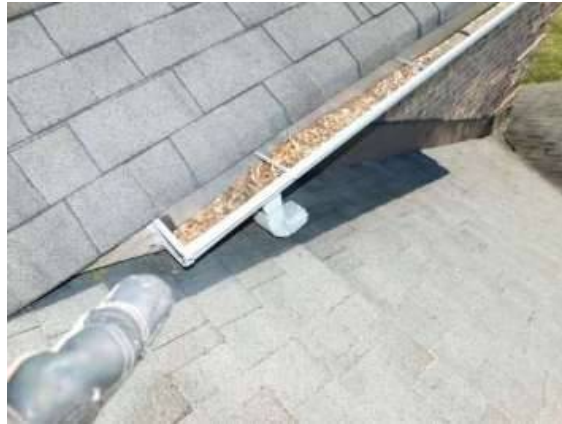
**Photo 30-2**

30) *Maintain* - Significant amounts of debris have accumulated in one or more gutters or downspouts. Gutters can overflow and cause water to come in contact with the building exterior, or water can accumulate around the foundation. This is a conducive condition for wood-destroying organisms. Recommend cleaning gutters and downspouts now and as necessary in the future.

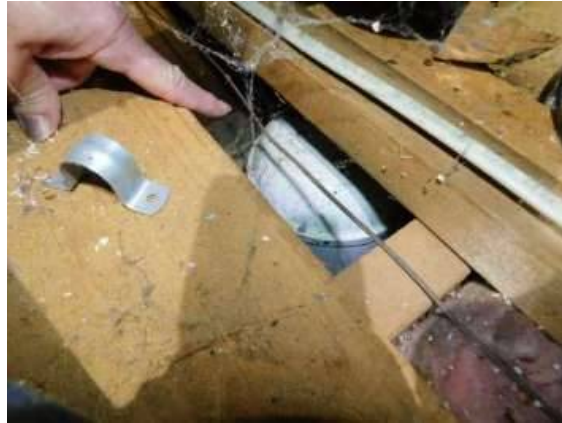
34) Repair/Maintain/Service, Evaluate - One or more recessed "can" lights were installed in the attic and there was no insulation around them. The inspector was unable to find a label or markings that indicated that these lights are designed to be in contact with insulation. If lights are not "IC" rated then putting insulation in contact may be a fire hazard. However, no insulation allows for warm moist 2nd floor air to rise into the attic. This A) Is energy inefficient and B) The rising, warm moist air will cause condensation in the attic in the cold of winter which, in turn, can cause mold. Recommend further evaluation by a qualified contractor to determine if these lights are rated for contact with insulation. If they aren't, or if their rating can't be determined, then

Photo 34-2 An open, recessed light can where warm, heated air will rise into the attic. This is energy inefficient and could be a conducive condition for microbial growths (Such as mold).

recommend that a qualified person repair as necessary to prevent air from escaping into the attic. For example, by installing shields around lights and installing insulation over the shields.

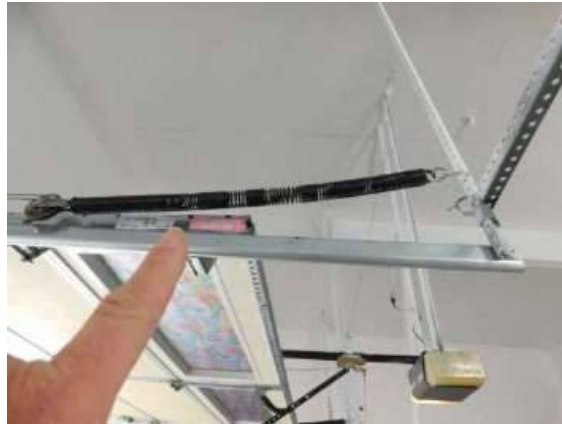
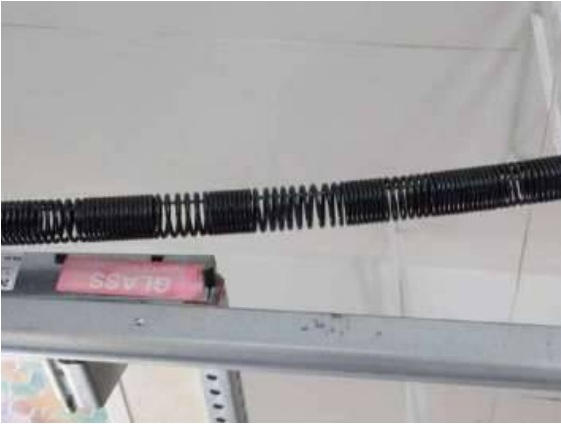
41) Material Defect/Safety, Replace - One or more extension springs supporting garage vehicle door(s) were stretched. This is an indication that the spring(s) have been weakened. Stretched extension springs are a potential safety hazard in the event that they break. The vehicle door could fall shut or a spring could strike someone nearby when it breaks. Recommend that a qualified contractor replace stretched extension springs.

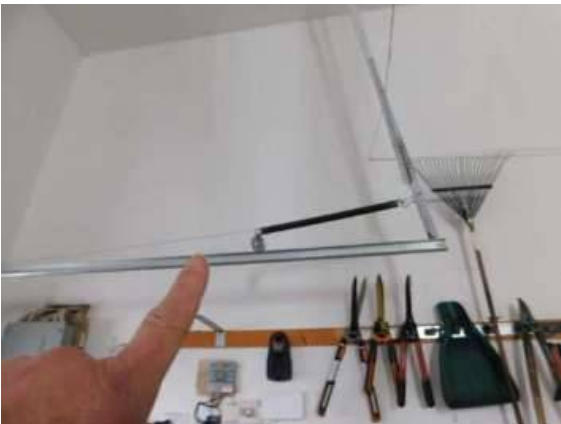
**Photo 42-1**

42) Material Defect/Safety, Repair/Maintain/Service, Evaluate - One garage vehicle door was not able to be opened or closed. Vehicle doors should open and close smoothly and easily. The counter-balance spring, cable and pulley mechanism was broken. A qualified garage door contractor must evaluate and repair as necessary. This is a safety issue because if one is strong enough to lift it, it can easily fall shut with a large amount of force and quickly with a high potential of doing serious injury to anyone that might be caught under it.

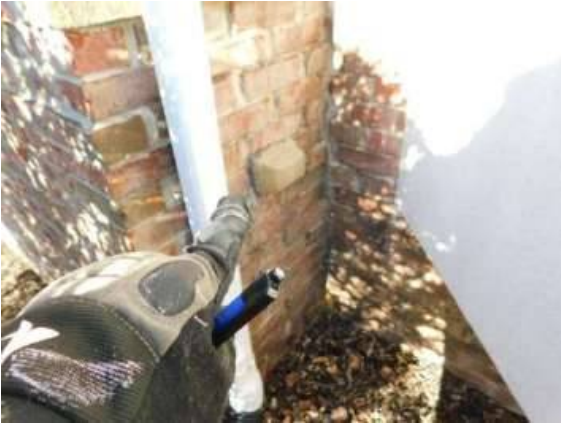
**Photo 47-1**

47) Material Defect/Safety, Replace, Evaluate - One or more ground fault circuit interrupter (GFCI) receptacles (outlets) wouldn't reset and had no power upon arrival at the exterior. This is a potential shock hazard. Recommend that a qualified electrician evaluate and repair as necessary.

Near the front door.

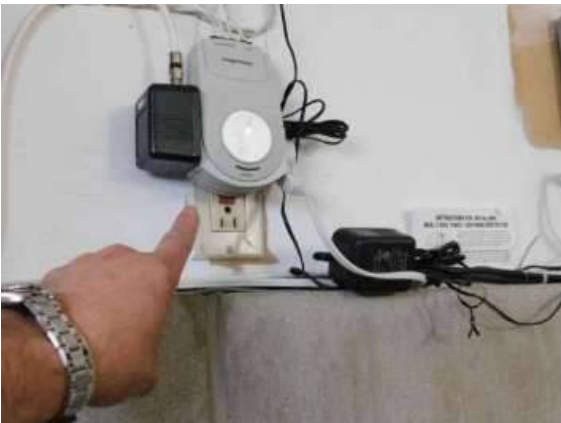
**Photo 48-1**

48) Material Defect/Safety, Replace, Evaluate - One or more ground fault circuit interrupter (GFCI) receptacles (outlets) wouldn't trip and/or wouldn't trip with a test instrument at the garage. This is a potential shock hazard. Recommend that a qualified electrician evaluate and repair as necessary.

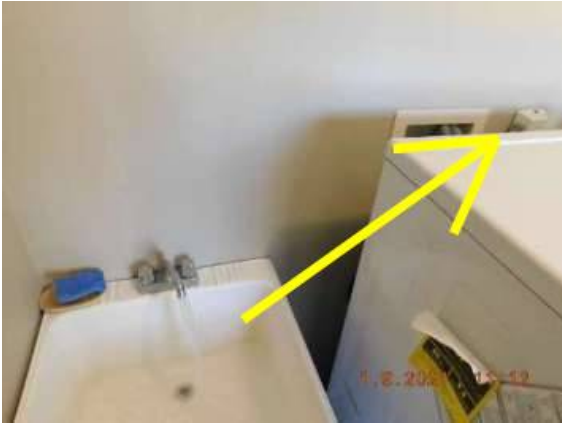
Photo 49-1

49) Material Defect/Safety, Replace, Evaluate - One or more electric receptacles (outlets) at the laundry sink had no visible ground fault circuit interrupter (GFCI) protection. If not GFCI-protected, receptacles in wet areas pose a shock hazard. Recommend that a qualified electrician evaluate and install GFCI protection if necessary and per standard building practices. General guidelines for GFCI-protected receptacles include the following locations:

licensed electrician install GFCI protection as an upgrade to any circuits where there is a higher potential for electrical shock and GFCI protection does not currently exist. National electrical standards currently require that all outlets that serve the kitchen countertop surfaces be GFCI protected regardless of their proximity to a sink. Lack of GFCI protection where currently required is a safety issue for the occupant.

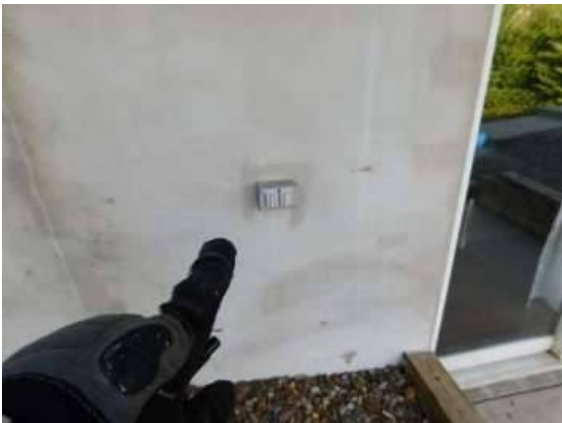
**Photo 53-1**

53) Replace, Evaluate - One or more electric receptacles (outlets) appeared to have no power. Recommend asking the property owner about this. Switches may need to be operated to make some receptacles energized. If necessary, recommend that a qualified electrician evaluate and repair.

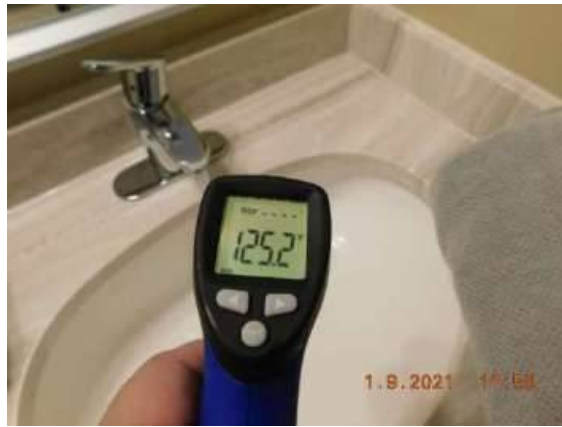
Photo 65-2 A similar difference can be seen between the sink and tub and the second floor hall bathroom.

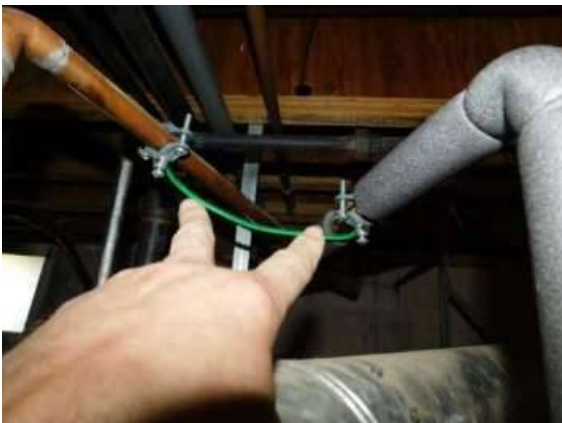
Photo 66-1

66) Repair/Maintain/Service - One or more bonding or grounding clamp(s) attached to copper water-supply pipes appeared to be made of steel. When these electrically energized dissimilar metals are in contact with each other, corrosion can occur on the water-supply pipes and result in leaks. Recommend that a qualified person replace steel clamps on copper pipes as necessary, with clamps made of brass, bronze or copper.

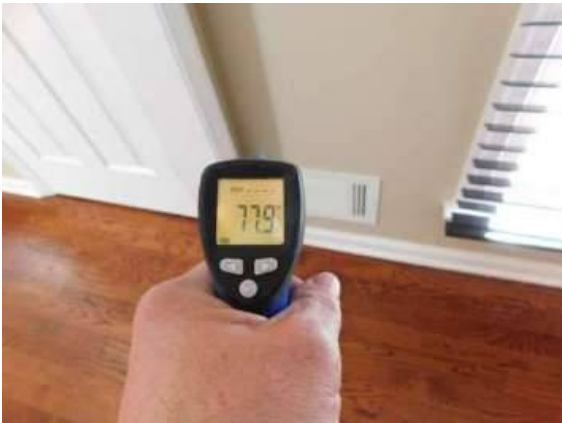
70) Replace, Evaluate - One or more heating or cooling air supply registers had a weak air flow, or no apparent flow. This may result in an inadequate air supply. Recommend asking the property owner about this. Adjustable damper(s) in ducts may exist and be reducing the flow. If dampers exist, then they should be opened to attempt to improve the air flow. If the property owner is unaware of such dampers, or if adjusting dampers does not improve the air flow, then recommend that a qualified HVAC contractor evaluate and repair or make modifications as necessary.

Photo 70-1 Compare the temperatures shown here with the sample temperatures shown below.

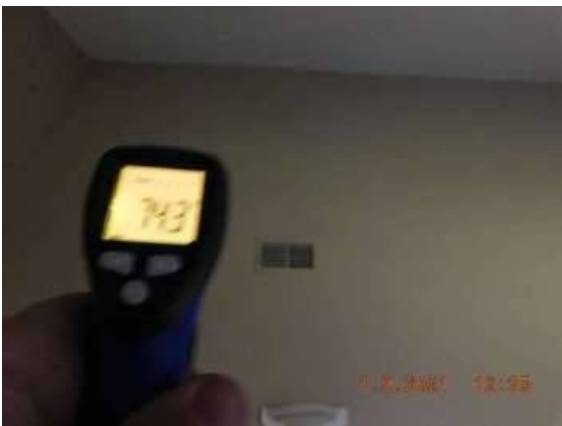
Photo 70-3 Seen in the master bathroom.

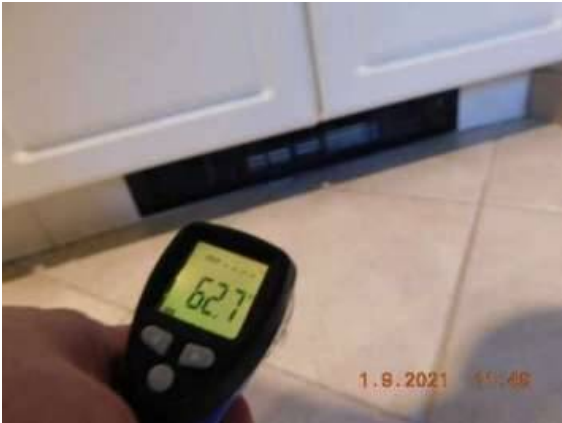
71) Replace - One or more electric heaters appeared to be inoperable, or the inspector was unable to find normal controls with which to operate it. Recommend asking the property owner about their operation, and if necessary, that a qualified electrician evaluate and repair.

Photo 71-1 Seen in the master bathroom.

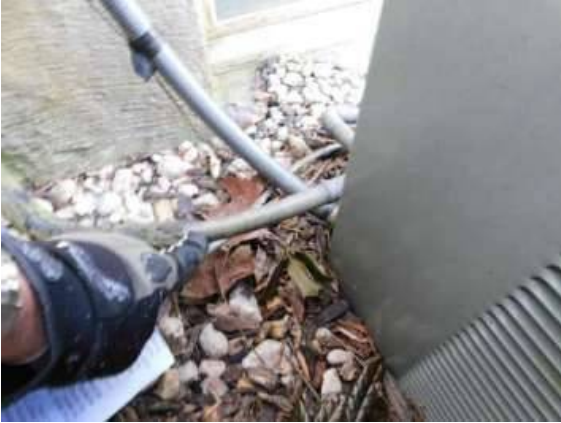
Photo 75-1

75) Repair/Maintain/Service - Insulation on the heat pump or air conditioning condensing unit's refrigerant lines was deteriorated or missing in some areas. This may result in reduced efficiency and increased energy costs. Recommend that a qualified person replace or install insulation as necessary.

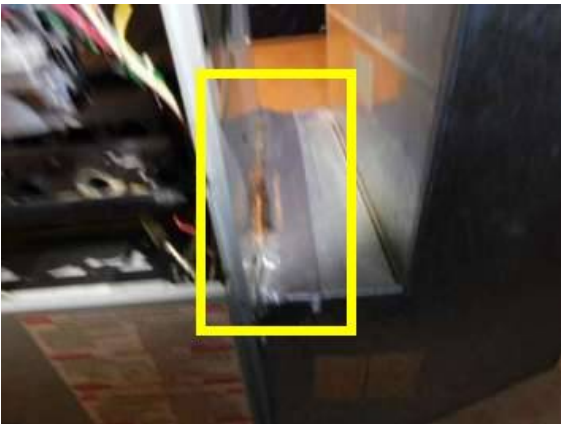
Photo 76-1

76) Repair/Maintain/Service - Recommend adding a convenient cover for the basement furnace filter chamber rather than duct tape. One option is <https://www.allergyzone.com/collections/clean-air-accessories/products/filterlock-furnace-filter-slot-seal>

Recommend that this cover, or something similar, be used to seal the opening over the air filter.

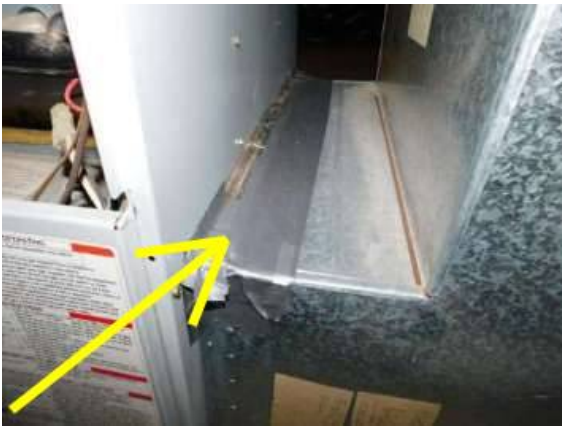
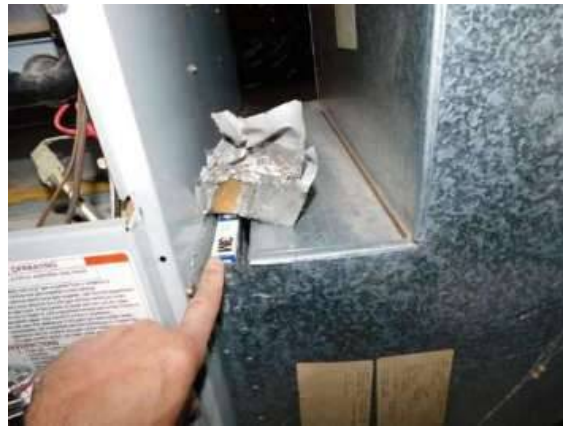
77) Maintain - Recommend replacing or washing HVAC filters upon taking occupancy depending on the type of filters installed (disposable or reusable). Regardless of the type, recommend checking filters monthly in the future and replacing or washing them as necessary and in accordance with the filter manufacturer's instructions. How frequently they need replacing or washing depends on the type and quality of the filter, how the system is configured (e.g. always on vs. "Auto"), and on environmental factors (e.g. pets, smoking, frequency of house cleaning, number of occupants, the season).

Photo 77-1 Basement air filter chamber and filter seen here and the next photo.

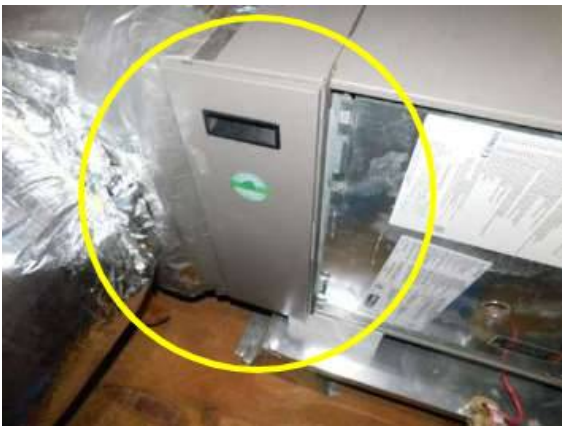
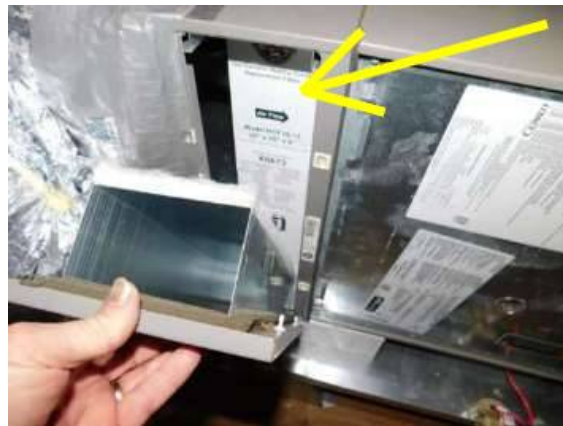
Photo 77-3 Attic air filter chamber and filter seen here and the next photo.

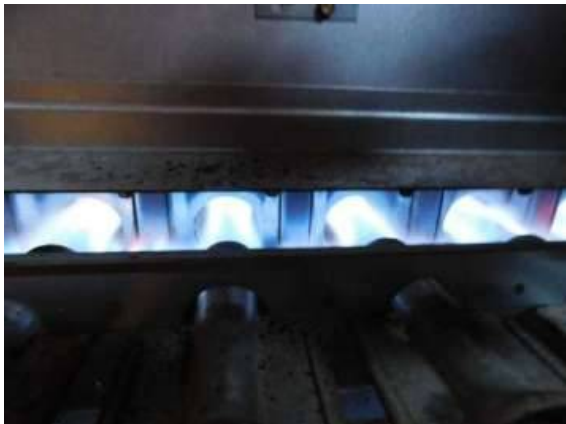
82) **Comment/FYI** - The furnace's burners were blue in color indicating proper fuel combustion.

Photo 82-1 Basement burners.

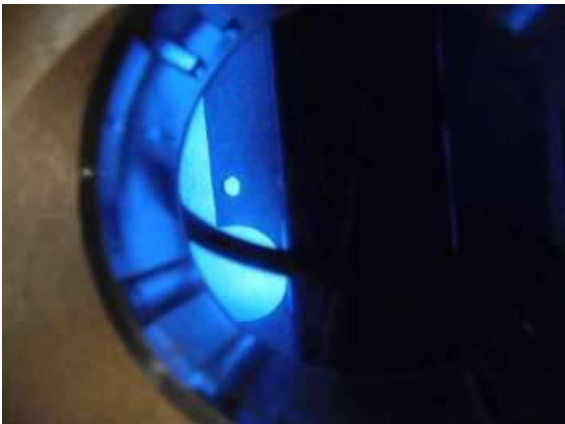
Photo 82-2 Attic burners.

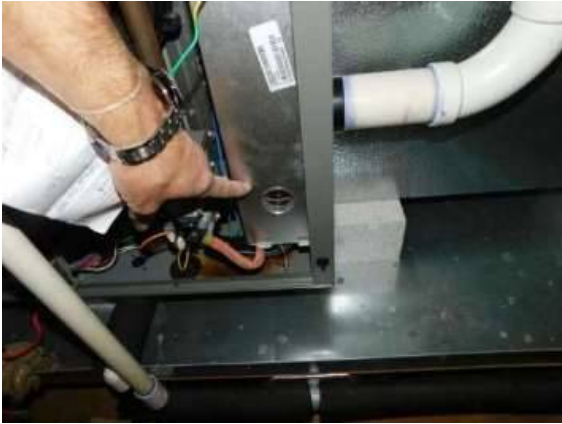
Photo 82-3 The attic burners are in a sealed burner chamber. The previous photo was taken looking through this sight glass.

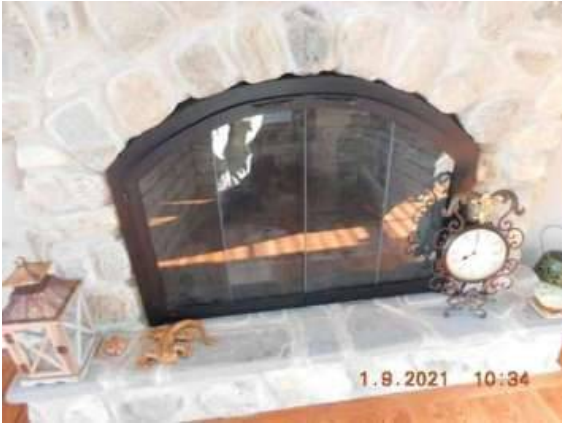
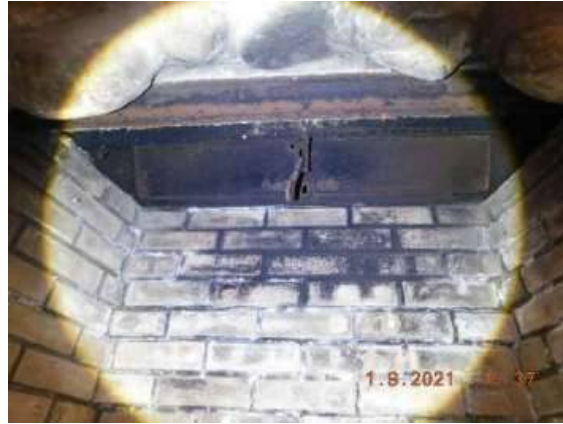
84) Material Defect/Safety, Replace - A fireplace was equipped with a gas burner and the chimney damper could close. This is a safety hazard due to the possibility of burner or pilot light exhaust gases entering living spaces. Modifications should be made to prevent the damper from ever closing to prevent this. A qualified contractor should repair per standard building practices so the damper cannot close.

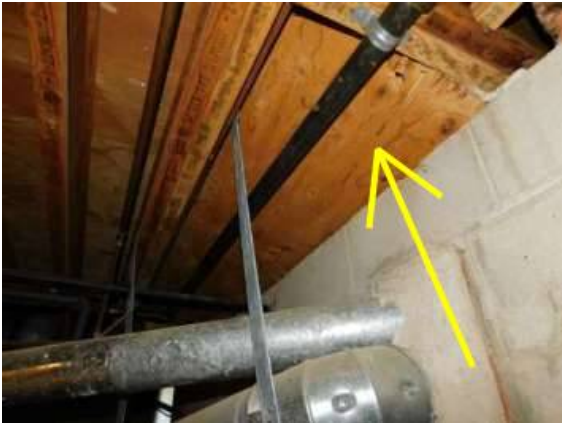
Photo 85-1

85) Material Defect/Safety, Replace - Masonry fireplace hearths and hearth extensions shall be constructed of concrete or masonry, supported by noncombustible materials, and reinforced to carry their own weight and all imposed loads. No combustible material shall remain against the underside of hearths and hearth extensions after construction.

There are wood (Combustible material) elements still below the fireplace hearth. A qualified chimney contractor must evaluate and remove the wood elements.

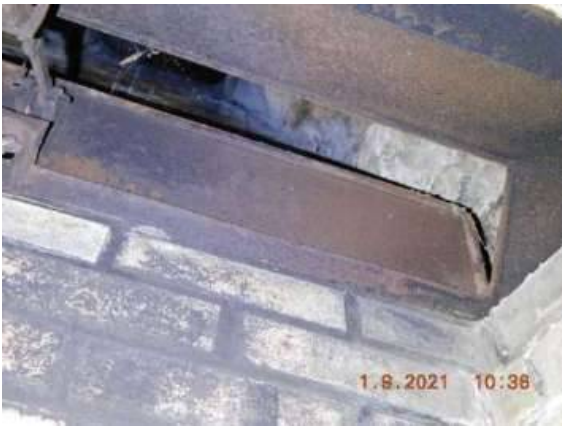
**Photo 87-3**

87) Repair/Maintain/Service - One or more gas-fired appliances such as the converted gas fireplace used a masonry chimney for venting, and no metal flue liner was visible. Metal liners should be installed to prevent drafting problems from an over-sized flue, to prevent corrosive exhaust gases from damaging the masonry chimney, and to prevent exhaust gases from leaking through gaps or seams in the chimney. This is a potential safety hazard. Recommend that a qualified contractor repair per standard building practices. For example, by installing a metal liner. For more information visit http://www.csia.org/chimney_liners.html

Photo 87-2 This and the following photo were taken at the fireplace looking up the chimney. No metal flue is visible.

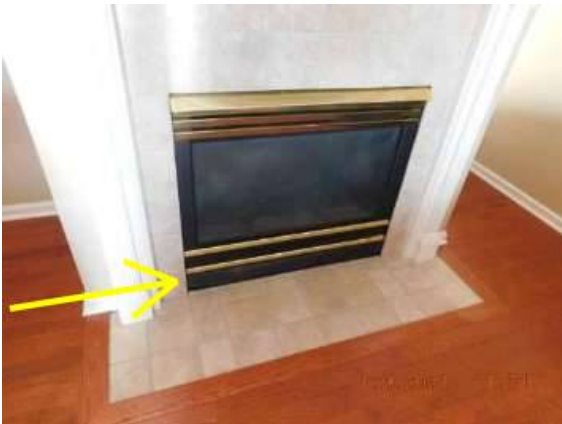
89) Evaluate - The gas fireplaces were not fully evaluated because the main gas valves for the fireplaces were off and therefore, the pilot lights were off. The inspector only operates normal controls (e.g. on/off switch or thermostat) and does not light pilot lights or, "operate [gas] shut-off valves" or "operate any system or component which is shut down" in accordance with NJ home inspection laws. Recommend that the client review all documentation for such gas appliances and familiarize themselves with the lighting procedure. If necessary, a qualified specialist should assist in lighting such appliances, and make any needed repairs.

**Photo 89-1** Close up of the inside of this panel shown in the following photo.

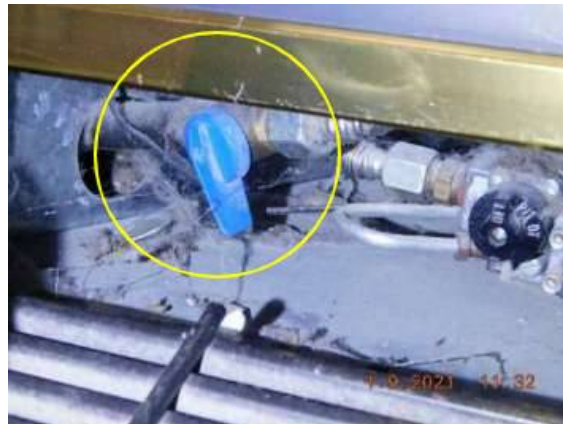
**Photo 89-2** The gas valve shown here is in the off position.

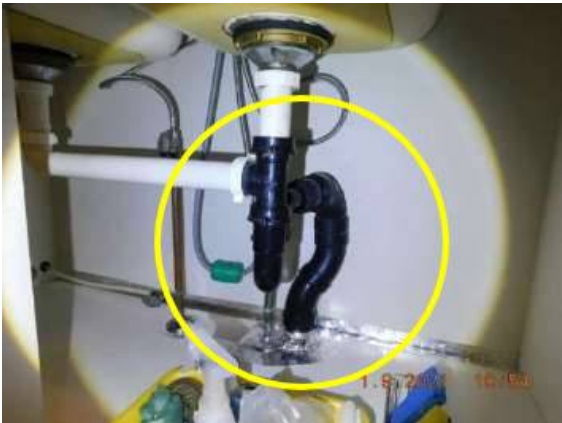
Photo 90-1

90) Replace - The kitchen sink drain pipe used an S-trap rather than a P-trap. Siphons and sudden flows of water in S-Traps can drain all the water out of the trap, leaving it dry. Sewer gases can then enter living areas. A solution is an Air Admittance Valve (AAV) installed by a licensed plumber. An AAV is an inexpensive part (\$20 - \$23 at Home Depot) and can provide the same functionality as an actual plumbing vent when a vent through the roof is not possible. Recommend consulting a licensed plumber.

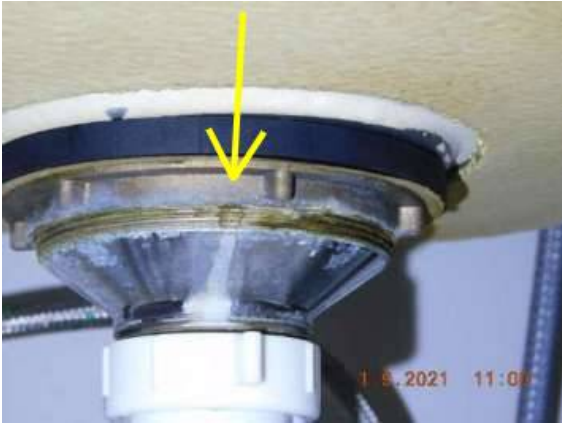
91) Repair/Maintain/Service - One or more sink drains appear to be leaking. A qualified plumber should repair as necessary.

Photo 91-1 Seen at the left side drain.

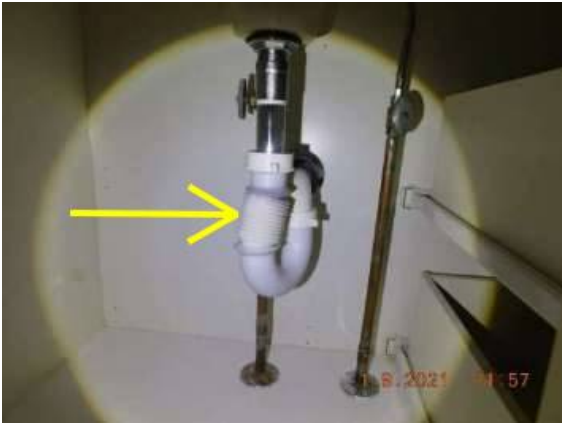
93) Replace - One or more bathroom or laundry sink drains use a flexible, accordion style drain. That is incorrect and violates generally accepted plumbing standards. Standards require that drainage fittings shall have a smooth interior waterway of the same diameter as the piping served. All fittings shall conform to the type of pipe used. Drainage fittings shall have no ledges, shoulders or reductions which can retard or obstruct drainage flow in the piping.

Photo 93-1 Seen at the second floor hall bathroom.

Recommend that a licensed plumber repair by replacing the accordion pipe section (Or sections) with the proper pipe material, shape and size.

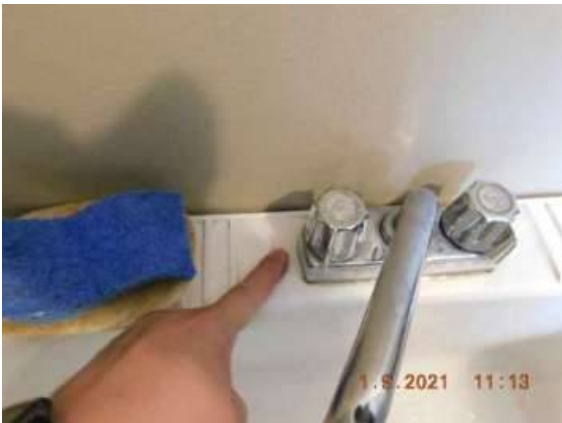
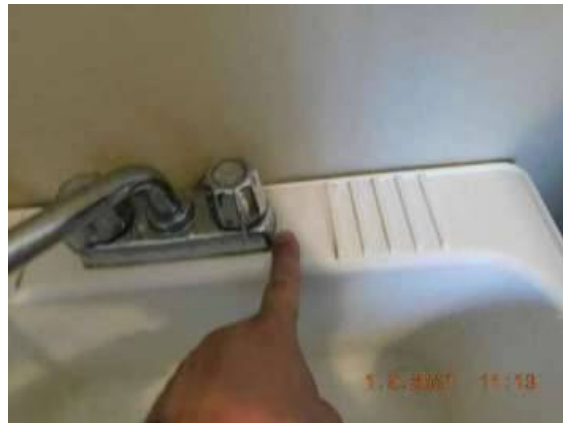
96) Repair/Maintain/Service - Water was leaking at the sink faucet base or handles at location(s) D. Recommend that a qualified plumber repair as necessary.

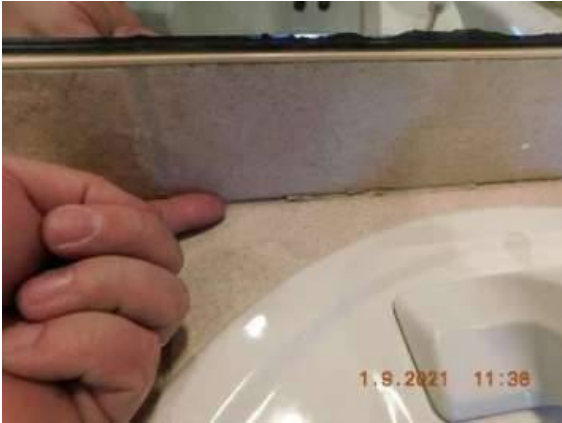
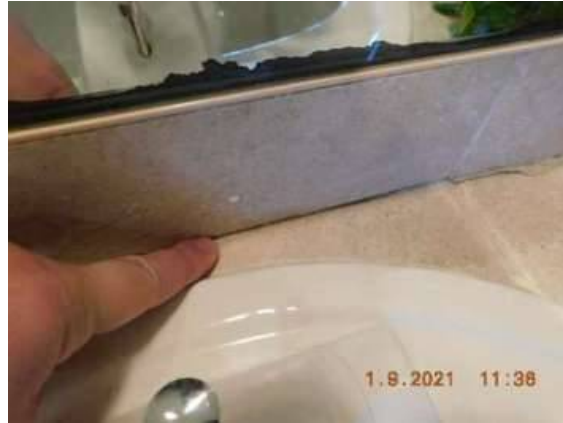
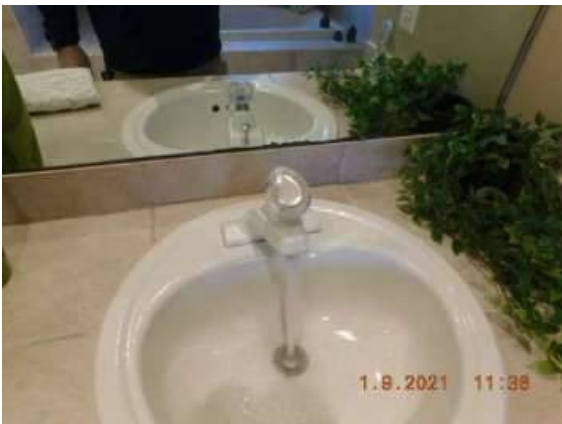
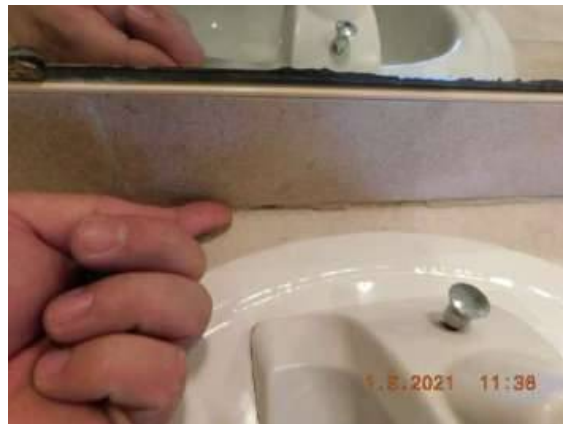
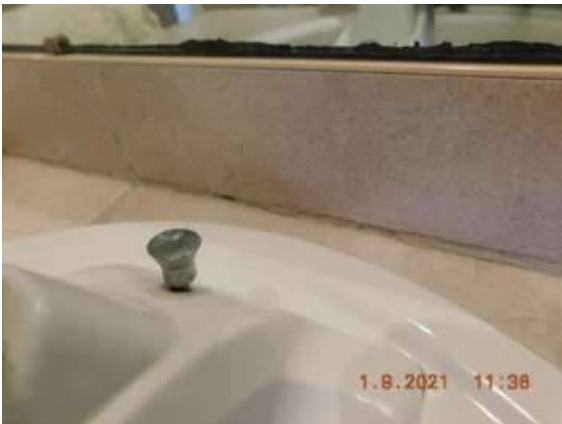
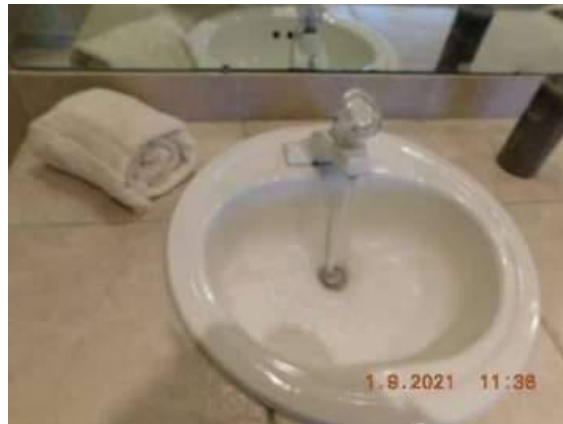
99) Maintain - Recommend cleaning and sealing the grout at countertops at location(s) B now and in the future

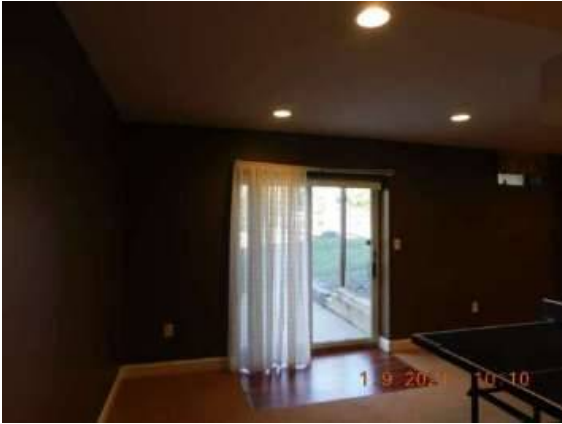
102) Material Defect/Safety, Replace - One or more exterior doors had double-cylinder deadbolts installed, where a key is required to open them from both sides. This can be a safety hazard in the event of an emergency because egress can be obstructed or delayed. Recommend replacing double-cylinder deadbolts with single-cylinder deadbolts where a handle is installed on the interior side.

Photo 102-1 This and the following photo were taken in the basement.

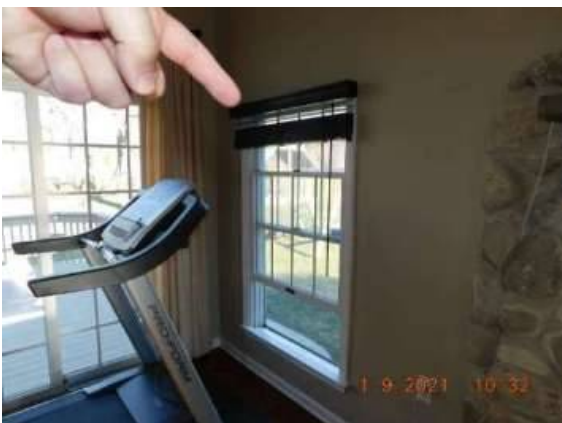
Photo 103-1

103) Replace - One or more windows that were designed to open and close were stuck shut. Recommend that a qualified person repair windows as necessary so they open and close easily.

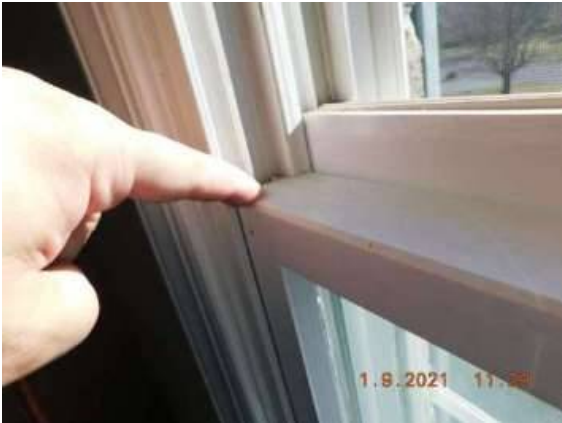
104) Repair/Maintain/Service - One or more double hung windows did not have fully functioning window retention mechanisms. One of the two retention string mechanisms was not properly retracting. None of the windows slammed shut which would then create a safety concern. The purpose of the window retention mechanism is to hold the window up when it is supposed to be open. A window repair specialist should repair all windows that do not function properly. Recommend that they verify the operation of all windows and repair

Photo 104-1 The string here is broken. Seen in the master bedroom.

those that were identified as well as any others that are in need of repair. This video shows how the Andersen window retention mechanisms are replaced demonstrating that this condition can easily be repaired by a window repair contractor. <https://www.youtube.com/watch?v=8KvjMG0IAWk>

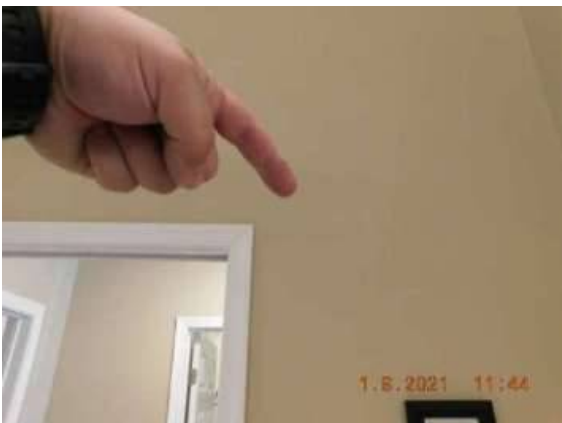
105) Comment/FYI - Minor cracks, nail pops and/or blemishes were found in walls and/or ceilings in one or more areas. Cracks and nail pops are common, are often caused by lumber shrinkage or minor settlement, and can be more or less noticeable depending on changes in humidity. They did not appear to be a structural concern, but the client may wish to repair these for aesthetic reasons.

Photo 105-1 Seen in the master bathroom.

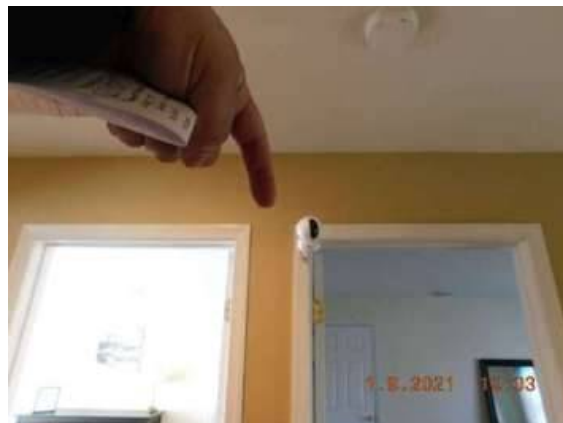
Photo 105-2 Seen in the second floor hallway.

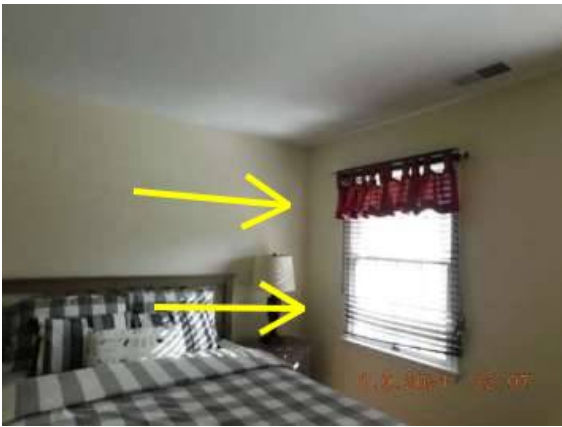
Photo 105-5 The previous two photos were taken in this second floor bedroom.

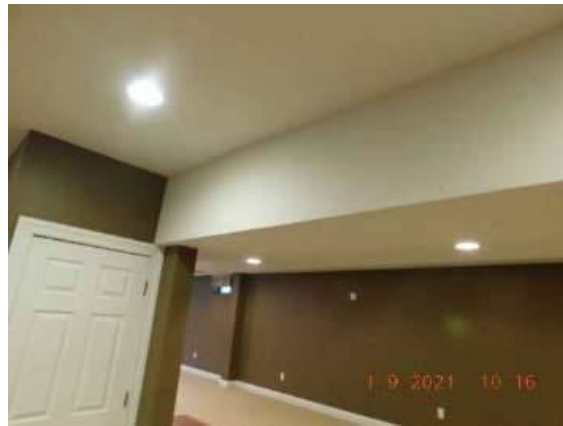
Photo 106-2

106) Comment/FYI - One or more rooms or hallways had ceilings that were too low. Standards vary for minimum ceiling heights, but generally they should be at least 7 feet high except in areas with sloped ceilings where at least half of the area should have 7 foot or higher ceilings. This may pose a safety hazard to tall people.
