Regal Home Inspections, LLC

Property Inspection Report

Property address: Any Street

Inspection date: Sunday, July 25, 2021

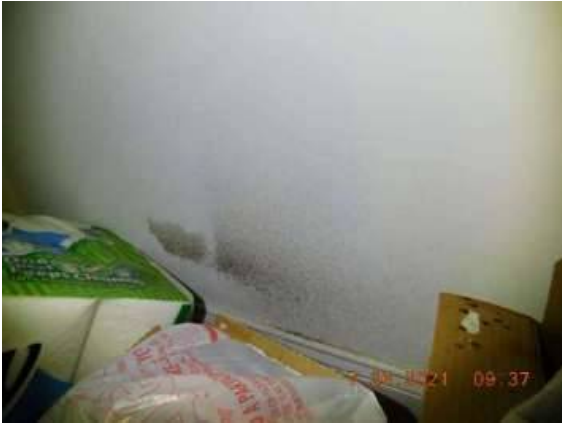
**Photo 1-1**

1) Repair/Maintain/Service, Evaluate - Microbial growths (Which could possibly be mold) were found at one or more locations in interior rooms. It is beyond the scope of this inspection to identify what substance or organism this staining is. However such staining is normally caused by excessively moist conditions, which in turn can be caused by plumbing or building envelope leaks and/or substandard ventilation. These conducive conditions should be corrected before making any attempts to remove or correct the staining. Normally affected materials such as drywall are removed, enclosed affected spaces are allowed to dry thoroughly, a mildewcide may be applied, and only then is drywall reinstalled. For evaluation and possible mitigation, consult with a qualified industrial hygienist or mold/moisture mitigation specialist.

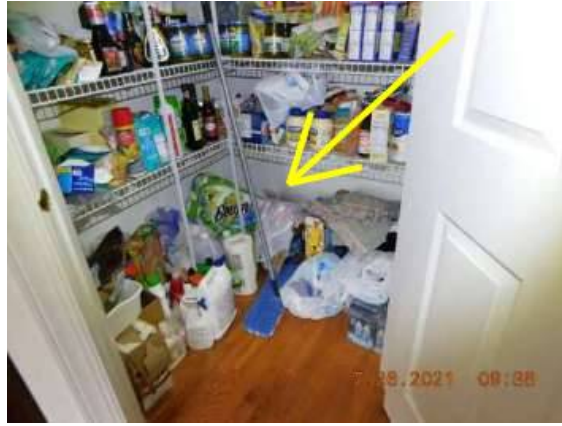
**Photo 1-2** Seen in the kitchen food pantry.

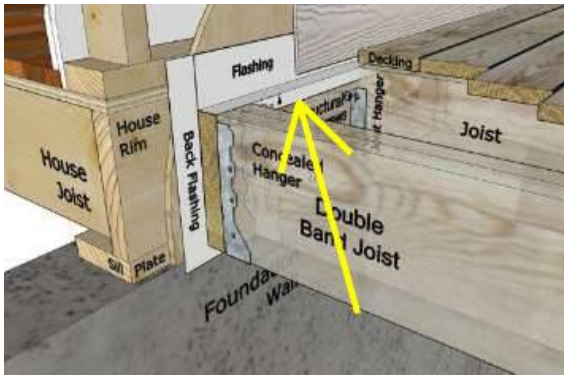
9) Material Defect/Safety, Replace - Flashing appeared to be missing from above one or more deck or porch ledger boards, or could not be verified. Missing flashing at this location can cause moisture to accumulate between the ledger boards and the building. Fungal rot may occur in this area and cause the ledger board fasteners to fail. The deck may separate from the building in this event. This is a potential safety hazard. Recommend that a qualified contractor install flashing above ledger boards per standard building practices. For more information, visit: <https://www.decks.com/how-to/28/flashing-the-ledger-board>

Photo 9-1 The flashing highlighted here is missing from under the back porch.

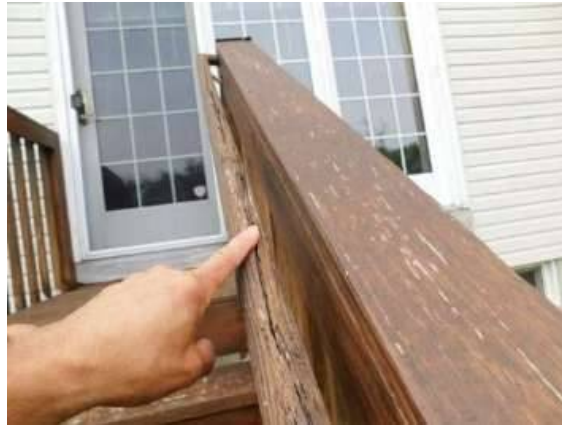
Photo 12-2

12) Material Defect/Safety, Repair/Maintain/Service - Handrails at one or more flights of stairs were damaged. This is a safety hazard. Recommend that a qualified person repair as necessary.

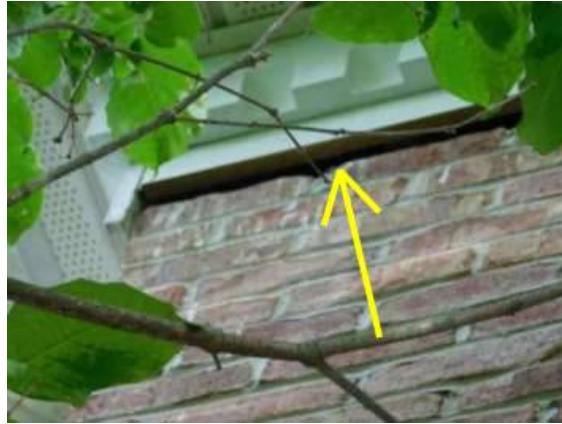
Photo 14-2

14) Replace - Few sections of siding and/or trim were damaged. Recommend that a qualified person repair, replace or install siding or trim as necessary.

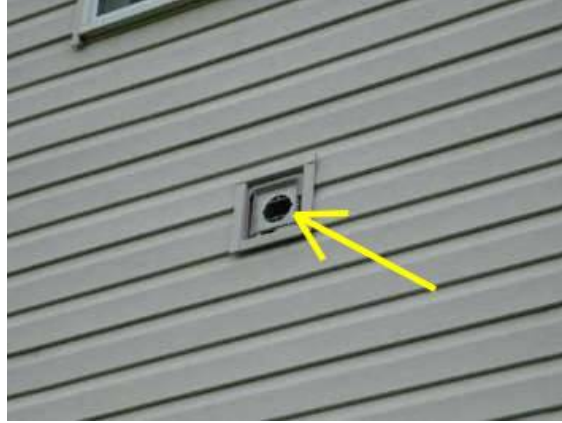
Photo 16-2

16) Replace - One or more exhaust duct end caps were damaged. Their purpose is to prevent unconditioned air from entering the building, and keep out birds, rodents and bugs. Blocked ducts can cause fan motors and/or clothes dryers to overheat and can pose a fire hazard. Recommend that a qualified person repair or

replace caps as necessary.

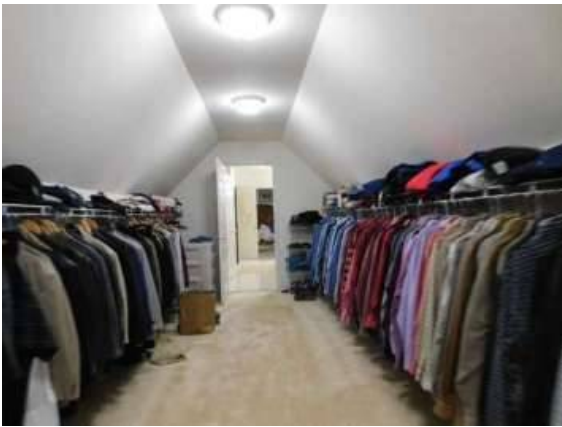
**Photo 27-1**

27) Exclusion, Comment/FYI - The house has vaulted ceilings in areas. The roof structure, insulation and ventilation is not visually accessible from the inside in the vaulted ceiling areas. There's no attic space above the vaulted ceiling area. The roof structure and insulation in these, vaulted ceiling areas, is not visually accessible for inspection and identification.

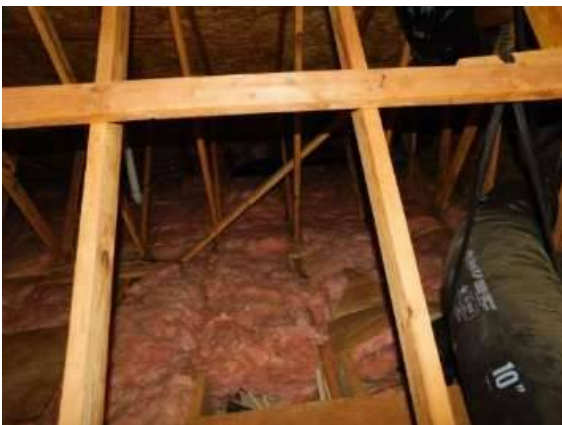
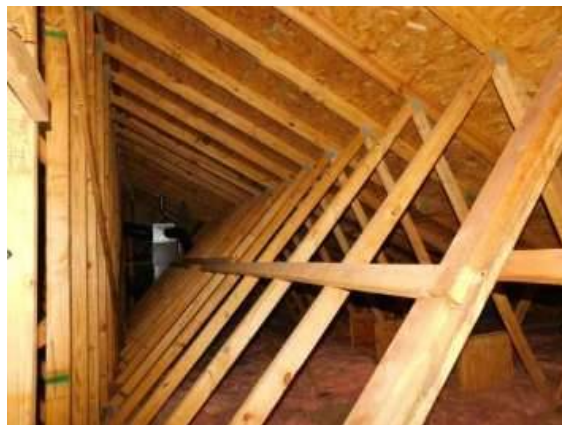
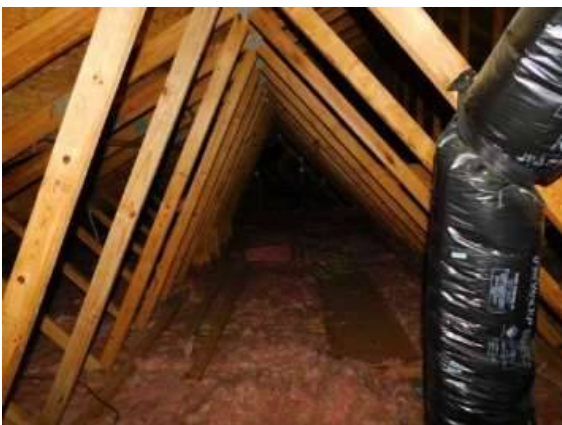
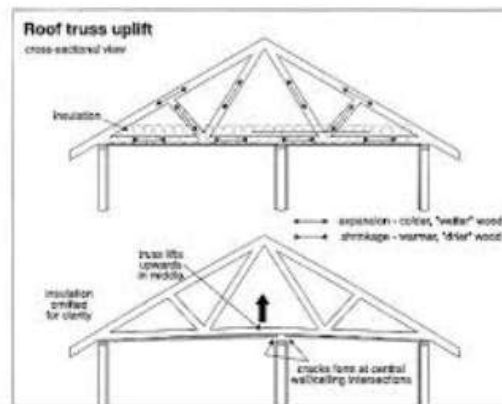
28) Monitor - The roof structure of this home has trusses. There is a phenomenon called truss uplift. It's explained at the link below. In essence, due to the fact that the bottom parts of the truss are embedded in insulation, in the winter, the upper parts of the trusses expand or contract differently than the truss cords embedded in the insulation. Consequently, the trusses flex. This can result in the appearance of cracks in ceilings or walls at specific times of the year due to the temperature differences between the parts of the trusses.

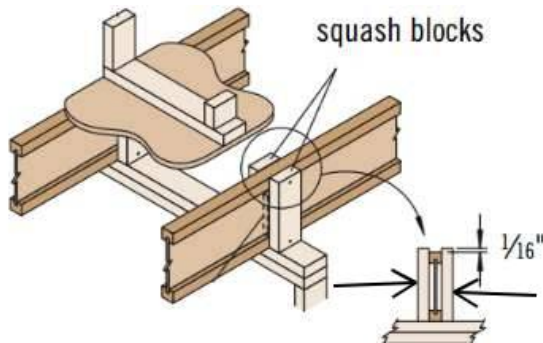
29) Repair/Maintain/Service, Evaluate - The floor structure has engineered joists. Squash blocks are often required at the load bearing ends of the engineered joists and at other points where the engineered joist is supporting a bearing wall above. The squash blocks help carry the load of the bearing walls. The primary design aspect of the engineered joists is to carry the load of the floor above and not, the bearing wall.

There are exposed areas of the engineered joist around the perimeter above the foundation and above the beam in the central part of the basement and no squash blocks are seen. The structural engineer or highly qualified framing contractor should evaluate and recommend repairs if that professional deems necessary.

Photo 29-1 This illustration shows where squash blocks should be located and how they help carry the load of the bearing wall above. No such blocks were seen in this basement.

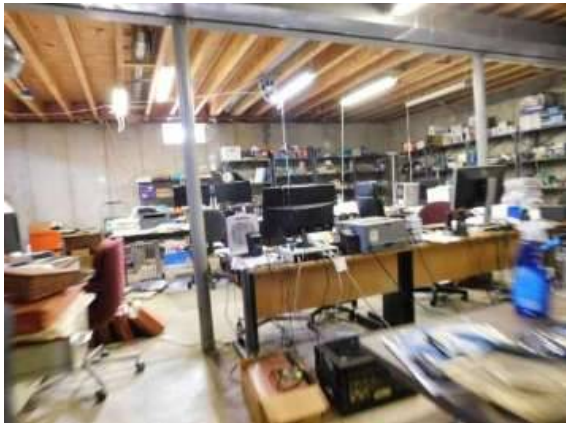
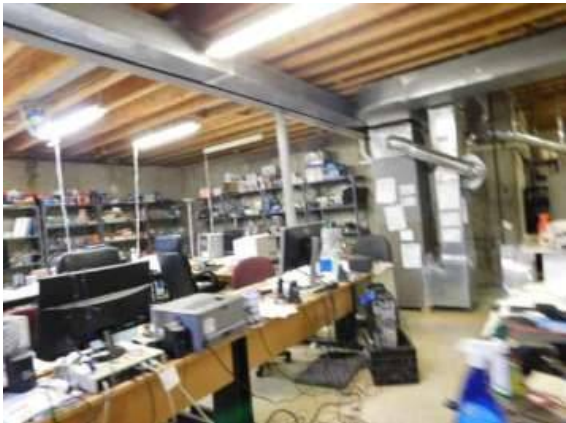
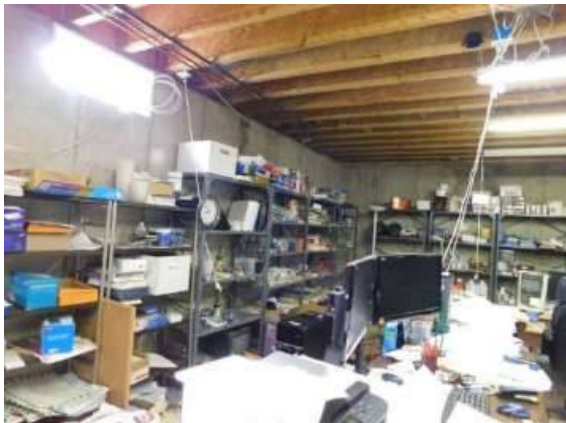
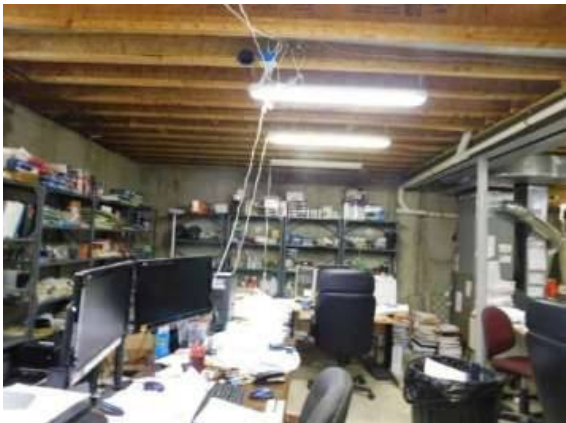
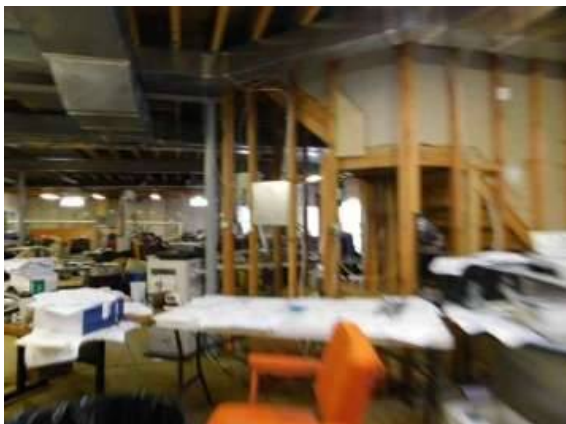
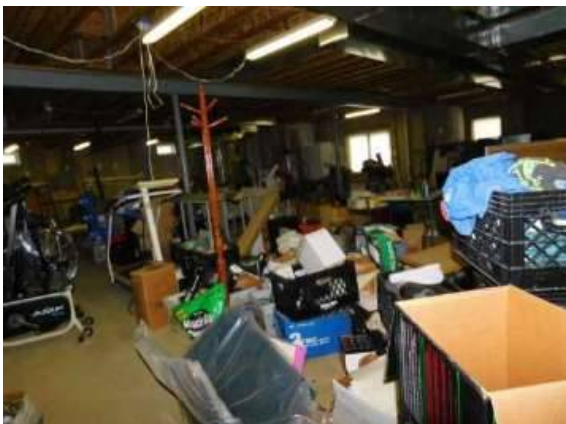
31) Exclusion, Comment/FYI - Much of the basement was obscured by shelving, desks, file cabinets, a safe and stored items. These significantly limit the visual inspection of the foundation and structure behind these obscured areas including for the purposes of the wood destroying insect inspection. Please note that portions of the house and structure that are behind these obstructions are not available for visual inspection and therefore excluded from the inspection. It is always possible that latent (aka hidden) material defects exist behind these obscured areas. In accordance with the NJ home inspection administrative code, the inspector conducts a visual inspection, "...without requiring the moving of personal property...destructive measures..." . When

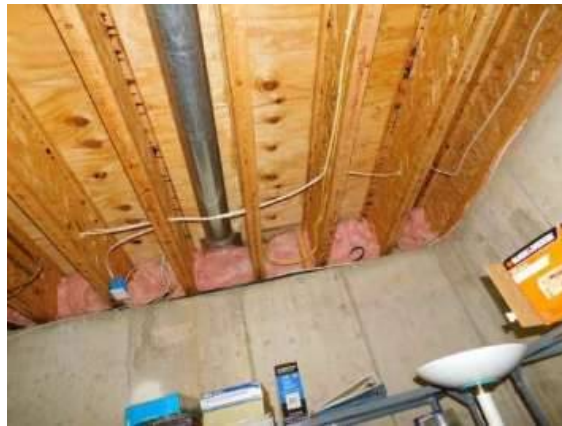
Photo 32-2

32) Comment/FYI - There was fiberglass insulation seen atop the foundation along the rim joist.

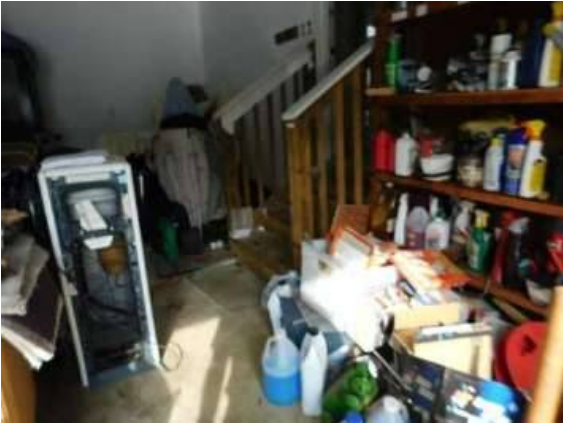
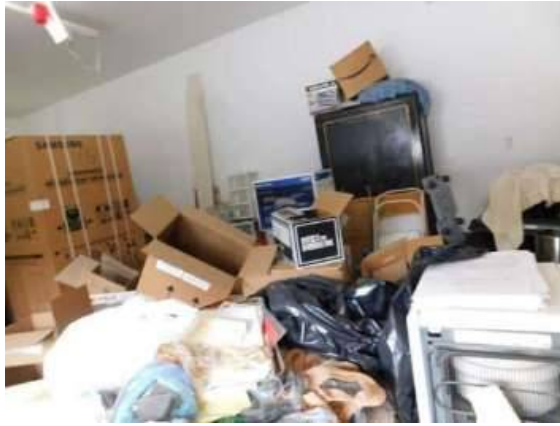
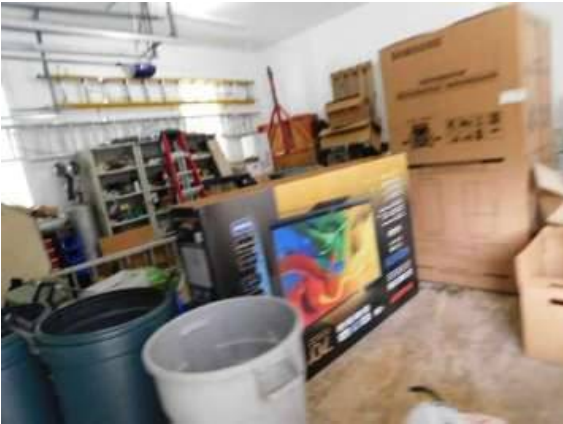
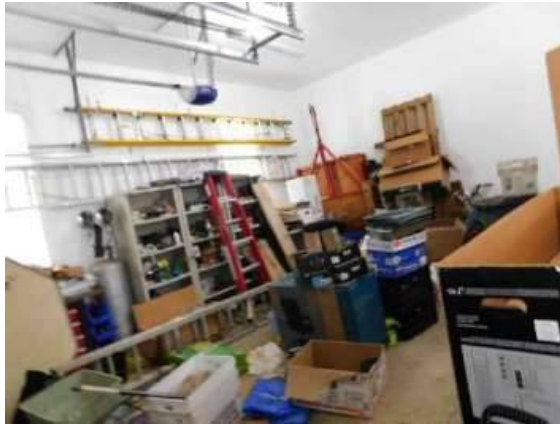
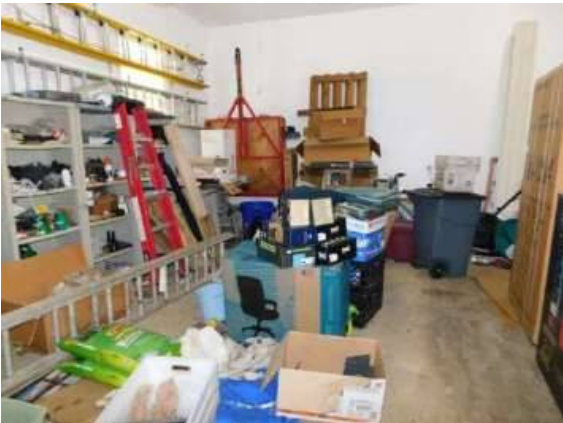
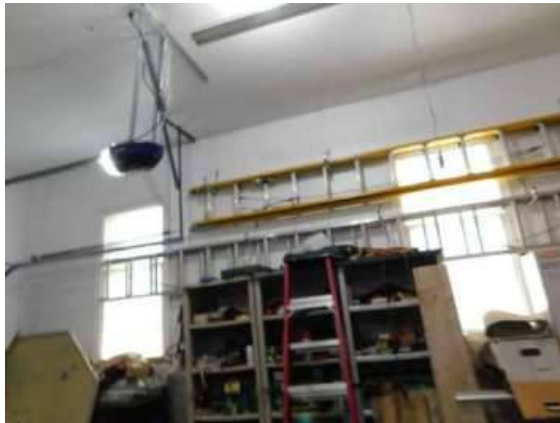
35) Exclusion, Comment/FYI - Areas of the garage were obscured by possessions. Areas that were not readily accessible for visual inspection are excluded from the inspection in accordance with New Jersey home inspection standards of practice. Please note that after the seller's possessions are removed damage, cracks, or deterioration may then be exposed including indications of wood destroying insects. Portions of the garage (house and structure) that are behind these obstructions are not available for visual inspection and therefore excluded from the inspection. It is always possible that latent (aka hidden) material defects exist behind these obscured areas. In accordance with the NJ home inspection administrative code, the inspector conducts a visual inspection, "...without requiring the moving of personal property...destructive measures..." . When furnishings, stored items, debris or other obstructions are present, all areas or items that are obscured, concealed or not readily accessible are excluded from the inspection.

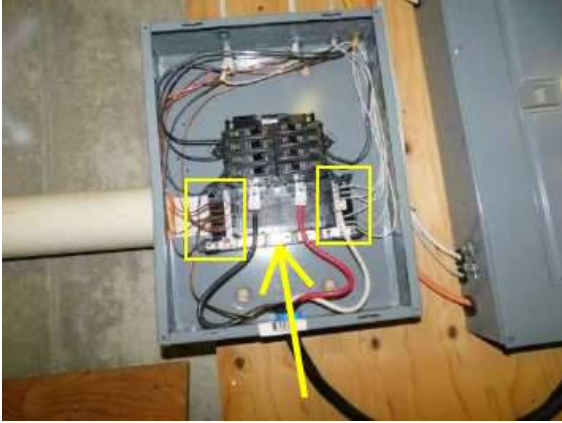
37) Material Defect/Safety, Replace - The neutral bus bar at sub-panel(s) B appeared to be bonded (connected) to the panel, and should instead be "floating" or insulated from the panel. This is a shock hazard. Recommend that a licensed electrician repair per standard building practices.

Photo 37-1 The grounds are connected on the left and the neutrals on the right. However, the horizontal bar across the bottom connects both instead of the grounds and neutrals being electrically isolated from each other.

The client is urged to submit a Freedom of Information Act (FoIA) or Open Public Records Act (OPRA) with the Manalapan Building Department to determine if the added electrical work in the basement was A) Permitted. B) Done by a licensed electrician and C) If it was inspected by the Manalapan Building Department's electrical inspector.

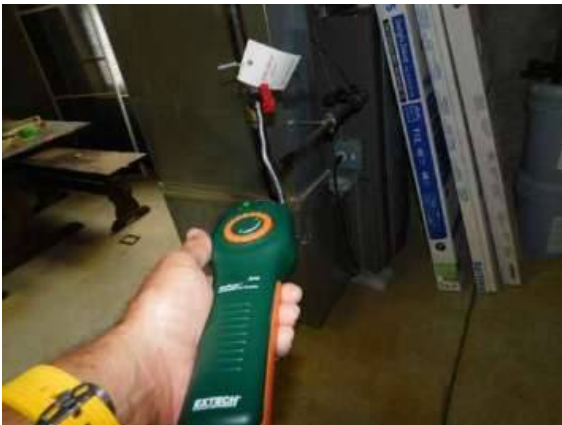
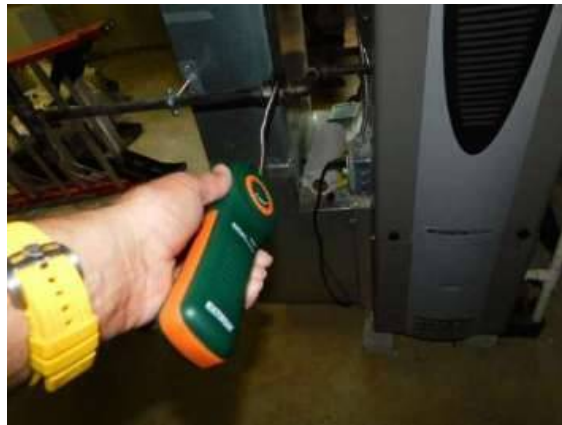
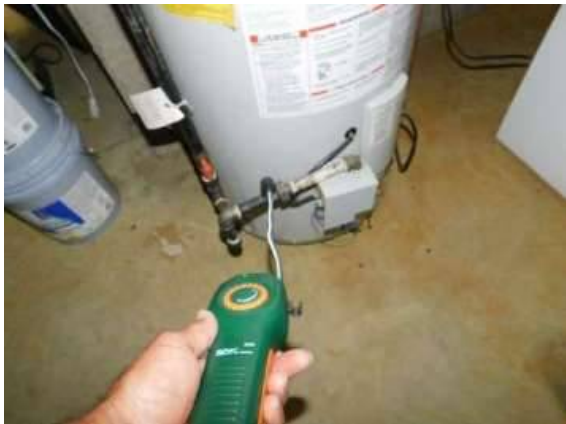
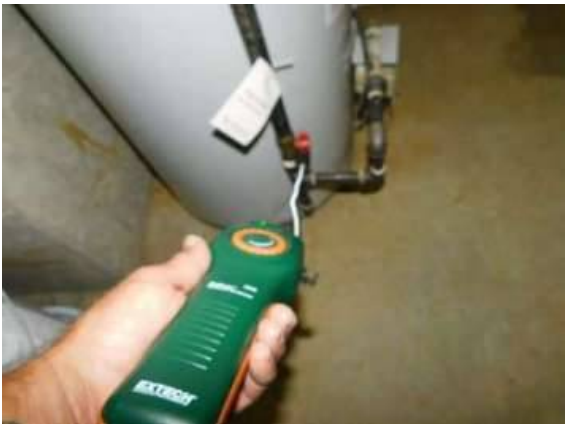
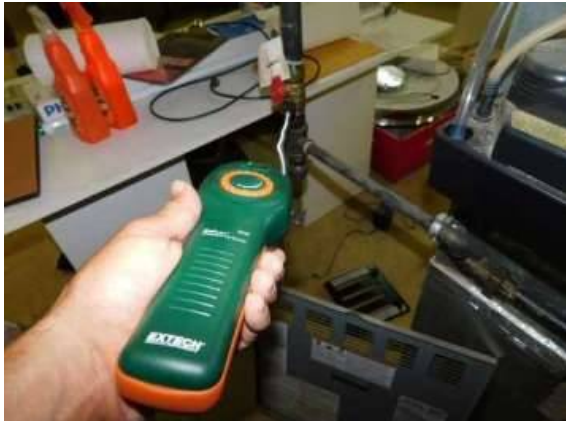
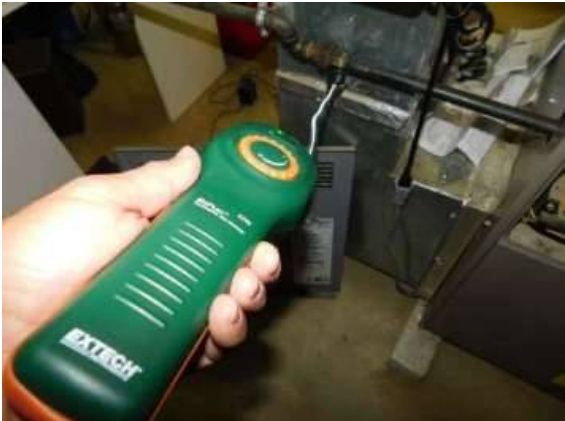
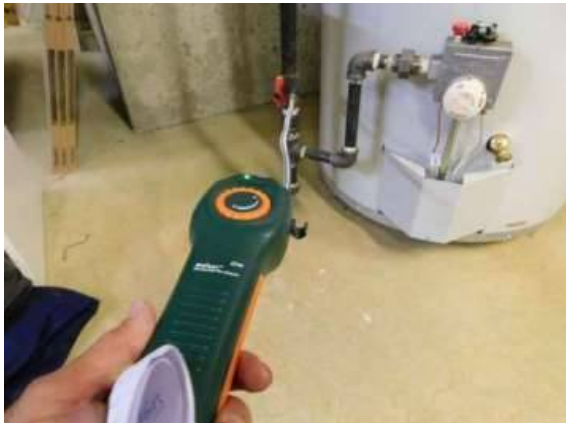
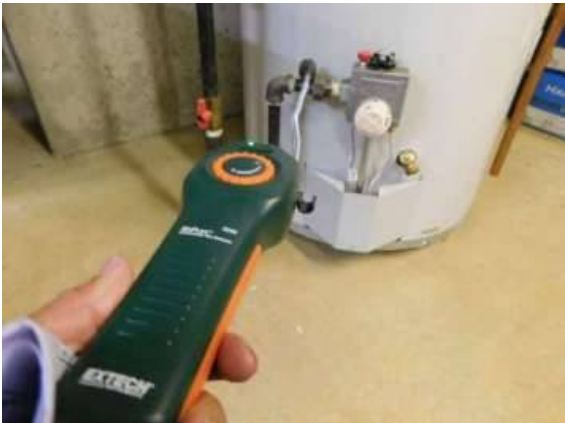
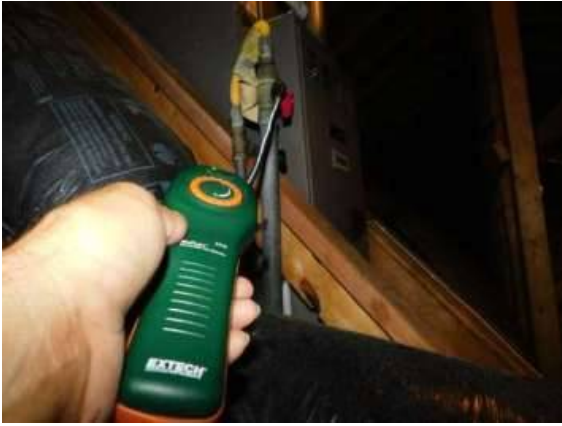
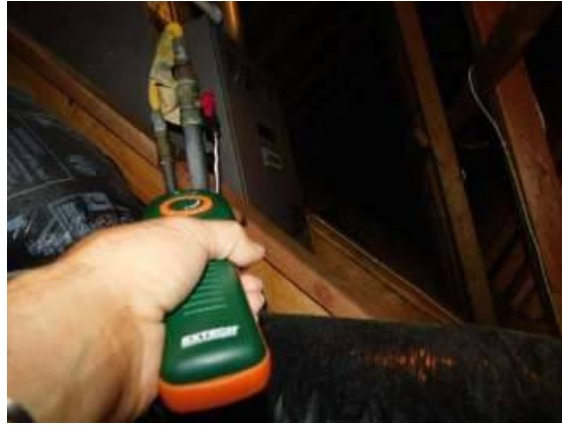
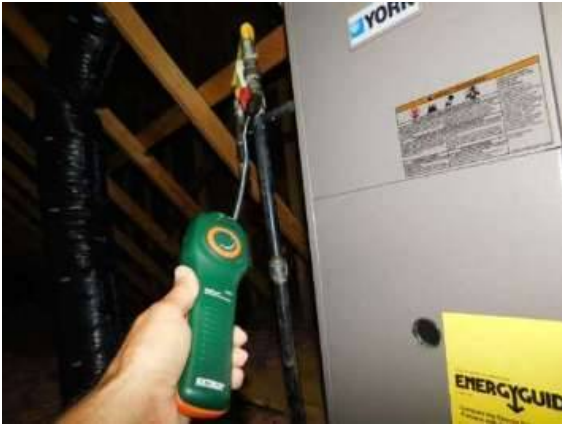
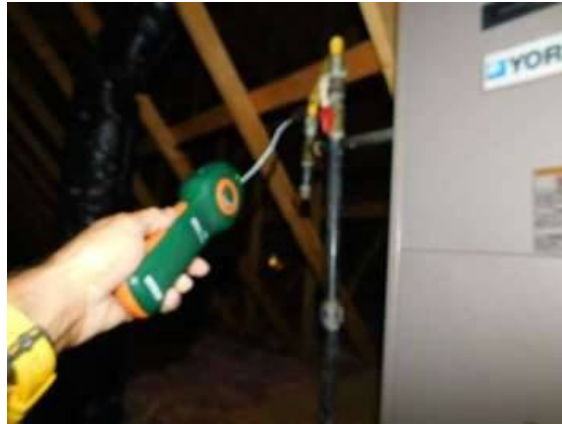
48) Monitor, Comment/FYI - The natural gas lines around the furnaces and the water heaters were checked with a combustible gas detector for leaks. There was no access behind the clothes dryer or the kitchen stove. None were detected by the instrument. This is absolutely not a substitute for owner diligence, awareness and appropriate response if a natural gas odor is ever detected. Immediately leave the house and call 911.

Green meter with orange dial can be seen in the photos. The probe extends to the gas piping for testing for leaks. None were detected. Few examples shown below.

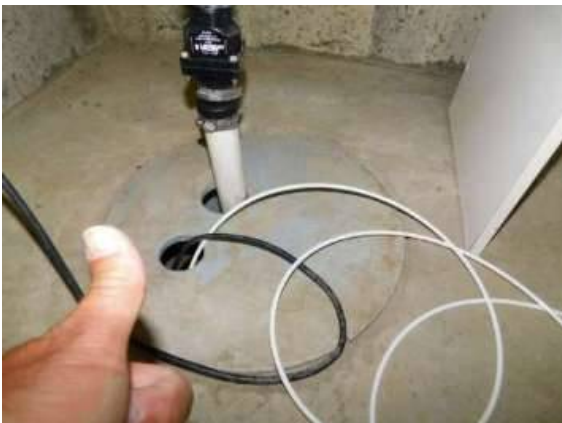
Photo 49-1

The sump pump's float switch was manually lifted and the pump turned on.

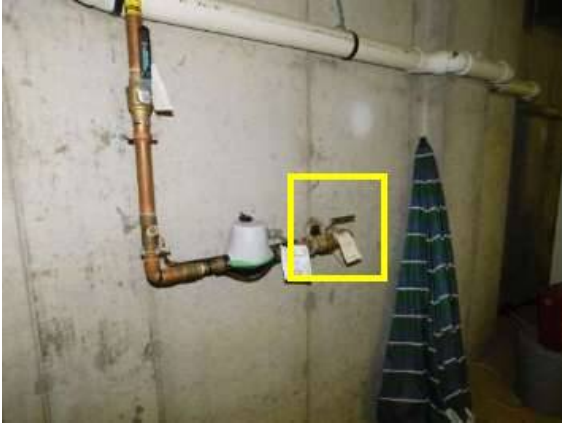
50) Comment/FYI - Water meter and main water shut off.

Photo 50-1 Close up of this area in the next photo.

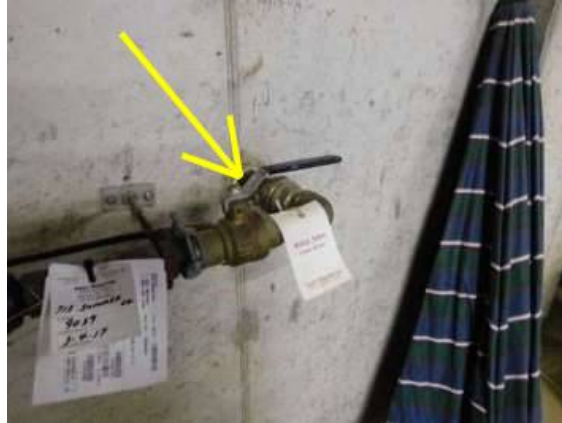
Photo 50-2 Main water shut off valve.

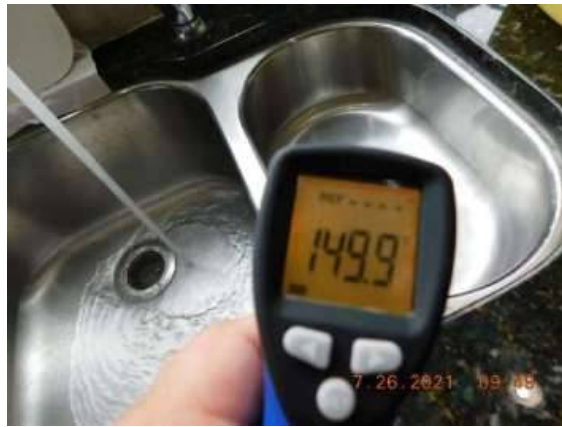
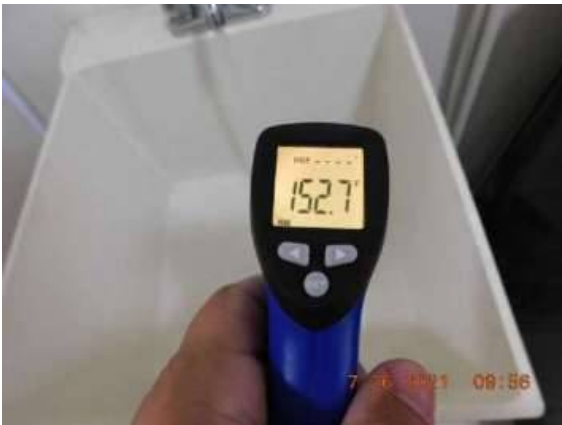
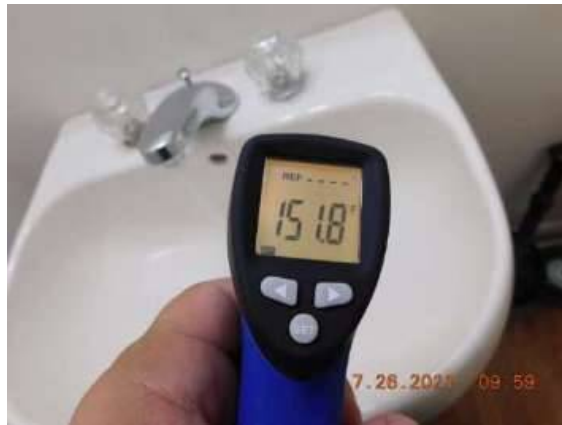
53) Material Defect/Safety, Maintain - The hot water temperature was greater than 120 degrees Fahrenheit. This is a safety hazard due to the risk of scalding. The thermostat should be adjusted so the water temperature doesn't exceed 120 degrees.

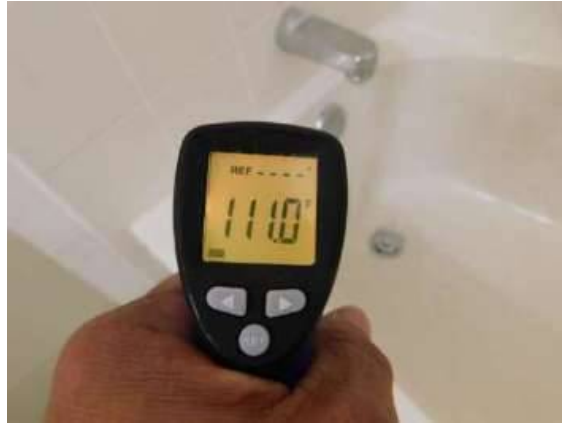
Photo 54-2

54) Repair/Maintain/Service, Evaluate - Please note that one or more of the blender (aka mixing) valves at one or more bathtubs or showers may require adjusting. A blender valve is one valve with both hot and cold water going into the single valve. As its name implies, the valve mixes or blends hot and cold water. If it's not adjusted properly, there's not enough hot water to overcome the cold water that's there. As seen in other homes inspected, often the easiest way to increase the water temperature at these poorly adjusted mixing valves is to simply increase the temperature at the water heater's thermostat. The water at the poorly adjusted blender valve is increased to a minimally suitable temperature but the water temperatures at all the other hot water faucets is now too high.

Recommend evaluation by a licensed plumber and the blender valves be properly adjusted and then the water heater can be adjusted so that the water at all fixtures is correct.

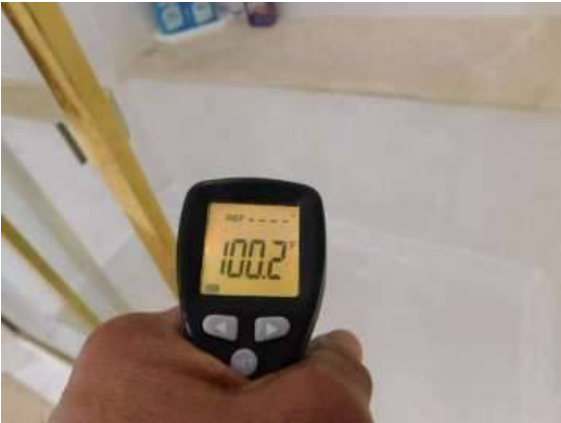
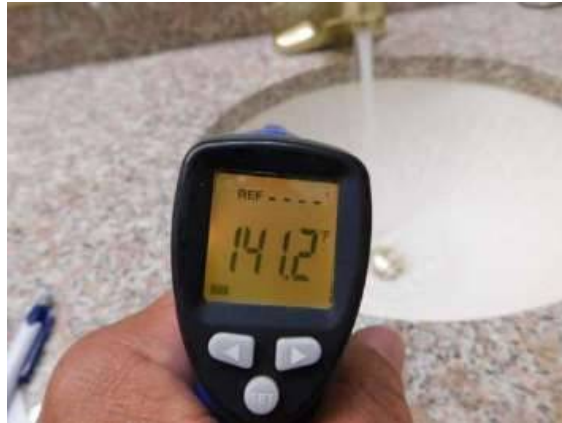
Photo 54-3 An even greater difference was seen between the sink and shower in the master bathroom.

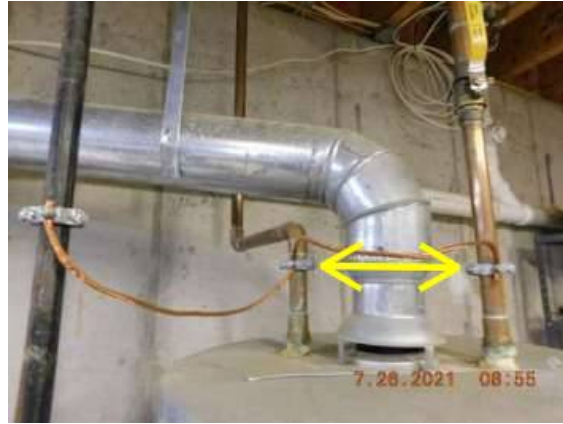
Photo 55-2

55) Repair/Maintain/Service - One or more bonding or grounding clamp(s) attached to copper water-supply pipes appeared to be made of steel. When these electrically energized dissimilar metals are in contact with each other, corrosion can occur on the water-supply pipes and result in leaks. Recommend that a qualified person replace steel clamps on copper pipes as necessary, with clamps made of brass, bronze or copper.

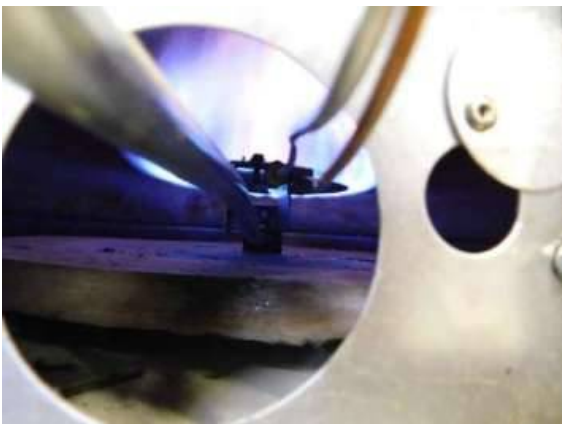
Photo 57-1

57) Comment/FYI - The office side unit water heater's burner flame was blue in color indicating proper combustion. As seen through the water heater's sight glass.

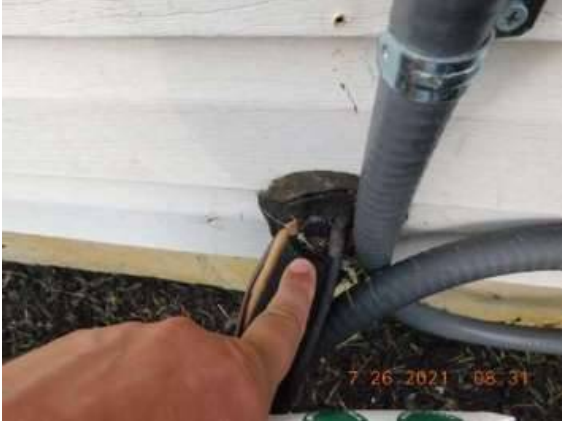
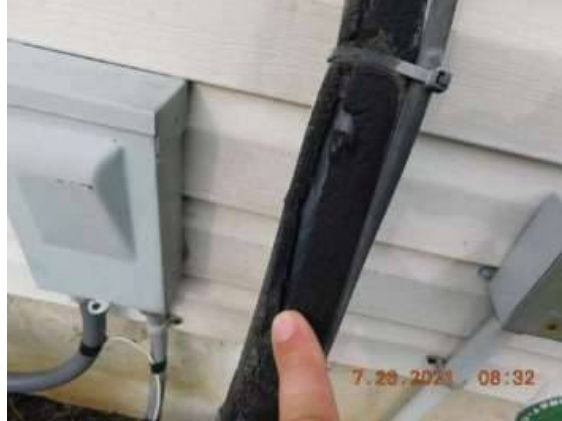
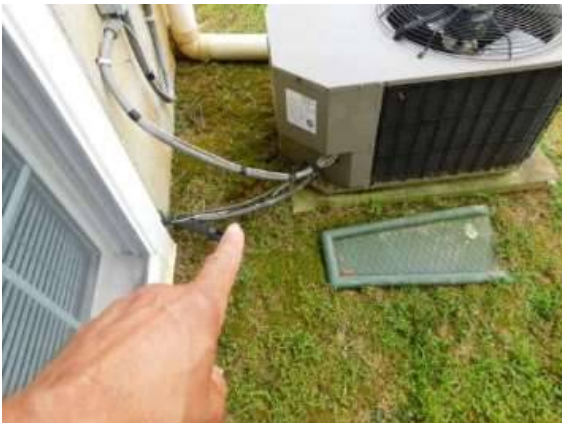
60) Repair/Maintain/Service - Insulation on the air conditioning condensing unit's refrigerant lines was deteriorated or missing in some areas. This may result in reduced efficiency and increased energy costs. Recommend that a qualified person replace or install insulation as necessary.

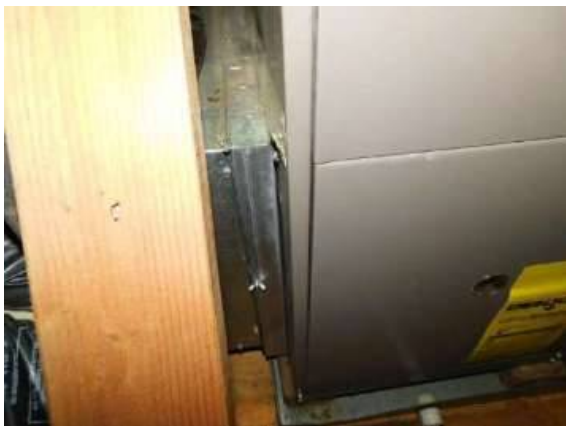
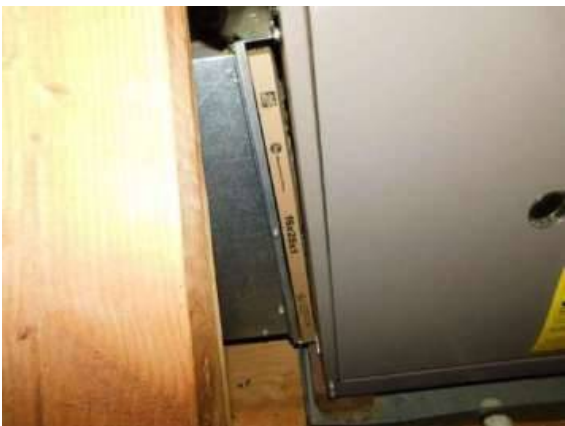
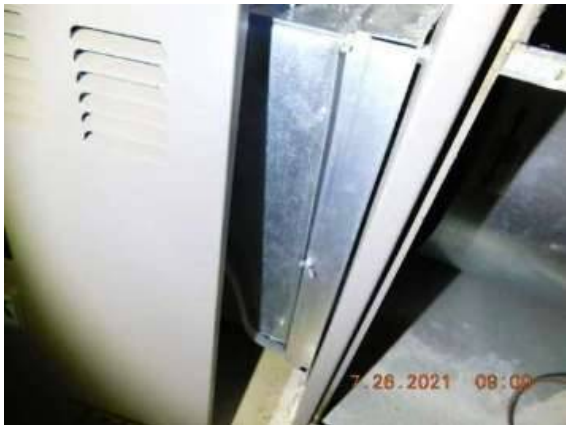
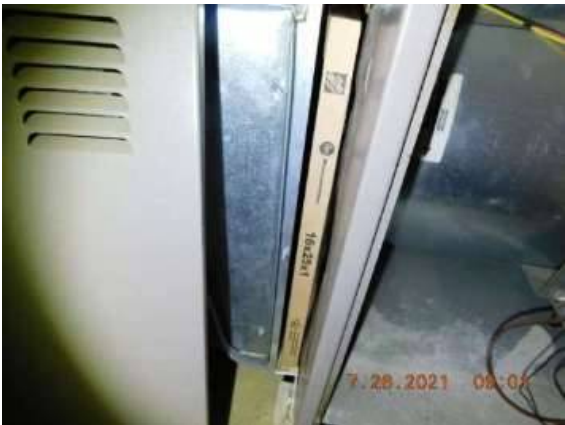
Photo 61-1 All four filter chambers and exposed filters are shown here and the following photos.

61) Maintain - Recommend replacing or washing HVAC filters upon taking occupancy depending on the type of filters installed (disposable or reusable). Regardless of the type, recommend checking filters monthly in the future and replacing or washing them as necessary and in accordance with the filter manufacturer's instructions. How frequently they need replacing or washing depends on the type and quality of the filter, how the system is configured (e.g. always on vs. "Auto"), and on environmental factors (e.g. pets, smoking, frequency of house cleaning, number of occupants, the season).

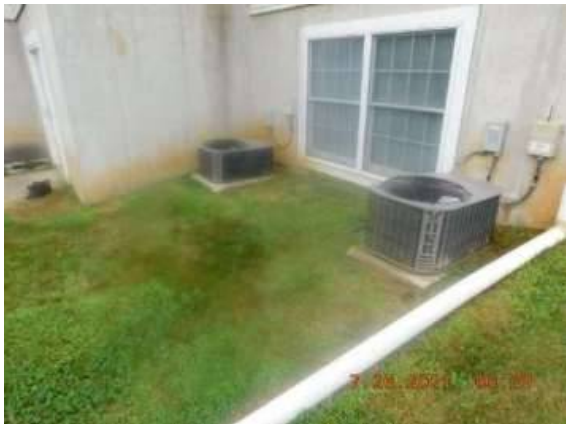
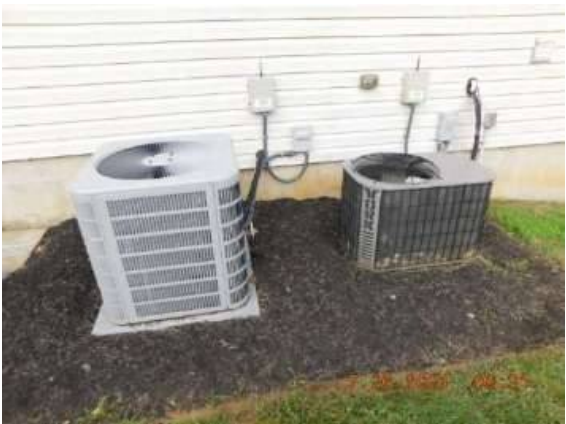
The left unit by the garage doors in December 2018. All of the other units were manufactured in 2005.

Please note that it's possible that the refrigerant used in the AC system may no longer be available and if one element of the AC system needs replacement then the entire central AC system would require replacement.

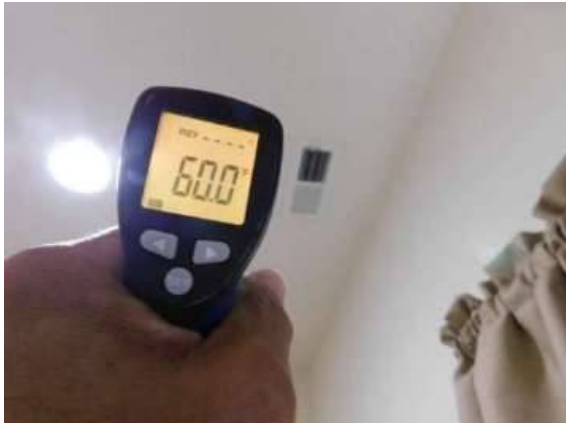
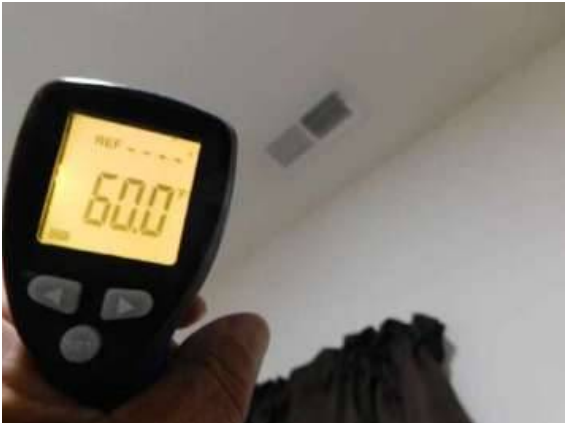
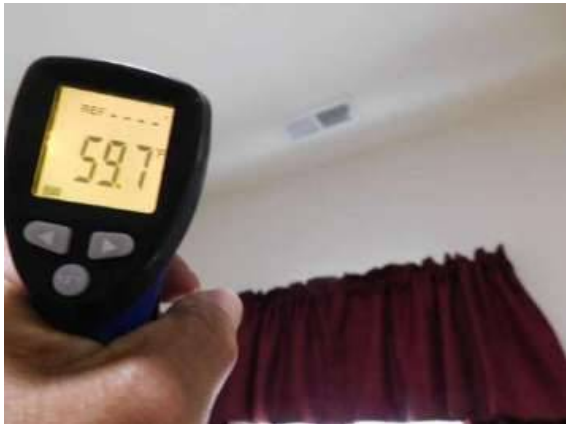
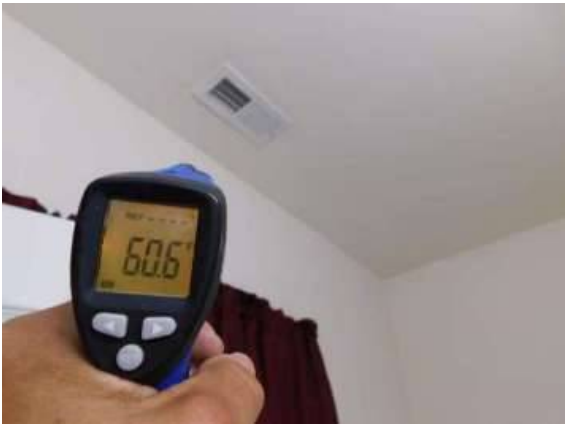
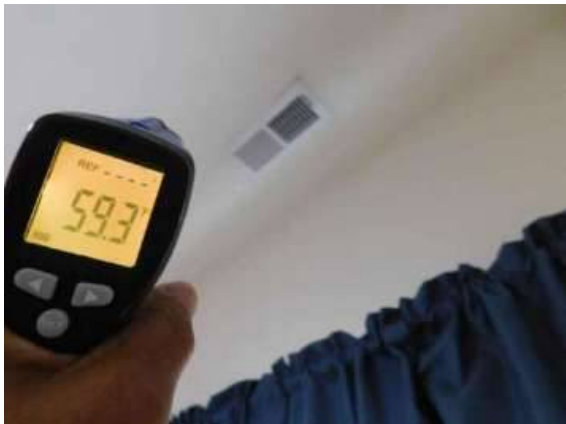
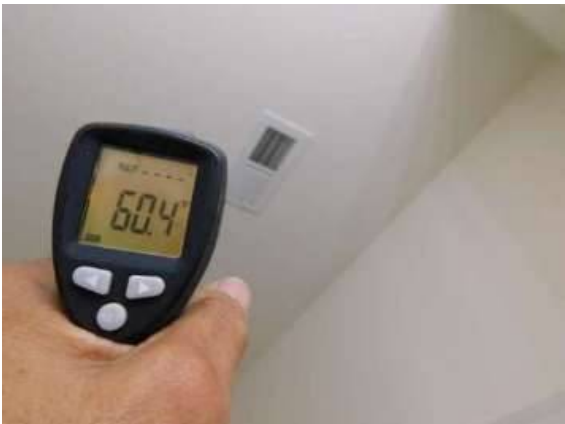
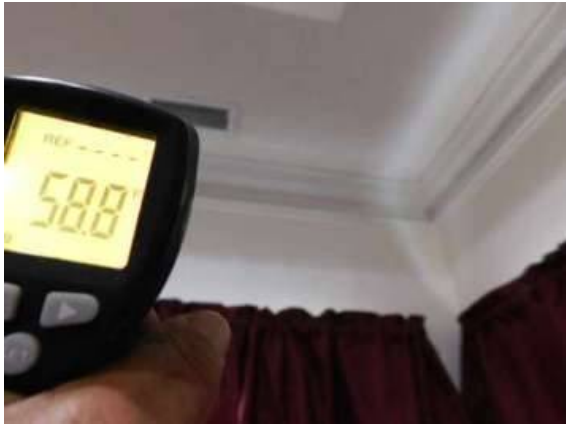
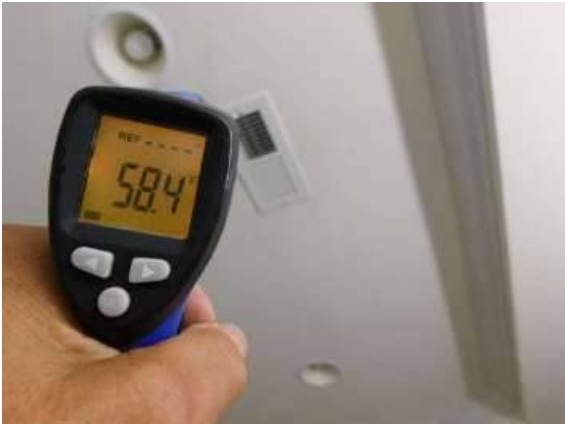
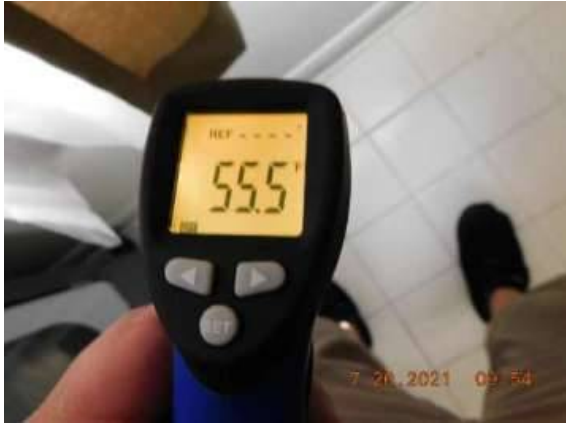
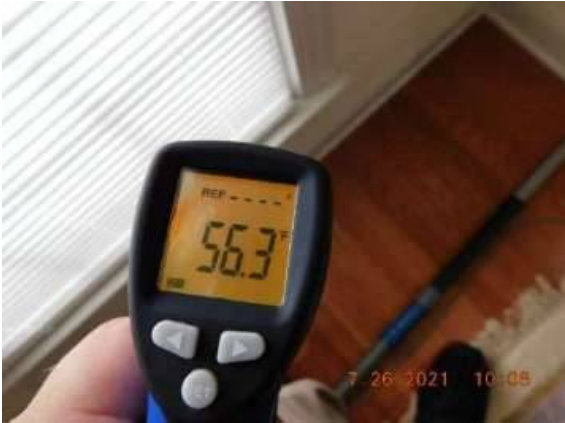
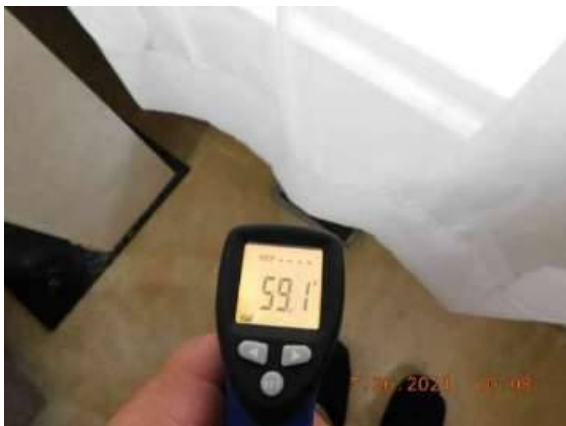
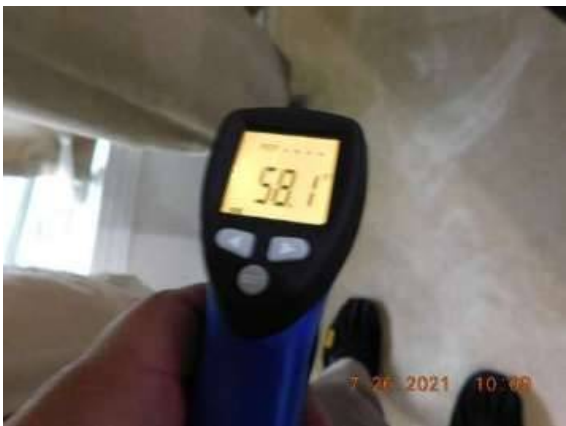
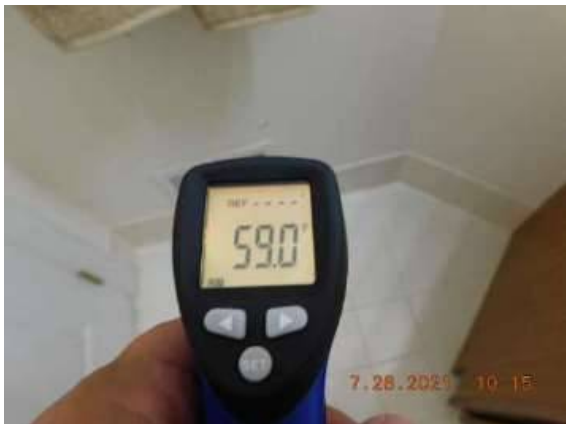
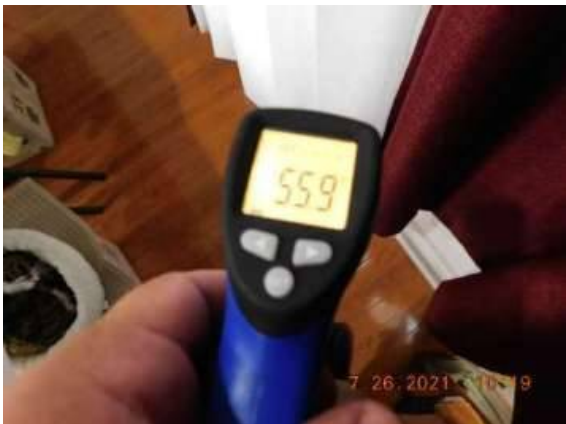
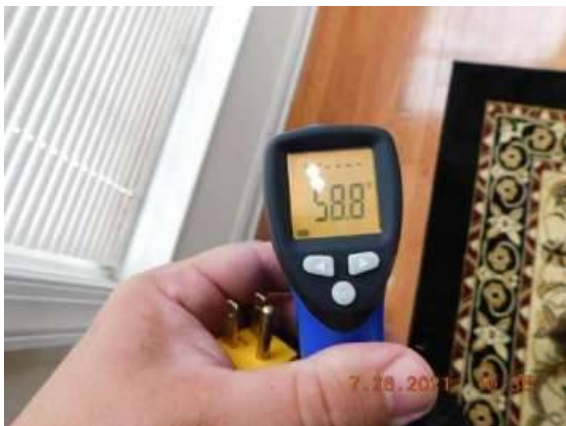
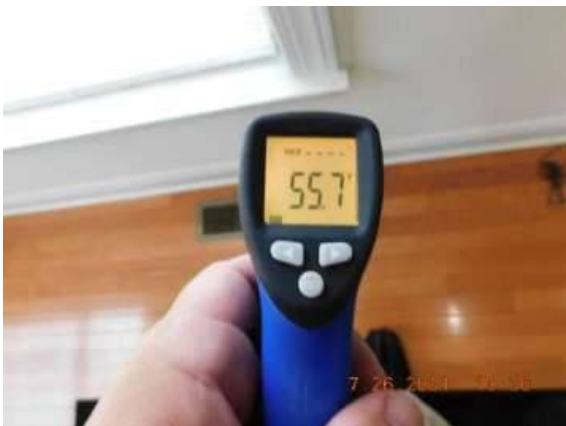
65) Comment/FYI - Sample AC temperatures. All accessible air supply registers were measured. A few examples are shown.

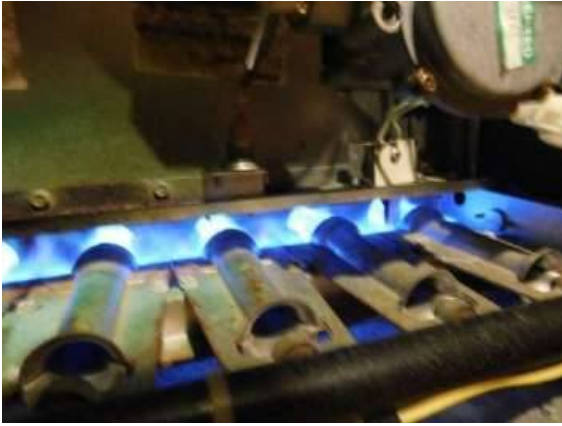
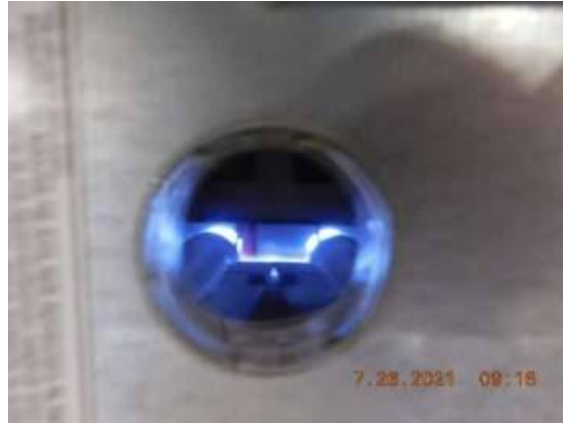
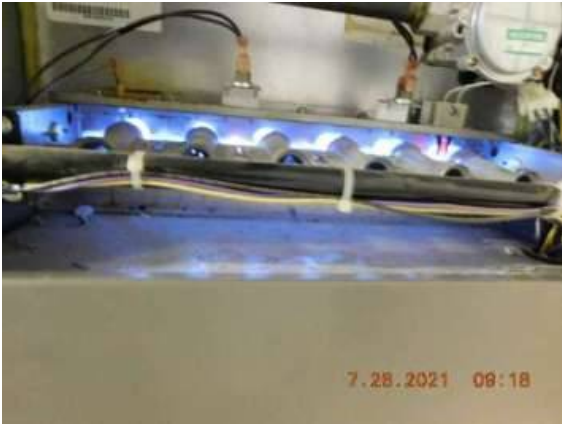
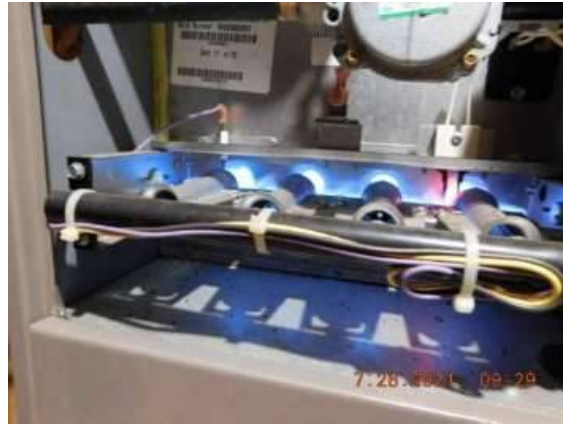
66) **Comment/FYI** - Each furnaces' burners were blue in color indicating proper fuel combustion.

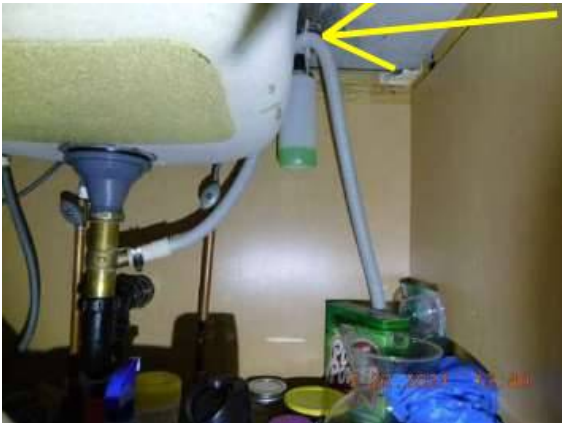
Photo 70-1 This is an example of a high loop from a DIFFERENT property.

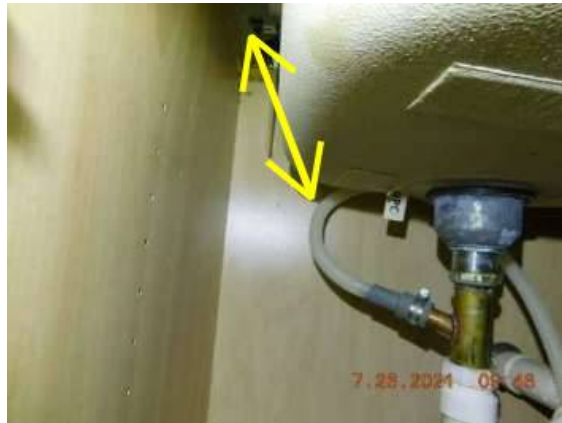
70) Replace, Evaluate - No high loop or air gap was visible for the dishwasher drain. A high loop is created by routing the drain line up to the bottom surface of the counter top above and securely fastening it to that surface. An air gap is a device that makes the drain line non-continuous. Both of these prevent waste-water backflow from entering the dishwasher, and possibly flooding out of the dishwasher if/when a siphon occurs. Some newer dishwashers have these devices built in. The client should try to determine if these devices are built in to this brand and model of dishwasher (e.g. review installation instructions). If not, or if this cannot be determined, then recommend that a qualified contractor install a high loop and air gap per standard building practices.

Photo 70-2 The dishwasher drain line from THIS property, shown here, should be routed to the highest point underneath the countertop.

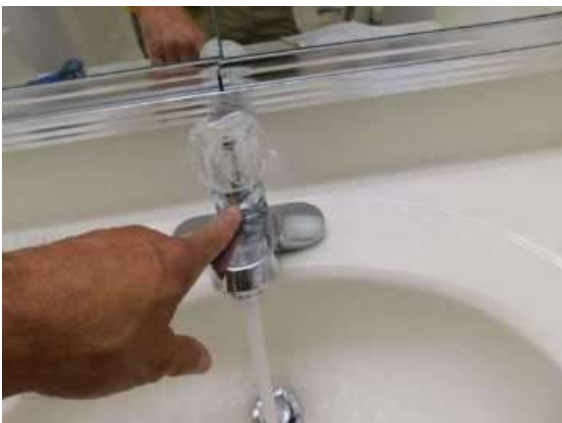
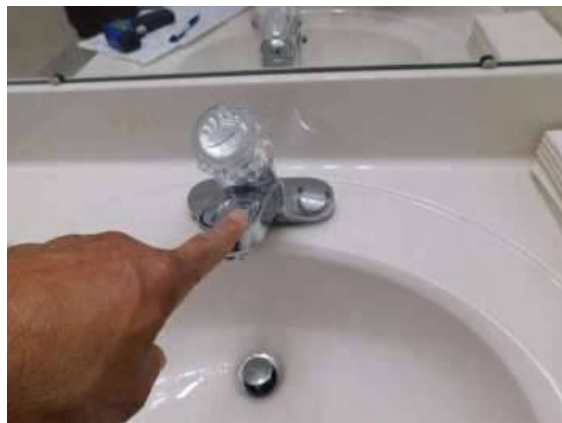
76) Repair/Maintain/Service - Water was leaking at the sink faucet base or handles at location(s) D and E. Recommend that a qualified plumber repair as necessary.
