Regal Home Inspections, LLC

Property Inspection Report

Property address: Any Street

Inspection date: Sunday, July 25, 2021

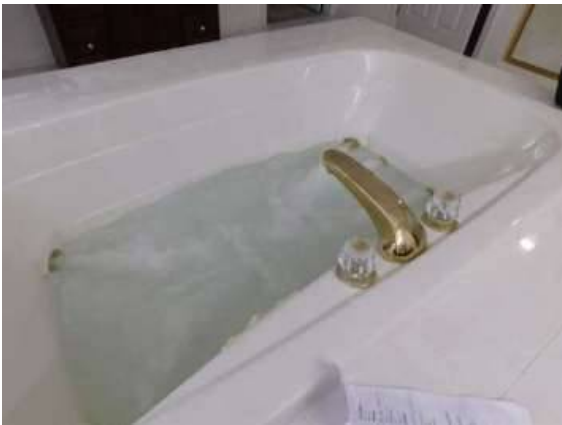
Photo 78-1

78) Comment/FYI - The jetted tub in the Master was filled and operated. Other than operation, the mechanical elements of the jetted tub were not inspected.

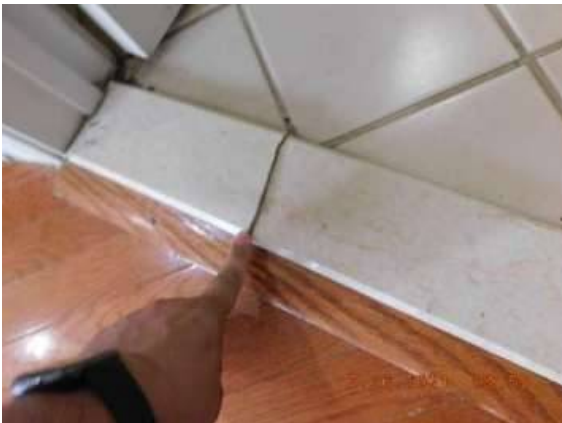
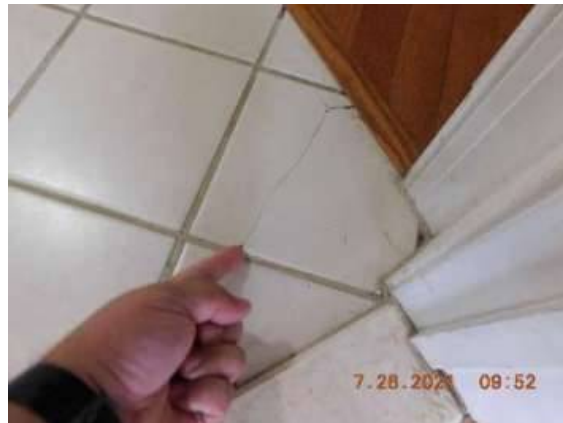
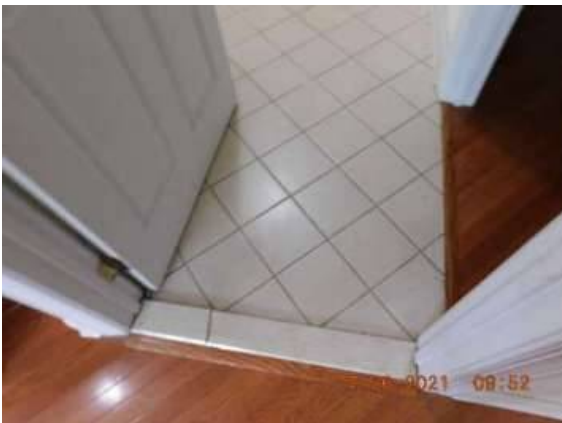
83) Repair/Maintain/Service - Tile, stone and/or grout in the flooring in one or more areas was deteriorated (e.g. loose or cracked tiles, missing grout) or substandard. If in a wet area, water can damage the sub-floor. Recommend that a qualified contractor repair as necessary.
