Regal Home Inspections, LLC

Property Inspection Report Seller's Inspection

**Property address: 6 Any Street
Marlboro, NJ 07746**

Inspection date: Sunday, November 14, 2021

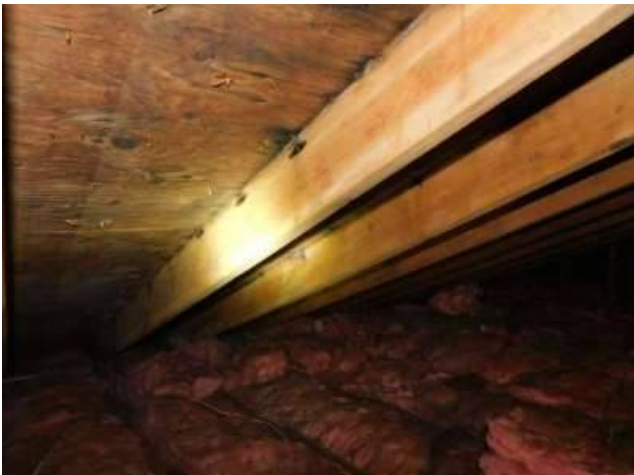
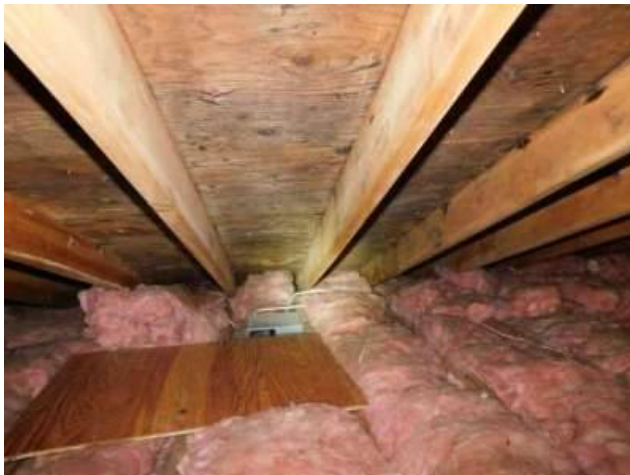
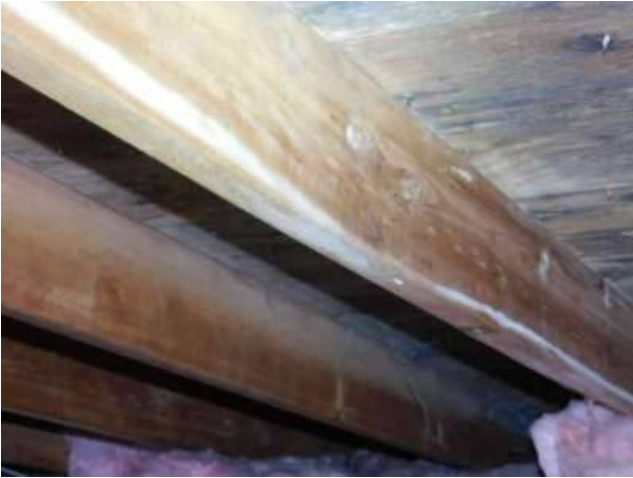
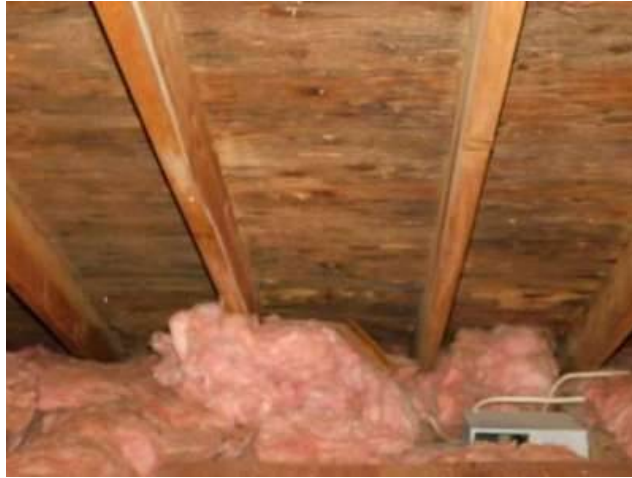
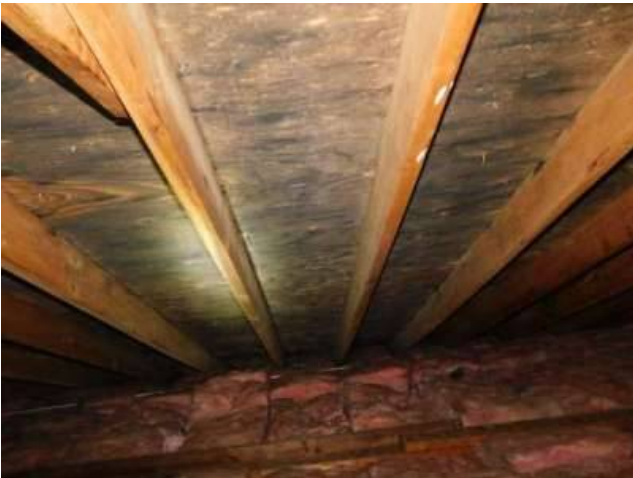
1) Repair/Maintain/Service, Evaluate - Microbial growths (Which could possibly be mold) were found at one or more locations in the attic. It is beyond the scope of this inspection to identify what substance or organism this staining is. However such staining is normally caused by excessively moist conditions, which in turn can be caused by plumbing or building envelope leaks and/or substandard ventilation. These conducive conditions should be corrected before making any attempts to remove or correct the staining. Normally affected materials such as drywall are removed, enclosed affected spaces are allowed to dry thoroughly, a mildewcide may be applied, and only then is drywall reinstalled. For evaluation and possible mitigation, consult with a qualified industrial hygienist or mold/moisture mitigation specialist.

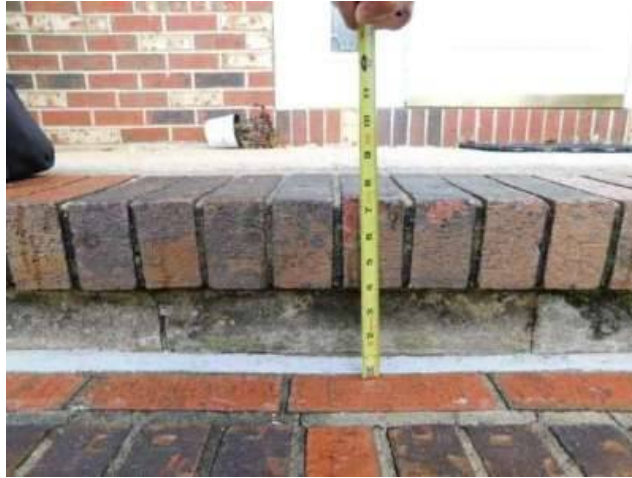
7) Material Defect/Safety, Repair/Maintain/Service - The risers for stairs at the front varied in height and pose a fall or trip hazard. Risers within the same flight of stairs should vary by no more than 3/8 inch. At a minimum, be aware of this hazard, especially when guests who are not familiar with the stairs are present. Recommend that a qualified contractor repair per standard building practices.

Photo 7-2 Approx. 7 & 1/4 inches.

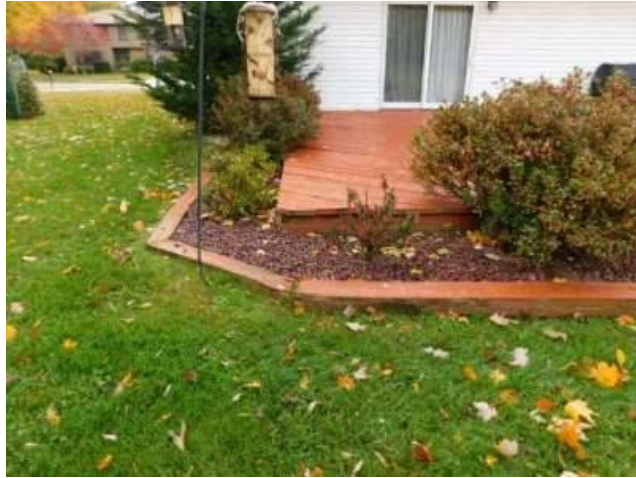
**Photo 8-2**

8) Repair/Maintain/Service - Soil was in contact with or too close to wooden deck substructure components. This is a conducive condition for wood-destroying organisms. Clearances to soil should be as follows:

It appears that this deck may be made with stringers. Stringers are joists that are resting on the ground. These are particularly susceptible to rot.

Pressure treated wood is typically rated for 25 year contact with soil, but the cut ends hidden below grade may not have been treated and can rot quickly. Support posts should be elevated above grade on concrete piers or footings, and be separated from the concrete by metal brackets or an impermeable membrane such as shingle scraps. For other components, soil should be graded and/or removed to maintain these clearances if possible. Otherwise, replacing non-treated wood with treated wood, or installing borate-based products such as Impel rods may help to prevent infestation and damage.

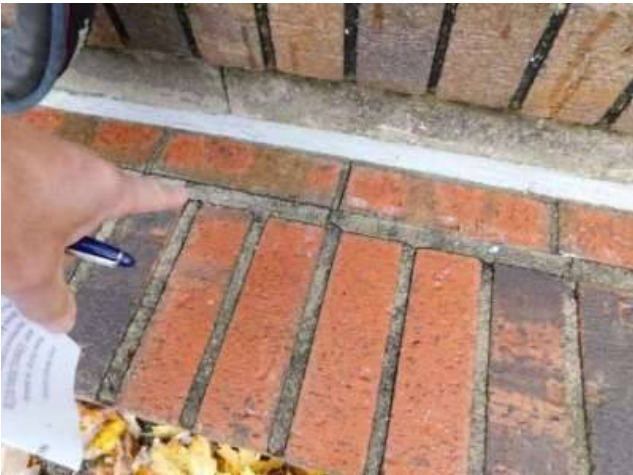
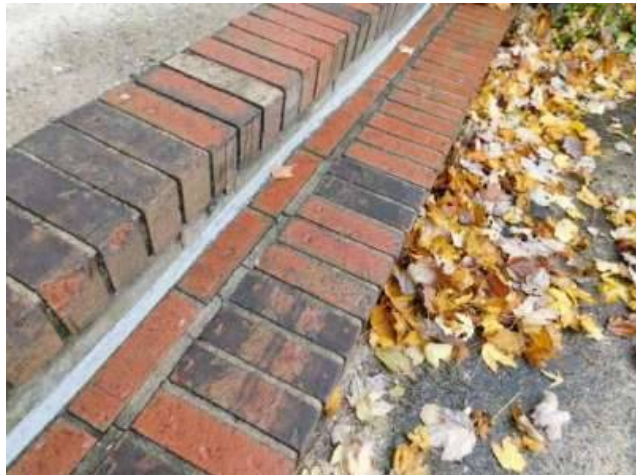
9) Repair/Maintain/Service - The bricks at one or more sets of steps have gaps in the mortar and cracks. These all allow water to penetrate the step/porch structure. In the freeze/thaw cycles of winter the ice will cause additional deterioration. Recommend that a qualified masonry contractor evaluate all and repair as that professional deems necessary. For example by sealing the cracks so water can't penetrate into the step/porch structure.

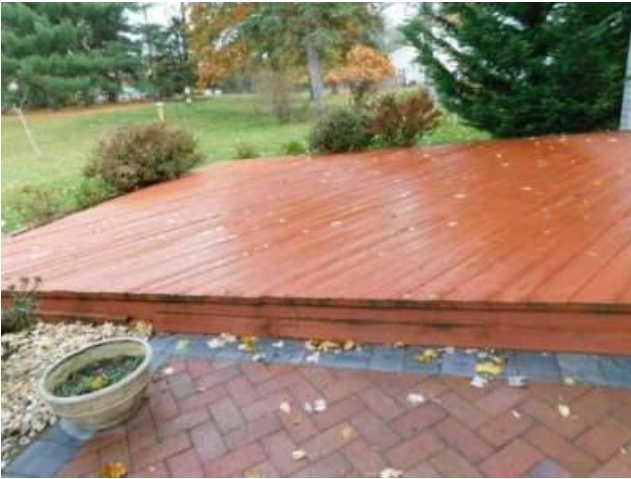
Photo 10-1

10) Exclusion, Comment/FYI - There was no access to the deck's structure. The low height prevented access. Areas of the deck's structure that were not readily accessible for visual inspection are excluded.

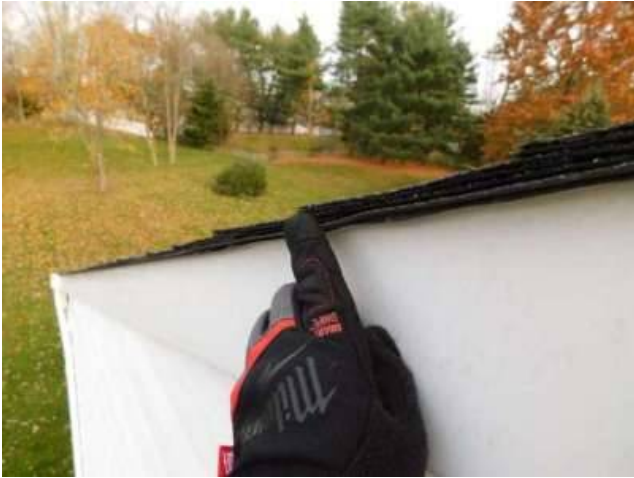
Photo 18-3 One layer seen.

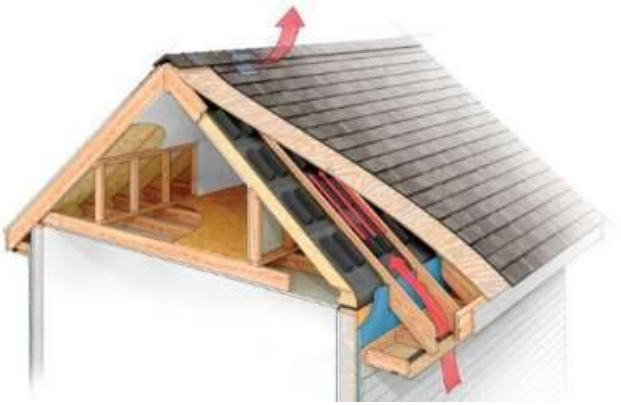
Photo 26-5 This illustration shows how cooler air should enter the attic via the soffit vents and exit via the ridge vent.

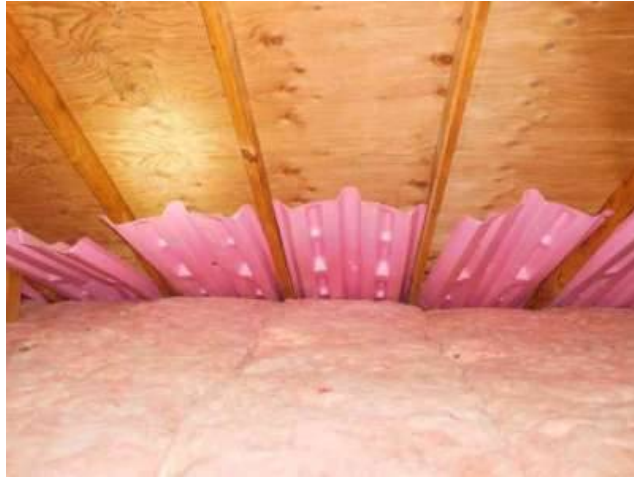
Photo 26-6 This is a photo from another home and shows how baffles can be used to maintain air flow from the soffit vents and how the baffles prevent the insulation from blocking the soffits.

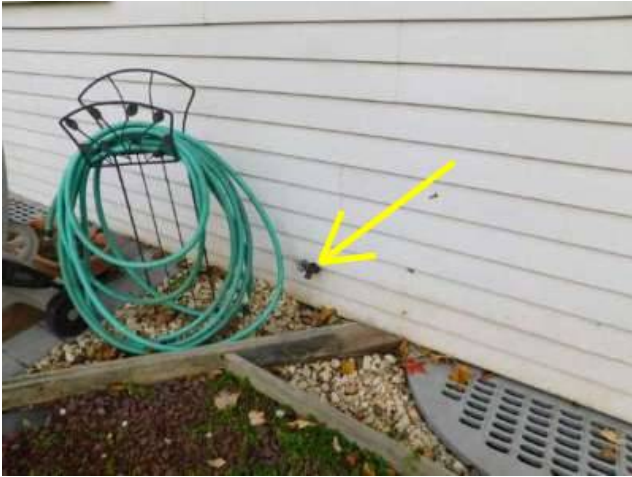
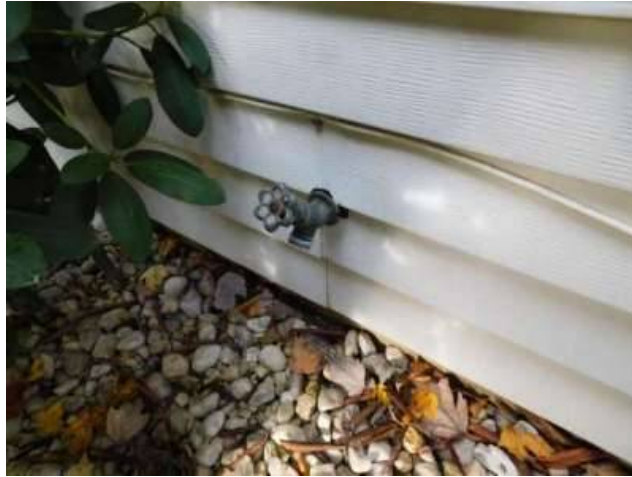
In the spring, after any potential of freezing temperatures have passed, open the inside valve and then close the outside valve to ensure there is no trapped air.

Please also be sure to disconnect any garden hoses from the hose bib for the winter so the bib drains properly.

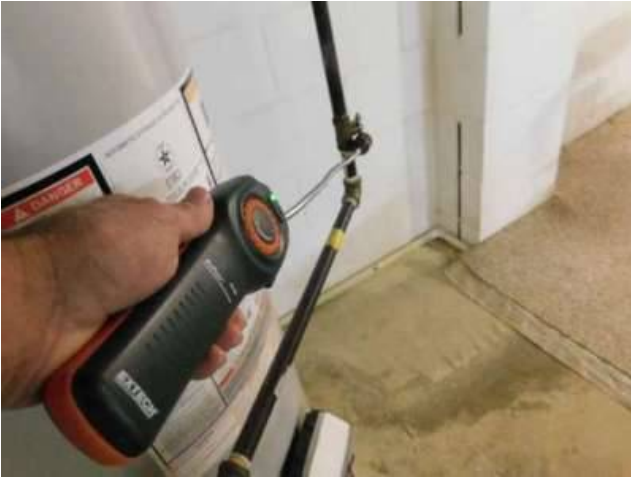
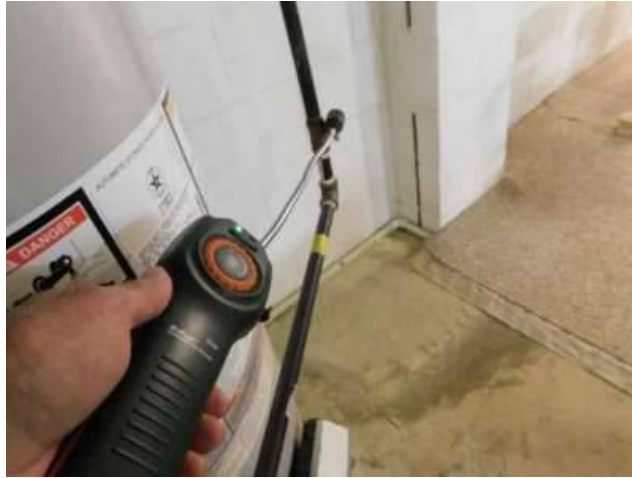
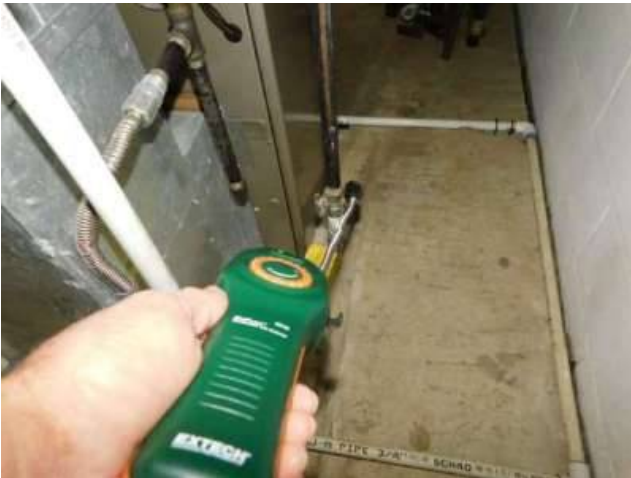
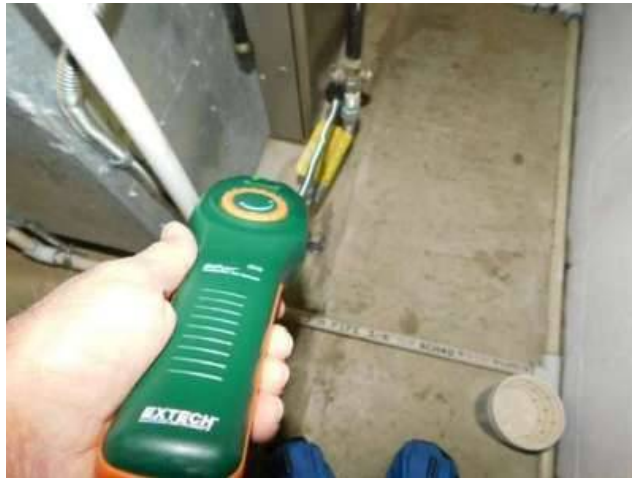
46) Monitor, Comment/FYI - The natural gas lines around the furnace and the water heater were checked with a combustible gas detector for leaks. There was no access behind the clothes dryer or the kitchen stove. None were detected by the instrument. This is absolutely not a substitute for owner diligence, awareness and appropriate response if a natural gas odor is ever detected. Immediately leave the house and call 911.

Green meter with orange dial can be seen in the photos. The probe extends to the gas piping for testing for leaks. None were detected. Few examples shown below.

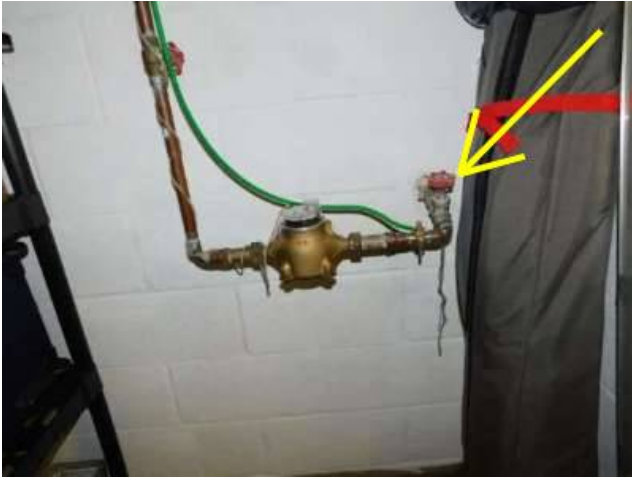
Photo 48-1

48) Comment/FYI - Water meter and main water shut off (Yellow arrow).

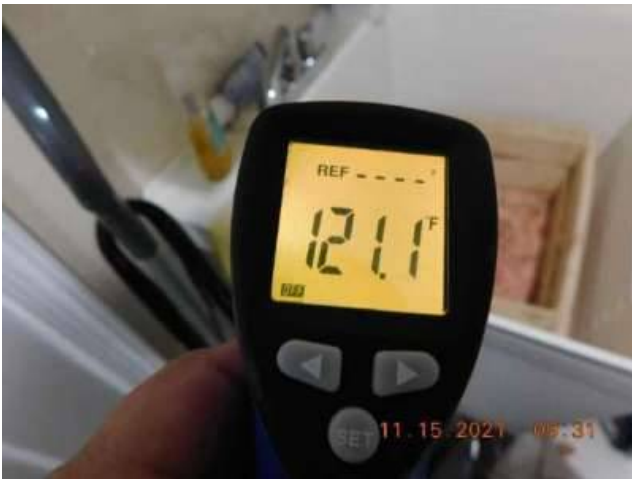
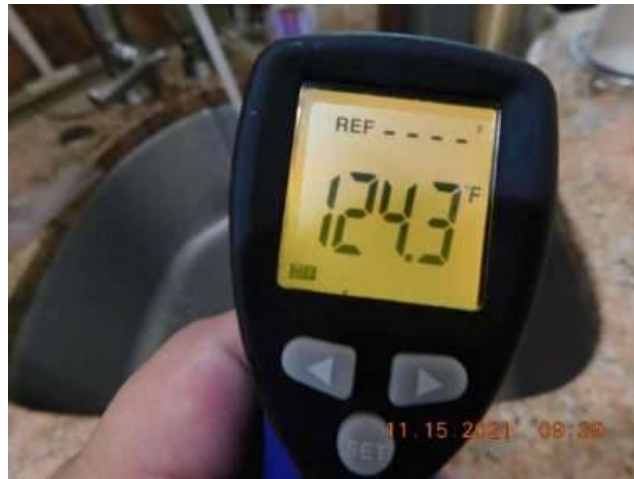
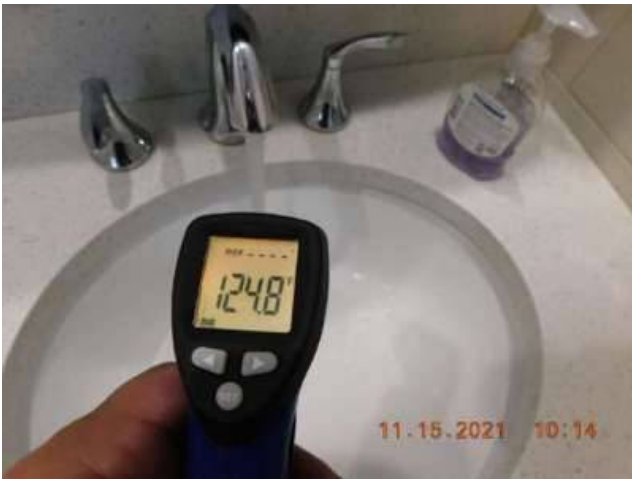
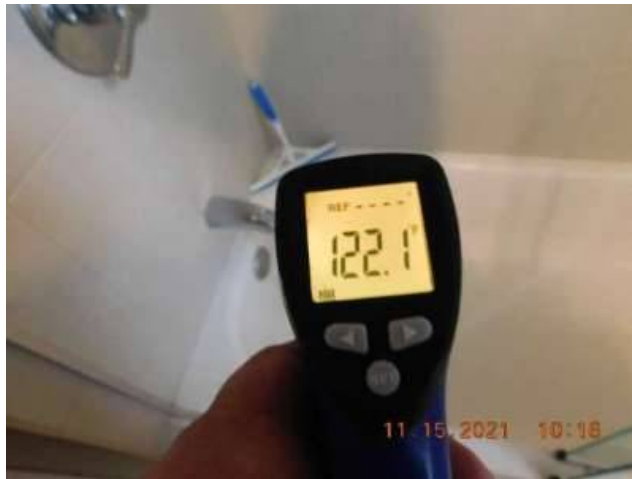
52) Material Defect/Safety, Maintain - The hot water temperature was greater than 120 degrees Fahrenheit. This is a safety hazard due to the risk of scalding. The thermostat should be adjusted so the water temperature doesn't exceed 120 degrees.

"The American Academy of Pediatrics identifies young children at risk for accidental hot tap water (HTW) burns and recommends that HTW temperatures be set no higher than 49 degrees C (120 degrees F). Studies show that a temperature of 52 degrees C (125 degrees F) can cause a full-thickness skin burn in 2 minutes and a temperature of 54 degrees C (130 degrees F) can result in a full-thickness skin burn in 30 seconds."

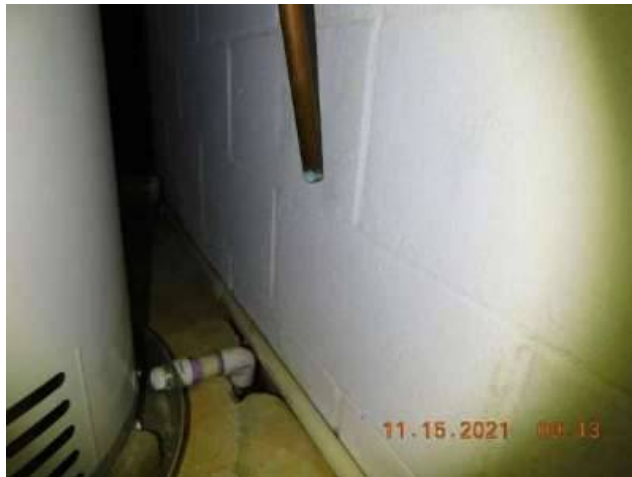
Photo 53-2

53) Replace - The temperature-pressure relief valve was leaking, based on corrosion seen at the end of the drain line. Recommend that a qualified plumber repair as necessary. For example, by replacing the valve.

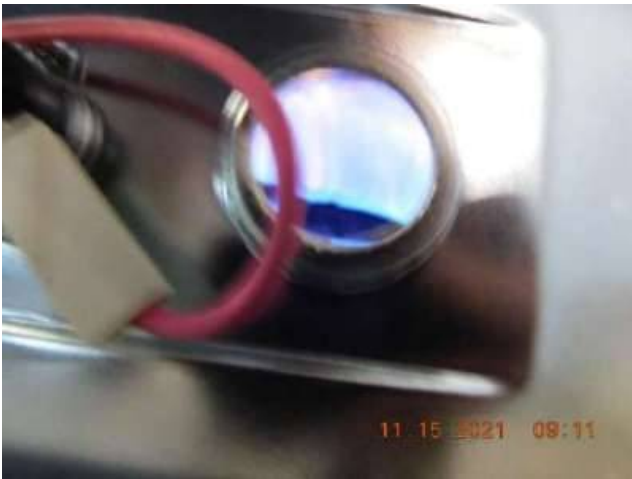
Photo 55-1

55) Comment/FYI - The water heater's burner flame was blue in color indicating proper combustion. As seen through the water heater's sight glass.

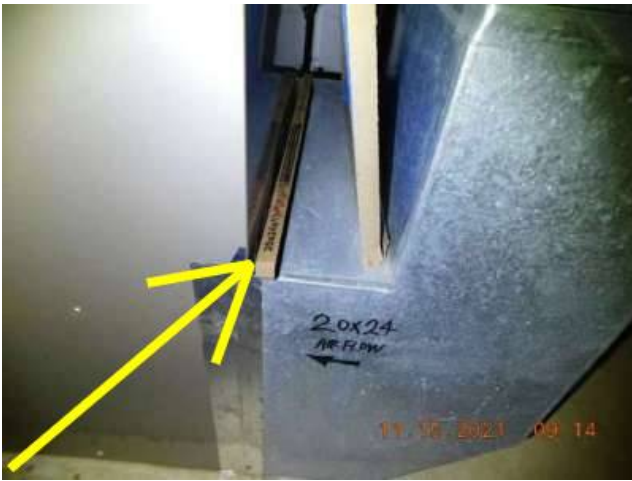
Photo 61-1

61) Maintain - Recommend replacing or washing HVAC filters upon taking occupancy depending on the type of filters installed (disposable or reusable). Regardless of the type, recommend checking filters monthly in the future and replacing or washing them as necessary and in accordance with the filter manufacturer's instructions. How frequently they need replacing or washing depends on the type and quality of the filter, how the system is configured (e.g. always on vs. "Auto"), and on environmental factors (e.g. pets, smoking, frequency of house cleaning, number of occupants, the season).

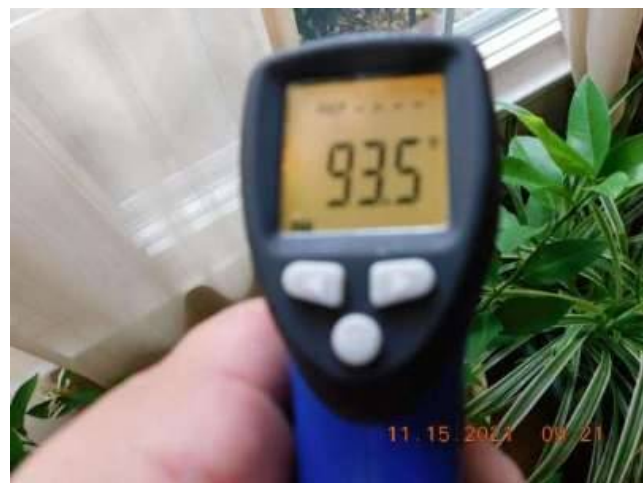
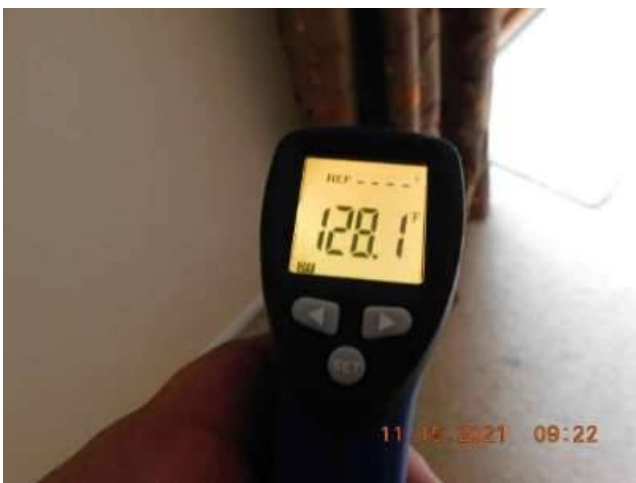
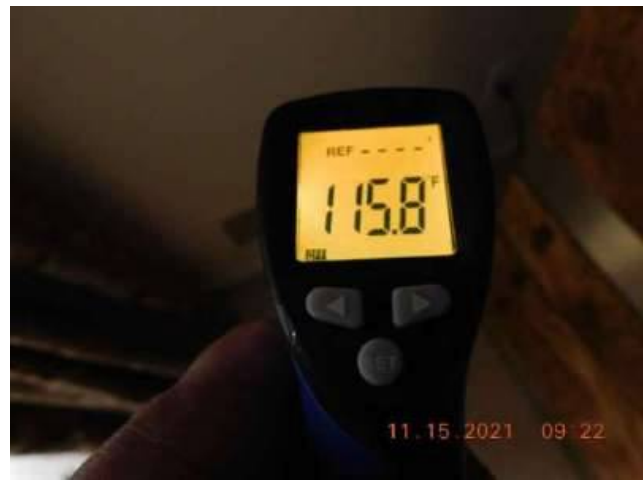
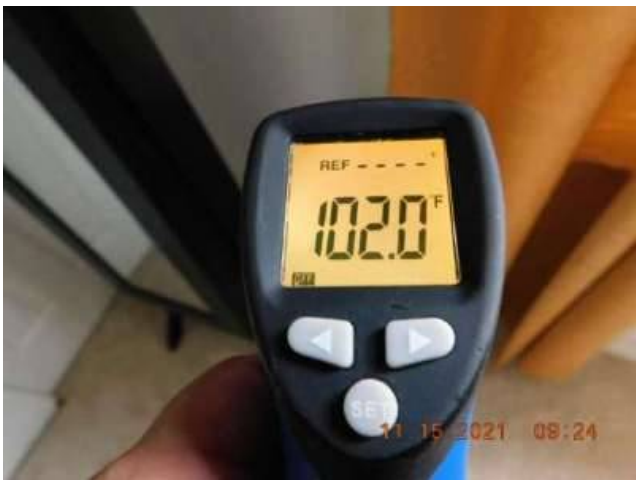
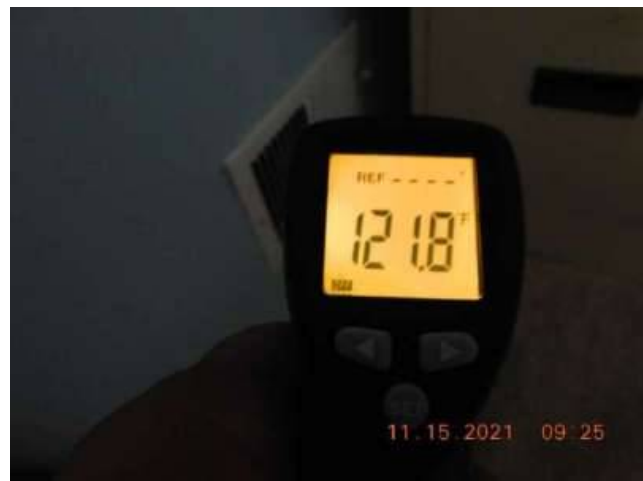
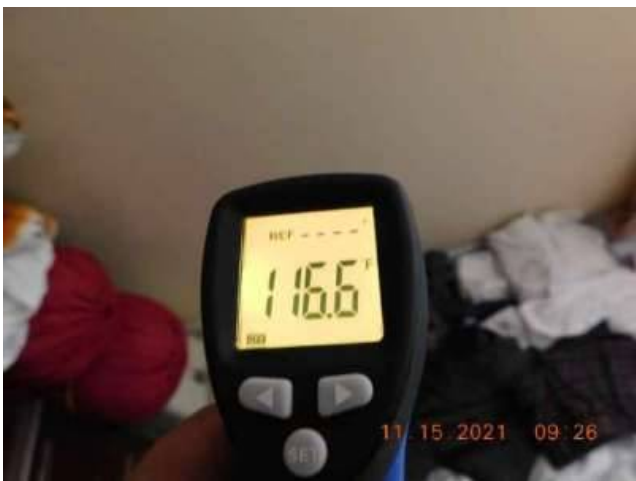
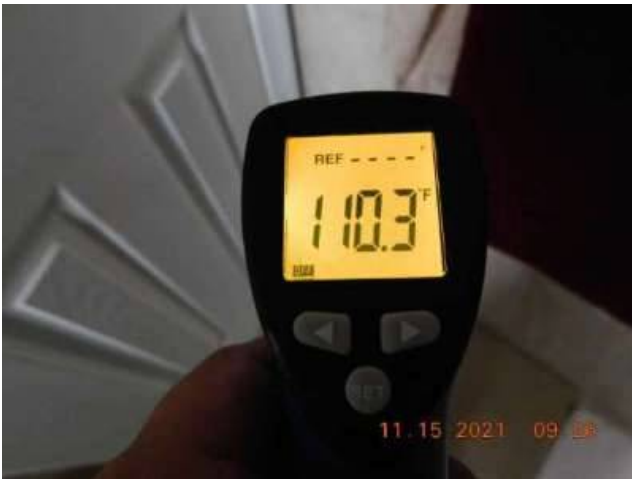
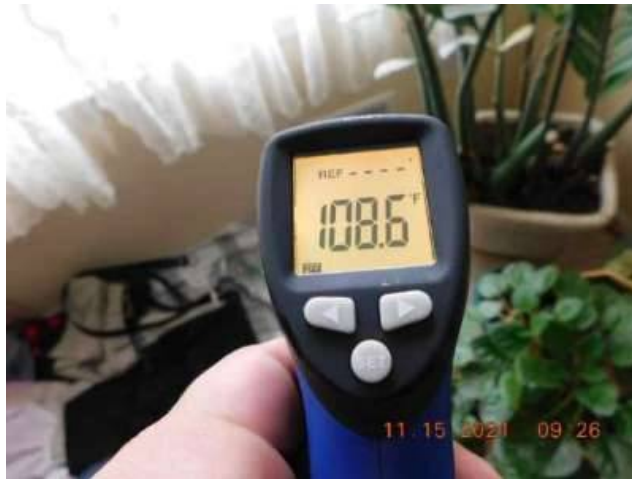
65) Comment/FYI - Sample heat temperatures. All accessible air supply registers were measured. A few examples are shown.

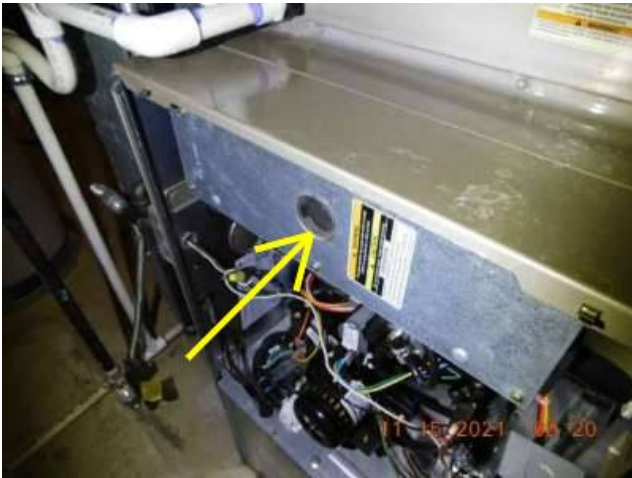
66) **Comment/FYI** - The furnace's burners were blue in color indicating proper fuel combustion.

Photo 66-1 Close up through this sight glass in the next photo.

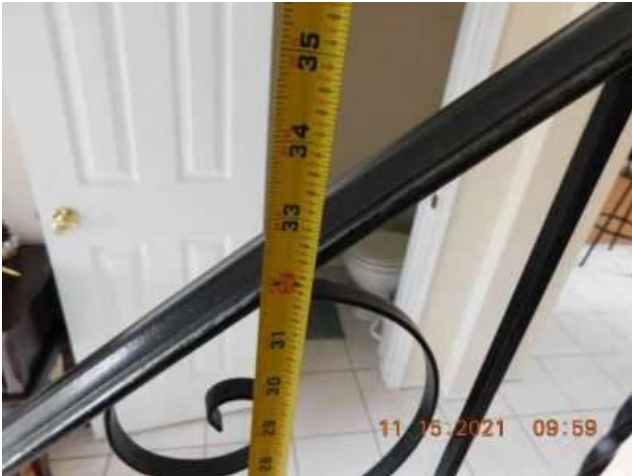
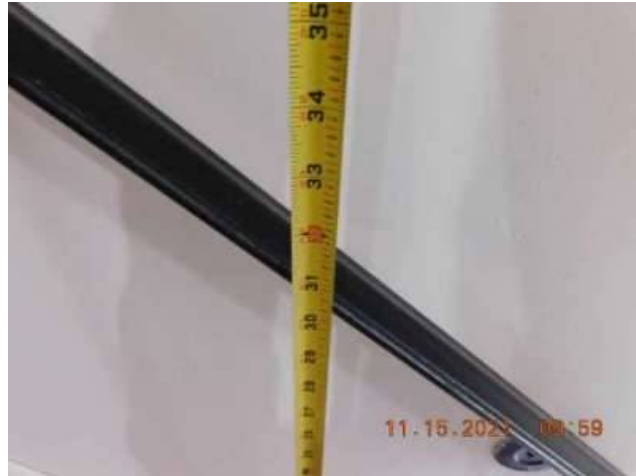
76) Material Defect/Safety, Replace - Handrails at one or more flights of stairs were too low or too high and pose a fall hazard. Handrails should be located at least 34 inches and at most 38 inches above the nose of each tread/riser. Recommend that a qualified person repair per standard building practices.

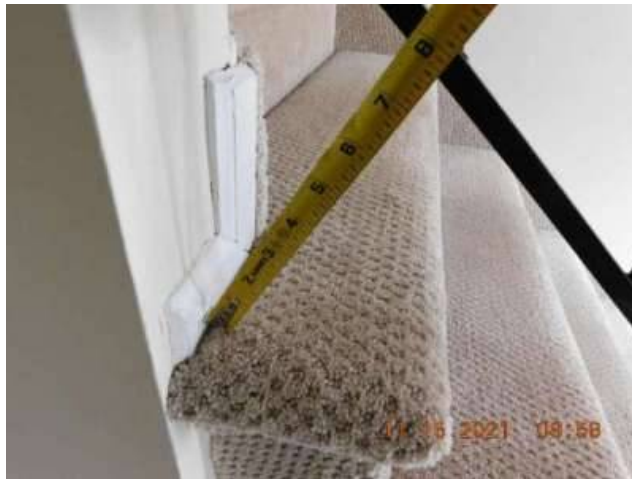
Photo 77-2

77) Material Defect/Safety, Replace - Guardrails at one or more locations with drop-offs higher than 30 inches had gaps that were too large. This poses a safety hazard for children (e.g. falling, getting stuck in railing). Guardrails should not have gaps or voids that allow passage of a sphere equal to or greater than 4 inches in diameter, or 6 inches in diameter at triangular spaces between stair edges and guardrails. Recommend that a qualified contractor repair or replace guardrails per standard building practices.
