Regal Home Inspections, LLC

Find of the Week 6/22/2019

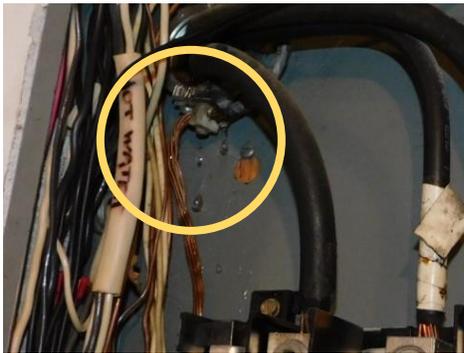
As I removed the panel cover, I commented to my assistant that my fingers that held the bottom of the panel as it was removed were now wet. After I put the panel cover down on and leaned it against the wall, I looked inside the panel and water was pouring in from the outside! For effect I used the word "Pouring" when it was a constant trickle. Regardless, ANY water getting into a circuit breaker panel may as well be a tsunami. IT DOESN'T BELONG! [Lots of emphasis going on here].

Notice the water as highlighted in both photos. Water is entering the panel as seen on the photo on the left and drops of water are hanging off the wires in the photo on the right.

I wasn't going to test my good fortune as I hadn't yet been electrocuted so I told the flipper that I was going to leave the cover off so it could be repaired.
