Regal Home Inspections, LLC

Find of the Week 5/11/2019

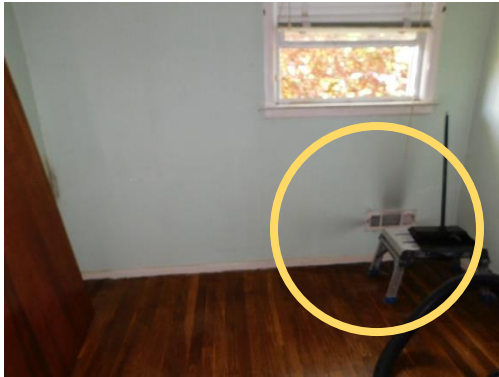
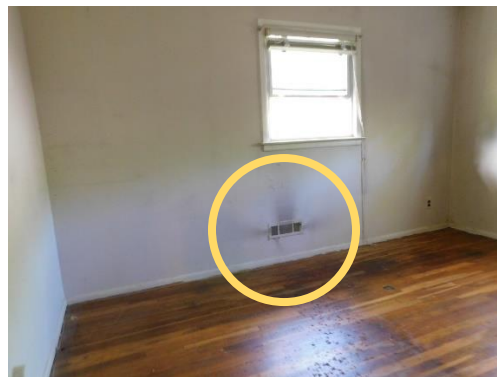
There may be a leak in the heat exchange where some gasses do get into the circulating air. This can be fatal to the occupants because some of the gasses include carbon monoxide. Carbon monoxide kills and often does.

At this inspection, there are soot marks around the air supply registers. Where's the soot coming from? It may be a leak in the heat exchange. This is classified as a, "Material Defect" in accordance with NJ home inspection standards of practice. The house is not occupied and the clients were advised to have it evaluated immediately. The furnace will likely need to be replaced. The heat exchange is not a part that can be replaced by itself. Additionally, the furnace was manufactured in 1992 so it's past its typical service life.
