Regal Home Inspections, LLC

Finds of the Week 9/14/2019

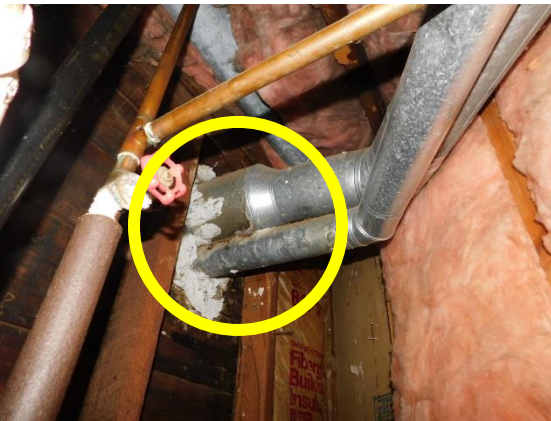
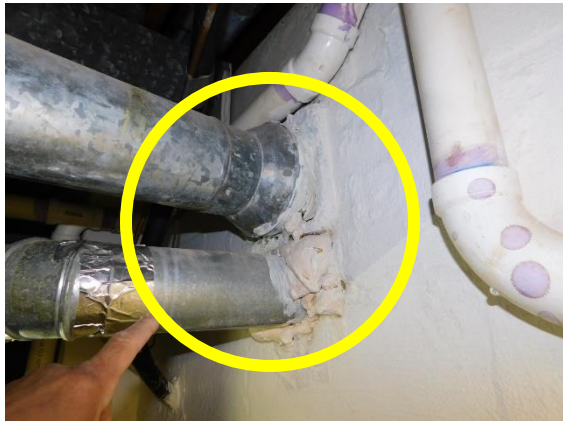
The standard is that the metal flue for the smaller (As measured by BTU) appliance has to enter the combined flue above the metal flue for the larger BTU appliance. Your average 40 or 50 gallon tank water heater is around 38,000BTU. Your average furnace is usually between 80,000 and 110,000BTU so the water heater must enter the combined flue above the furnace.

Shown below are two, incorrect installations. One was seen on Friday in Lincroft and the other was seen on Saturday in Spotswood. In both instances, the water heater enters the combined flue below the larger furnace.
