Regal Home Inspections, LLC

Find of the Week 5/18/2019

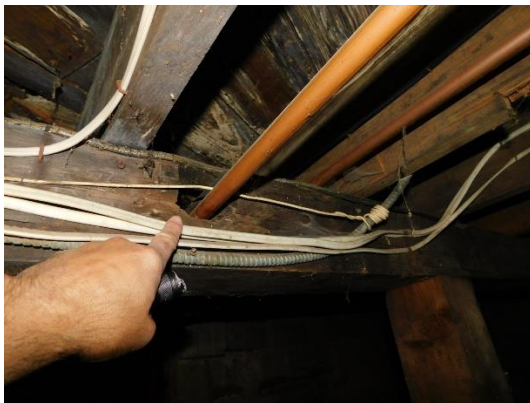
This happens more often than it should. A plumber cuts a beam to make life easier than routing the copper pipe over or under the beam. It seems to me that it would take longer to cut the beam than simply installing a couple of elbows in the pipe to go around it.

Beams should never be cut or drilled. At this location, there was more than one such notch in the important, structural beam.
