Regal Home Inspections, LLC

Find of the Week 8/3/2019

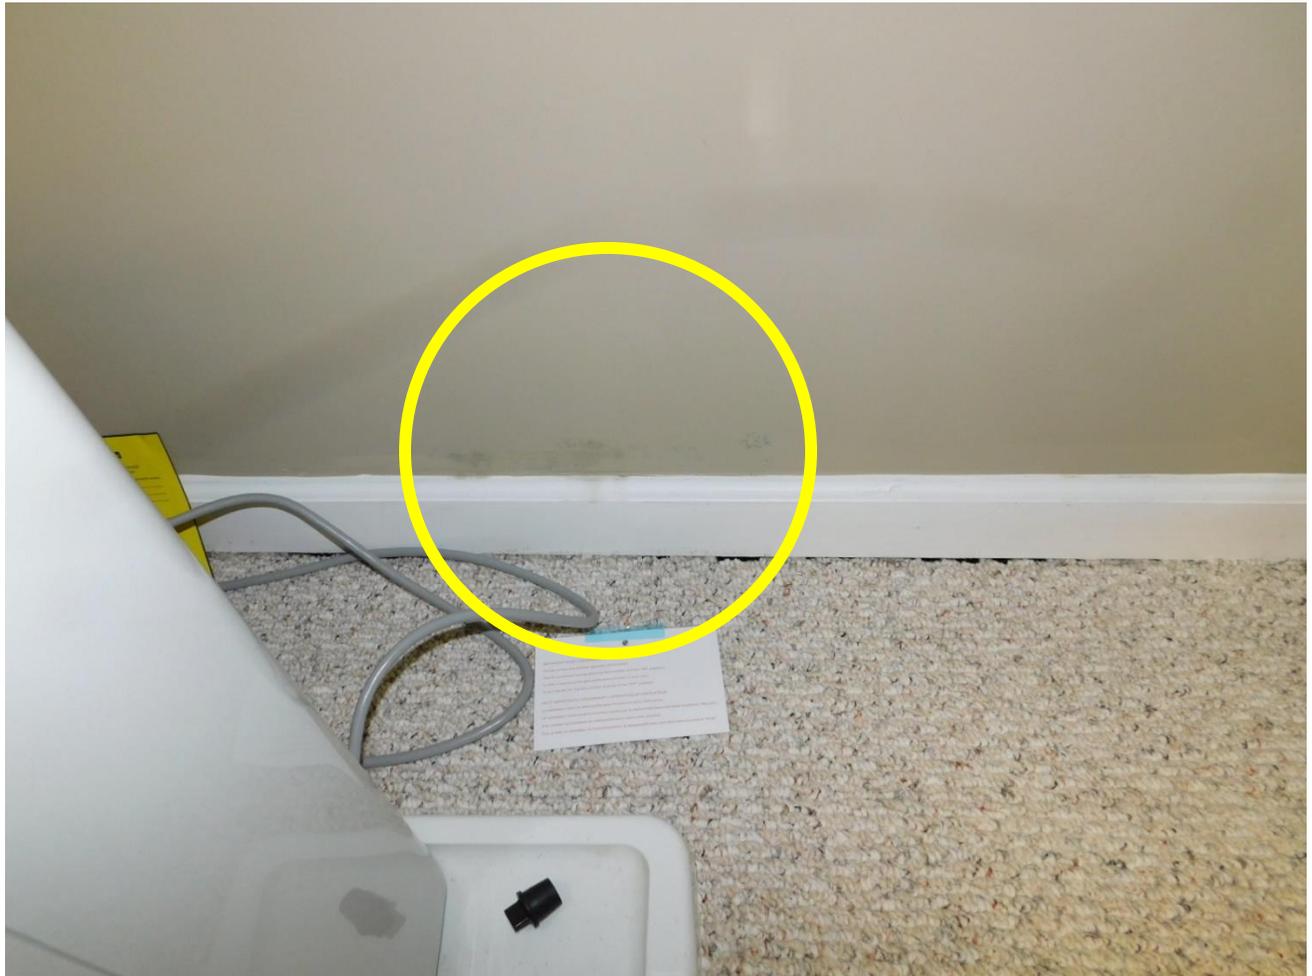
In this case there were very small specs on the wall just above the molding. Can you see it in this photo?

“1) Material Defect/Major, Repair/Maintain/Service, Evaluate -
Microbial growths were found at one or more locations in the basement. It is beyond the scope of this inspection to identify what substance or organism this staining is. However such staining is normally caused by excessively moist conditions, which in turn can be caused by plumbing or building envelope leaks and/or substandard ventilation. The moisture meter confirms that the levels of moisture in the drywall (Sheetrock [® Like material]) are excessive. These conducive conditions should be corrected before making any attempts to remove or correct the staining. Normally affected materials such as drywall are removed, enclosed affected spaces are allowed to dry thoroughly, a mildewcide may be applied, and only then is drywall reinstalled. For evaluation and possible mitigation, consult with a qualified industrial hygienist or mold/moisture mitigation specialist. Please note that it's very possible that the extent of the microbial growths is more significant inside the wall and only, "the tip of the iceberg" is showing on the outside.”

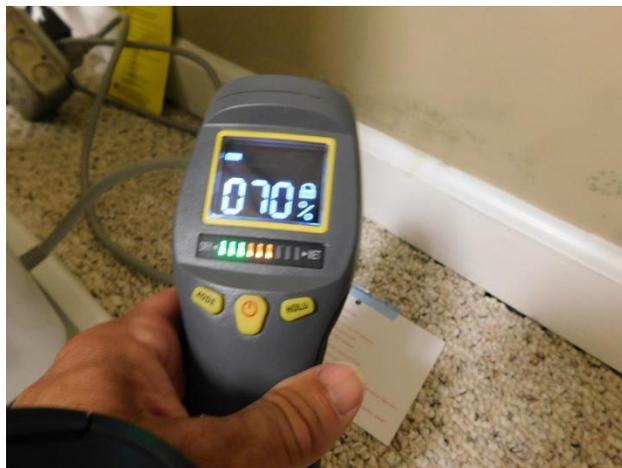
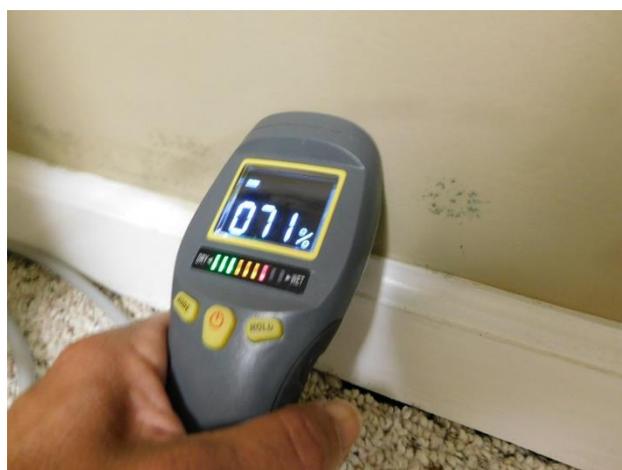
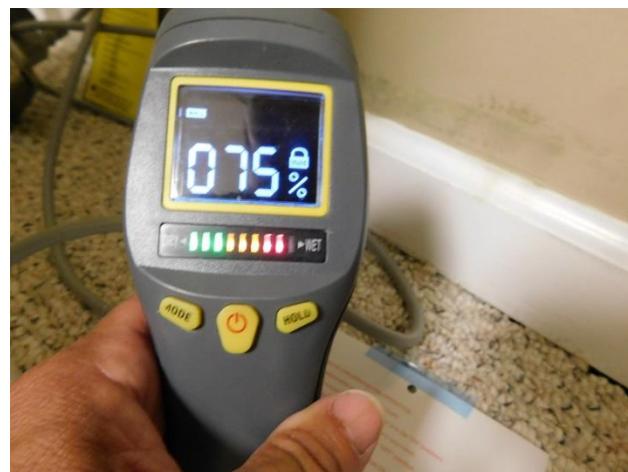
As you can see in the next few photos using a moisture meter (a required tool for home inspectors as stated in the NJ AC) confirms that there are high levels of moisture in the drywall wall. The source is unknown but the report states,
