Regal Home Inspections, LLC

Find of the Week 3/23/2019

Aged Roof Surface

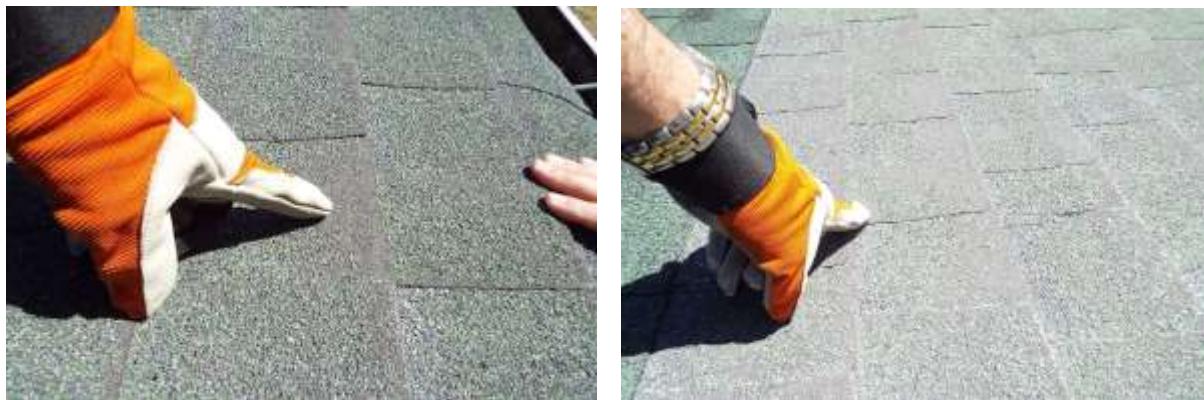
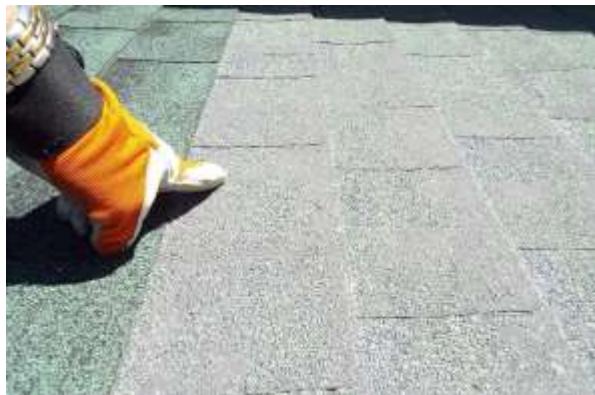
In this case, the loss of the gravel on the surface of the roof shingles is an indication that the roof shingles may be old and more importantly, the deterioration of the shingles will continue and at an accelerated rate. The purpose of the gravel on a roof shingle is to block the sun's harmful, UV rays. Without the gravel the shingle's basic materials will be exposed to the sun's rays and age and become damaged more rapidly.

Even in the close-up photos below it's hard to see the missing gravel and from the ground, it's near impossible to see that detail (or missing detail). This roof is definitely worn and near the end of its service life. That's a significant cost to the buyer if they weren't aware and soon after moving in they had to replace the roof.

Therefore, from a home inspection and report writing perspective, this condition was flagged as a, "Material Defect"

In accordance with the NJ home inspection standards of practice, a Material Defect is (and I paraphrase here) a condition of aspect of the structure or a system or component that substantially effects the value, habitability or safety of the house.

In this case, in my judgement, the potential cost to replace the roof substantially effects the value and cost of the house. Therefore it was flagged as a material defect in the property inspection report.
