Regal Home Inspections, LLC

Finds of the Week 9/20/2019

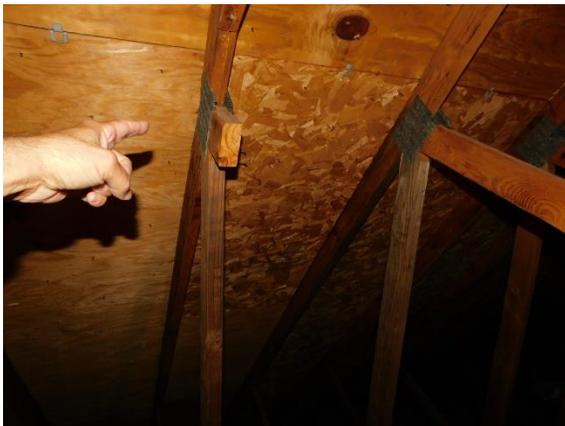
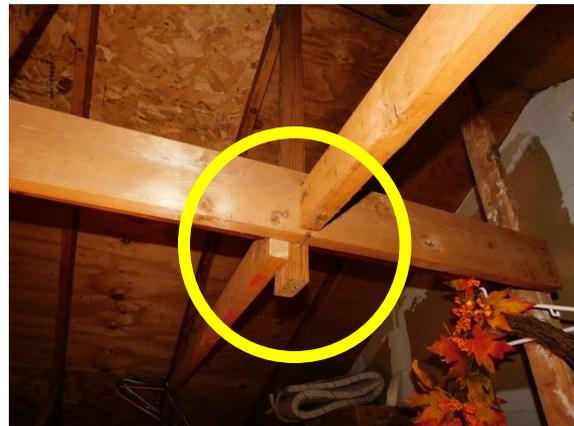
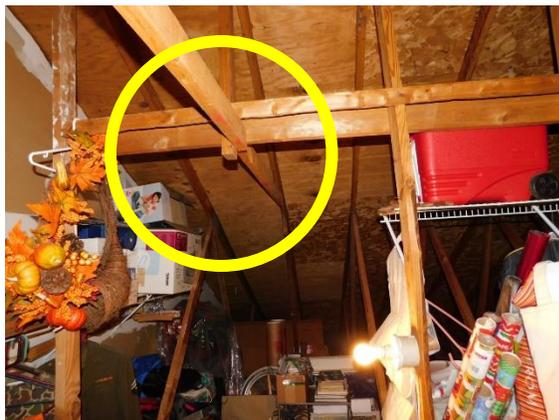
In this find, trusses were cut in a townhouse to allow for the installation of attic steps for someone to gain access to an area that the occupant often can't access.

As seen in these photos, the trusses were cut and therefore, the structure of the roof was improperly modified. In the report this was brought to the attention of the client. They were advised to have the modifications evaluated by an engineer and that they will likely

have to be put back to their original condition. Additionally, in the report I tried to emphasize to the buyer that if this isn't properly addressed now, before they own the unit, then years down the line when they try to sell the home they may then be responsible for the modifications and have to pay for any repairs.

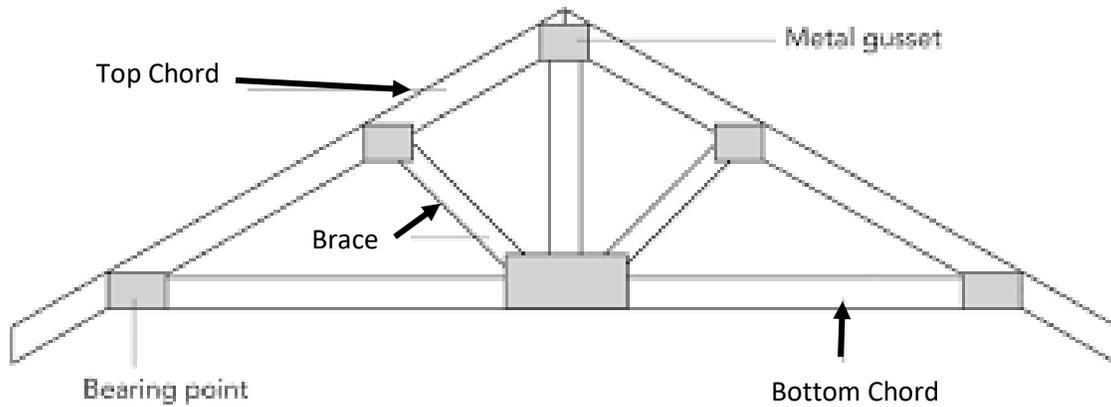
Below is a diagram of a roof truss. Cutting or modifying any truss member, Top chord, a brace or bottom chord, weakens the entire truss and therefore the roof structure. In this find, the three braces were modified to make room for the pull down attic steps.
