Regal Home Inspections, LLC

Property Inspection Report

Property address: **1 Any Street
Manalapan, NJ 07726**

Inspection date: **Sunday, September 29, 2019**

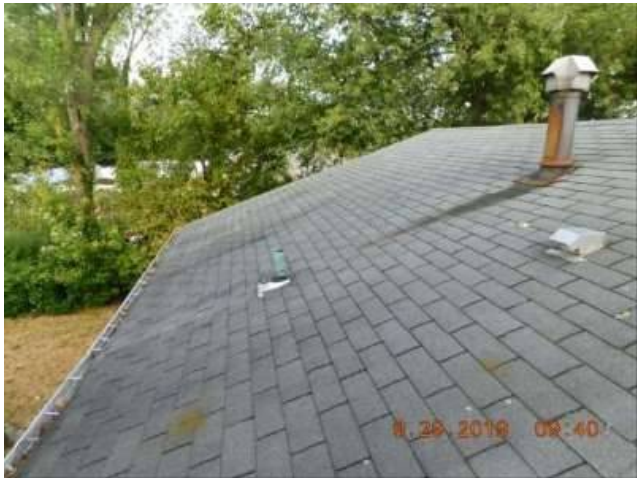
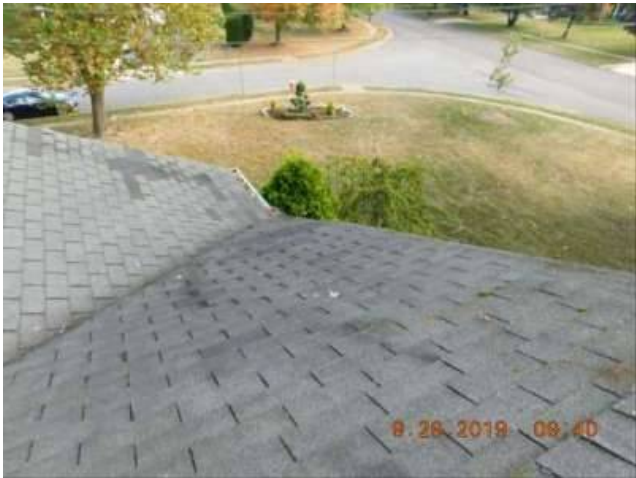
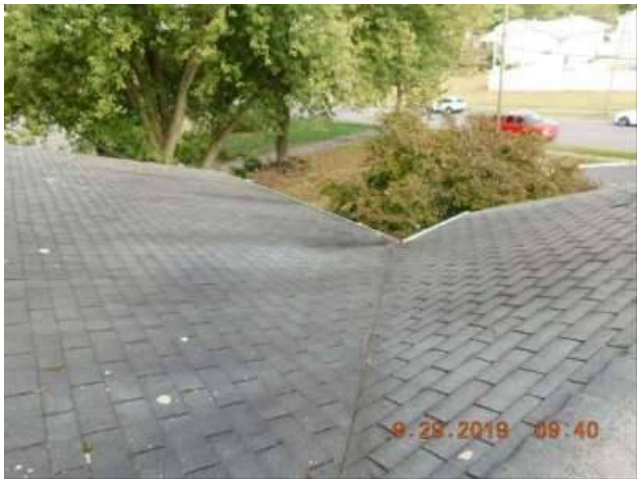
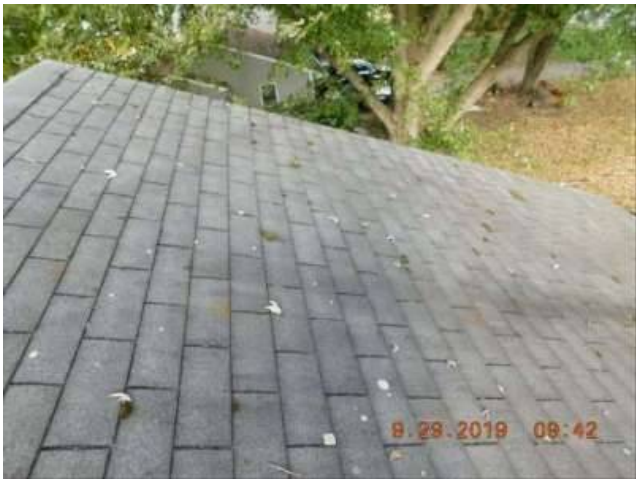
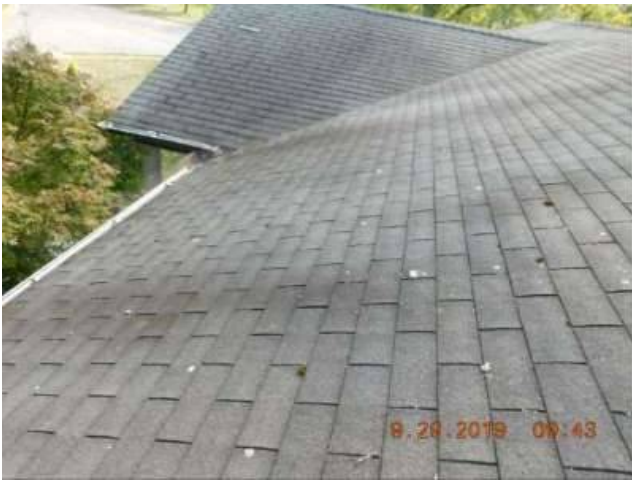
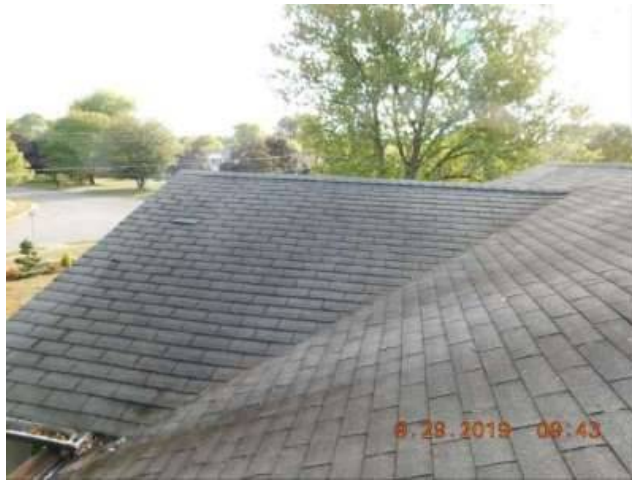
21) *Comment/FYI* - General roof photos.

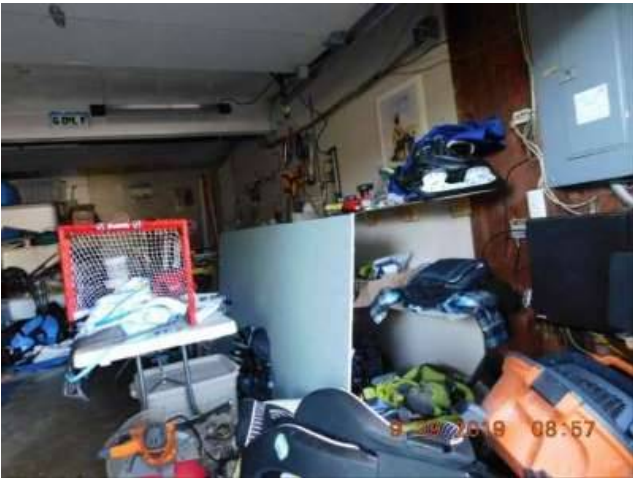
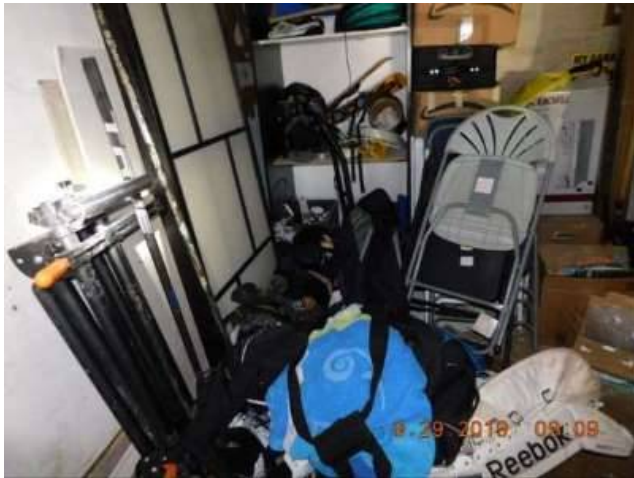
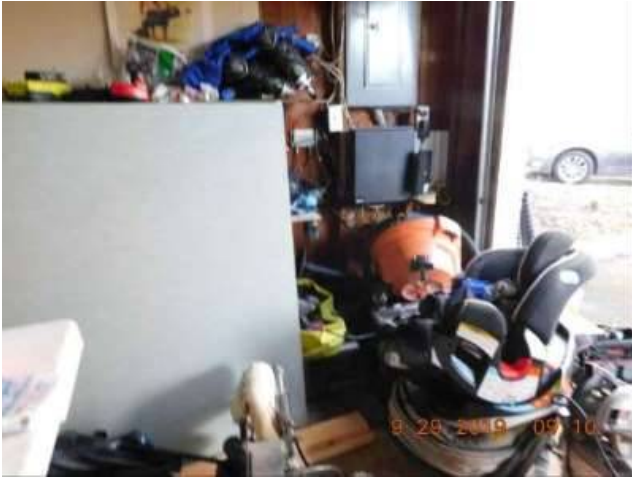
28) Comment/FYI - Areas of the garage were obscured by possessions. Areas that were not readily accessible for visual inspection are excluded from the inspection in accordance with New Jersey home inspection standards of practice. Please note that after the seller's possessions are removed damage, cracks, or deterioration may then be exposed including indications of wood destroying insects. Portions of the garage (house and structure) that are behind these obstructions are not available for visual inspection and therefore excluded from the inspection. It is always possible that latent (aka hidden) material defects exist behind these obscured areas. In accordance with the NJ home inspection administrative code, the inspector conducts a visual inspection, "...without requiring the moving of personal property...destructive measures..." . When furnishings, stored items, debris or other obstructions are present, all areas or items that are obscured, concealed or not readily accessible are excluded from the inspection.

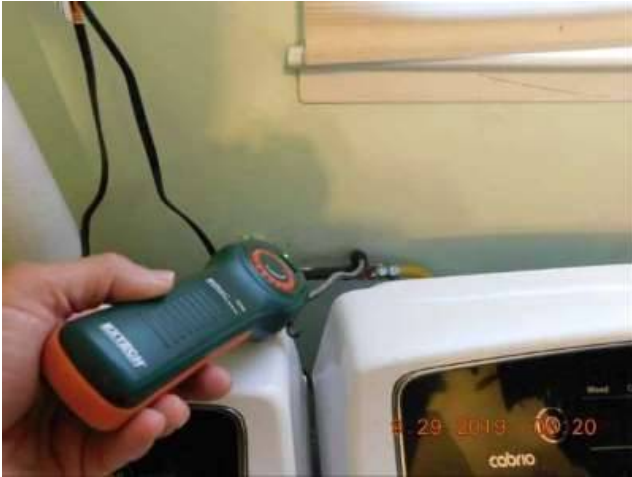
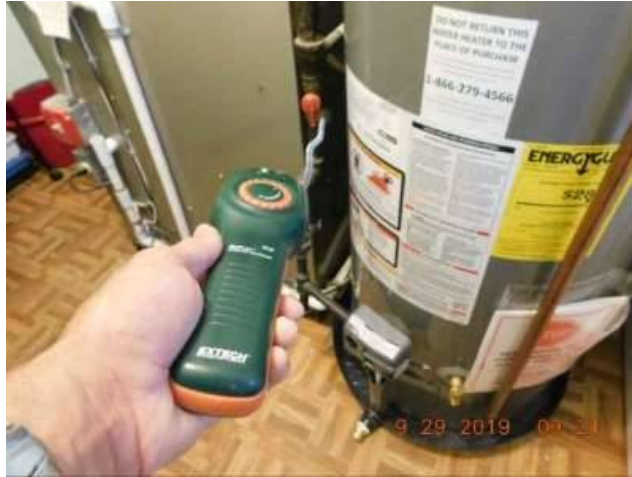
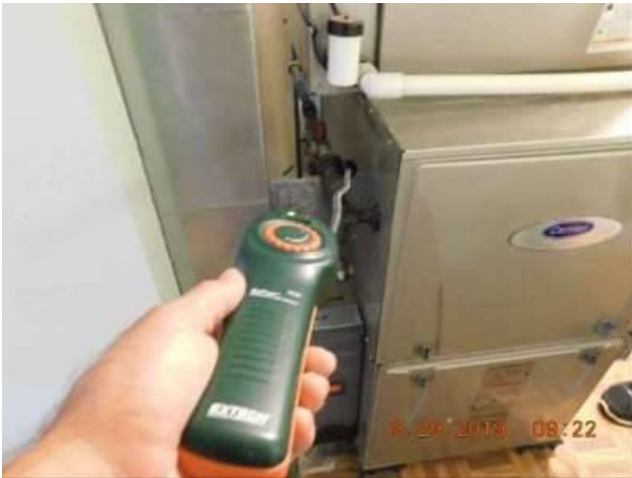
37) Monitor, Comment/FYI - The natural gas lines around the dryer, furnace and the water heater were checked with a combustible gas detector for leaks. There was no access behind the kitchen stove. None were detected by the instrument. This is absolutely not a substitute for owner diligence, awareness and appropriate response if a natural gas odor is ever detected. Immediately leave the house and call 911.

Green meter with orange dial can be seen in the photos. The probe extends to the gas piping for testing for leaks. None were detected. Few examples shown below.

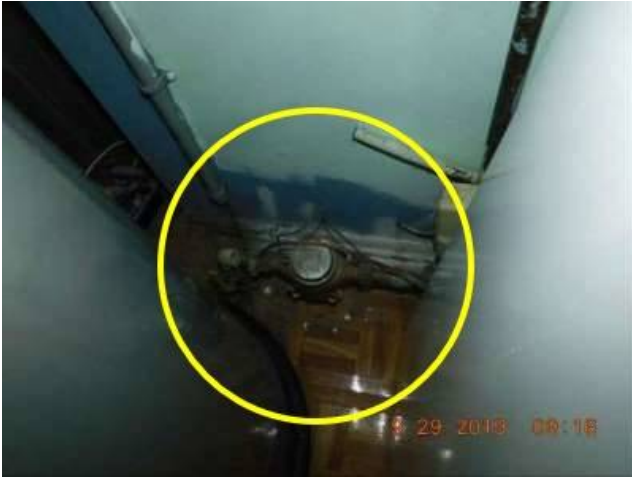
Photo 38-1

38) Comment/FYI - Water meter and main water shut off. Seen in the photo below between the furnace and the water heater.

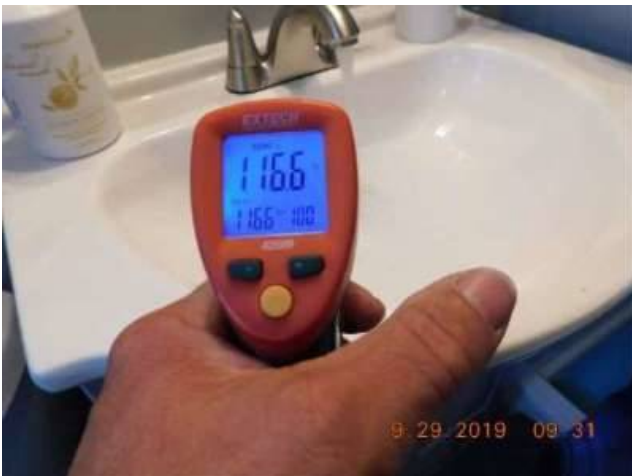
41) Comment/FYI - Sample water temperatures.

Photo 41-1 116.6

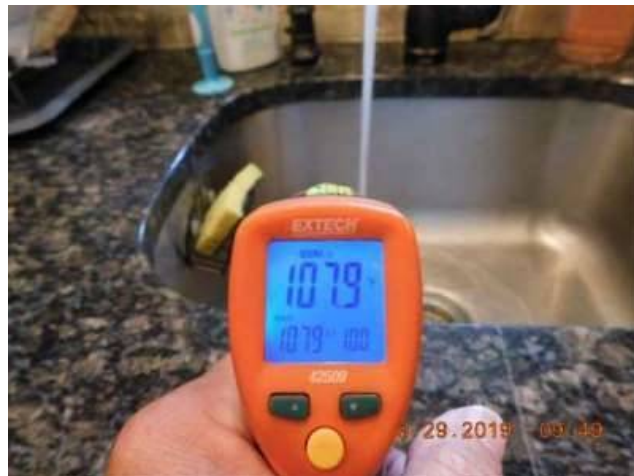
Photo 41-2 107.9

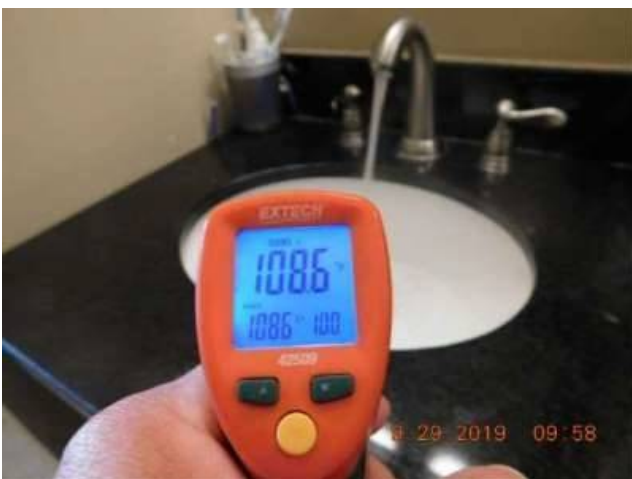
Photo 41-3 108.6

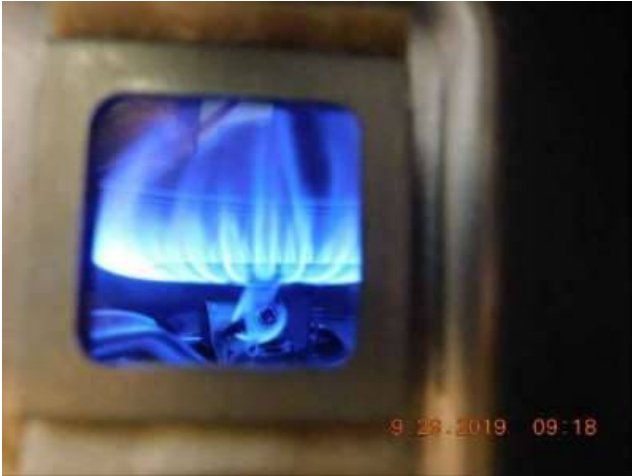
Photo 42-1

42) Comment/FYI - The water heater's burner flame was blue in color indicating proper combustion. As seen

through the water heater's sight glass.

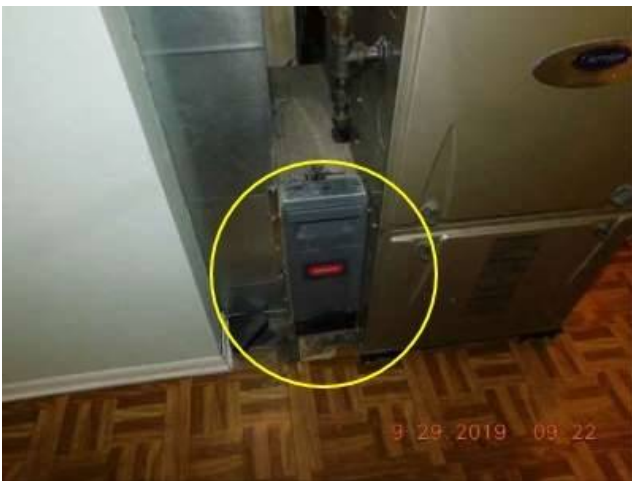
44) Maintain - Recommend replacing or washing HVAC filters upon taking occupancy depending on the type of filters installed (disposable or reusable). Regardless of the type, recommend checking filters monthly in the future and replacing or washing them as necessary and in accordance with the filter manufacturer's instructions. How frequently they need replacing or washing depends on the type and quality of the filter, how the system is configured (e.g. always on vs. "Auto"), and on environmental factors (e.g. pets, smoking, frequency of house cleaning, number of occupants, the season).

Photo 44-1 Filter chamber shown here with the cover on. Chamber cover removed in the next photo exposing the filter.

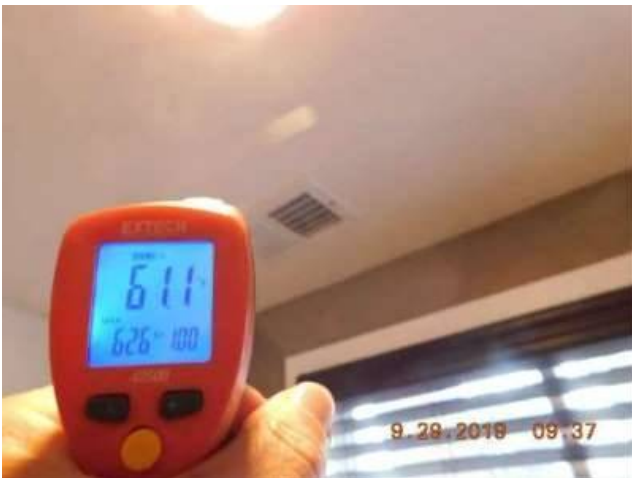
49) Comment/FYI - Sample AC temperatures.

Photo 49-1 Lower level temperatures shown here and in the next two photos. Upper level temperatures shown in the last three photos. 61.1

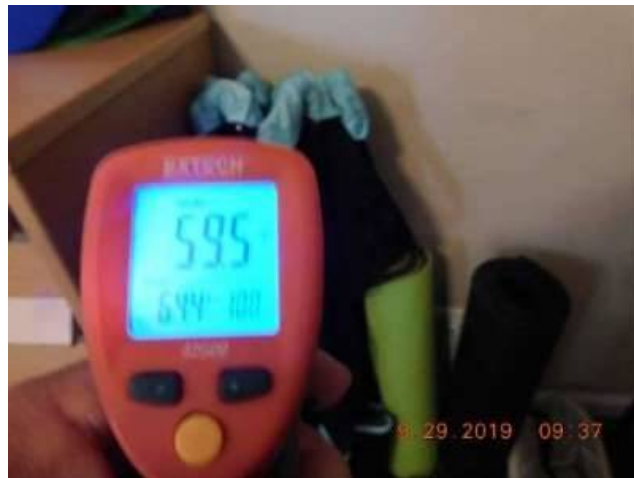
Photo 49-2 59.5

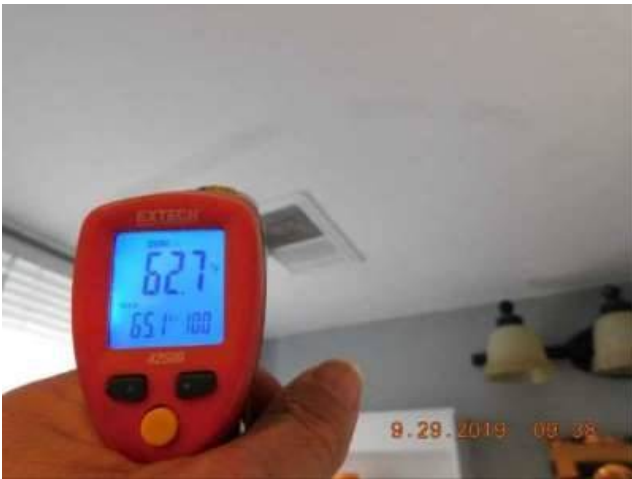
Photo 49-3 62.7

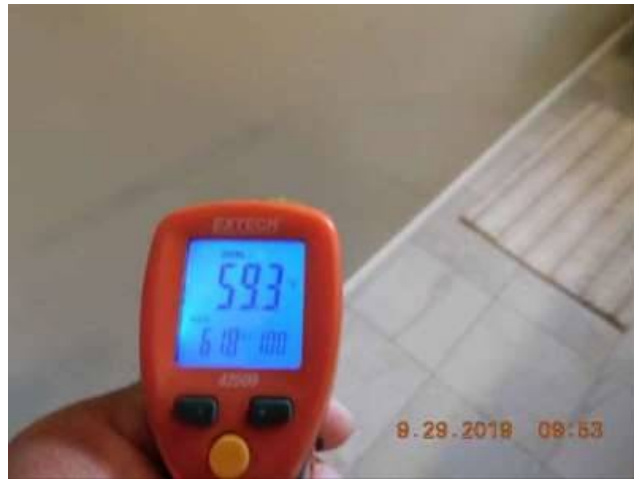
Photo 49-4 59.3

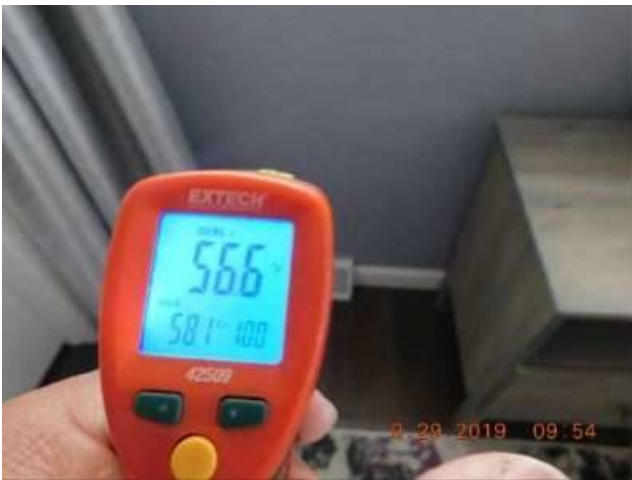
Photo 49-5 56.6

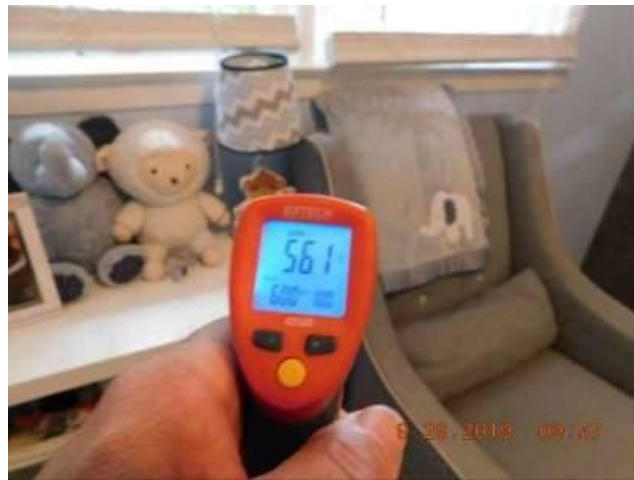
Photo 49-6 56.1
